**Federal Building and Fire Safety Investigation of the  
World Trade Center Disaster**

**Structural Fire Response and  
Probable Collapse Sequence of  
World Trade Center Building 7**

**NIST NCSTAR 1-9**

August, 2008

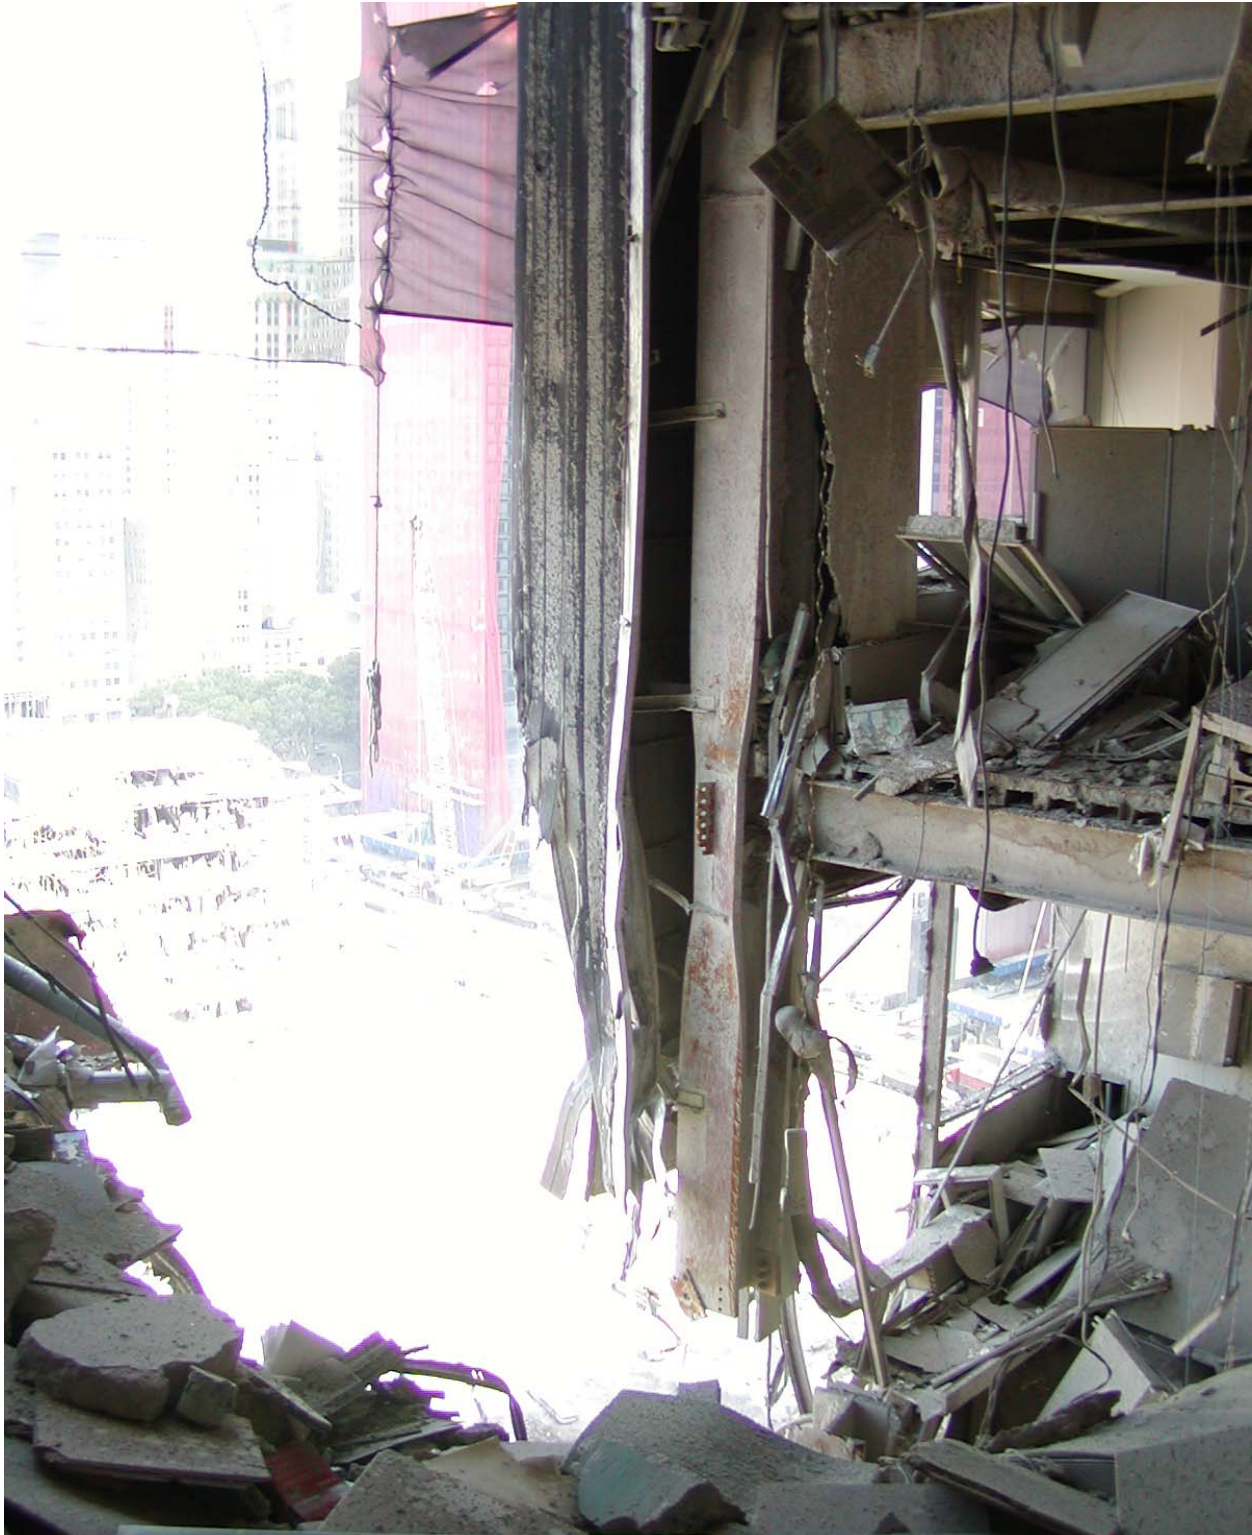
**Figure 2–31. Interior view of damage to the north face of 130 Liberty Street by debris falling from WTC 2.**

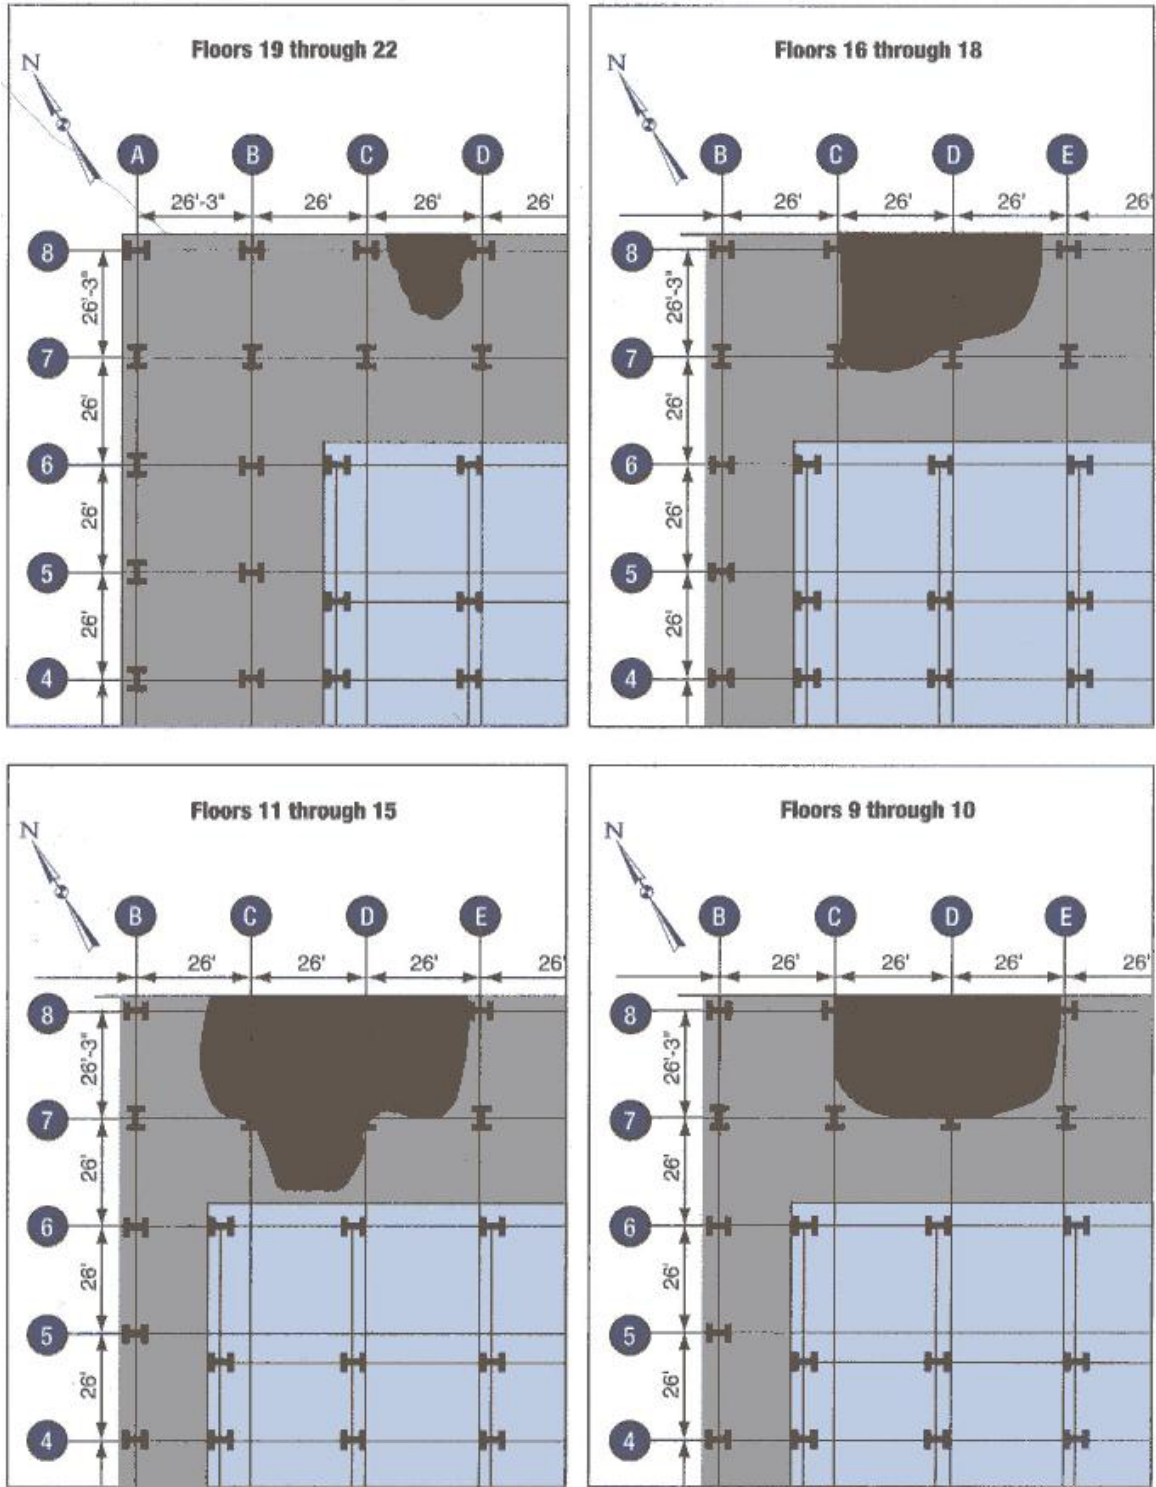
Figure 6-5 Approximate zones of damage – 19th through 22nd floors, 16th through 18th floors, 11th through 15th floors, and 9th through 10th floors.

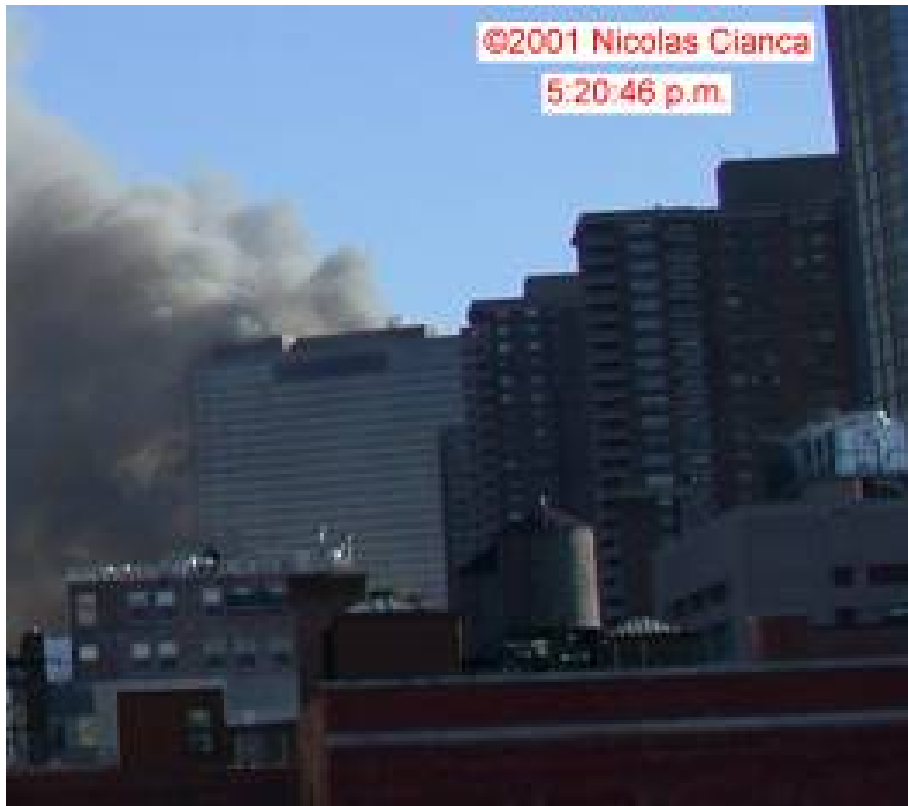
Figure 5–1. A photograph (top) and a frame from a video clip (bottom) showing the east penthouse of WTC 7 beginning to sink into the building.

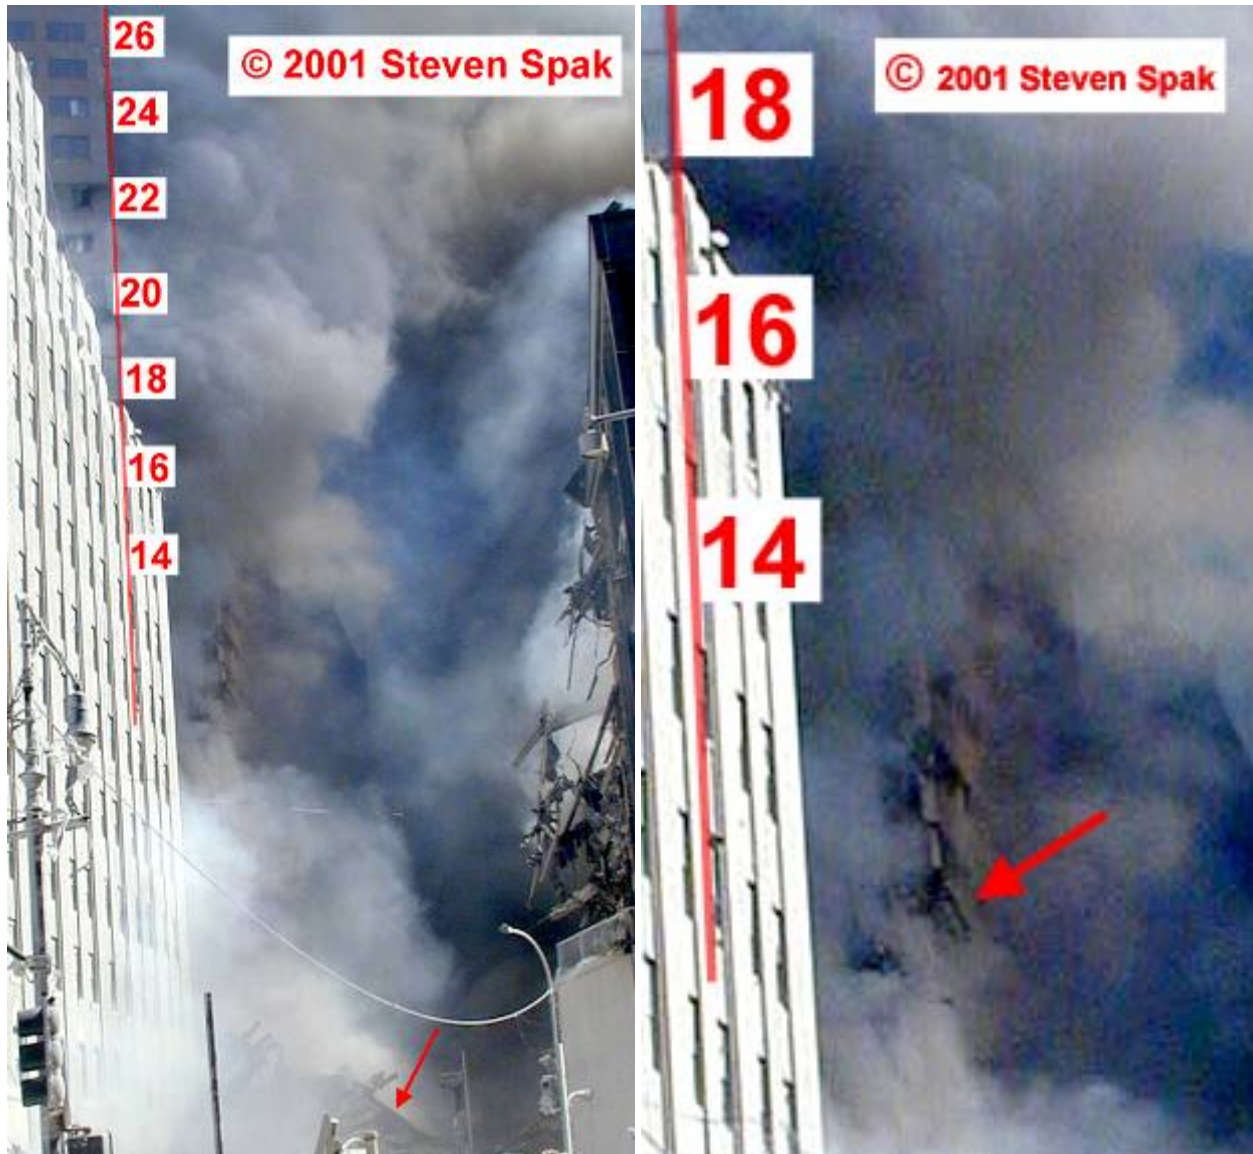
**Figure 5–53. Two enlargements from Figure 5–52, showing the south face of WTC 7.** The vertical red line indicates the location of the southwest corner of the building. Floor number locations were determined as described in the text. The red arrow in the left enlargement identifies debris that may be from the Promenade, and the arrow on the right indicates a characteristic damage pattern.

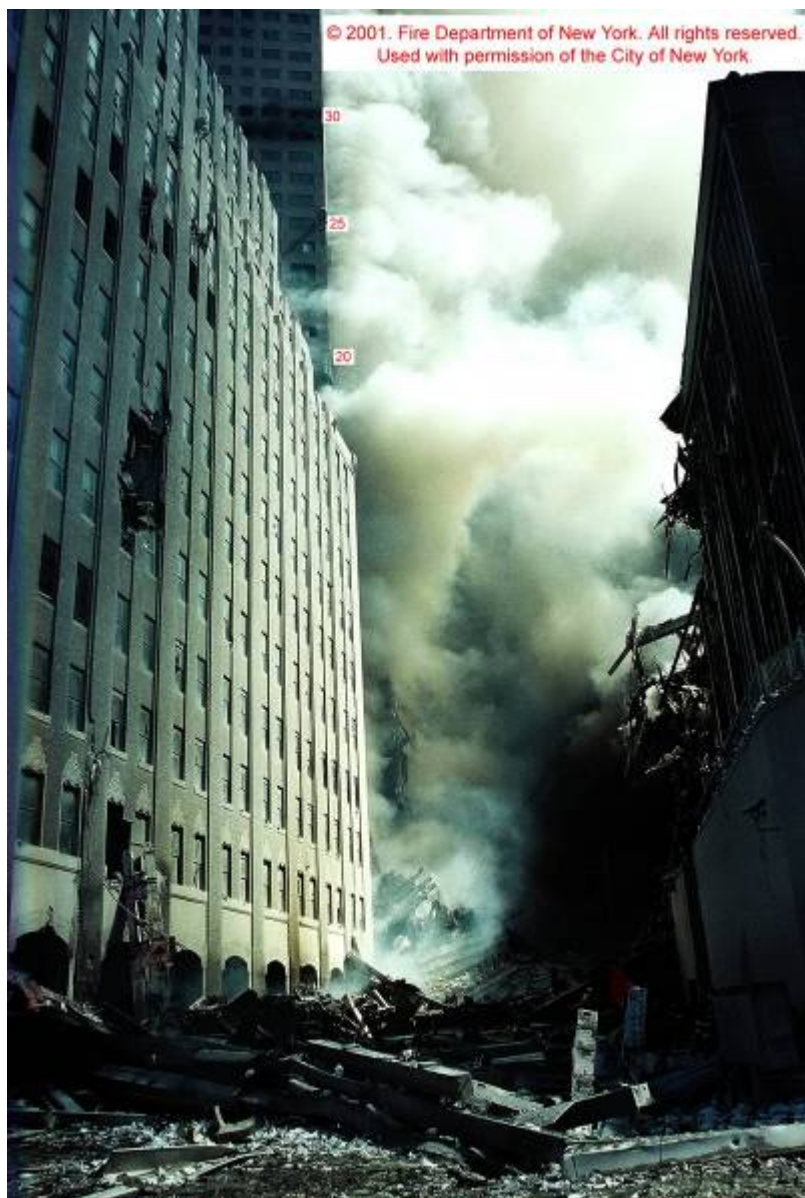
**Figure 5–56. Photograph of damage on the south face of WTC 7, shot looking down Vesey Street between the Verizon Building (left) and WTC 6 (right), shortly after 1:30 p.m.**  
The intensity levels have been adjusted.

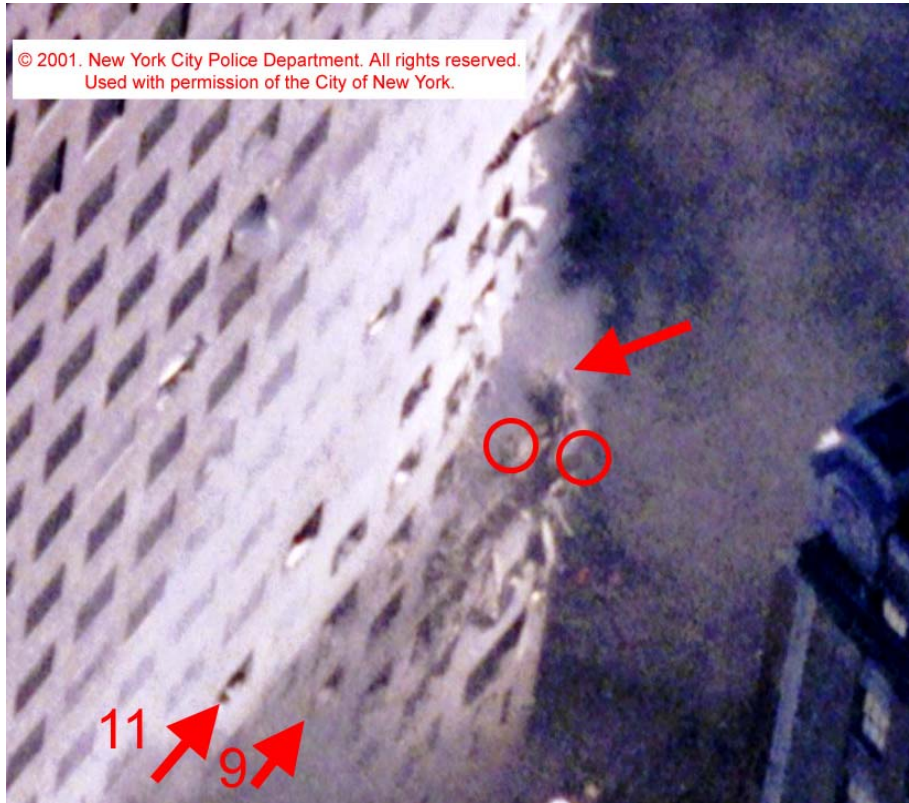
**Figure 5–69. Enlargement of an area from the photograph in Figure 5–64 showing the damaged southwest corner of WTC 7.**

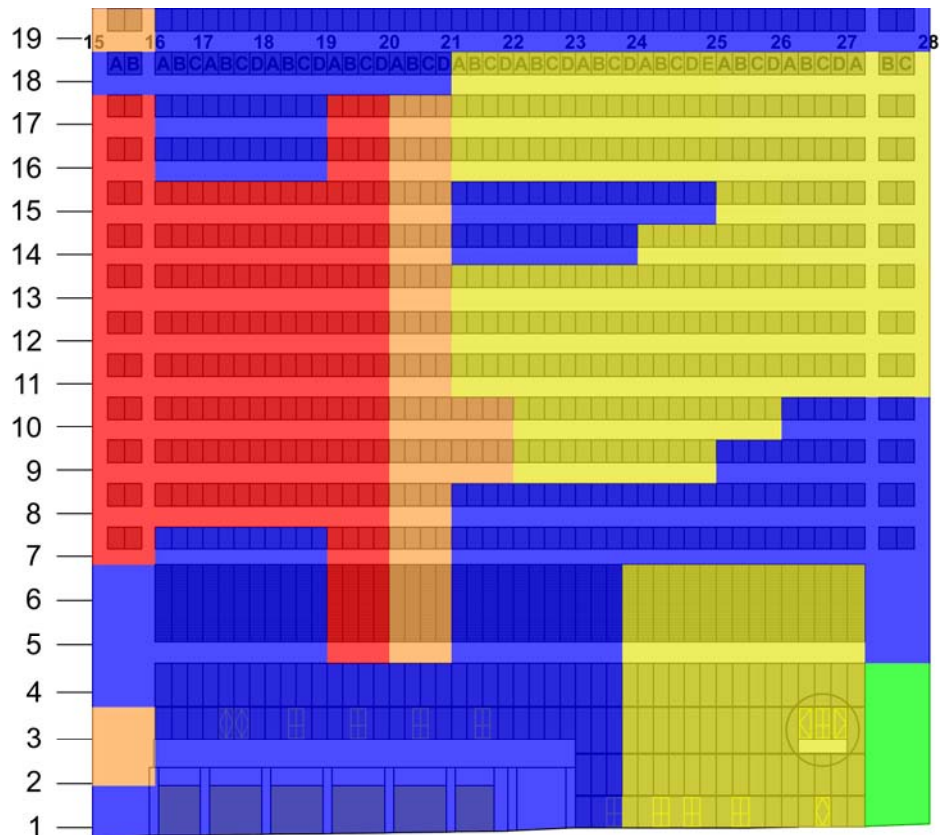
**Figure 5–73. Summary of observed damage for the lower 19 floors on the south face of WTC 7 following the collapse of WTC 1.**

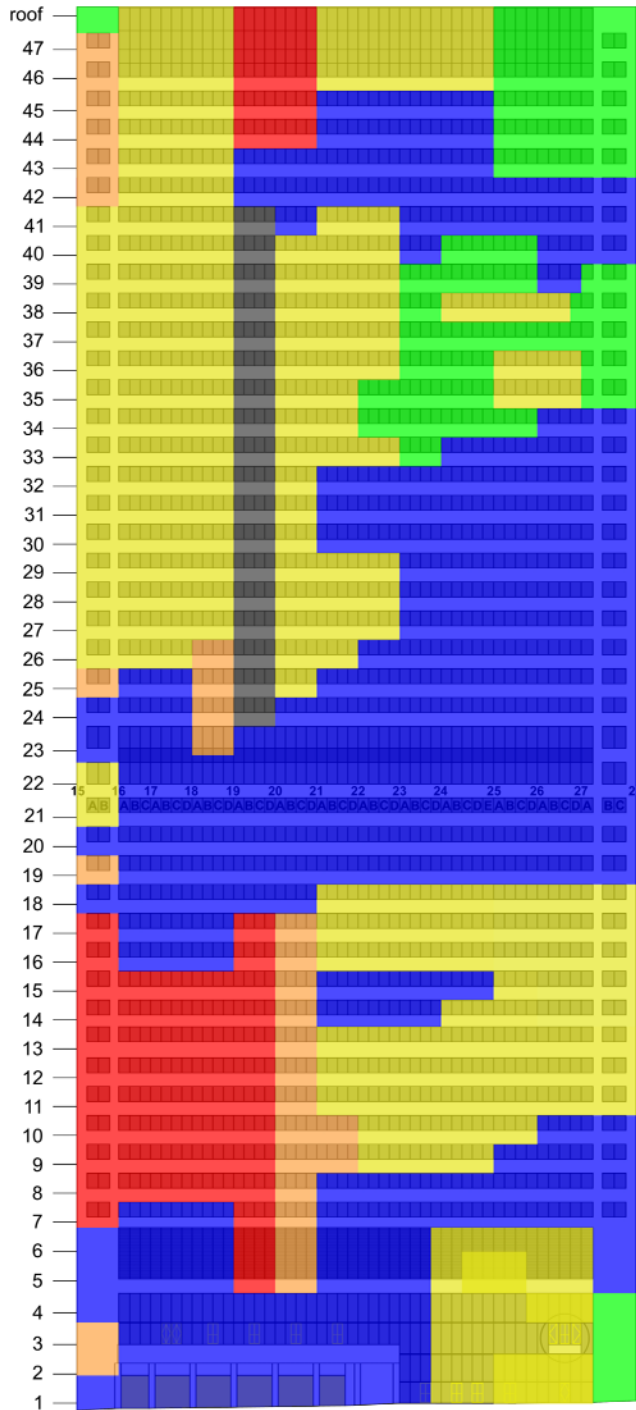
**Figure 5–83. Observed damage on the south face of WTC 7 following the collapse of WTC 1.**

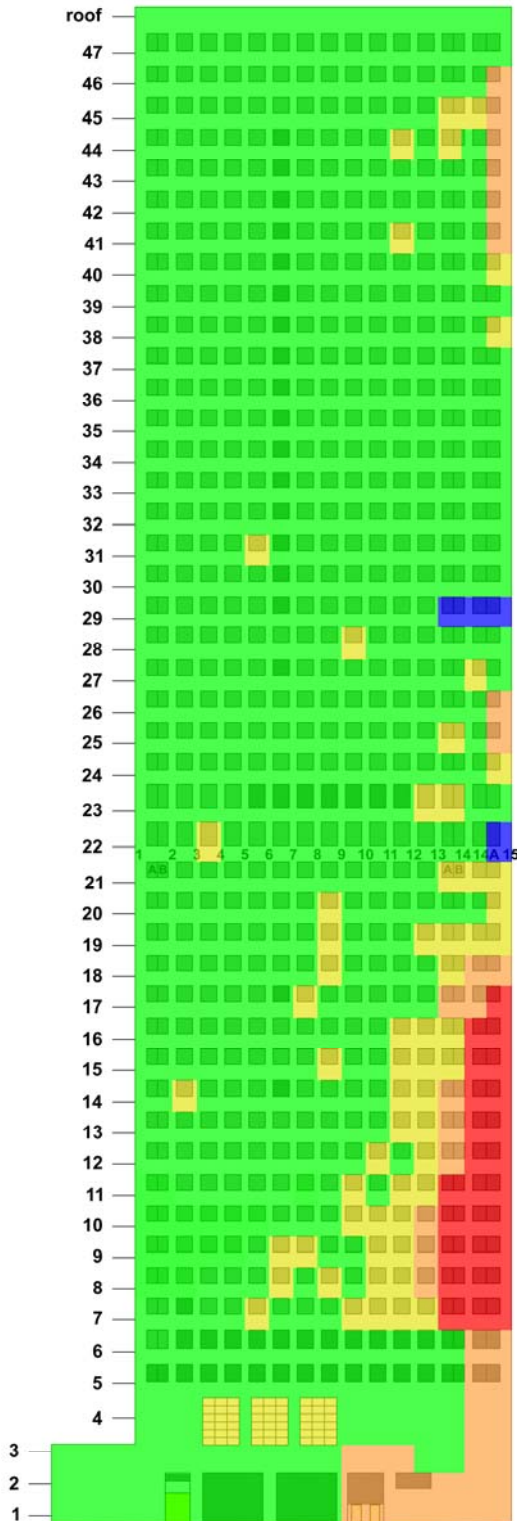
**Figure 5–89. Observed damage on the west face of WTC 7 following the collapse of WTC 1 is shown.**

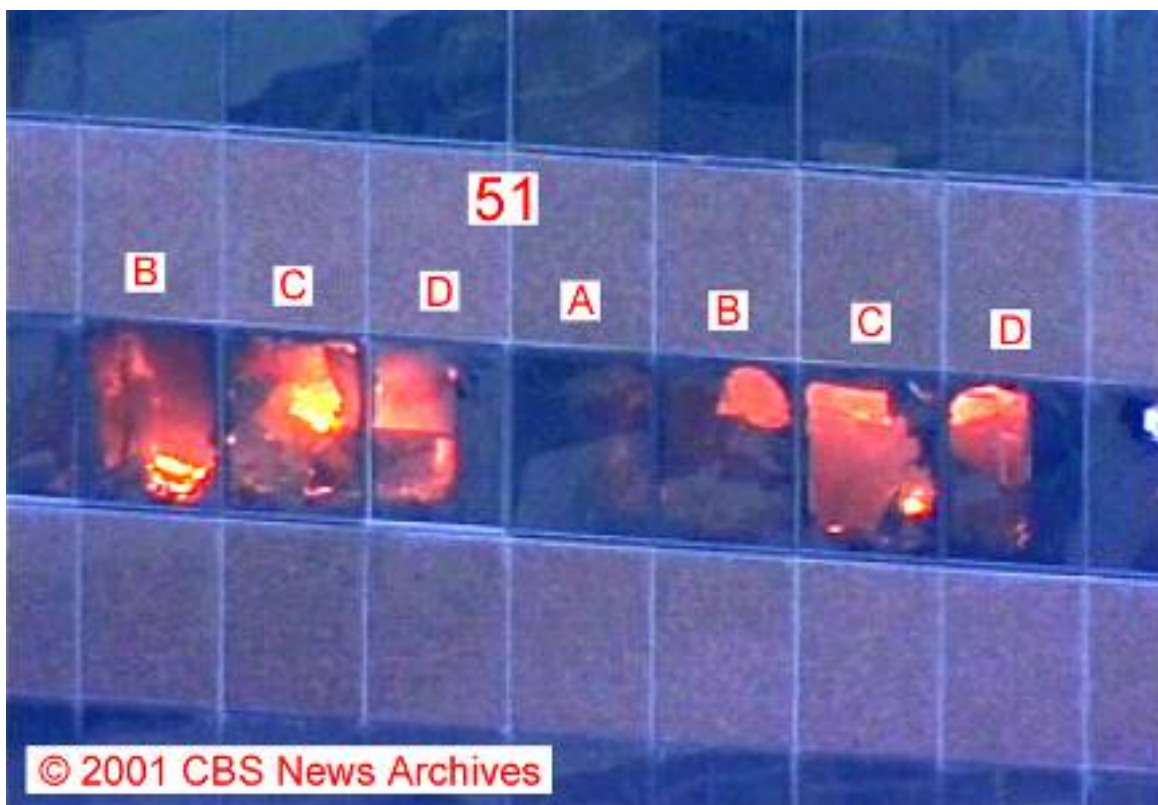
**Figure 5–120. Frame taken from a video clip shot looking down on WTC 7 from a building to the northwest showing the fires along a length of the north side of the 7<sup>th</sup> floor of WTC 7.**

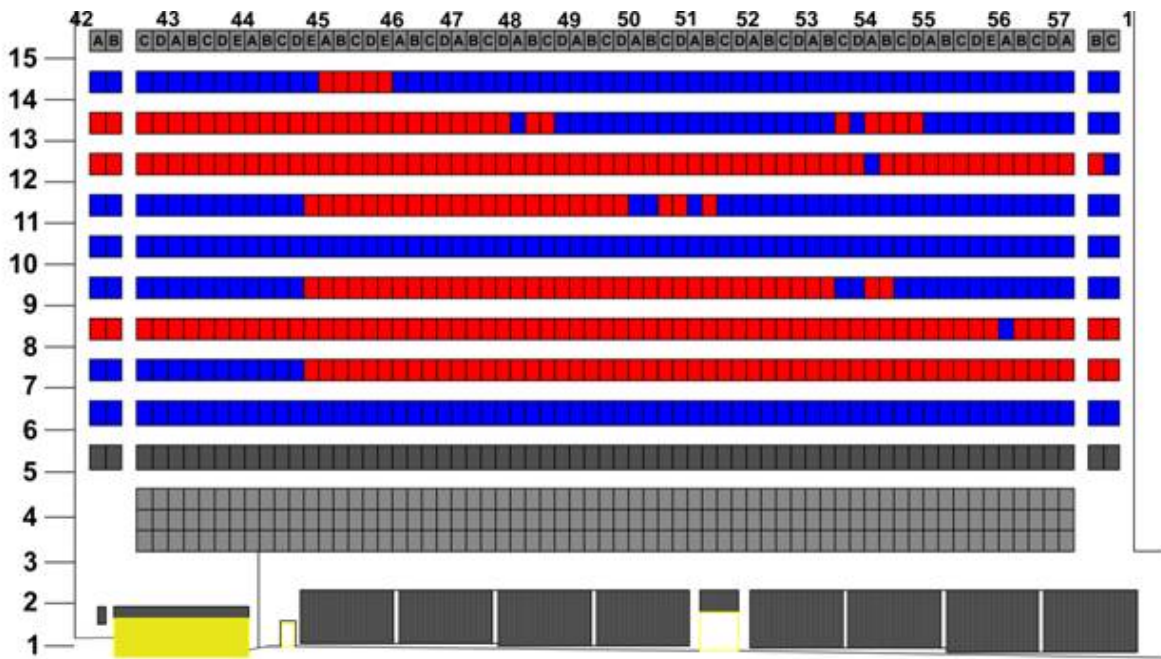
**Figure 5–180. Façade map of the north face of WTC 7 showing where windows were broken and/or fire was observed during the period when fire first appeared on the face shortly before 3:00 p.m. until the building collapsed at 5:20:52 p.m.**

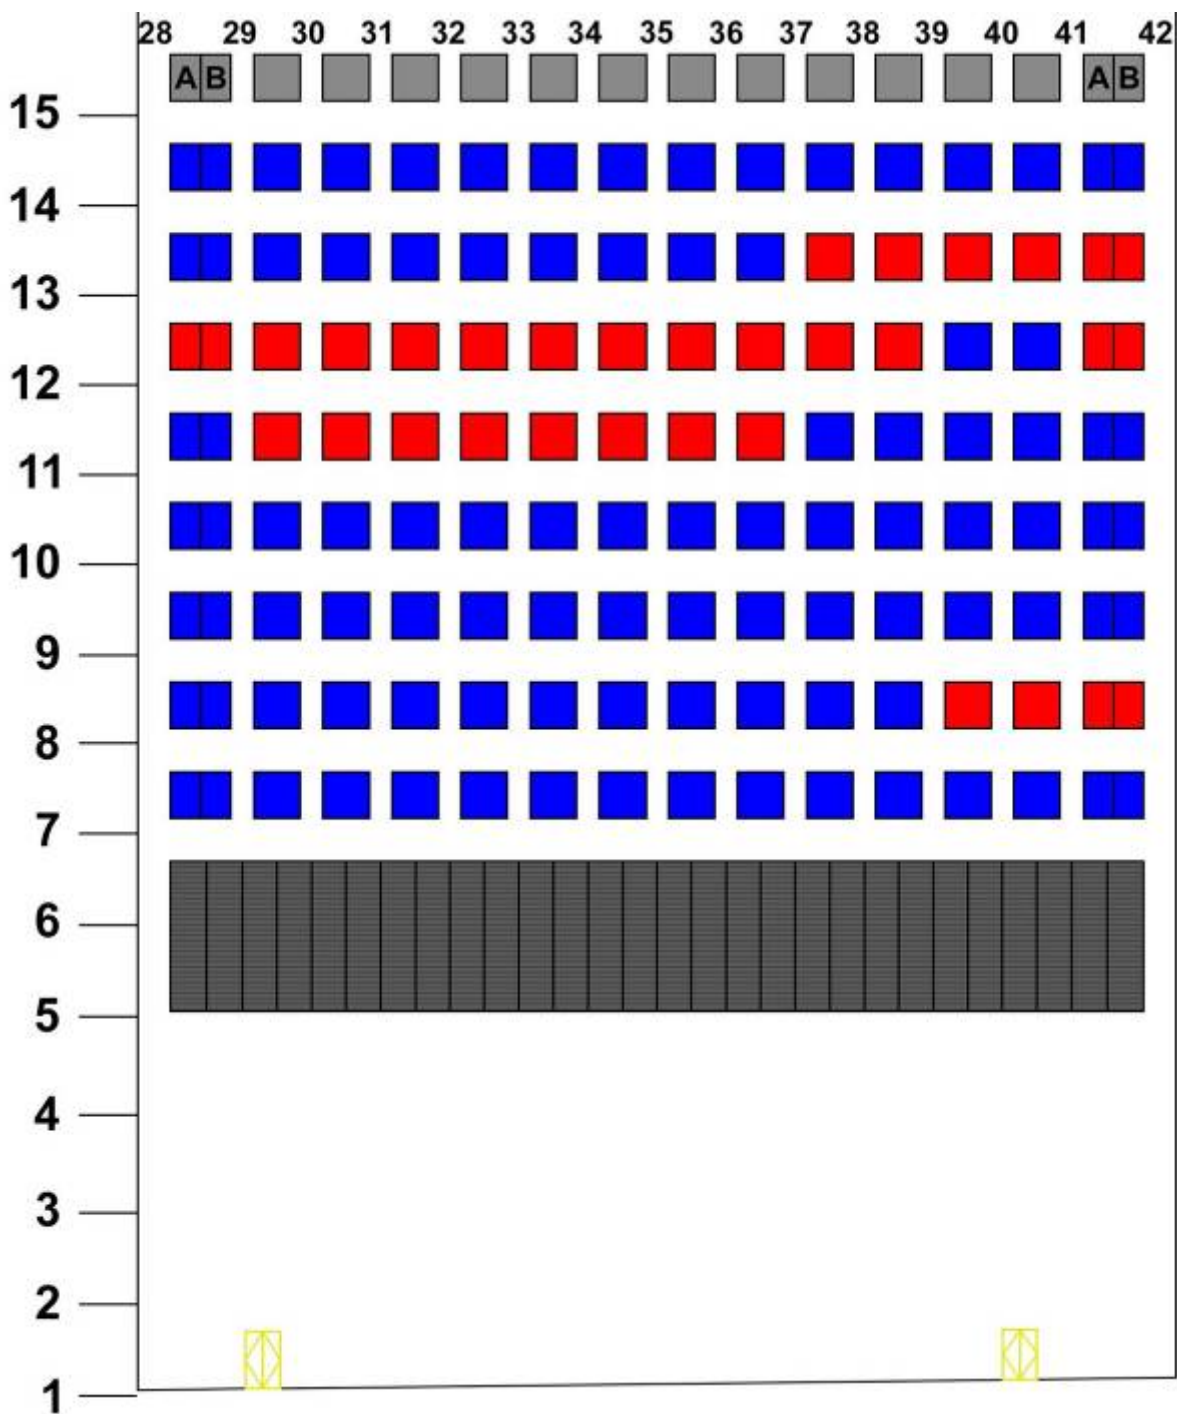
Figure 5–181. Façade map of the east face of WTC 7 showing locations where windows were broken and/or fire was observed during the period when fire first appeared on the face around 2:00 p.m. and the building collapsed at 5:20:52 p.m.

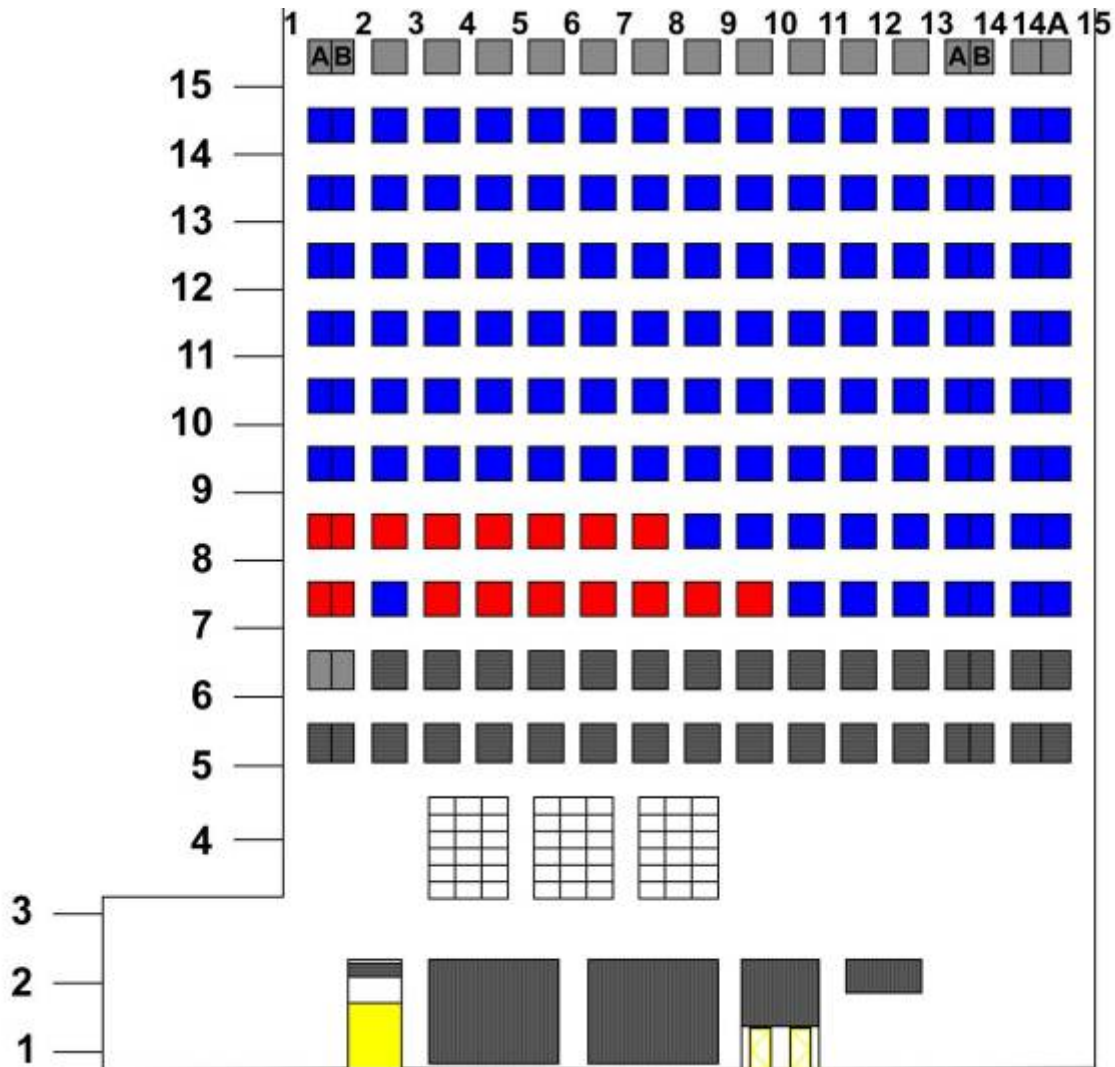
Figure 5–182. Façade map of the west face of WTC 7 showing locations where windows were broken and/or fire was observed during the period when fire first appeared on the face before 2:00 p.m. and the building collapsed at 5:20:52 p.m.

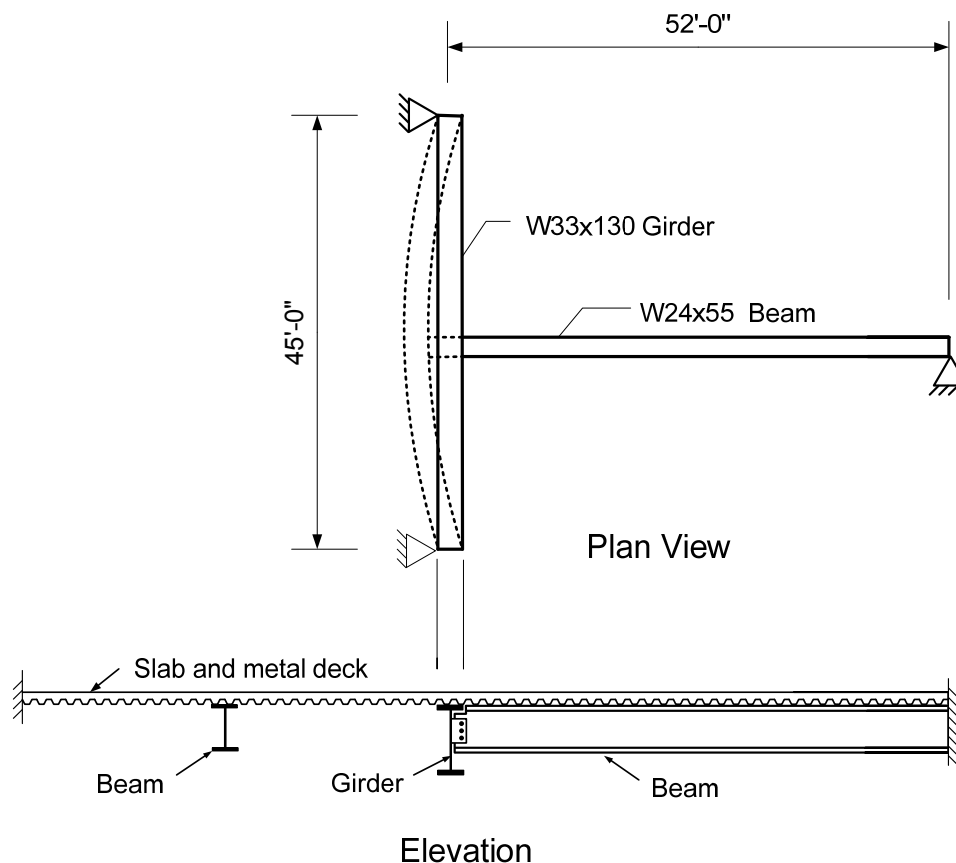
**Figure 8–19. Thermal expansion of floor beams**
