NIST Special Publication 1000-5

June 2004
Progress Report on the
Federal Building and Fire Safety
Investigation of the
World Trade Center Disaster

Volume 1

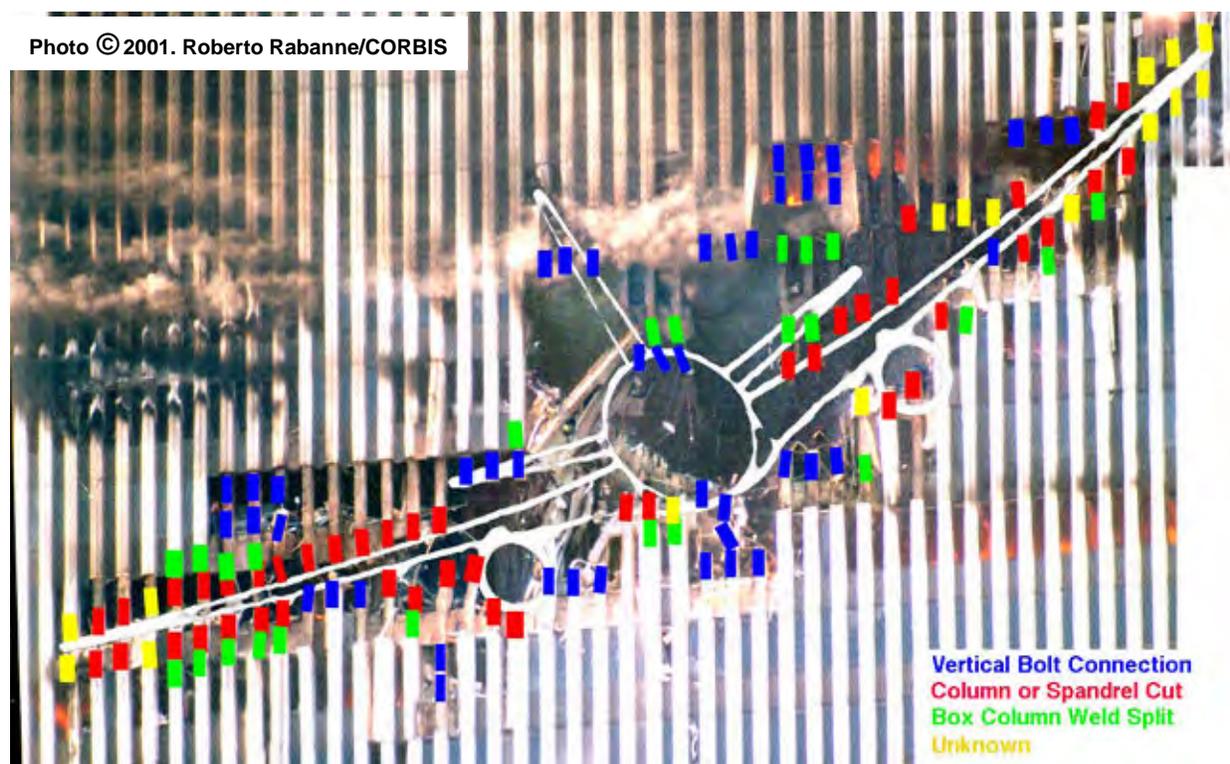
Figure 2–7. Enhanced precollapse image of the north face of WTC 1 with superimposed outline of the Boeing 767. Likely failure modes of damaged columns are indicated.

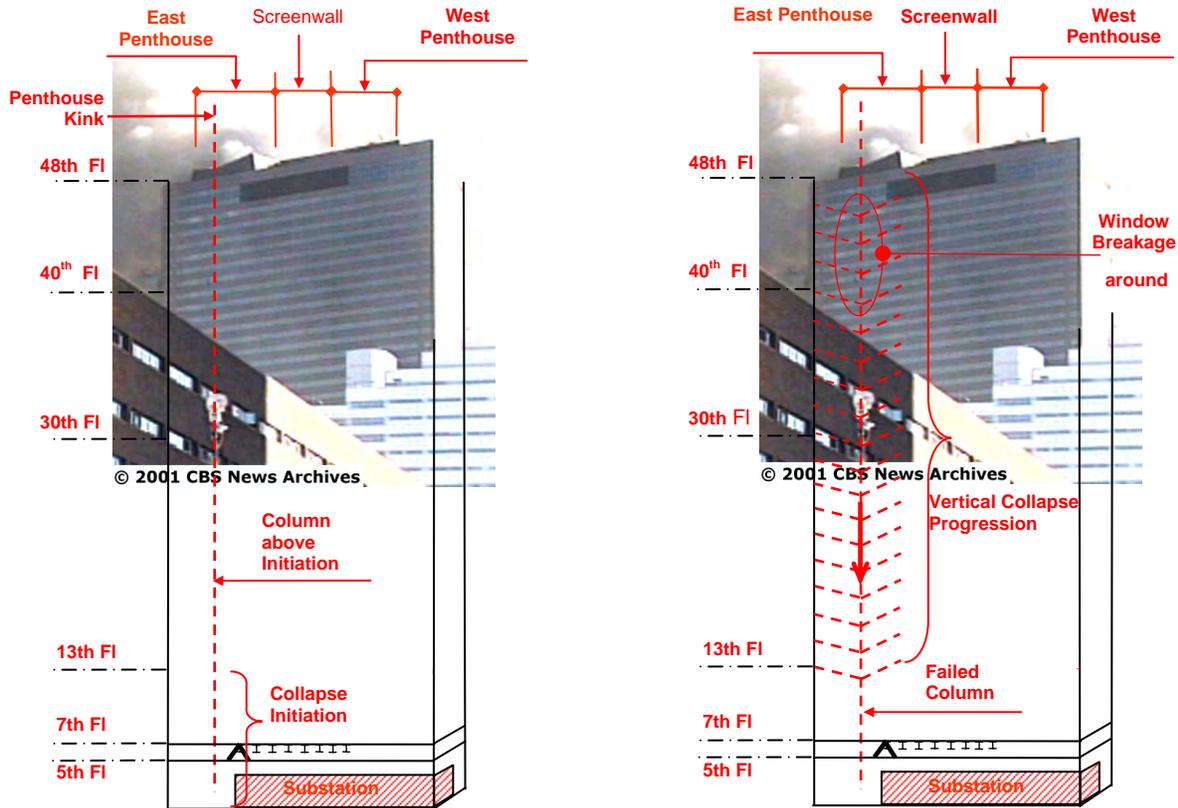
- Interior columns 79, 80, and 81, were located directly below the east penthouse on the roof and supported large tributary areas. The tenant floor areas on the east side of the building had spans of approximately 50 ft between columns. Their failure would likely result in failure of the tributary floor system, as analysis indicates that the floors would not be able to redistribute their loads. This failure mechanism would progress vertically upward within the failed bay to the roof level, and would not be visible from the exterior until the east penthouse lost support, as shown in Fig. 2–23. Available information on the floor-to-column connections indicate that the connections would fail under this scenario without significantly damaging the perimeter or interior columns.

Figure 2–23. Collapse initiation and vertical progression on the east side of WTC 7.

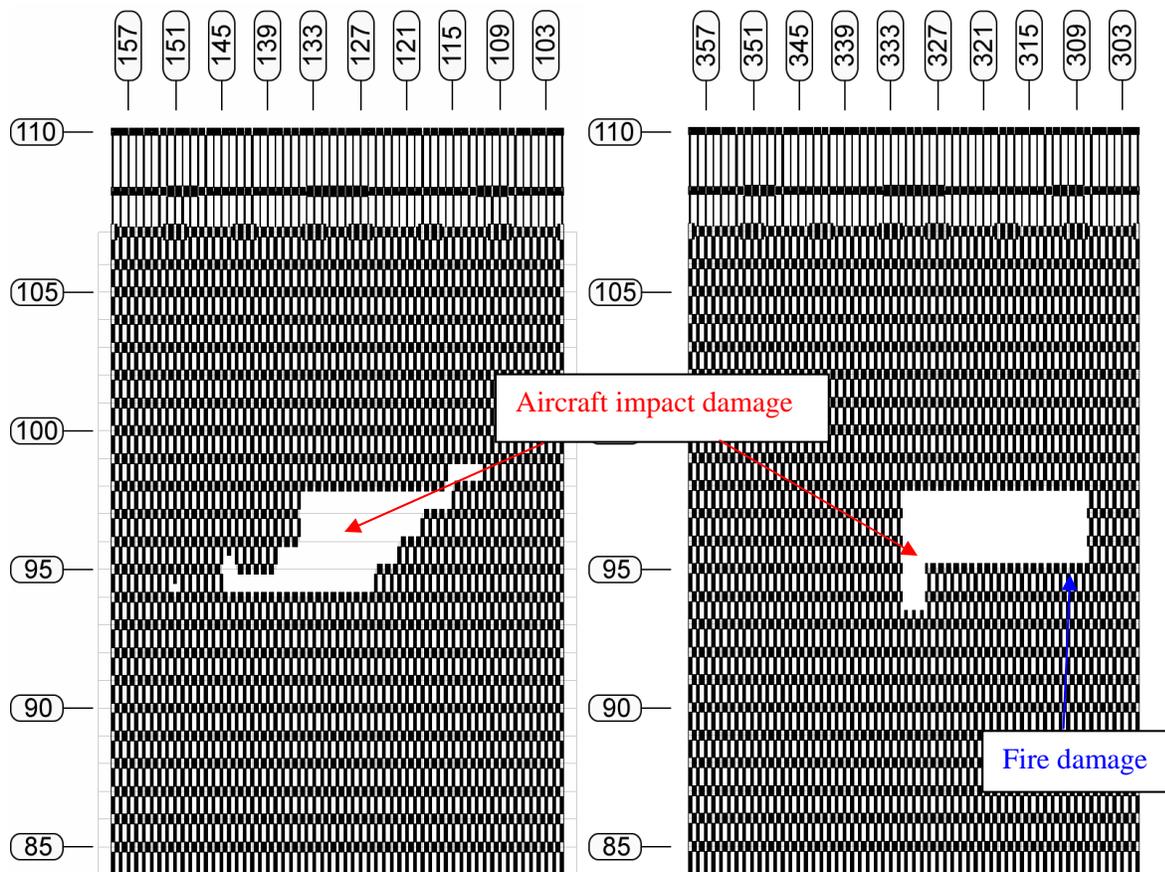
The exterior members that were removed in this damage scenario are indicated in Fig. D-3.

Figure D-3. North and south elevations of WTC 1 indicating columns and spandrels removed due to aircraft impact and fire effects.

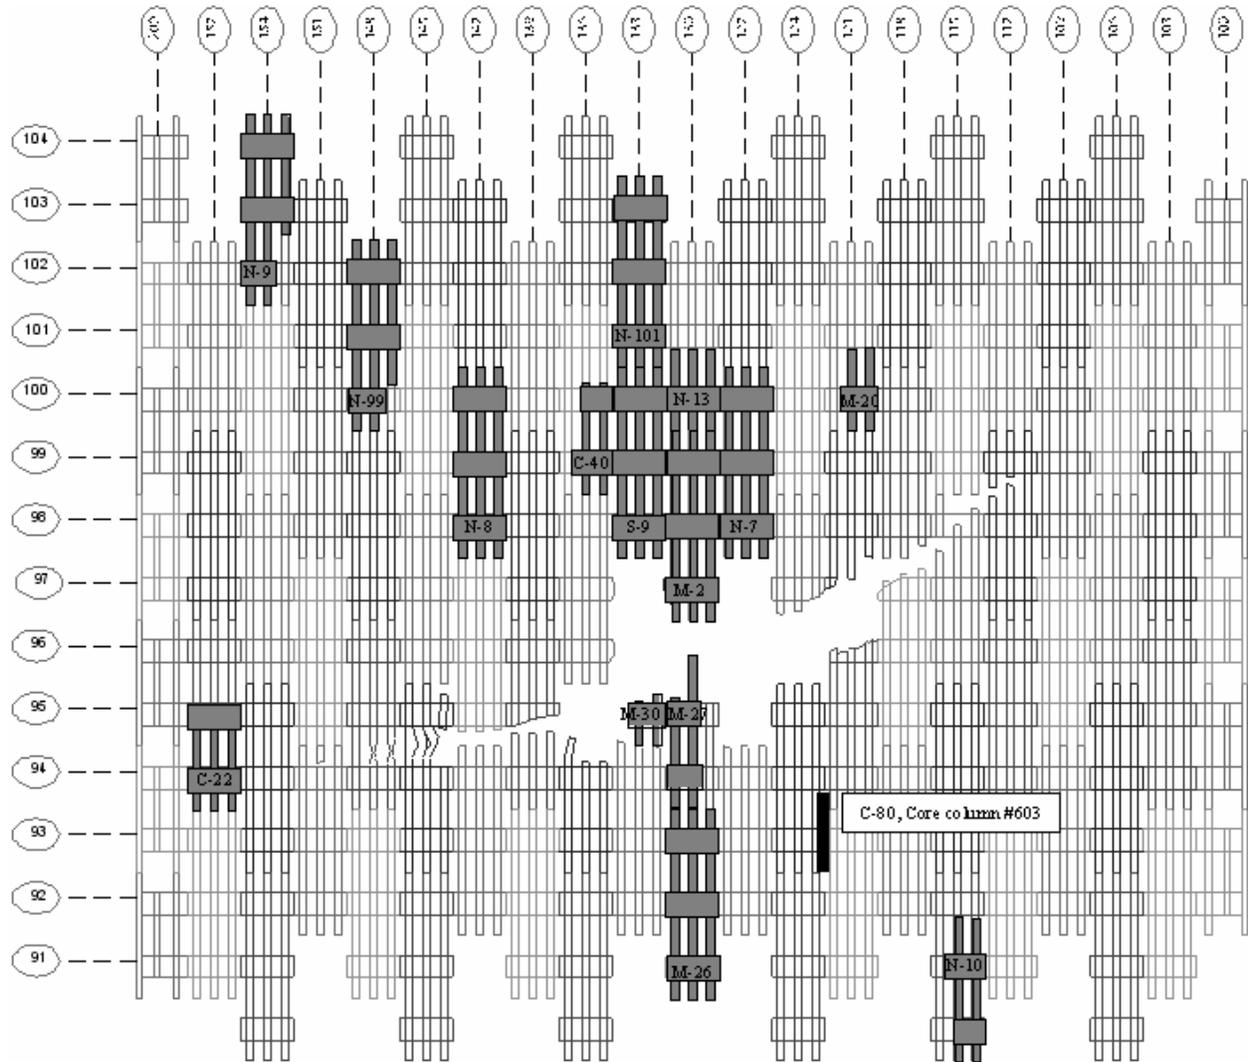
Figure F-12. Interpreted column damage, from photographic evidence, to WTC 1, with overlay of samples in NIST's possession.

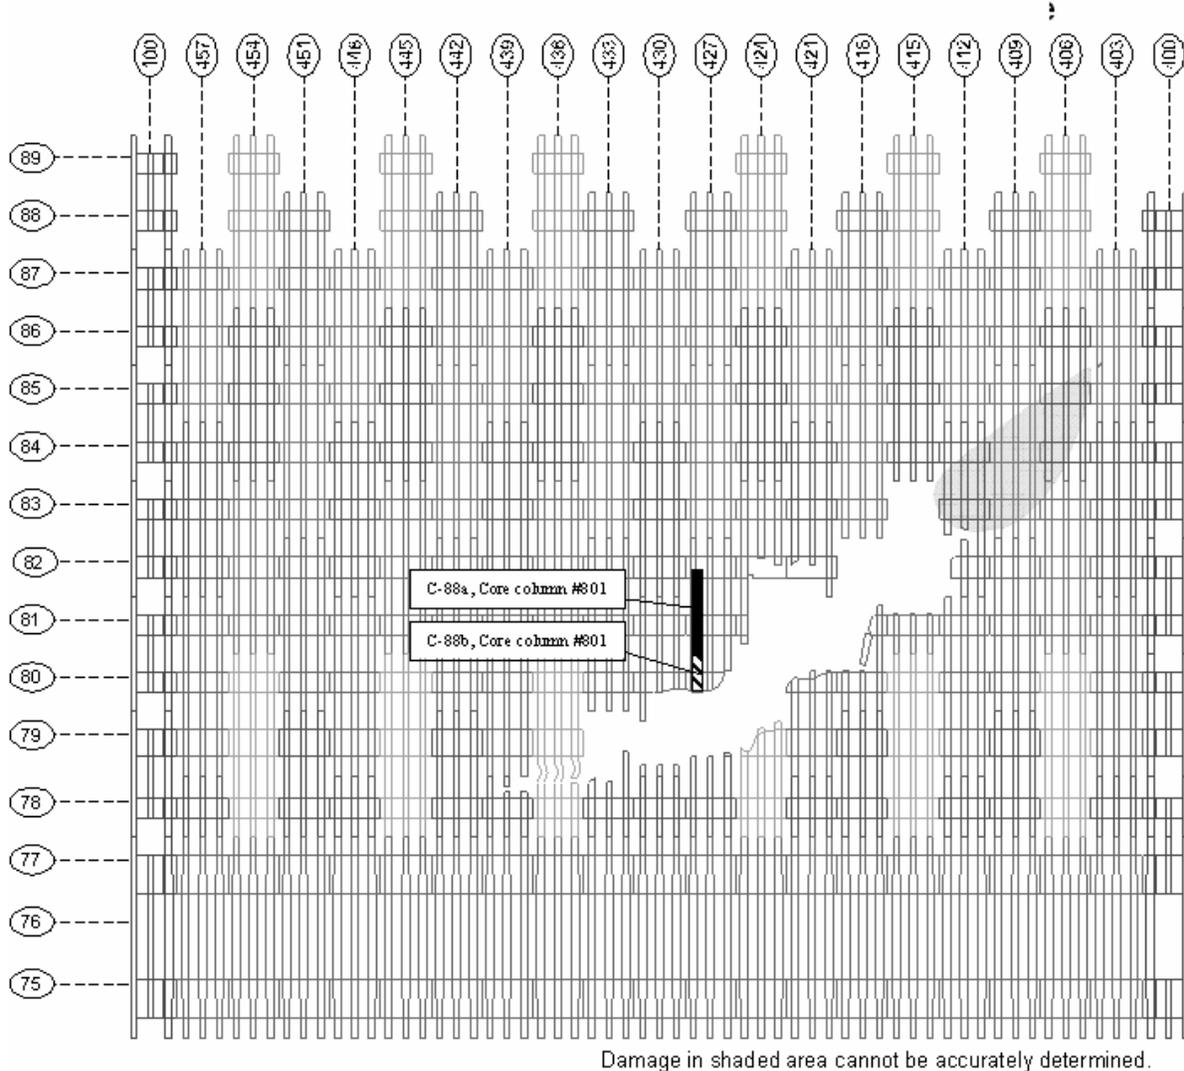
Figure F-13. Interpreted column damage, from photographic evidence, to WTC 2, with overlay of samples in NIST's possession.

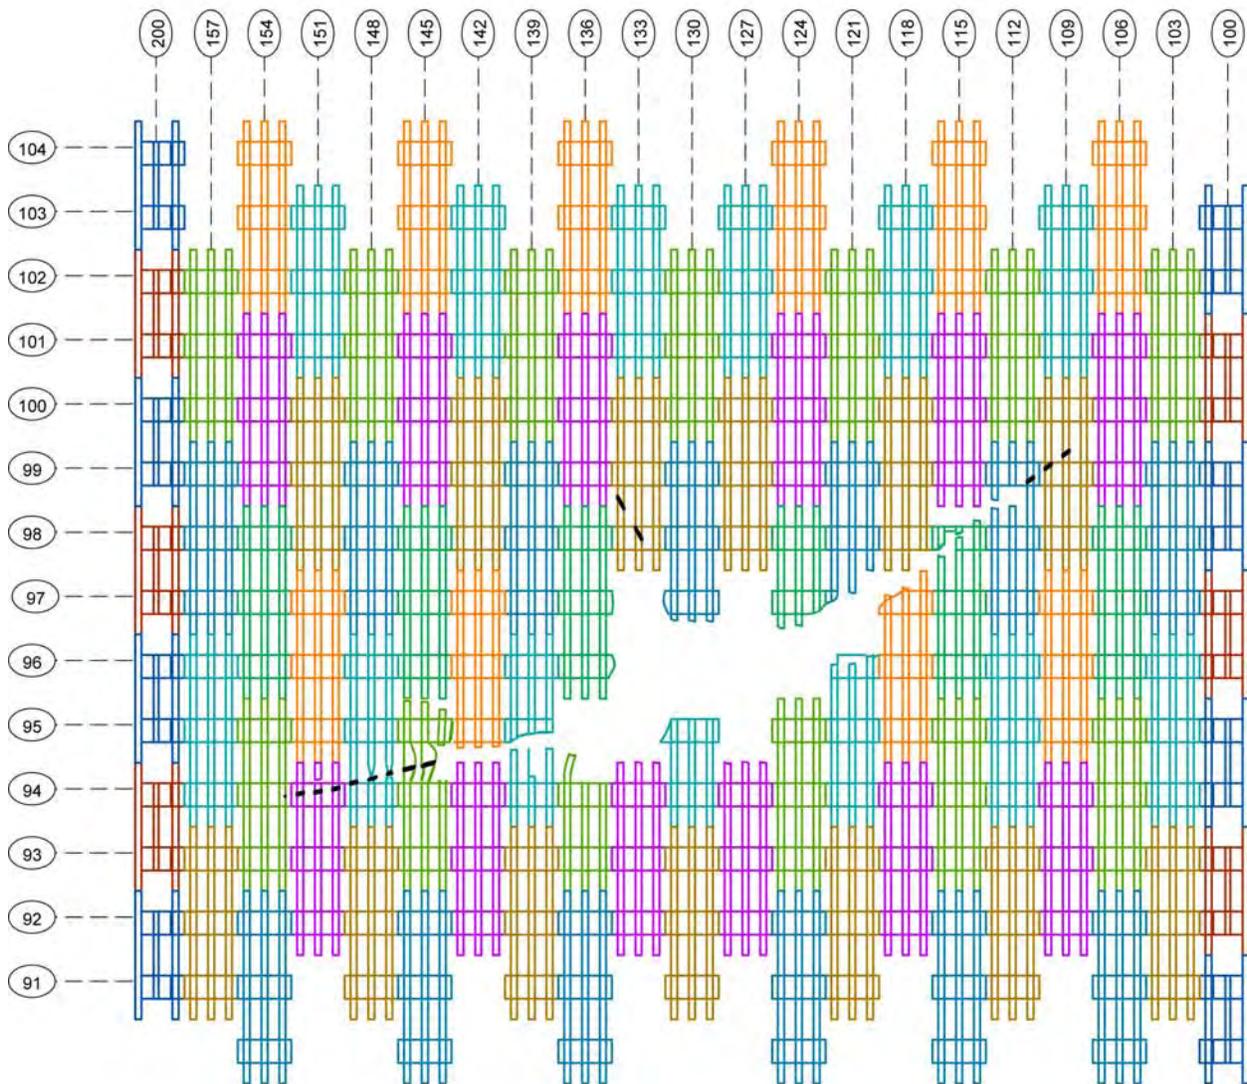
Figure H-12. A drawing of the damage to the steel façade of WTC 1. The dark dotted lines show locations where the airplane wings and vertical stabilizer marked the aluminum cladding on columns.

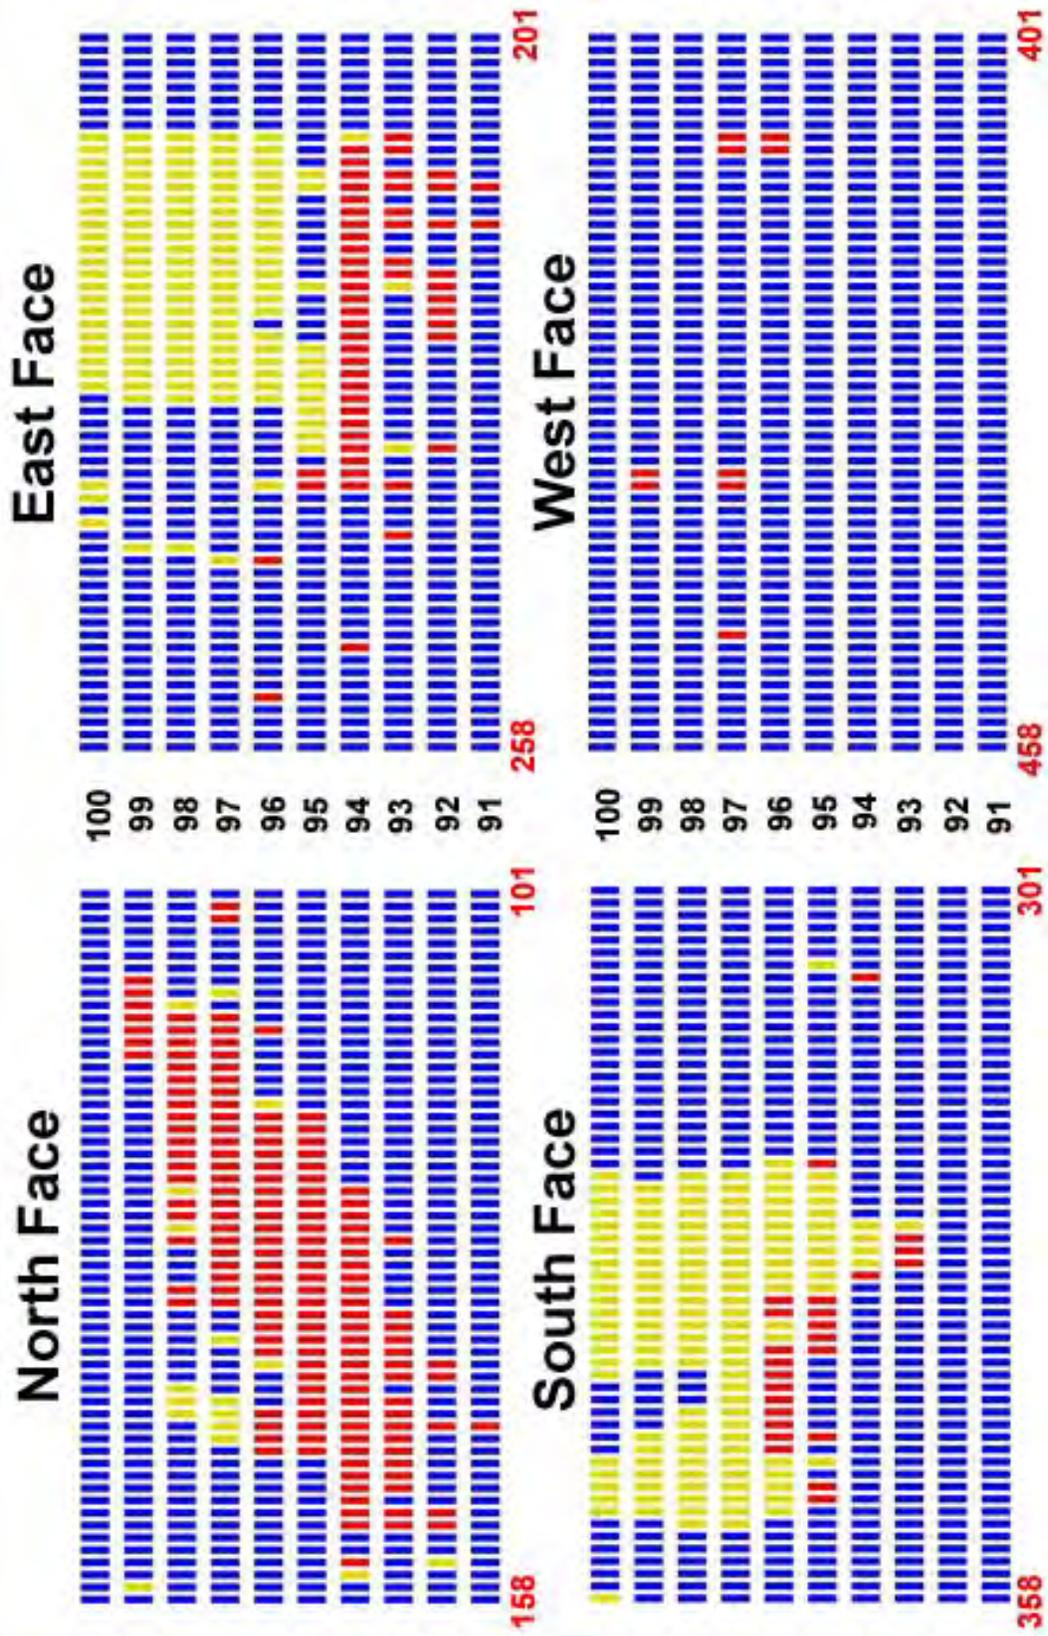
Figure H-13. The condition of windows is shown for the four faces of WTC 1 around 8:47 a.m. shortly after it was struck by American Airlines Flight 11. The colors represent ■ - window open, ■ - window in place, and ■ - not visible.

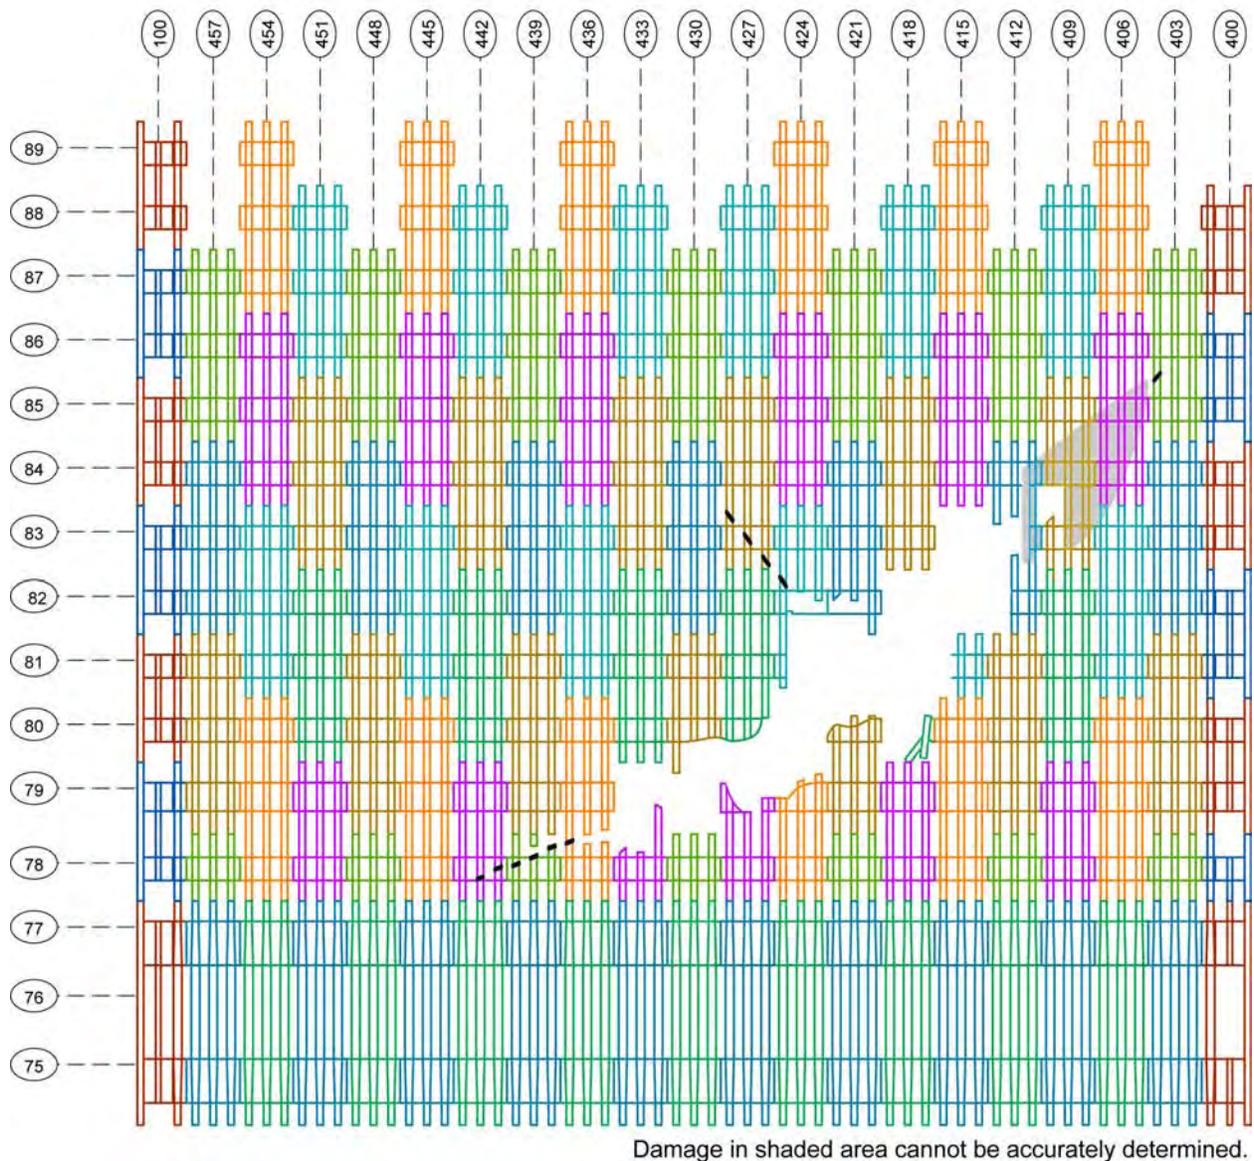
Figure H-19. A drawing of the damage to the steel facade of WTC 2. The dark dotted lines show locations where the airplane wings and tail marked the aluminum cladding on the columns. The area shaded in gray was hidden by smoke and could not be observed.

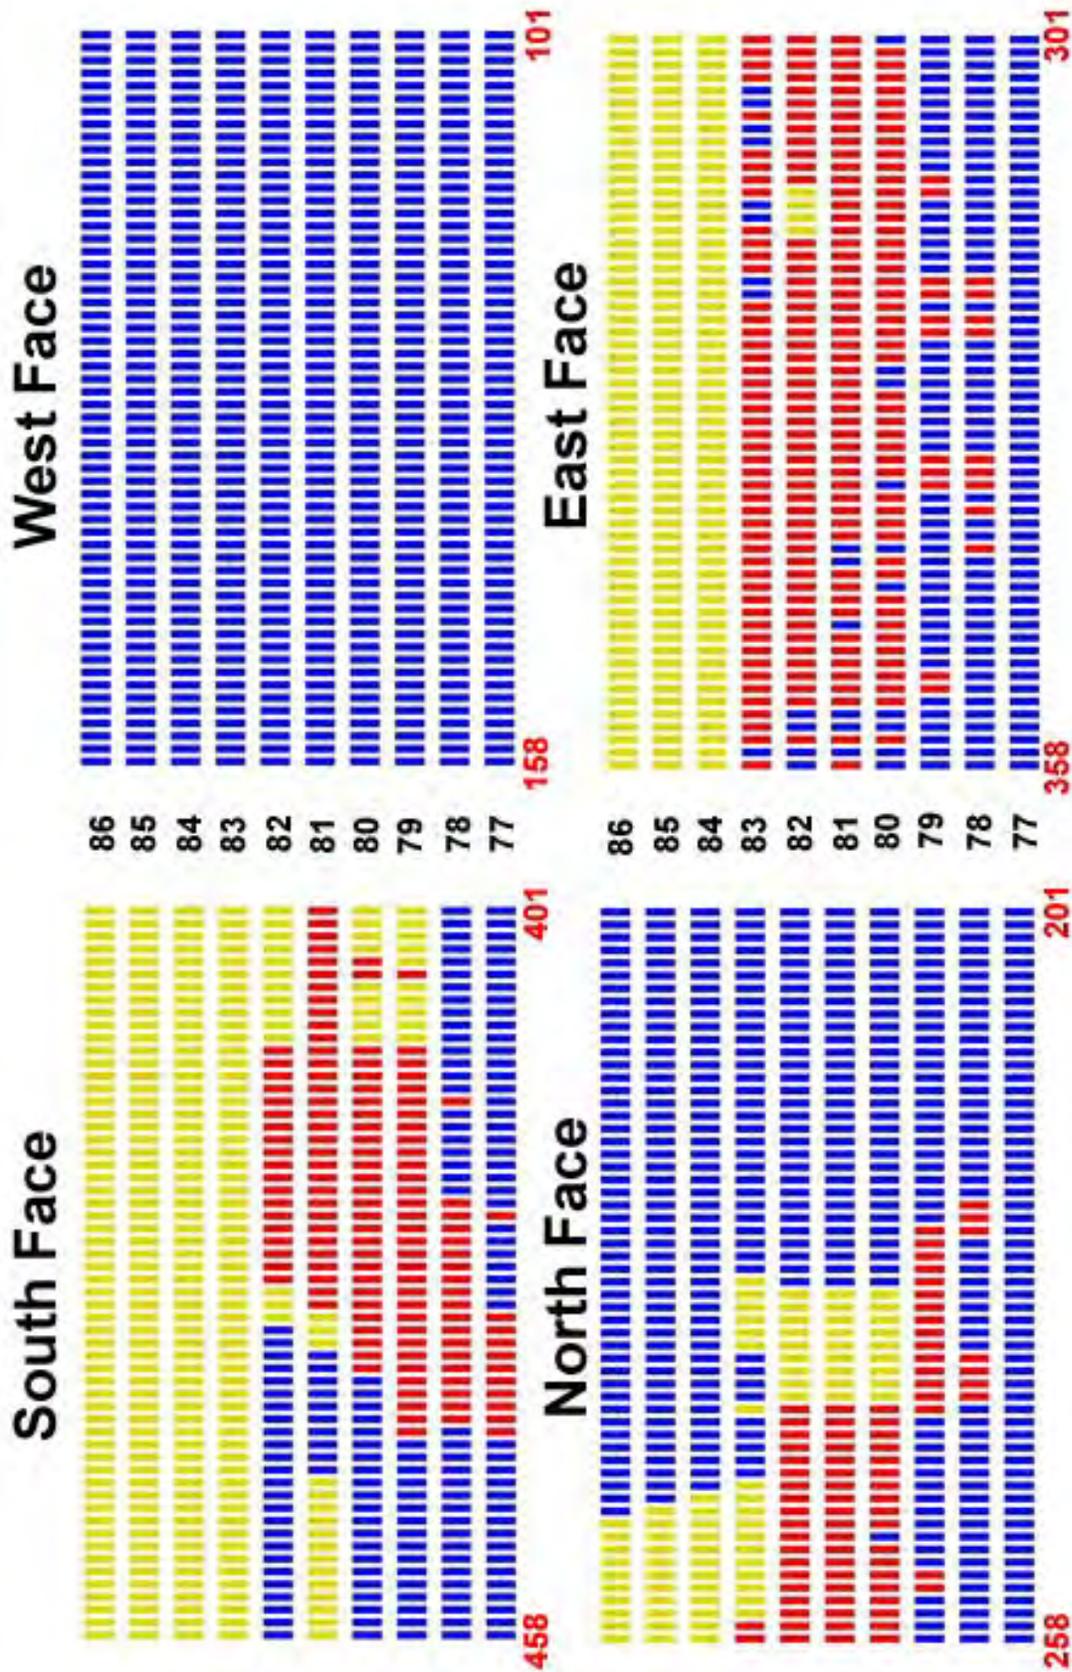
Figure H-20. The condition of windows is shown for the four faces of WTC 2 around 9:03 a.m. shortly after it was struck by United Airlines Flight 175. The colors represent ■ - window in place, ■ - window open, and ■ - not visible.

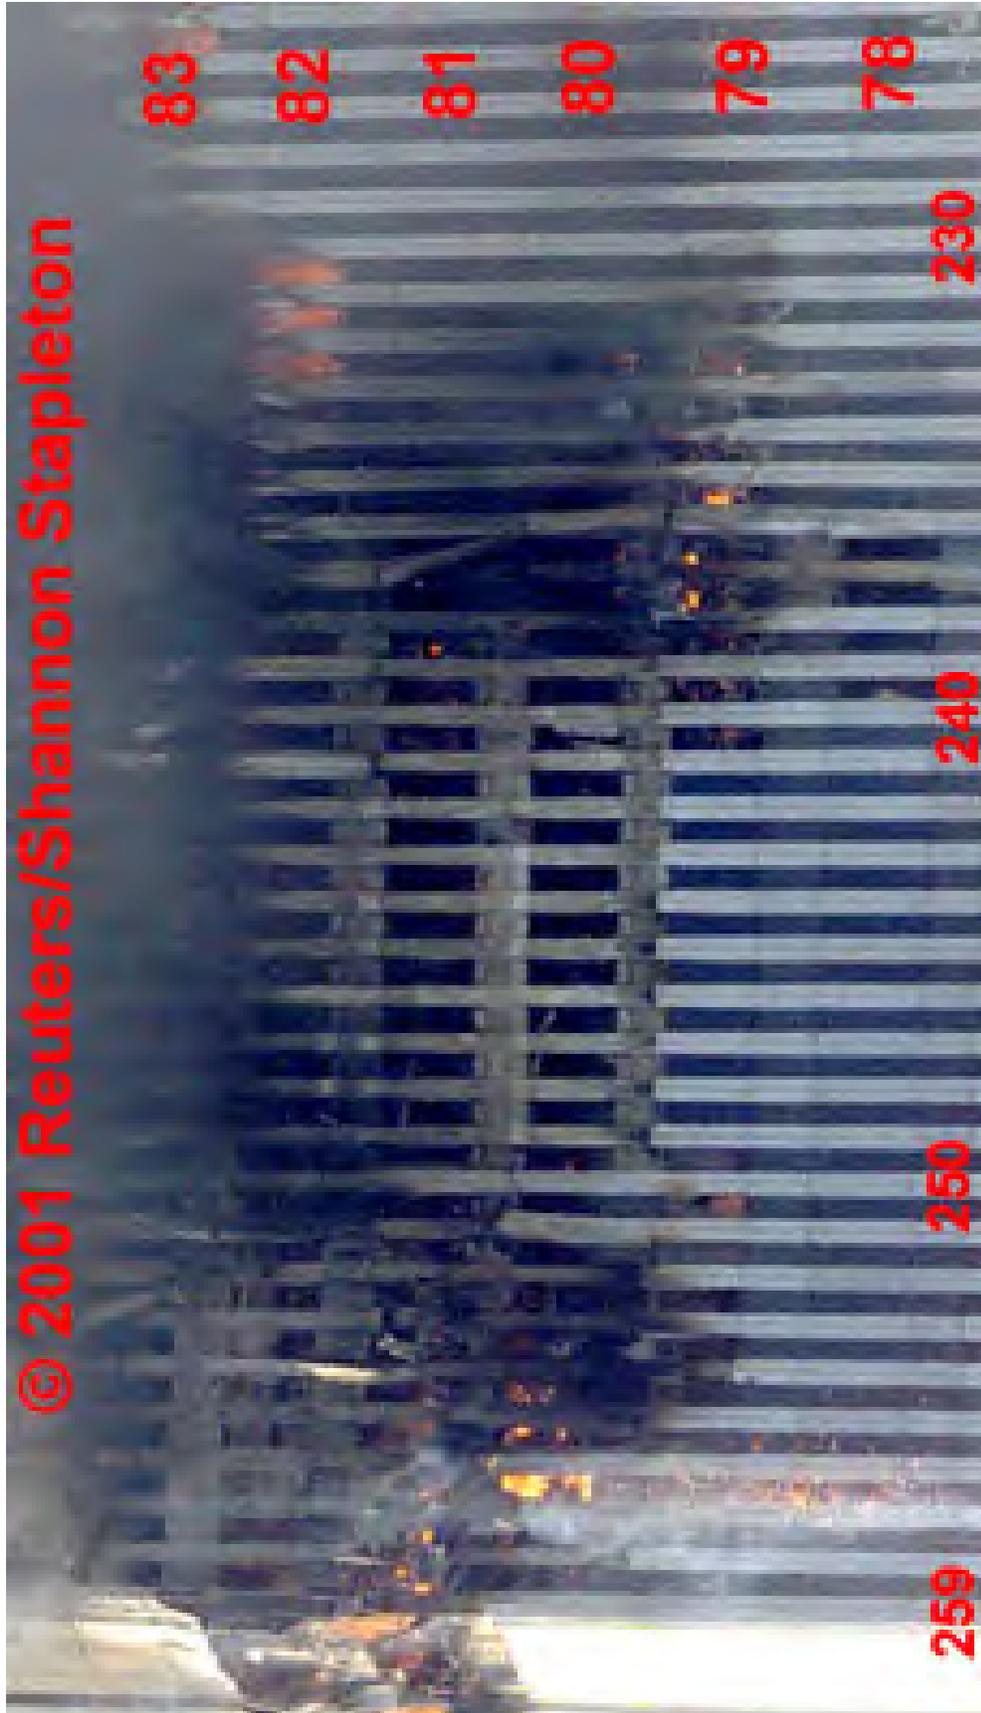
Figure H-21. An enhanced photograph of the north face of WTC 2 taken at 9:58 a.m. shows the east side of the north face. Piles of debris are evident on floor 80 and floor 81 on the northeast corner and on floor 79 to the right of column 230. The "cold" area extends over floor 80 to floor 82 from roughly column 229 to 240. There is a break in column 253 on floor 81, and the adjacent column, 254, is bent. Floors 80, 81, and 82 appear to be partially collapsed. It appears as if the collapsed floor 83 in the northeast corner has broken into sections.

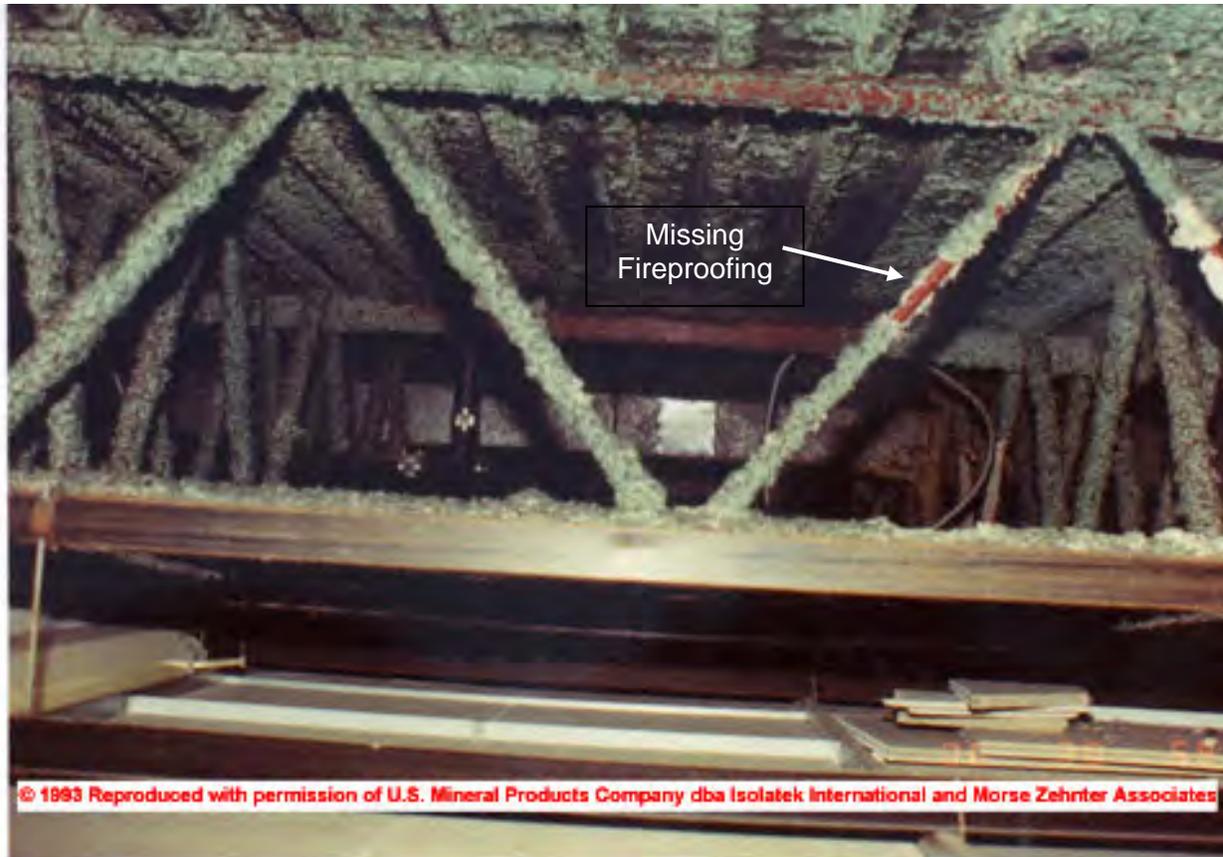
Figure I-4. Example of “gap” in fireproofing on diagonal member of a bridging floor truss.

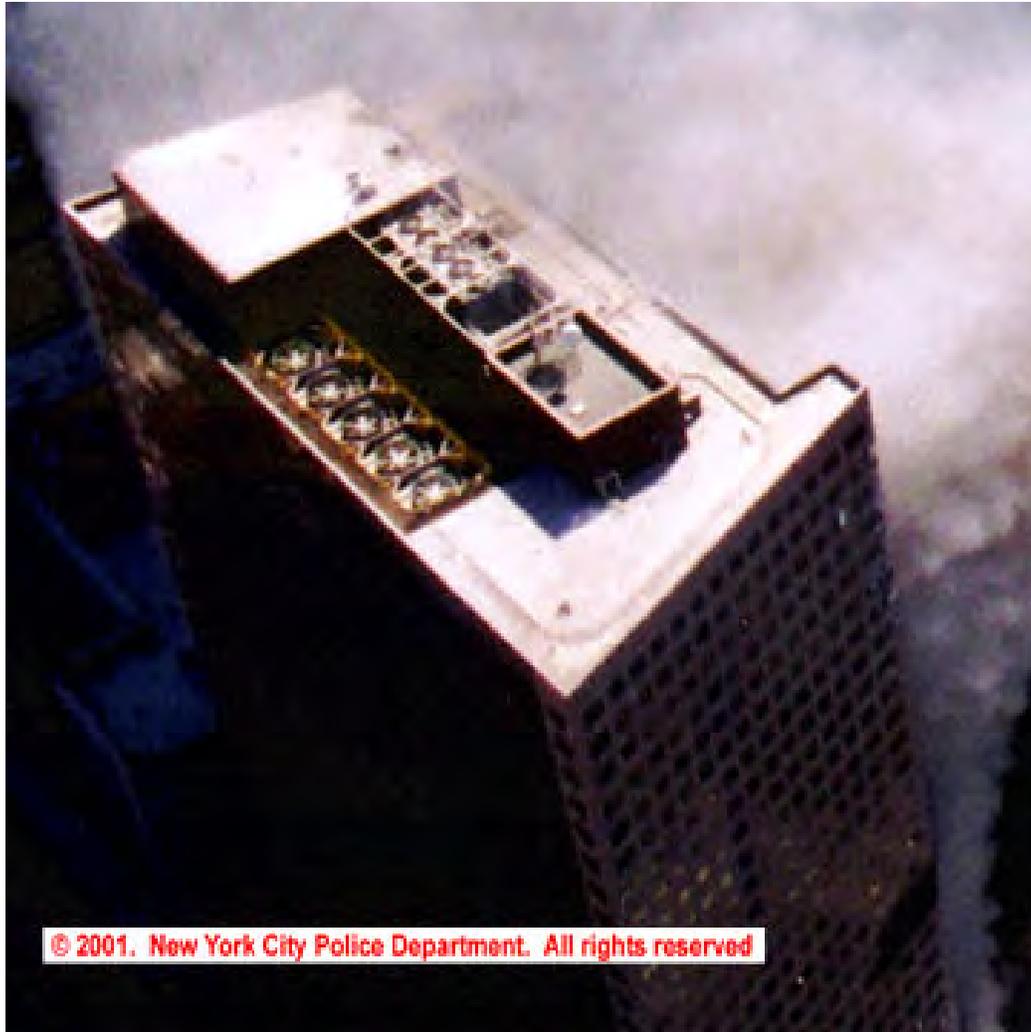
Figure L-21. Photograph of roof after WTC 1 collapse.

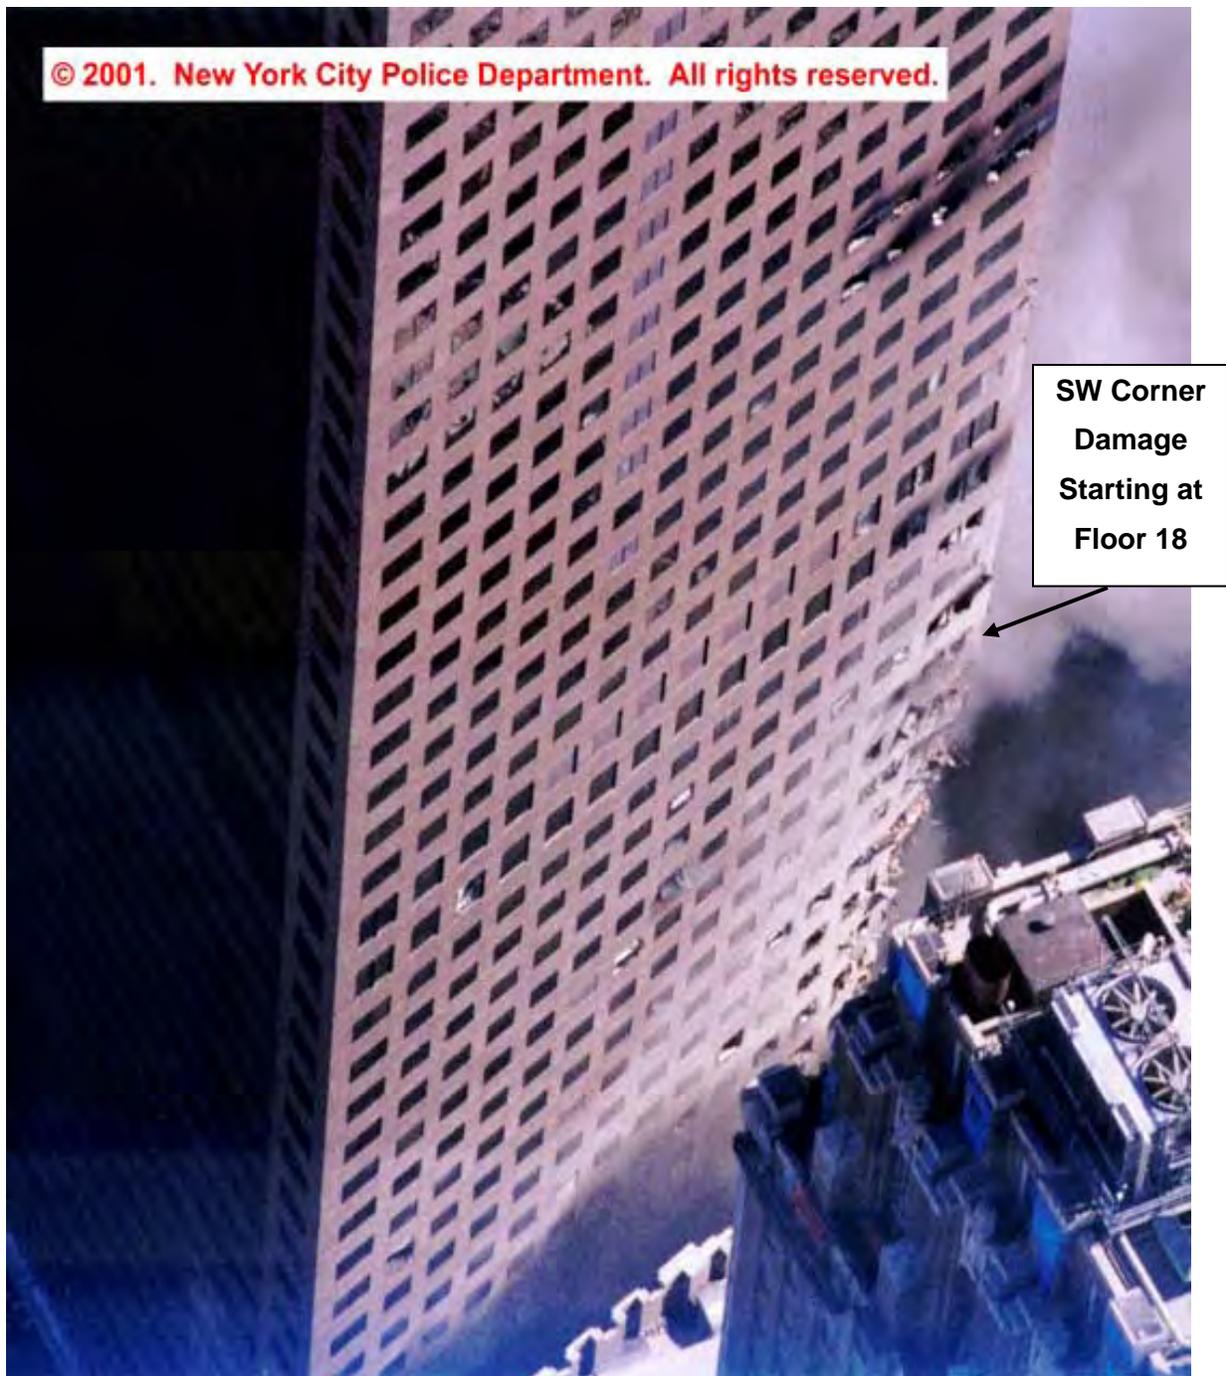
Figure L-22a. Debris damage around Floor 18 of the southwest corner.

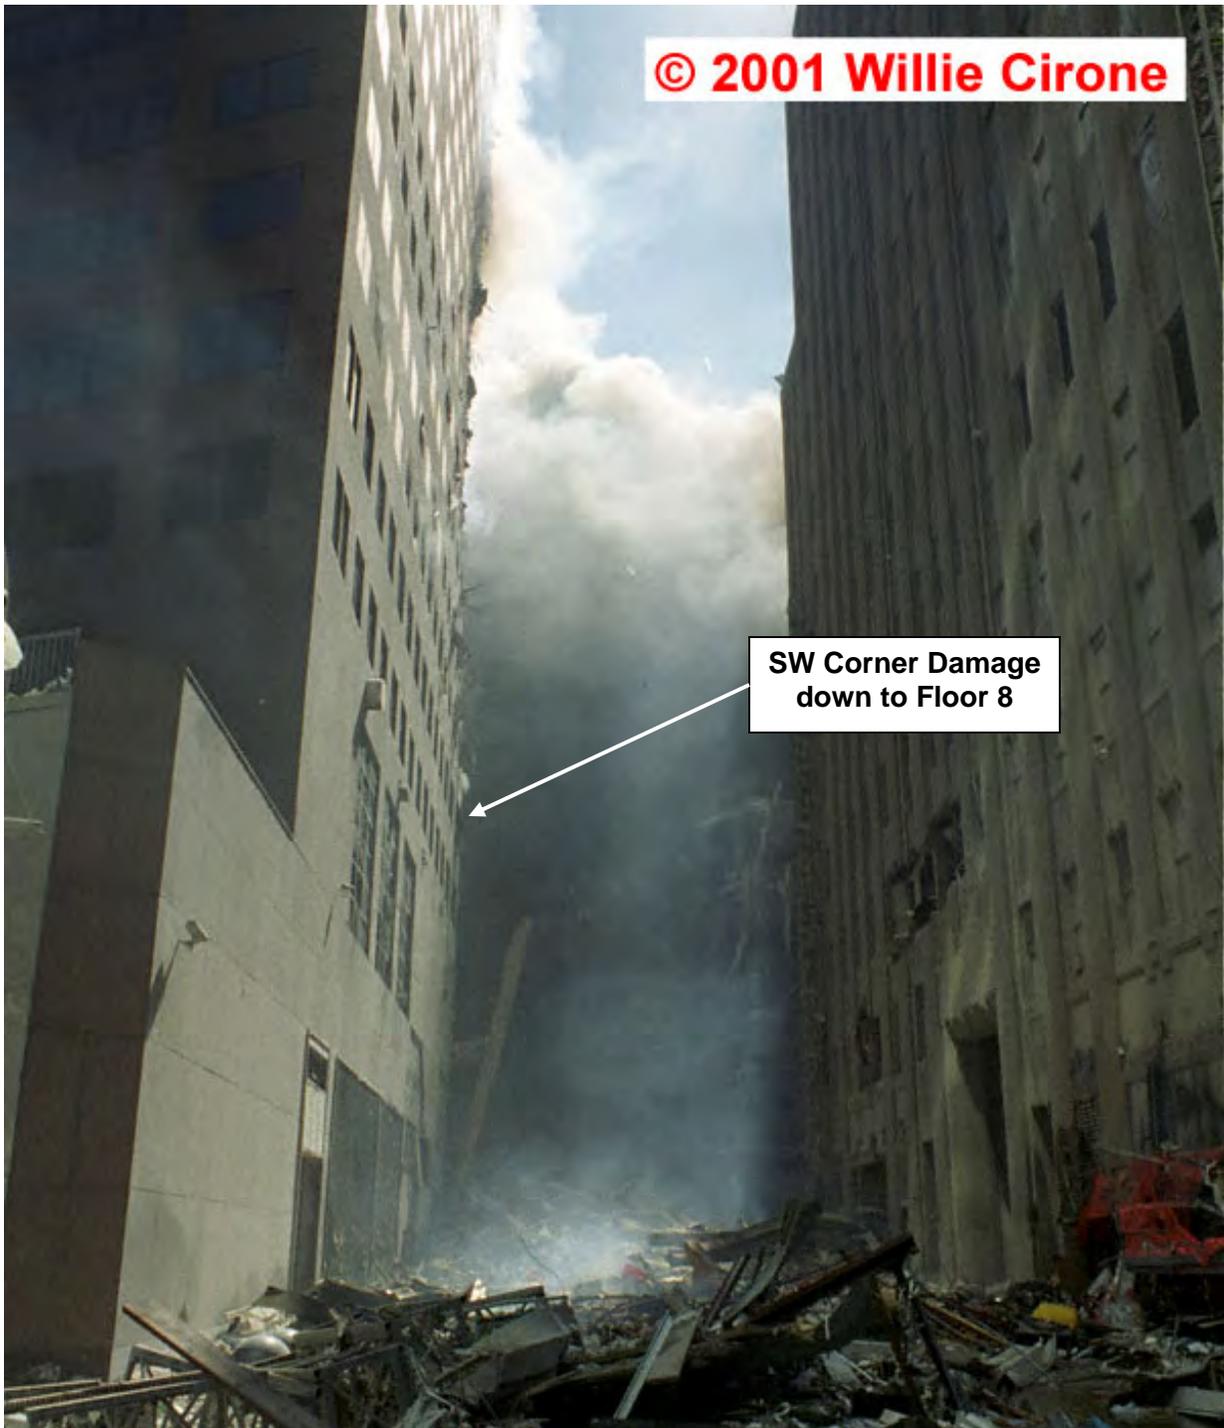
Figure L-22b. Debris damage around Floor 8 of the southwest corner.

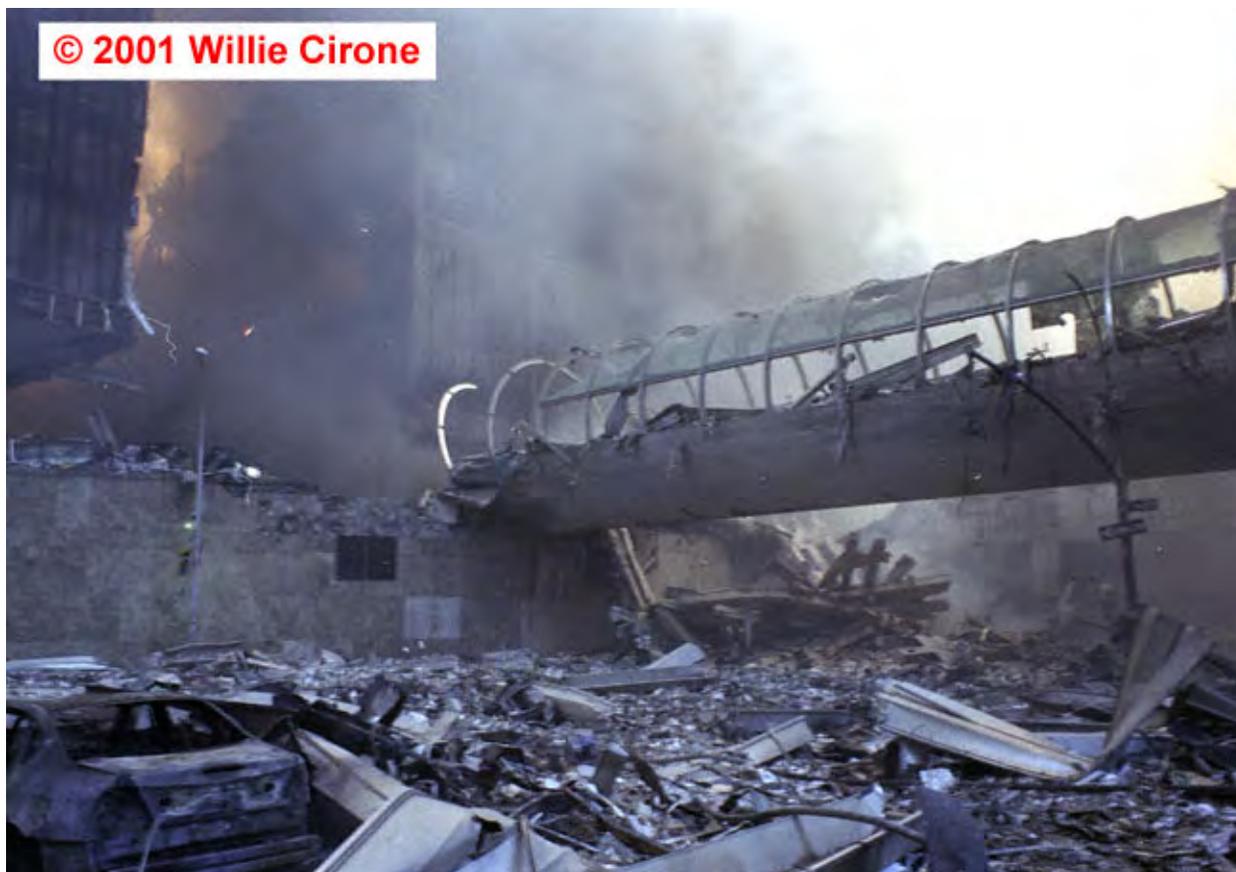
Figure L–23a. Pedestrian bridge and debris on Vesey Street after WTC 1 collapsed.

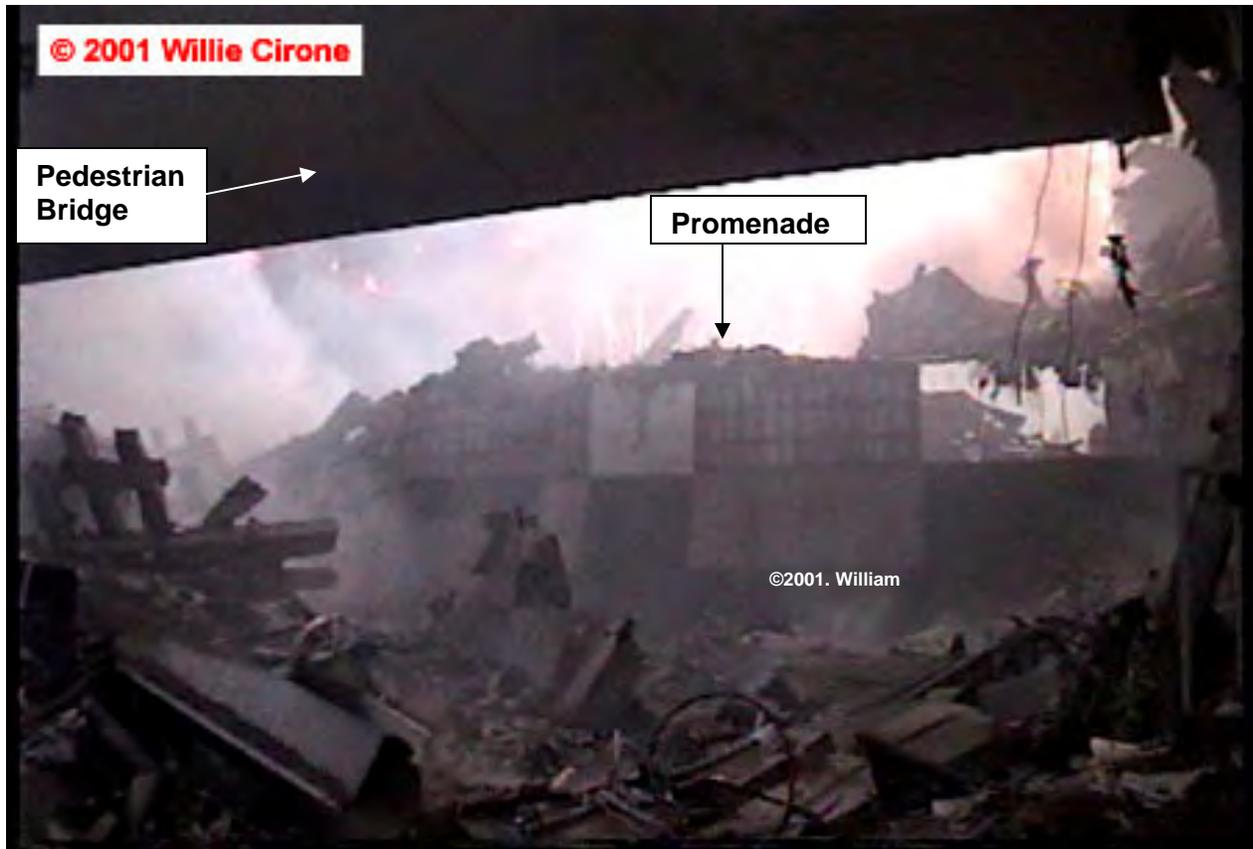
Figure L-23b. WTC 7 Promenade and debris on Vesey Street after WTC 1 collapsed.
