NIST Special Publication 1000-5

June 2004
Progress Report on the
Federal Building and Fire Safety
Investigation of the
World Trade Center Disaster

Volume 1

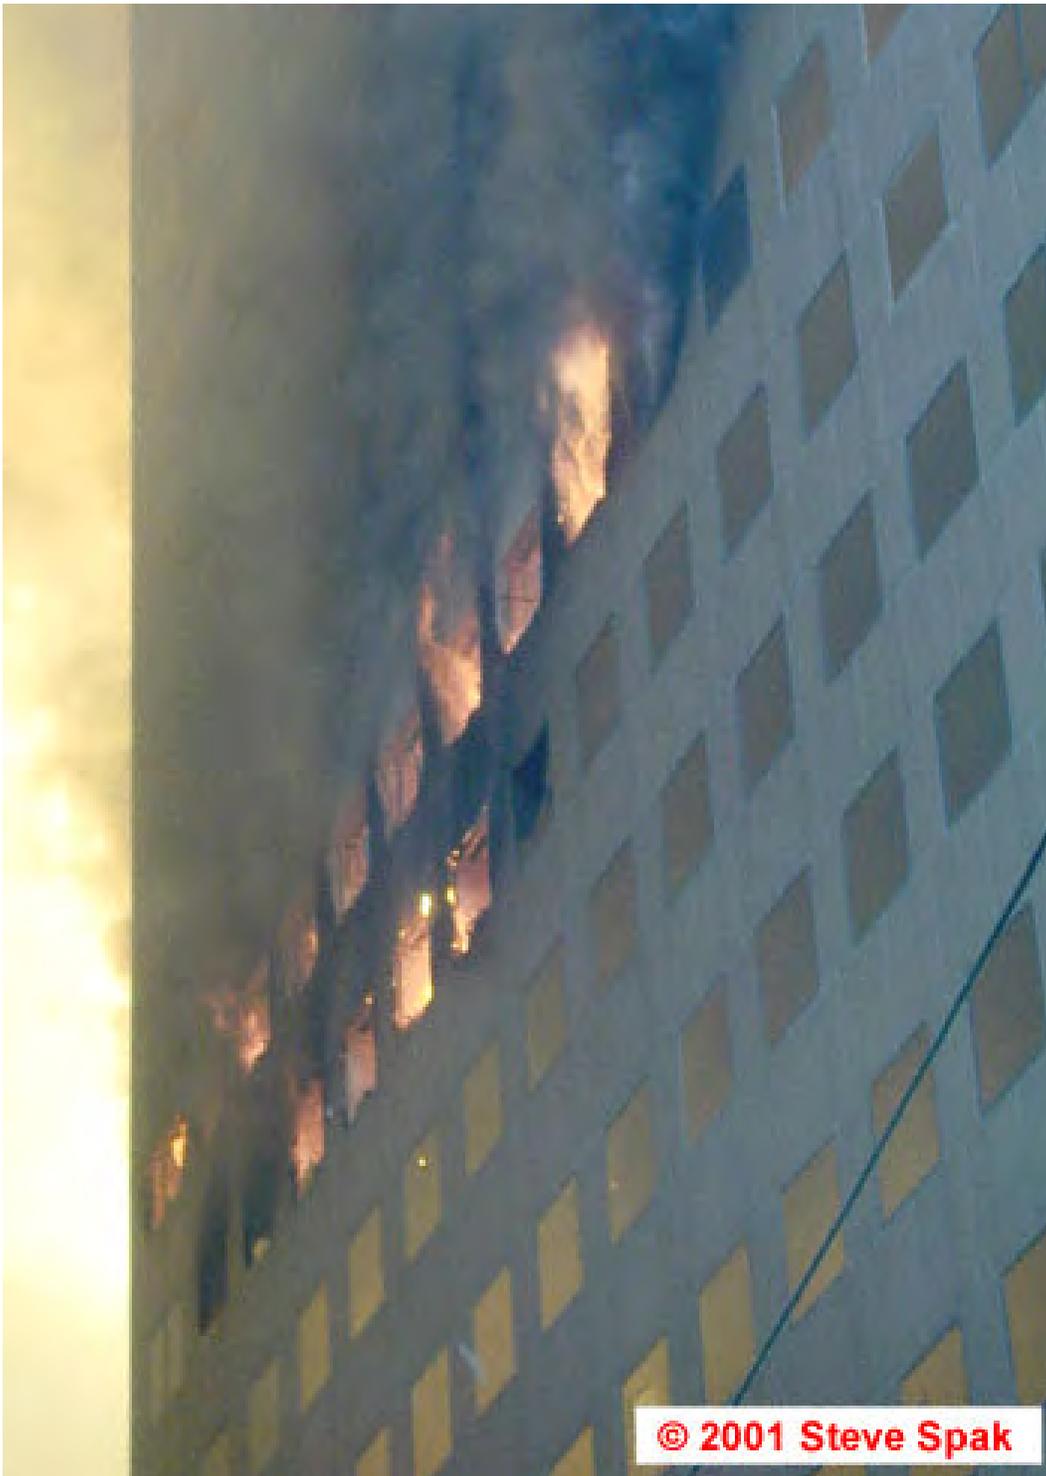
Figure L-24a. Fires on Floors 11 and 12 on the east face.

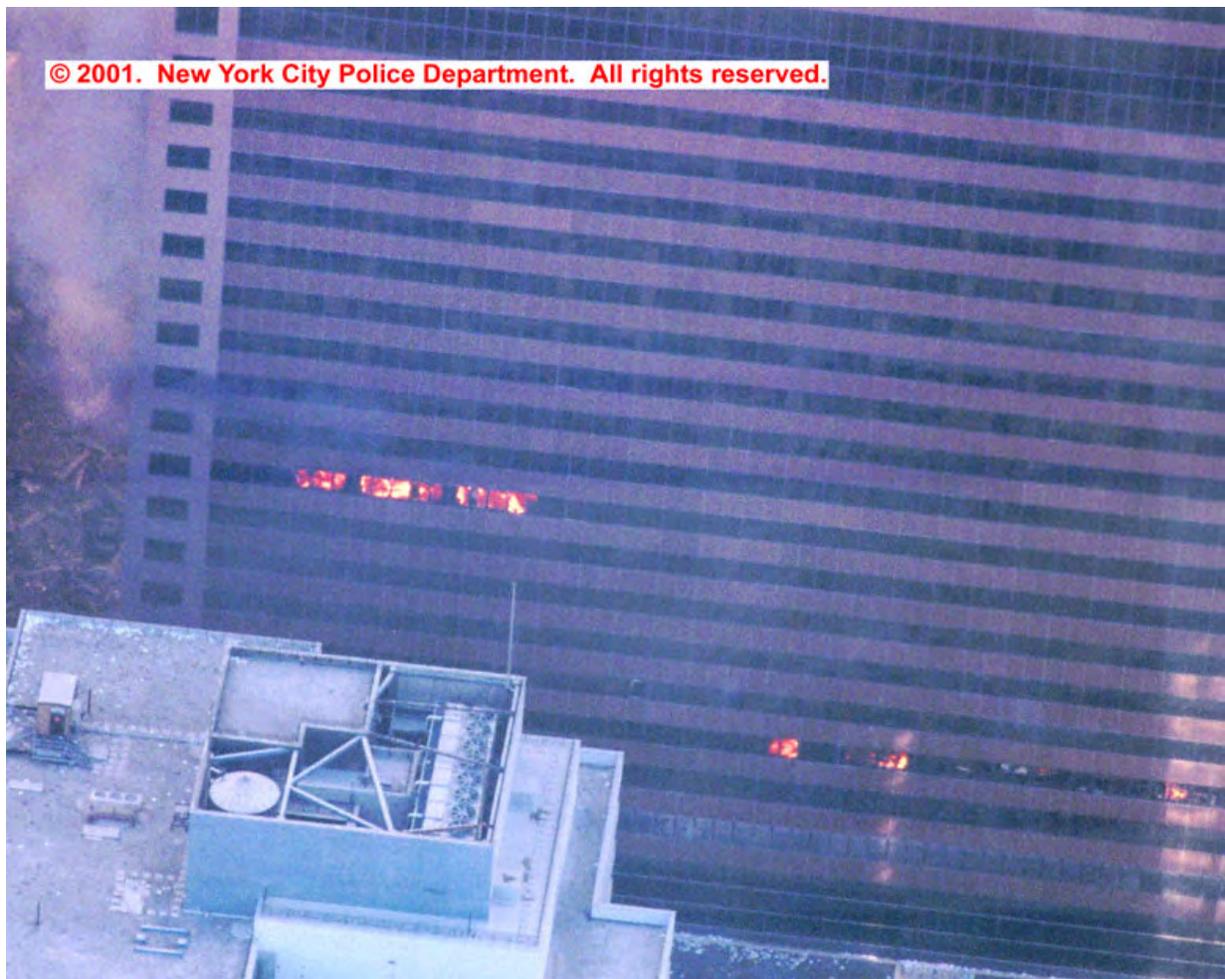
Figure L-24b. Fires on Floors 7 and 12 on the north face.

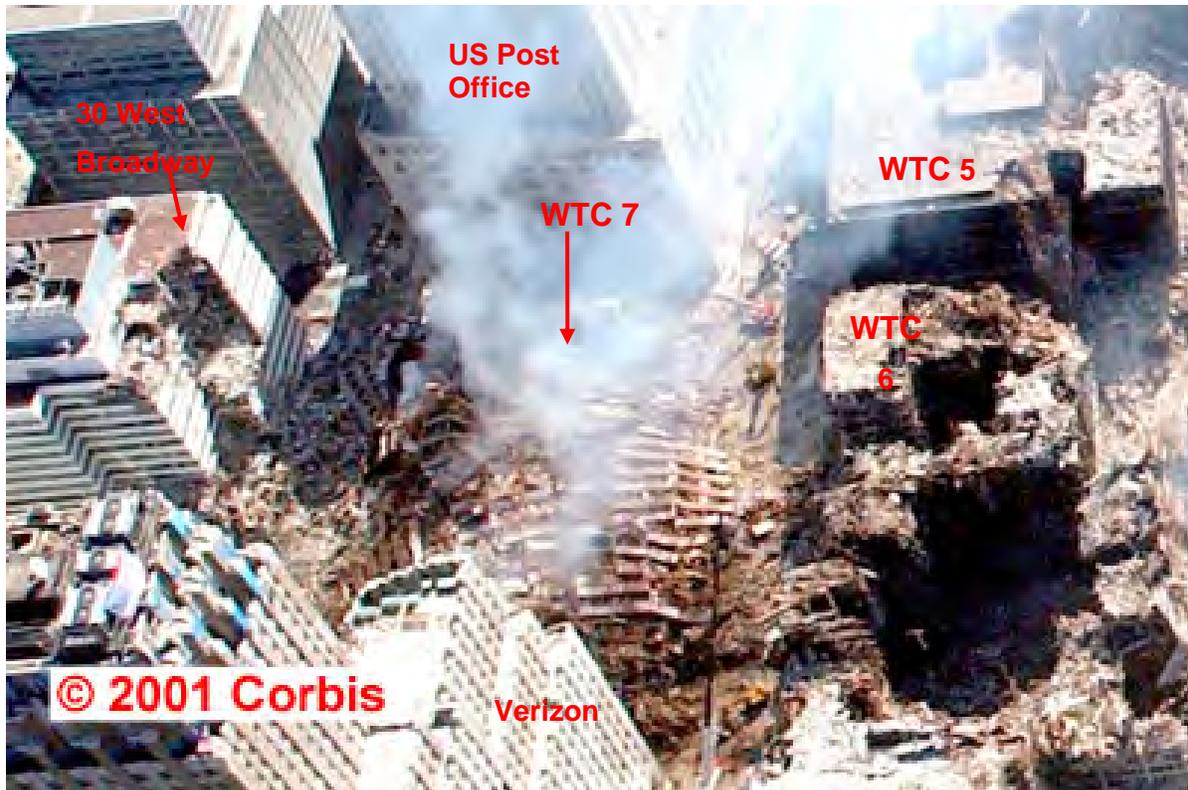
Figure L–32. Aerial view of WTC 7 after collapse.
