**Federal Building and Fire Safety Investigation of the  
World Trade Center Disaster**

**Structural Fire Response and  
Probable Collapse Sequence of  
World Trade Center Building 7**

**NIST NCSTAR 1-9**

August, 2008

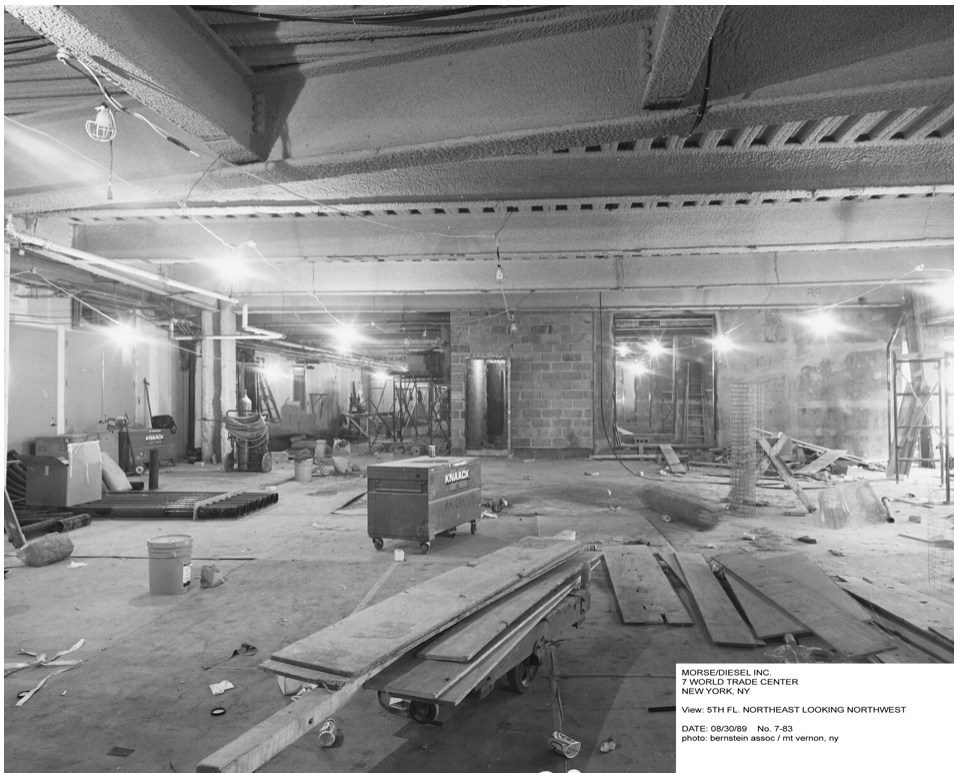
The review of available documents and witness accounts indicated that the condition of the SFRM in WTC 7 prior to the events of September 11, 2001, was adequate and well-maintained. The photographs in Figure 2–27 through Figure 2–29 show the condition of the SFRM on Floors 5, 33, and 36 during renovations in 1989. Review of similar photos showed SFRM removal in selected areas for construction purposes, but the general condition of the SFRM in the photos reviewed was adequate, with an even application and no visible gaps.

**Figure 2–27.**  
**Photograph of**  
**Floor 5 during**  
**renovations**  
**showing SFRM on**  
**steel beams and**  
**metal deck, dated**  
**08/30/89.**

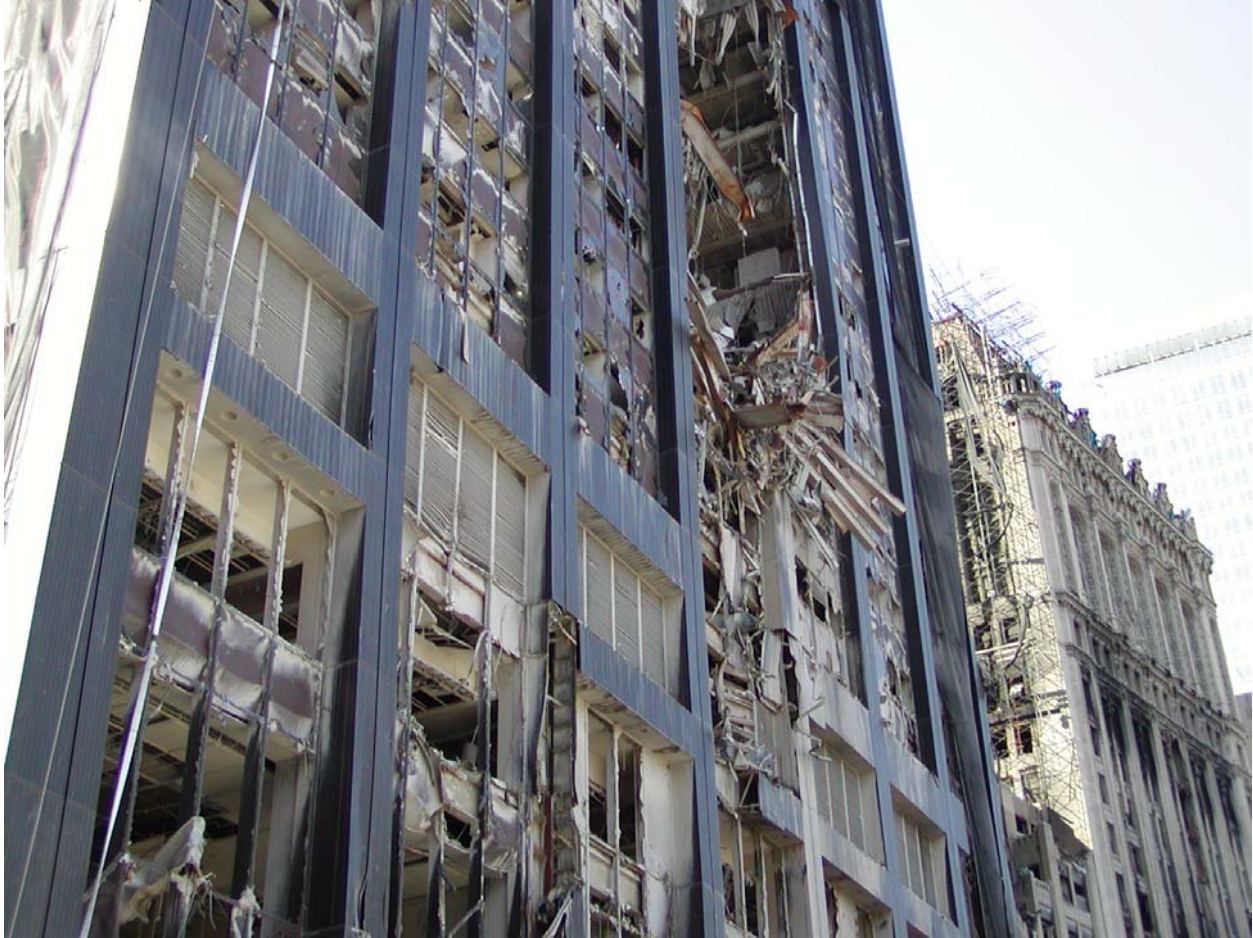
NIST photograph 2006.

The WTC 7 structural damage resulted from debris falling from WTC 1. In a similar fashion, the building located at 130 Liberty Street (referred to as Deutsche Bank or the Bankers Trust building), was damaged by falling exterior panels from WTC 2 as it collapsed. NIST was granted access to inspect floors where damage occurred in the building on 130 Liberty Street on August 21 and 22, 2006. The debris from WTC 2 had penetrated the north face of the 130 Liberty Street building and caused damage to Floors 9 through 22, as shown in Figure 2–30 and Figure 2–31. The north face had severed spandrel beams between exterior columns, with the damage extending into the interior that grew in magnitude as the debris fell. Figure 2–31 shows that the floor beams framing into intact exterior columns remained in place, but the SFRM in the immediate vicinity of the damage was knocked off.

**Figure 2–30. Exterior view of damage to the north face of 130 Liberty Street by debris falling from WTC 2.**

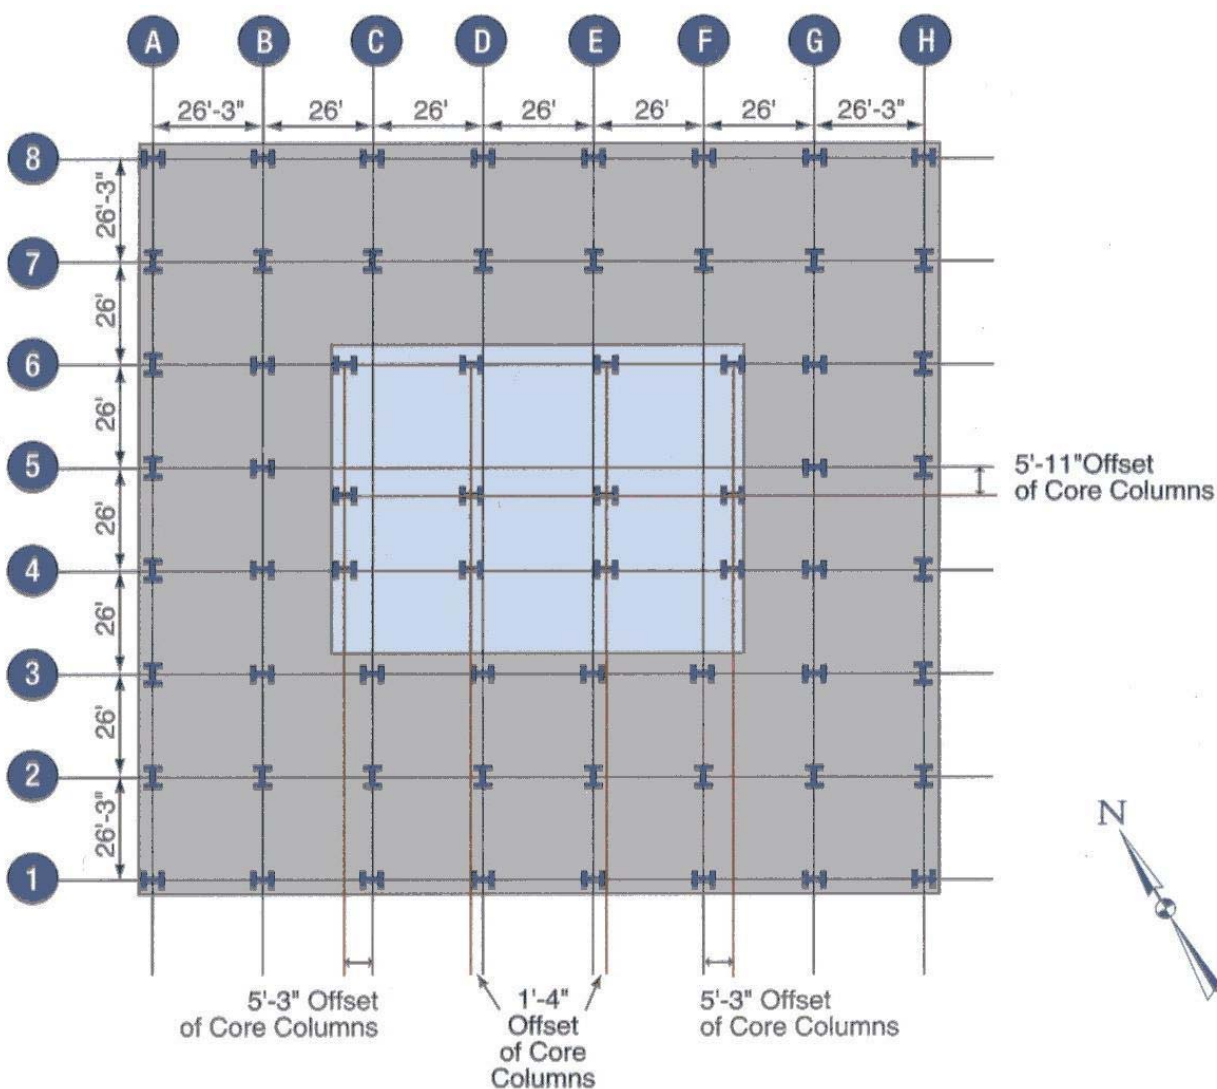
Figure 2–33 shows a typical floor plan with the column line numbering that was used to indicate the locations that were examined. SFRM had been applied to all columns, floor beams, and steel deck observed. The floor beams and steel decks appeared to have had a uniform coating of approximately  $\frac{3}{8}$  inch to  $\frac{1}{2}$  inch (visual estimate), as shown in Figure 2–34. The location of the photograph was near F2 on Floor 16. The columns appeared to have had heavier coatings that ranged from approximately 1 inch to several inches (visual estimate). Figure 2–35 was taken at location B6 on Floor 16. In the photograph, the column coatings tended to be thicker at the flange tips. Primer was observed on floor beams and columns in some areas with missing SFRM.

**Figure 2-33. Typical floor plan for the building at 130 Liberty Street.**

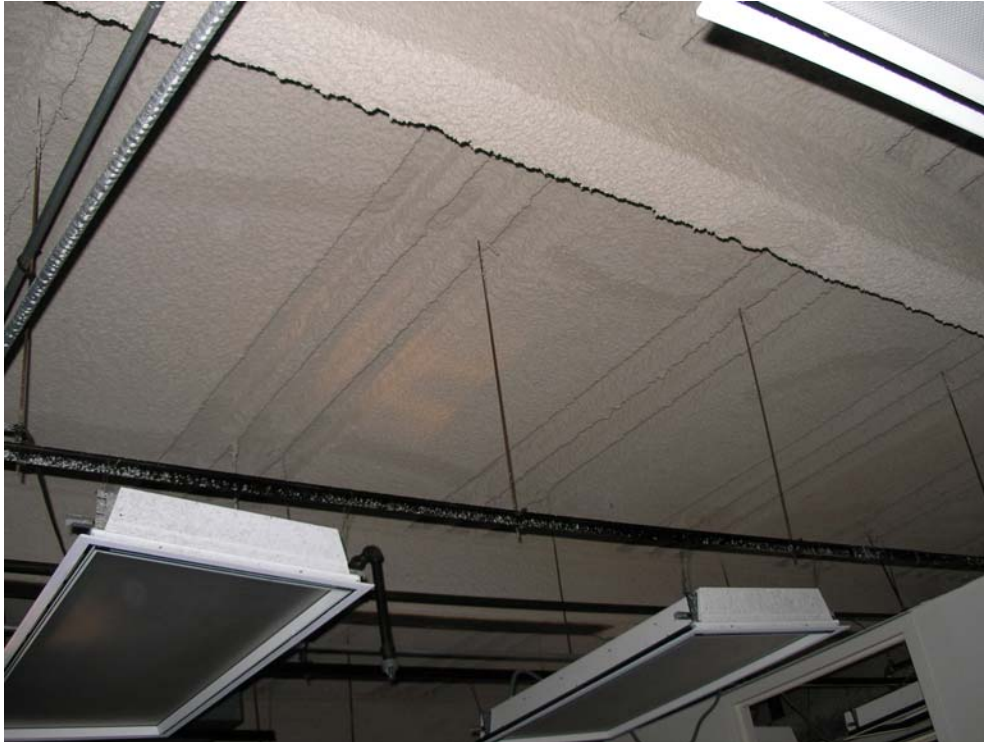
**Figure 2–34.**  
Floor beams  
with intact  
SFRM.

In general, the SFRM was observed to be intact a few feet away from the area of structural damage. In some locations, SFRM had been removed and sampled for tests of contaminants in the building (e.g., square shape of removed area). There were also some areas where SFRM was missing from the bottom surface of the lower flanges of floor beams. It was not always clear whether the SFRM had fallen off due to an event unrelated to the sampling or if it had been knocked off while samples were being taken.

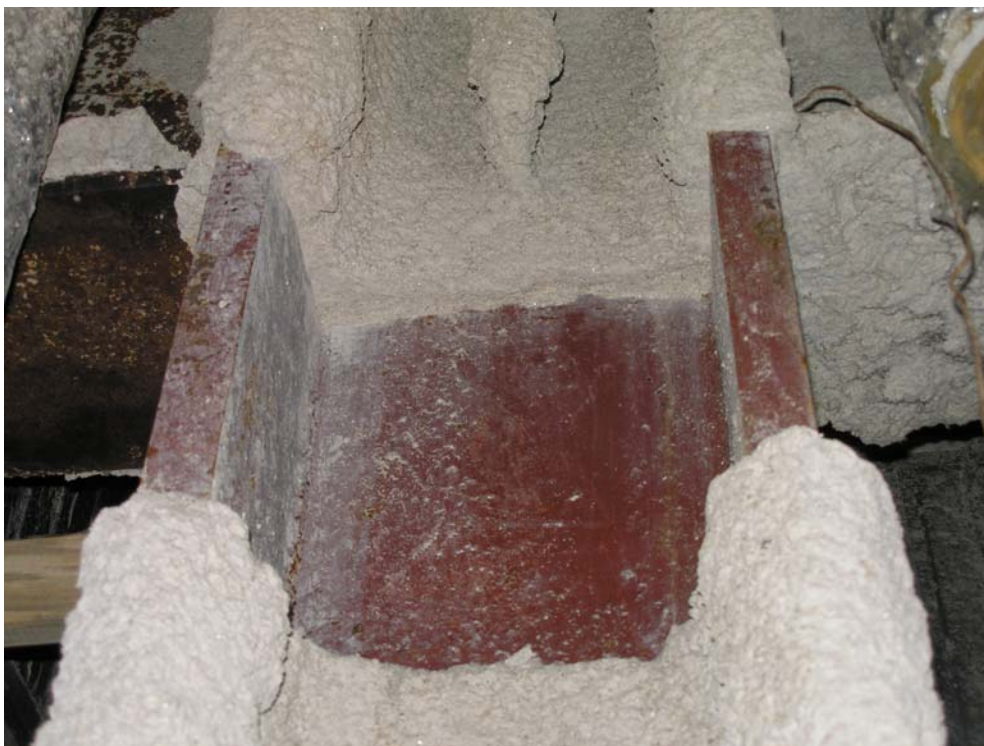
**Figure 2–35.**  
Column with  
removed SFRM  
and intact  
primer.

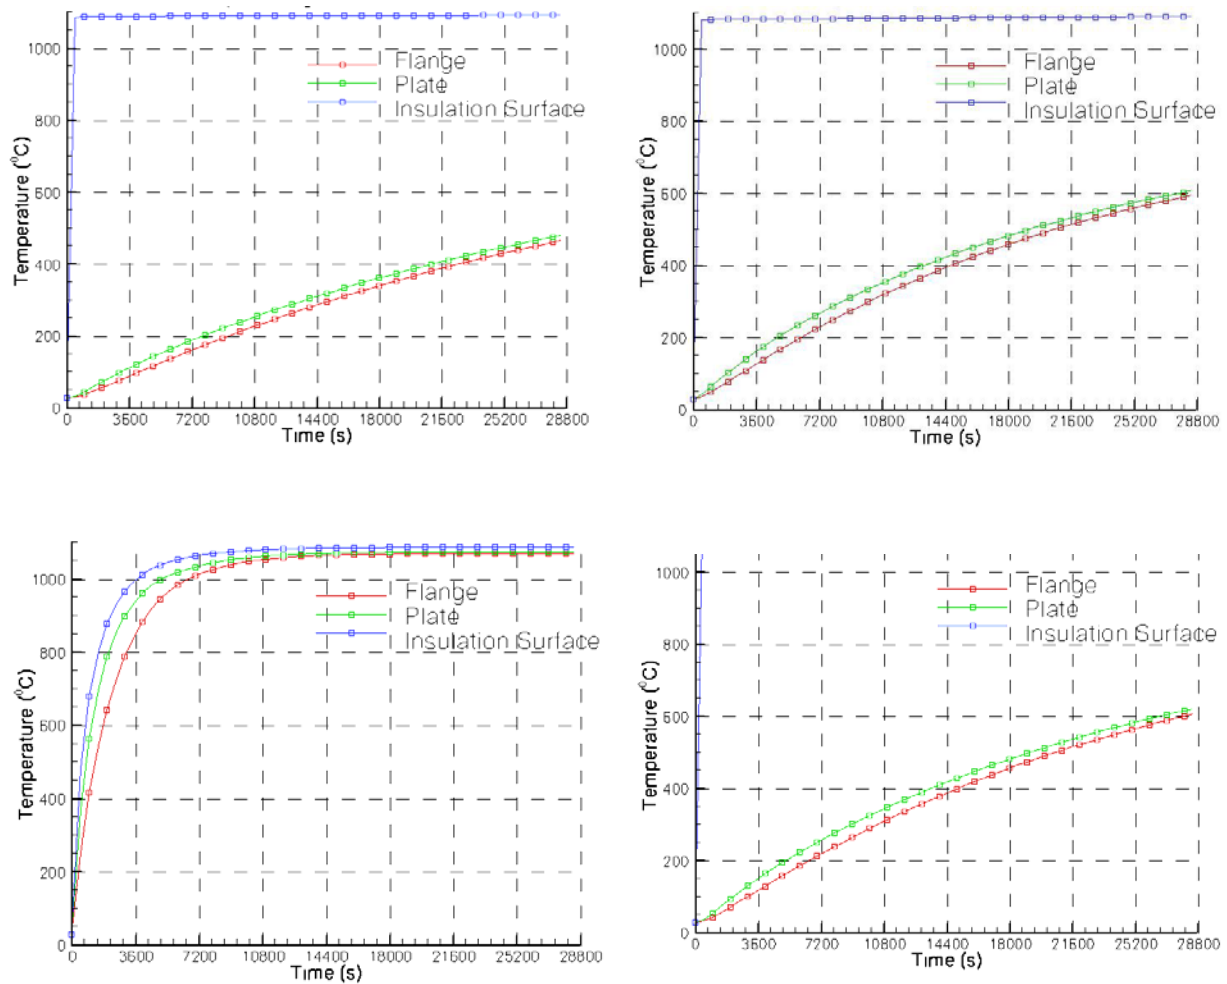
**Figure 4–4. Calculated temperature rise in Column 79 at varying insulation thicknesses and thermal exposures.**

With either thickness of insulation applied, it would take at least 7 h (3,600 s = 1 h) for the steel to reach 600 °C, the temperature at which the steel would have lost approximately 50 percent of its strength. (See NIST NCSTAR 1-3D for a thorough description of the loss of strength as a function of temperature.) For the fires in the WTC towers and in WTC 7 (see Chapter 9 of this report), the compartment air temperatures typically were near 1100 °C for less than 2 h. Even if the room temperature from the fires reached 1400 °C, a temperature that might be realized in a wind-aided fire and an extreme upper limit to the air temperatures probable in the types of fires experienced in WTC 7, the steel temperature would remain low enough after 4 to 5 h of such intense fire exposures for the steel to preserve its strength. By contrast, with no thermal insulation, the column would lose much of its strength within the first half hour of exposure to 1100 °C.

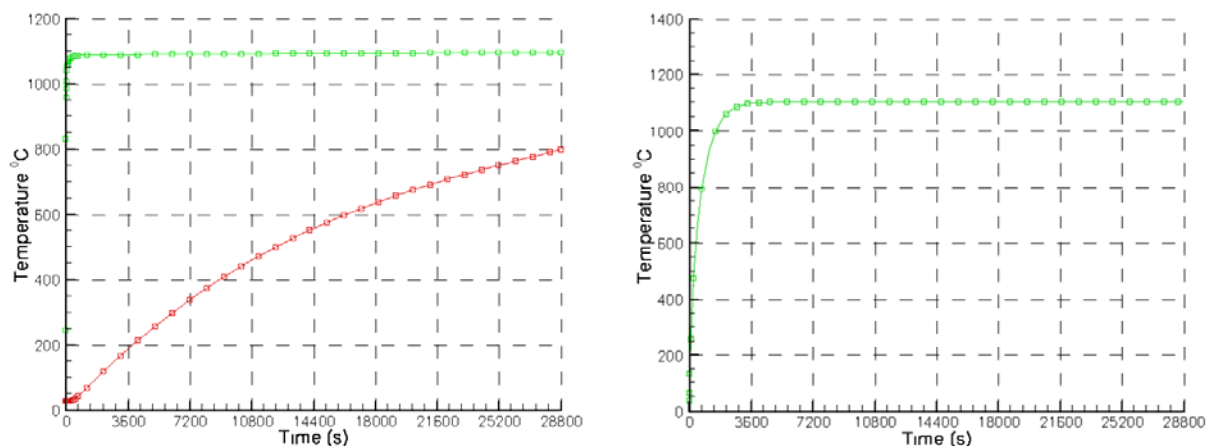
Figure 4–5 shows the results of similar calculations for the lighter, W14 x 500, column. The green data represent temperatures at the outer surface of the thermal insulation; the red data represent temperatures at the interior of the center of the web plate. For the insulated column, shown in the left plot, the web temperature reaches 600 °C in about 4 h. With no insulation (right plot), this temperature is reached in a matter of minutes. As expected, the lighter columns heat somewhat more rapidly, but, if properly insulated, the steel temperature would remain low enough after 3 h of such intense fire exposures for the steel to preserve its strength.

**Figure 4–5. Calculated temperature rise in a typical core or perimeter column exposed to 1100 °C air temperature.**

Left: insulated with 7/8 in. Monokote MK-5; right: uninsulated.

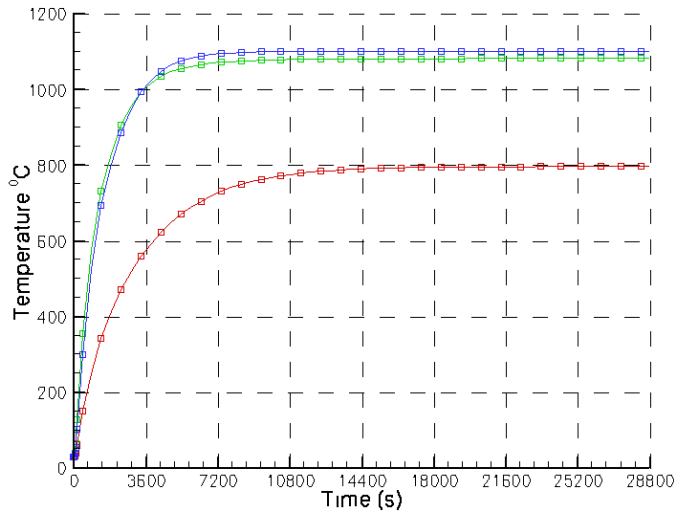
Each composite floor, with one of three representative beam sections, was exposed to an 1100 °C air temperature from below. Figure 4–6 shows the result of heating the floor with the insulated lightest steel section. The lower flange of the steel reached compromising temperatures in about 15 min, the upper flange in about 1 h. Figure 4–7 and Figure 4–8 show the slower temperature rises in the insulated midweight and heaviest beams, respectively. The lower flange temperatures are virtually identical to the web plate temperatures. Figure 4–9 shows the temperatures reached at the top and bottom of a typical floor slab at the thinnest sections located at the top of the steel deck corrugation.

**Figure 4–6. Calculated temperature rise in a W14 x 22 floor beam in an insulated composite floor assembly exposed to 1100 °C air from below.**  
Blue: lower flange; green, web plate, red: upper flange.

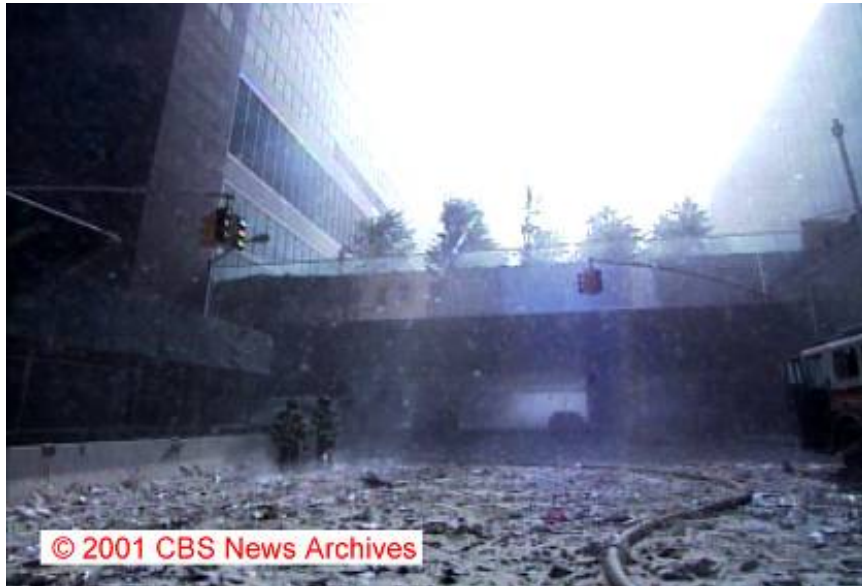
**Figure 5–18. An image from a video, shot from Vesey Street and looking toward the east, shows the south face of WTC 7 and the Promenade crossing over to WTC 6. The video was recorded around 10:15 a.m. on September 11. The intensity levels of the image have been adjusted.**

A frame taken from this video is reproduced in Figure 5–18. Even though the street is passable, a large amount of dust and small debris, such as paper, has been deposited on the street. The trees on the Promenade are upright and appear unharmed. Windows on several floors above the Promenade appear to be intact.

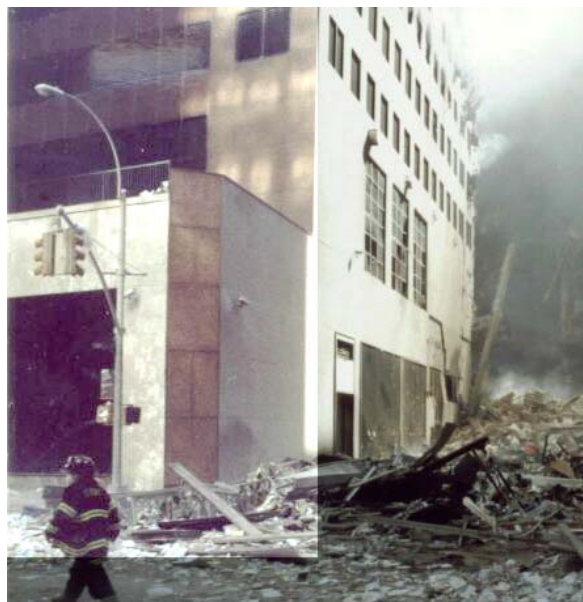
**Figure 5–25. Cropped photograph showing the lower floors of the west face and a small section of the north for WTC 7, taken on September 11 sometime after 12 p.m.**

To the immediate right of the large ground floor louvers, an area is visible on the 2<sup>nd</sup> floor where the granite cladding has been knocked off. Immediately below the damaged area there is a set of inactive vertical louvers. Immediately below these louvers, there was a 2.49 m (8 ft 2 in.) high vestibule with two entry doors. The doors led to a stairway that provided employee access to the 2<sup>nd</sup> through 4<sup>th</sup> floors.

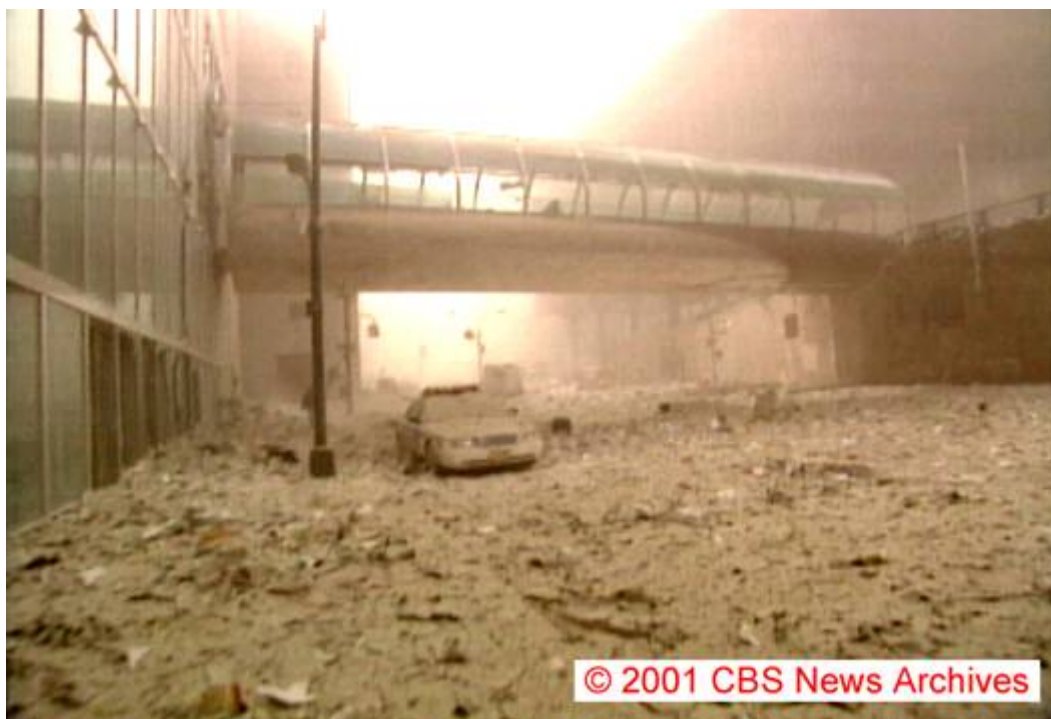
Another frame from this video taken closer to WTC 7 is shown in Figure 5–36. The amount of dust and debris is greater than seen further west on Vesey Street. It appears to be several inches deep. Most of the debris appears to be paper. A portion of the south face of WTC 7 is visible to the left. Numerous plate glass windows at the ground floor are broken out between column 24 and column 26. There appears to be some light façade damage higher up near the Pedestrian Bridge. There is no indication of any structural damage on WTC 7. The covering on the Pedestrian Bridge appears to be intact following the collapse of WTC 2. There are no indications of fire in the image.

**Figure 5–36. Frame from a video filmed just outside of WTC 7 looking east up Vesey Street around 10:15 a.m.**

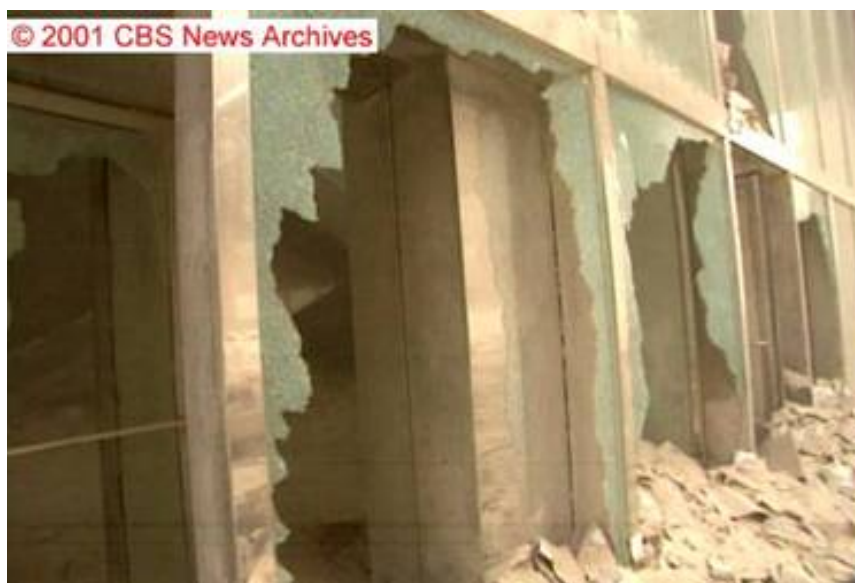
A closer view of the broken windows on the ground floor of WTC 7 is shown in Figure 5–37. A broken window is apparent above the door on the right side. An enclosed column, 25, is visible near the center of the image. It is clear that this column was undamaged at this time. The deep piles of dust and light debris have been pushed through the broken windows at the base. As the videographer entered the 1<sup>st</sup> floor lobby, the video shows that the entire floor was also covered by a thick layer of dust and light debris.

On exiting the building, the videographer again shot the interior of the 1<sup>st</sup> floor lobby. Figure 5–37 shows a view looking across the four story high lobby from the northwest towards the southeast. Some of the broken windows in the south face are visible. Columns 24 to 27 are visible, and it is clear that they have not sustained significant damage.

**Figure 5–37. Video frame showing the ground floor of the south face of WTC 7, taken around 10:15 a.m.** The column visible near the center is the base of column 25. The intensity levels have been enhanced.

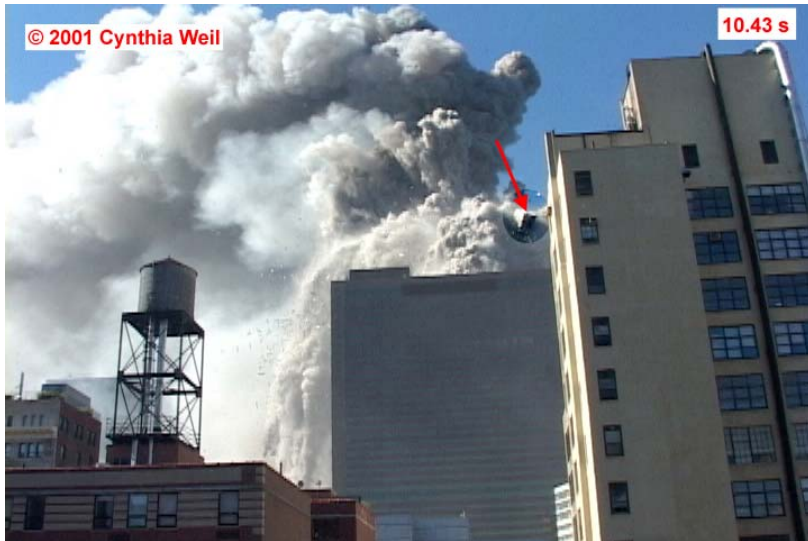
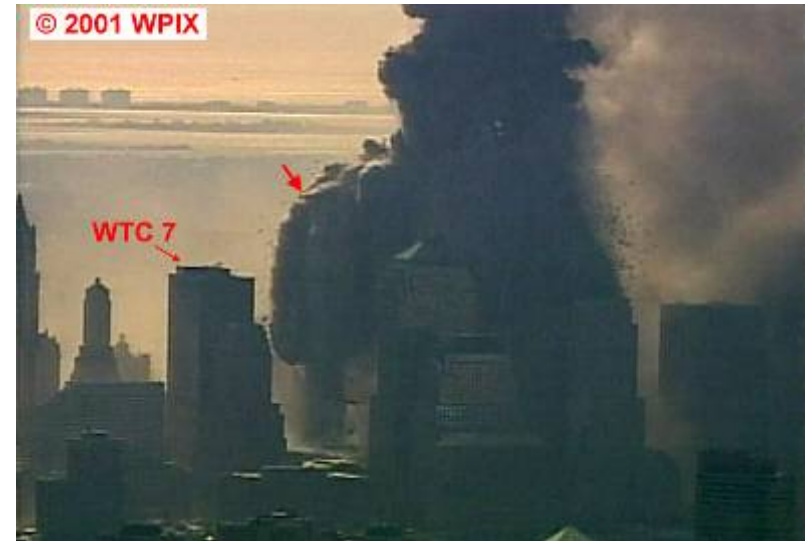
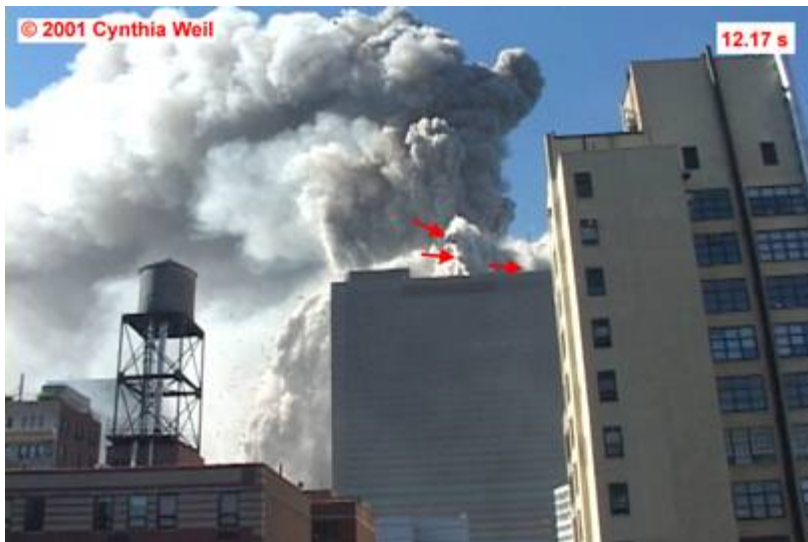
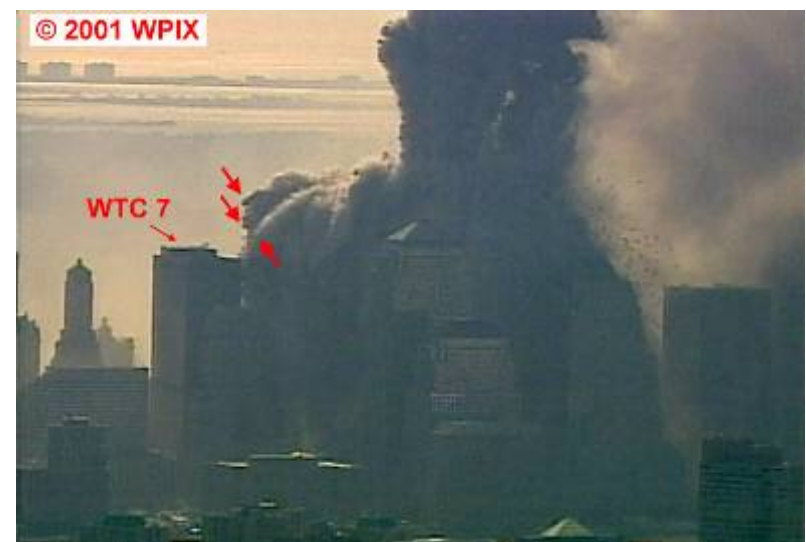
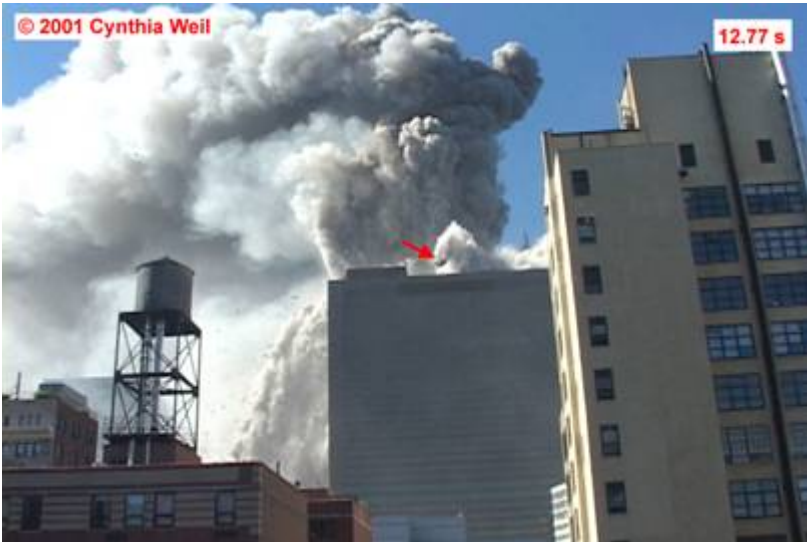
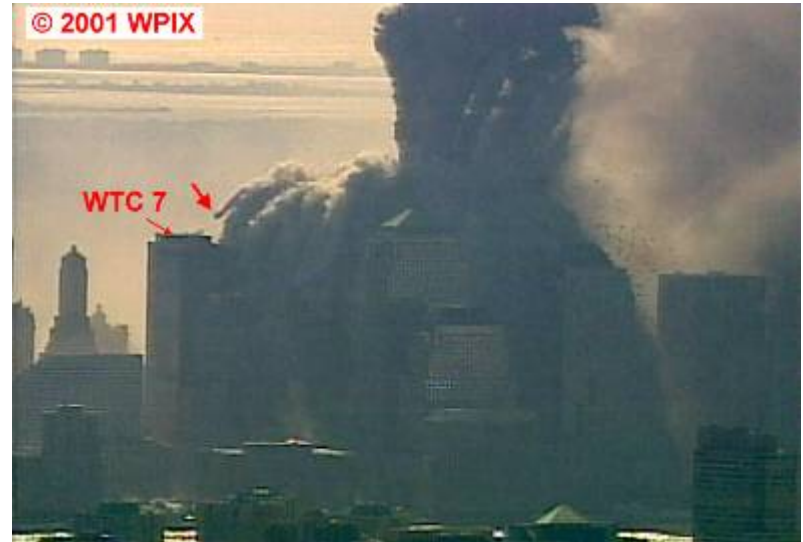
The next pair of images was recorded 12.17 s after the collapse started. The arcing path formed by the object observed at 10.43 s is visible from both directions (marked with arrows), even though the object itself has moved behind WTC 7 by this time in the north view. Note that this object appears to have passed behind WTC 7 at a location roughly halfway between the end of the west penthouse and the edge of the building. The two arrows to the left in the north view indicate additional objects that are just beginning to emerge from the dust cloud. These objects are also visible in the west view. The upper object is the same as observed for the three latest times in Figure 5–40. It ultimately formed the distinct arc seen in the images taken at 12.77 s that seemed to travel further outward. The videos show that the debris marked by the lower arrows in the images taken at 12:17 also arced downwards and had apparently disappeared behind WTC 7, just to the west of the building center, by 12.77 s.

**Figure 5–41. Three pairs of frames taken from videos shot from the north and west, showing the collapse of WTC 1.**  
 Times are relative to the start of the collapse. Arrows indicate large objects that were projected toward WTC 7.  
 The intensities of the video frames have been adjusted.

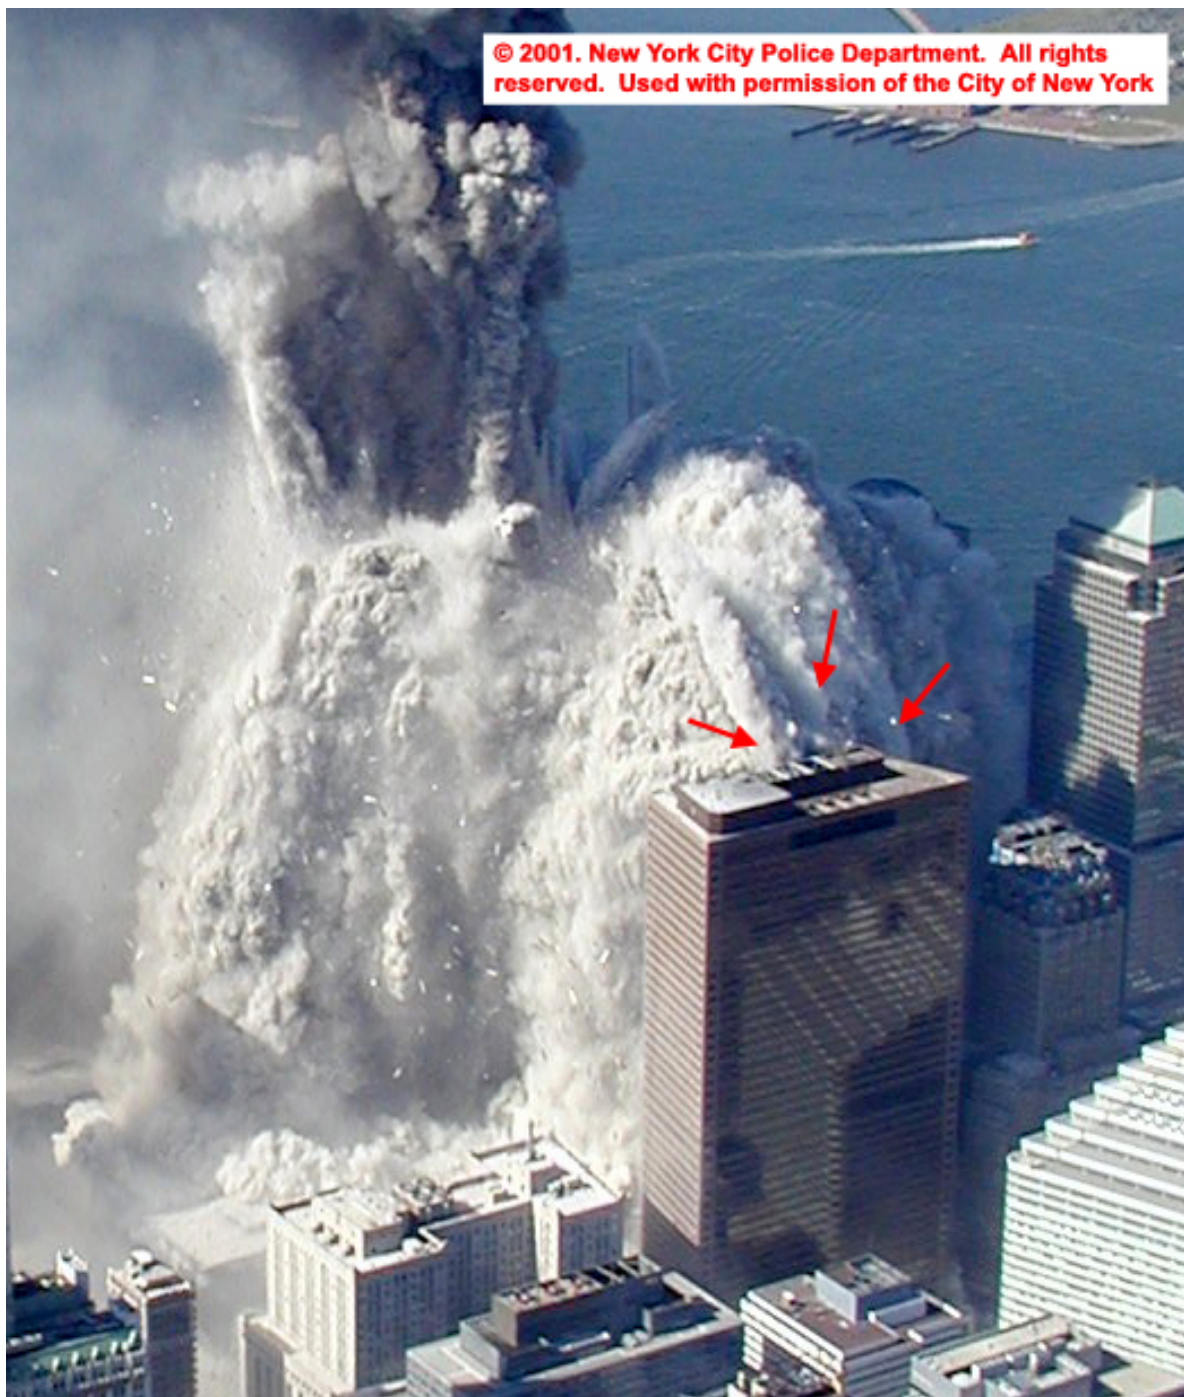
An aerial view from the northeast, showing the falling debris from WTC 1 with WTC 7 in the foreground, is shown in Figure 5–42. This photograph was taken about 14 s after the start of the collapse, or just over one second after the last pairs of images in Figure 5–40 and Figure 5–41. Arrows have been added indicating the three arcs generated by debris ejected from the primary debris cloud. Comparison with videos shows that these arcs resulted from the same material as those marked with arrows in Figure 5–40 and Figure 5–41. In this photograph, the easternmost arc, which was generated by the highest debris in the earlier photographs, appears to be approaching WTC 7 just west of the building center, while the westernmost arc seems to have passed just to the west of the building. In Figure 5–40 and Figure 5–41, the arcs appeared to be located slightly further east. This difference is mostly likely associated with parallax effects due to the relative locations of the cameras and the debris at the times the images were recorded.

**Figure 5–42. Aerial photograph shot 14 s  $\pm$  0.5 s after WTC 1 began to collapse.**  
Arrows mark arcs formed by debris that seemed to be ejected outwards from the debris cloud.

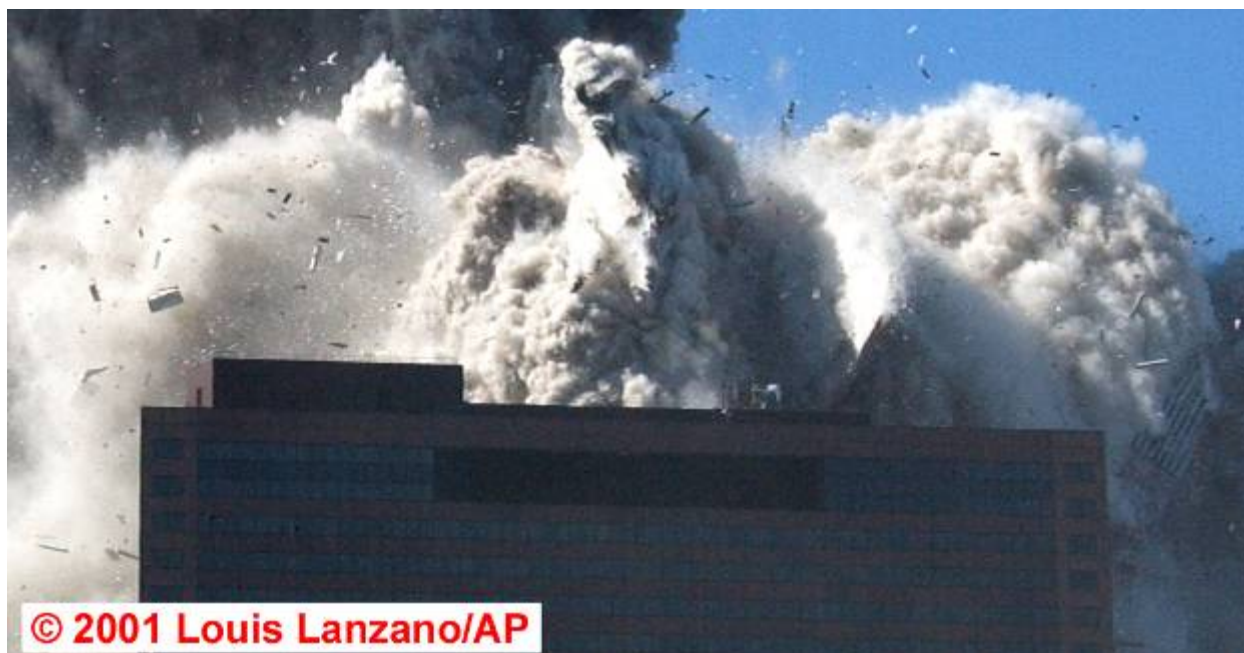
A large amount of smaller debris is visible outside of the primary debris field in Figure 5–46. Their size and shape suggest that many of these smaller pieces are individual 3.6 m (12 ft) long aluminum cladding that covered the outer steel skeleton of the towers. These are described in NIST NCSTAR 1-5A. The opacity of the dust cloud created by the collapse of WTC 1 is also evident in the photograph.

Figure 5–46. Enlarged section of Figure 5–45 focused on the area above WTC 7.

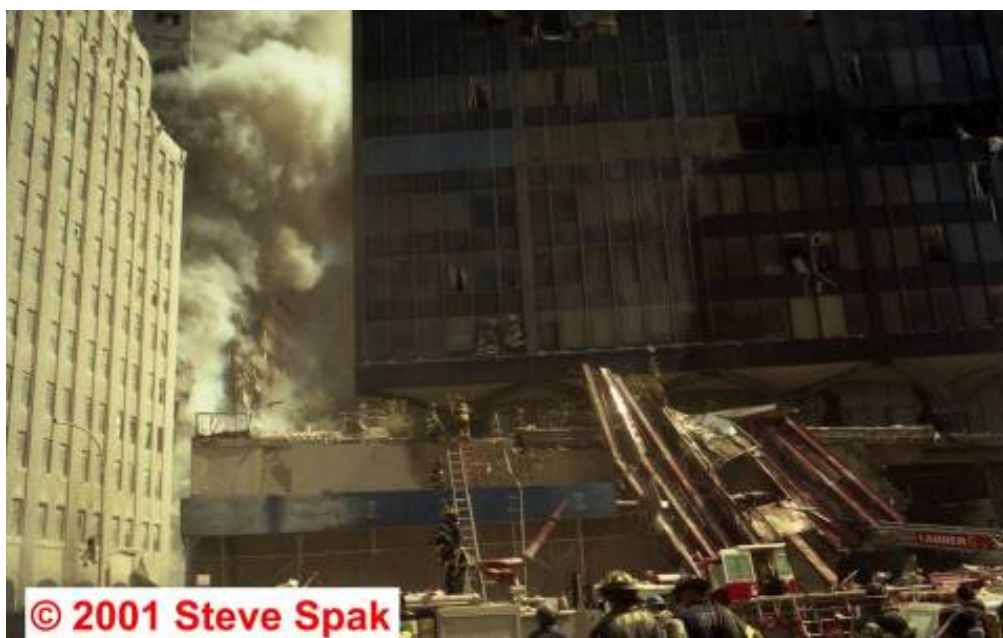
Figure 5–47. Photograph showing a portion of the south face of WTC 7, taken just after 1:30 p.m.

A damaged area is visible on the south face of WTC 7, and an opening has been created on the left side of the visible part of the face. Heavy smoke appears to be coming from this opening. A closer inspection shows there is an area to the right where the alternating spandrels and windows, characteristic of the south face (see the earlier discussion), are visible. A series of white vertical lines are also present. These lines reveal the locations of the steel columns that were located along the south periphery of the building, immediately behind the windows. These columns appear white because of their enclosures.

In Figure 5–47, the four sets of columns to the immediate right of the damaged area have roughly the same spacings, but the distance to the next set of columns appears to be somewhat larger. In fact, the spacing between columns 24 and 25 was about 1.8 m (5 ft 10 in.) larger than the spacings between columns 21, 22, 23, and 24. On this basis, the five sets of columns visible to the right of the damaged area were tentatively assigned as column 21 to column 25.

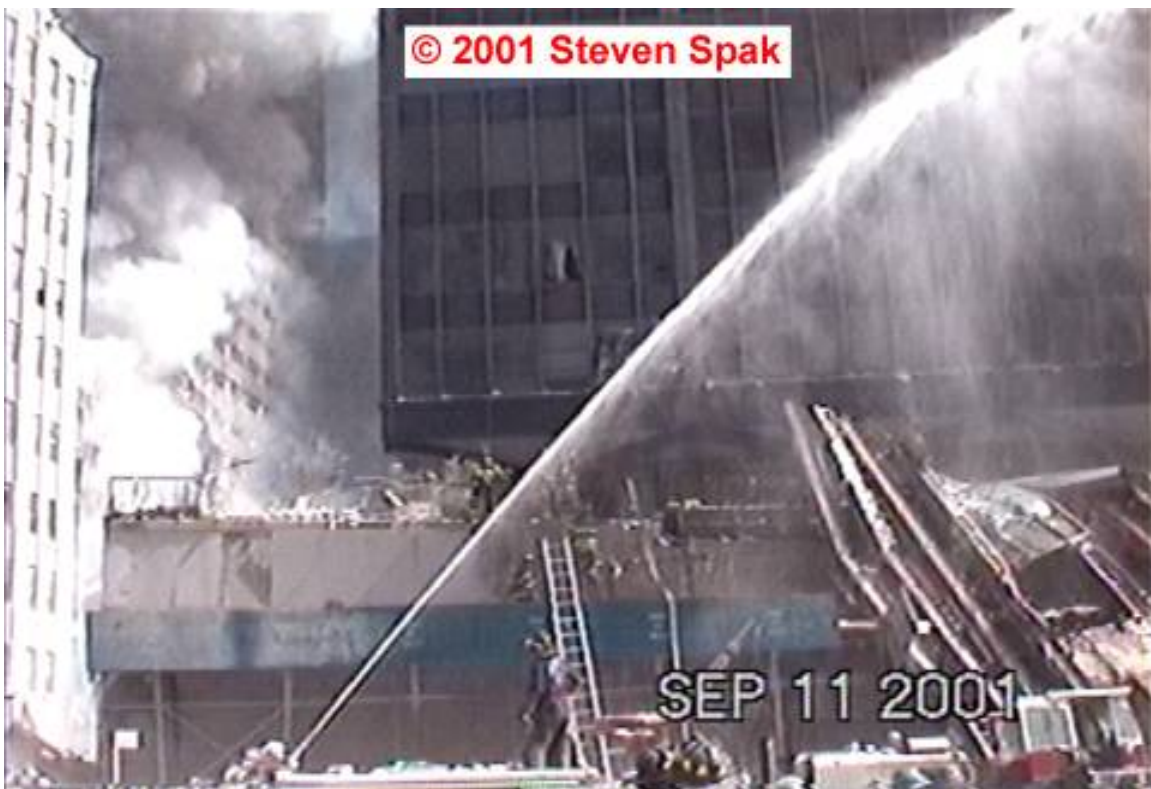
This photographer also recorded a short video segment of the south face from near the same location at roughly the same time as the photograph in Figure 5–47. As the smoke rolled across the south face in the video, additional areas on the south face (primarily on the east side) were momentarily revealed. Figure 5–48 shows a frame taken from this video. By appropriate scaling (the video has much lower resolution) and rotation of such frames, it was possible to obtain good overlap of the captured video frames and the image shown in Figure 5–47.

**Figure 5–48. Frame taken from a video recorded shortly after 1:30 p.m., showing a partial view of the south face of WTC 7.**

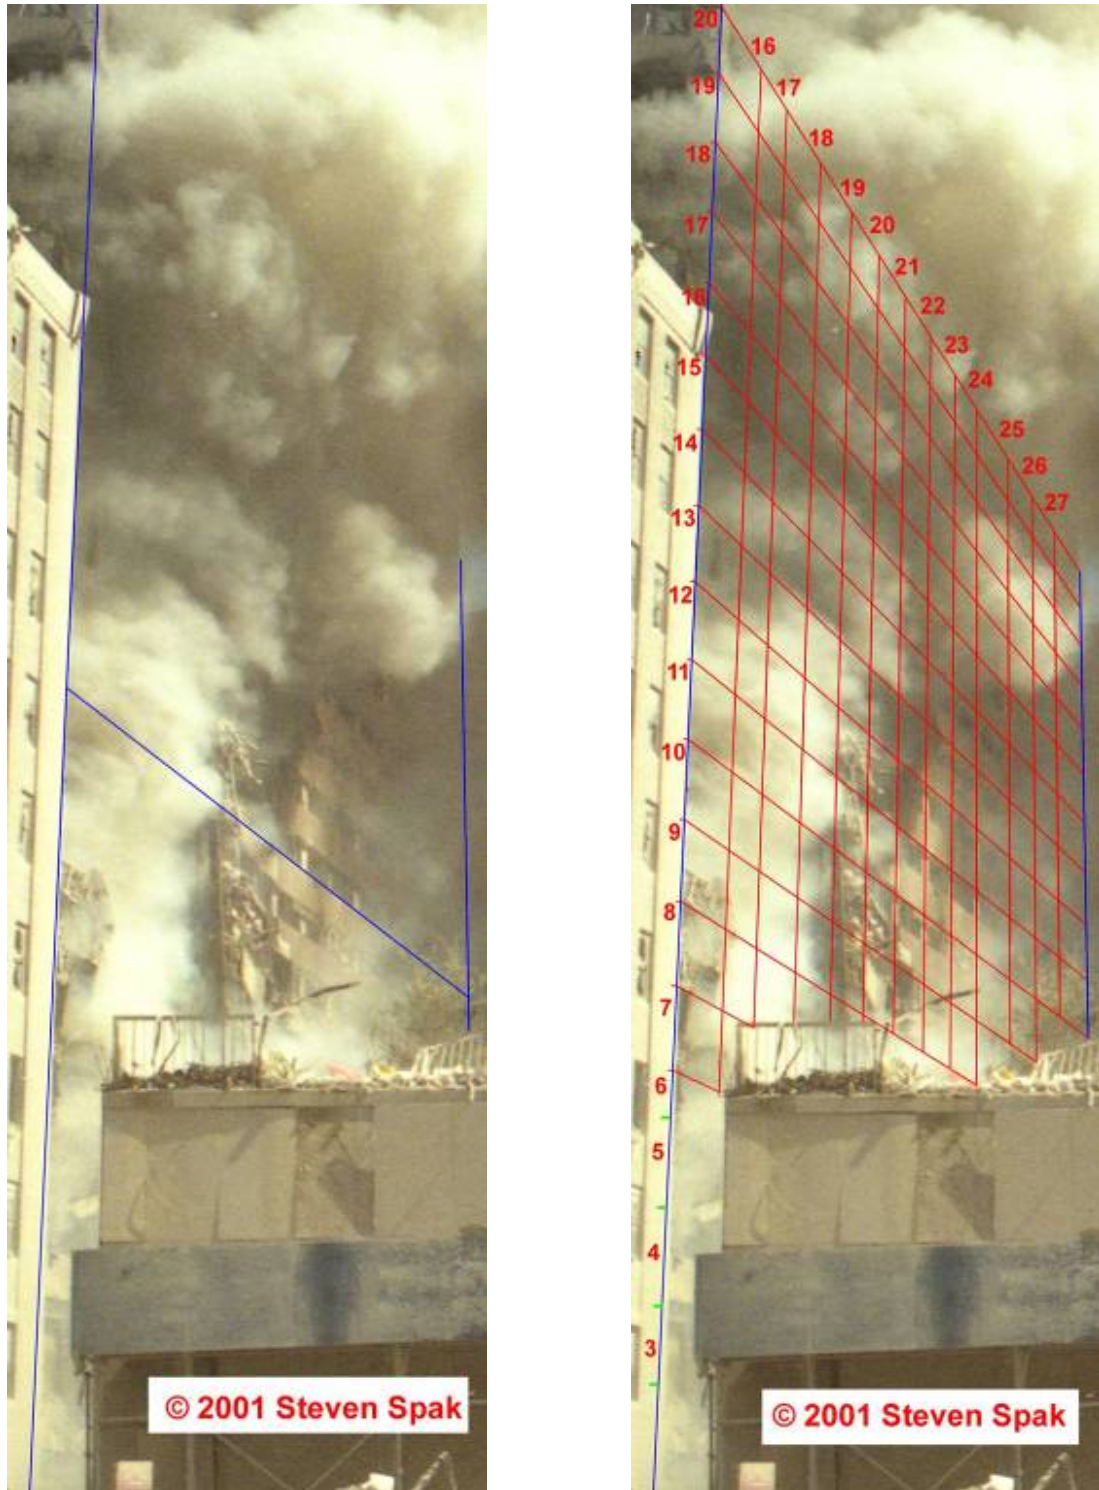
**Figure 5–49. Enlarged sections of the photograph shown in Figure 5–47.**

In Figure 5-49, the area to the immediate right of column 20 on the 11<sup>th</sup> and 12<sup>th</sup> floors appeared dark, as if it was an opening, while the higher floors were hidden by smoke. However, it is clear from Figure 5-63 that the columns between column 20 and column 23 were intact on the 11<sup>th</sup> through 14<sup>th</sup> floors, along with the spandrel beams and at least part of the granite cladding on the 12<sup>th</sup> through 14<sup>th</sup> floors. In Figure 5-49, the granite cladding appears to be damaged below the 13<sup>th</sup> floor near column 23.
