**Federal Building and Fire Safety Investigation of the  
World Trade Center Disaster**

**Structural Fire Response and  
Probable Collapse Sequence of  
World Trade Center Building 7**

**NIST NCSTAR 1-9**

August, 2008

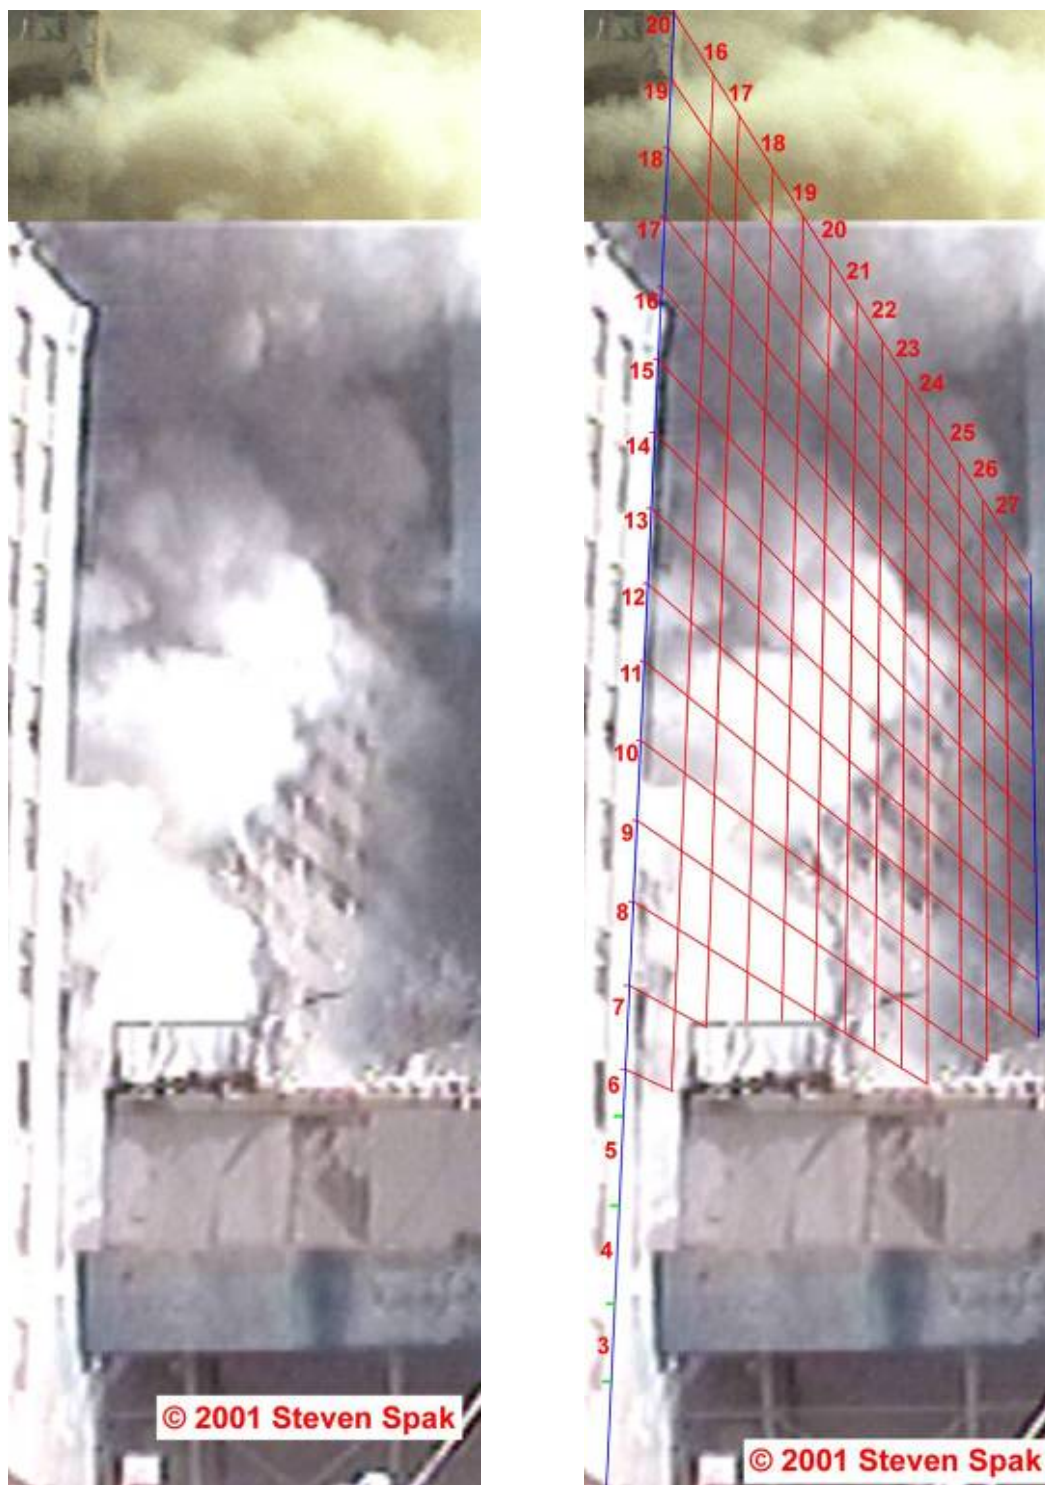
Figure 5–50 shows an enlargement of the damaged south face from the video frame shown in Figure 5–48 overlaid on the photograph shown in Figure 5–49. On the right, the grid taken from Figure 5–49 has been superimposed on the same image. While the image has a relatively low resolution, it is clear that the columns and spandrels to the right of the damaged area were essentially intact, but that most of the window glass had been broken out.

**Figure 5–50. An enlarged section of the south face of WTC 7 from the video frame in Figure 5–48.**

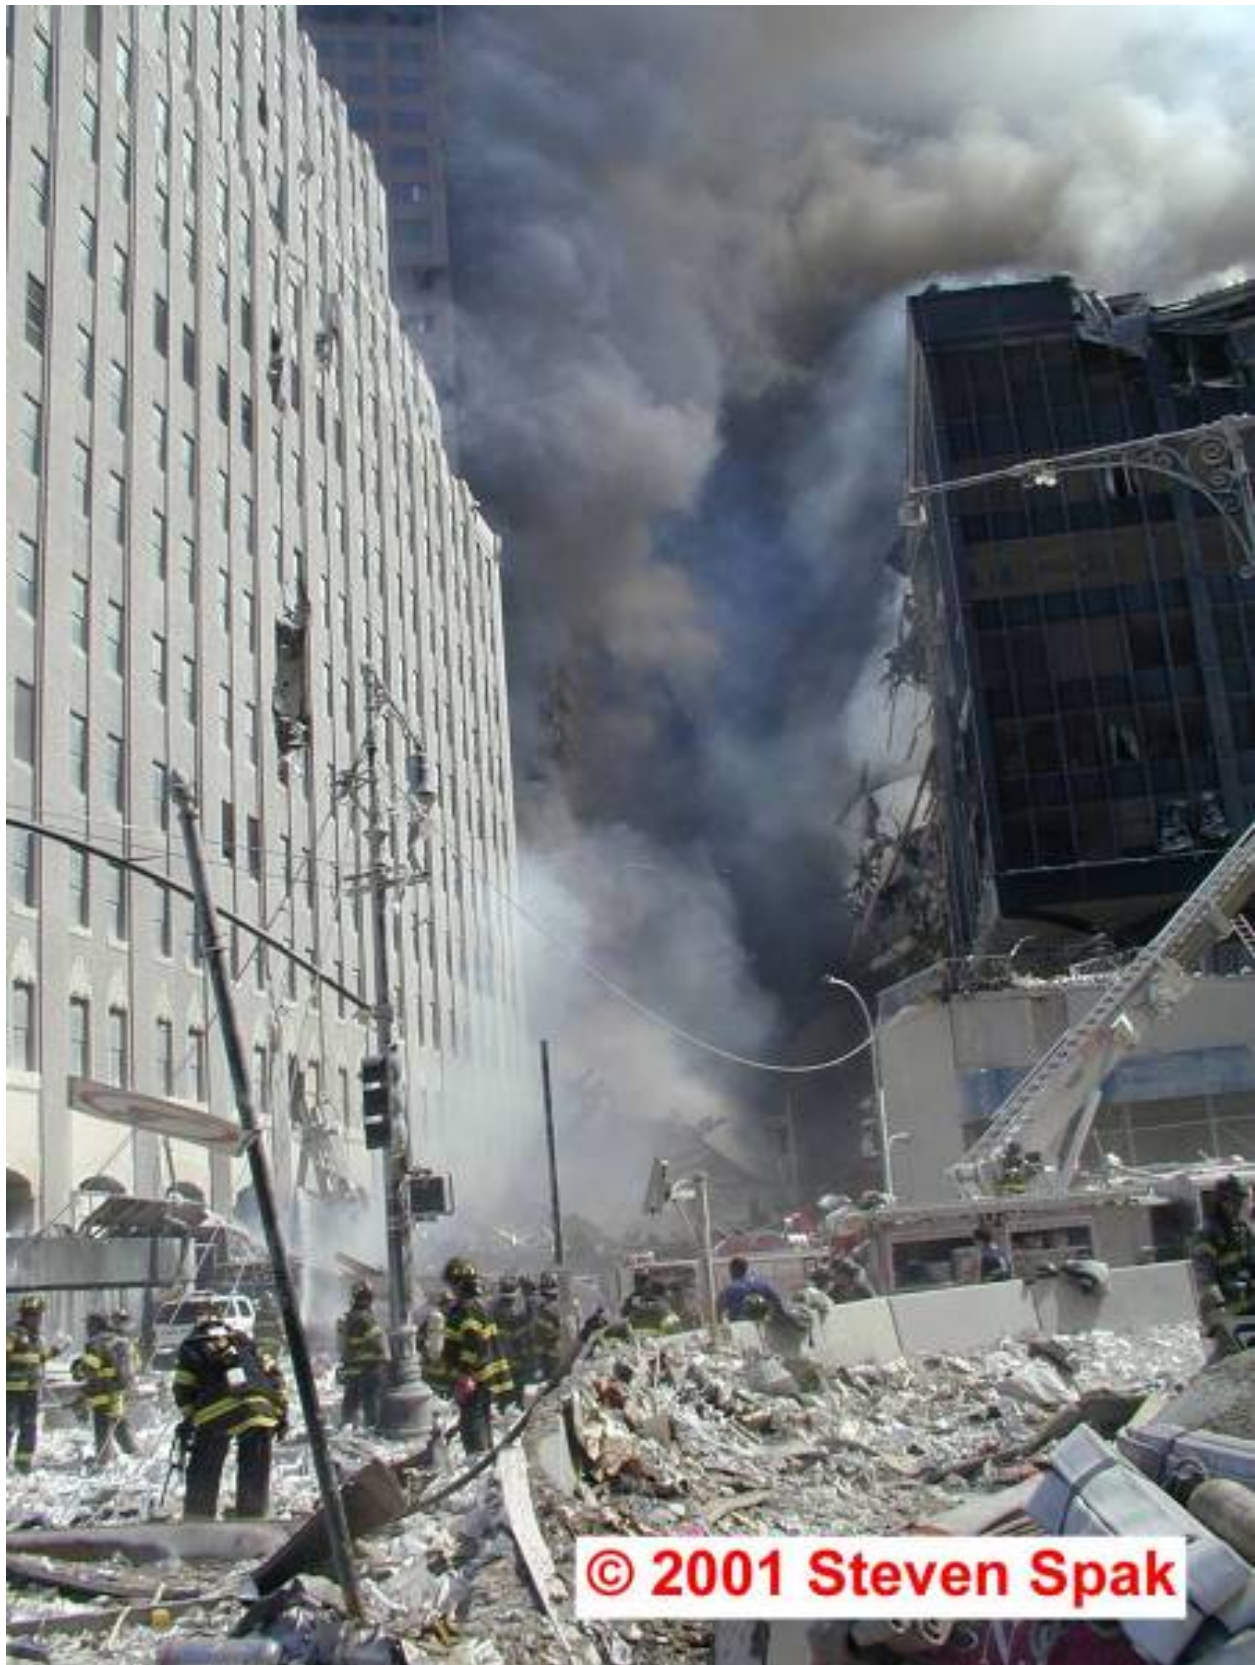
Figure 5–52 is another photograph showing damage to the south face of WTC 7. It was shot from West Street looking down Vesey Street. The Verizon Building is on the left, WTC 7 is behind it, and WTC 6 is on the right. Even though this image provides a more oblique view than the photograph in Figure 5–48, it is possible to see locations closer to the street.

Figure 5–52. Photograph showing a portion of the south face of WTC 7 at 12:46:39 p.m.

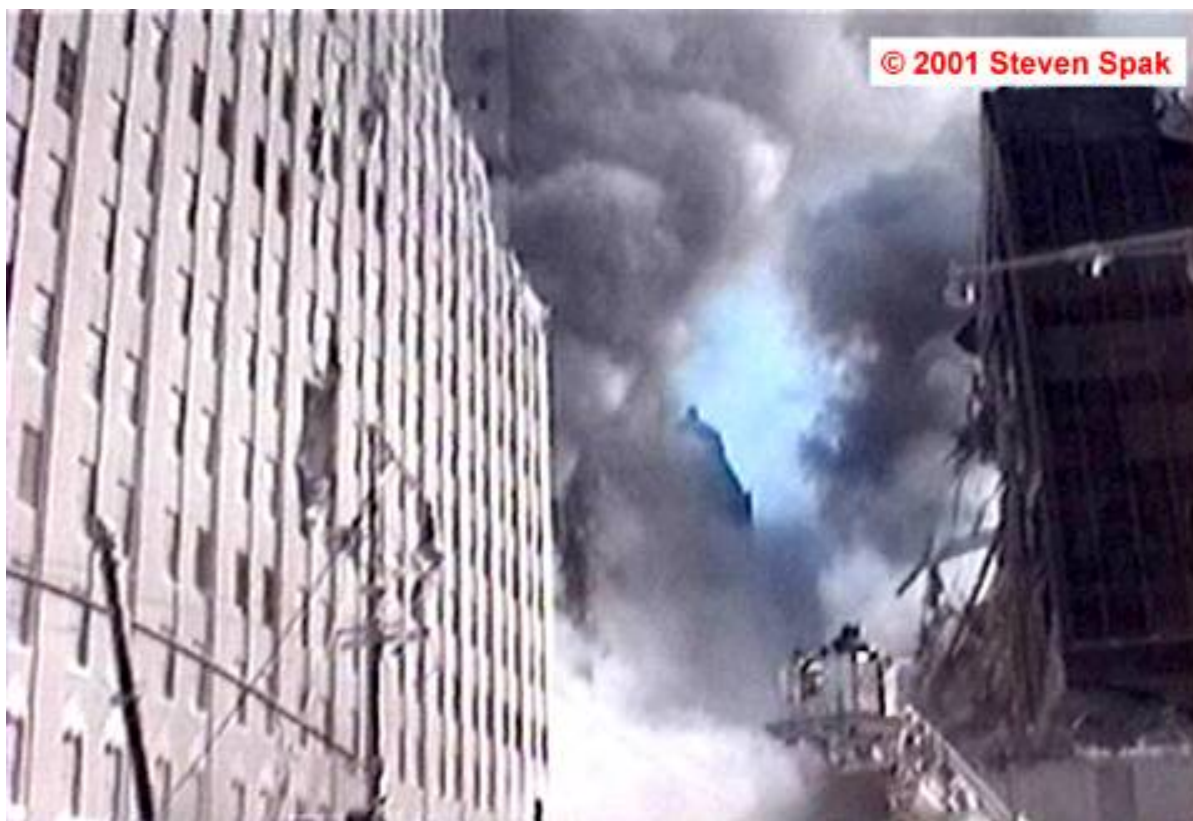
**Figure 5–54. Frame from a video showing a view of the south face of WTC 7** shot from roughly the same location as Figure 5–53, earlier than and within a few minutes of 12:46:39 p.m. The intensity levels have been adjusted.

The smoke that obscured much of damaged area had cleared somewhat, and a larger area of the damage on the south face is visible than in the images described above. The damaged area is enlarged in Figure 5–55. Based on the overlay of the image on the photograph, an arrow indicates the location marked in the image on the right-hand side of Figure 5–53. Comparison with Figure 5–53 indicates that the damage visible in Figure 5–55 spans multiple floors downward from the 15<sup>th</sup> floor and is at least two columns wide. Areas higher up on the south face remain hidden by smoke.

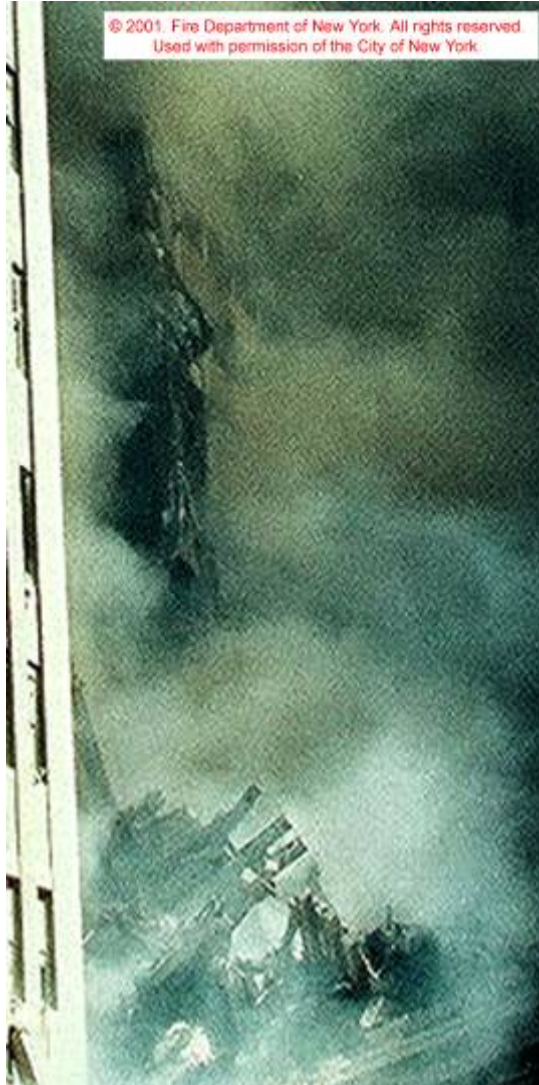
The smoke near the base of WTC 7 had momentarily cleared at this time, and it is possible to observe a damaged area on the lower part of the south face. An opening in the building spanning several floors is apparent. This part of the image has been enlarged in Figure 5–57. A row of several windows with some columns visible can be seen near the top of the visible damage. Closer inspection reveals that there is another row of windows immediately below. A single window is visible just to the right of the curved damage section. Lower down a single rectangular opening is present to the left of the opening in the face. This opening is much taller than the windows visible above. Its shape indicates that it is one of the vents that spanned the 5<sup>th</sup> and 6<sup>th</sup> floors. Thus, the damage visible in the image spans the 5<sup>th</sup> to 8<sup>th</sup> floors.

There is insufficient information in the image to identify the exact horizontal location of the damage on the face. However, it is likely that the damage area is a downward extension of the opening visible in Figure 5–47 and Figure 5–49 to the immediate left of column 20. If this is correct, the opening in this area extends from at least the 5<sup>th</sup> floor to the 15<sup>th</sup> floor.

**Figure 5–57. Expanded portion of Figure 5–56 showing damage on the south face of WTC 7.** The contrast of the image has been enhanced.

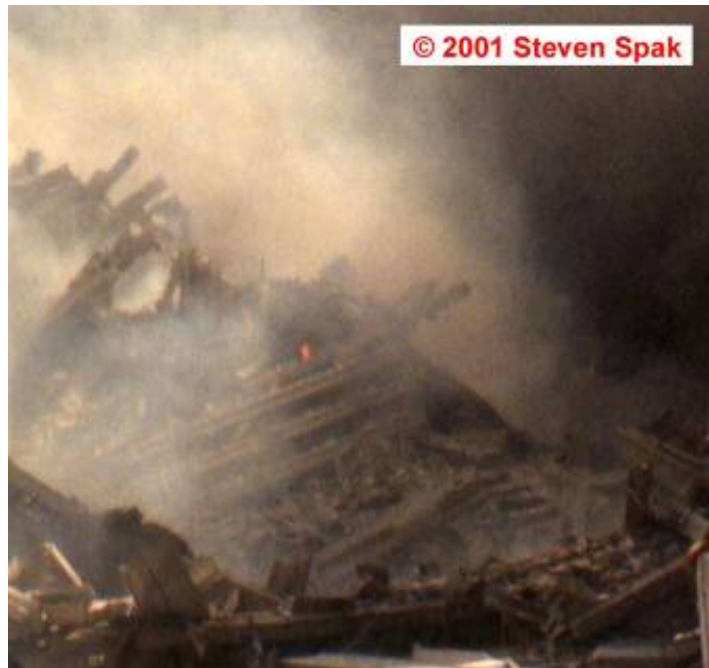
Another view of the debris piled up at the base of WTC 7 is shown in Figure 5–58. The large number of steel panel sections from WTC 1 is evident. A small fire is burning in the pile. The large amount of debris in Vesey Street is consistent with the large areas of WTC 1 panel sections that were described earlier as falling toward WTC 7.

**Figure 5–58. View of the rubble at the base of the south face of WTC 7.** The original image was cropped, and the intensity levels and contrast were adjusted.

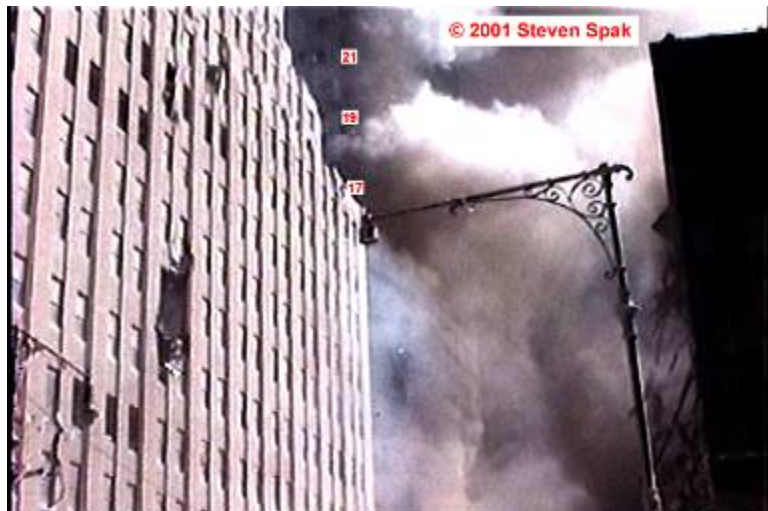
Another frame from a video clip showing the south face of WTC 7 taken looking up Vesey Street is shown in Figure 5–59. Visible floors along the south edge of the west face are indicated. The hole near the center of the south face is only partly visible, but this image is noteworthy because the smoke is clear enough to confirm that the spandrels and columns are intact over a large area to the east of the hole. By using lines running along the tops of the windows to extrapolate to the west edge, it was possible to identify this area as extending from the 11<sup>th</sup> floor to the 15<sup>th</sup> floor.

**Figure 5–59. Frame from a video clip shot shortly after 12:30 p.m. showing the south face of WTC 7 framed by the Verizon Building and WTC 6. The intensity levels have been adjusted and floor numbers have been added.**

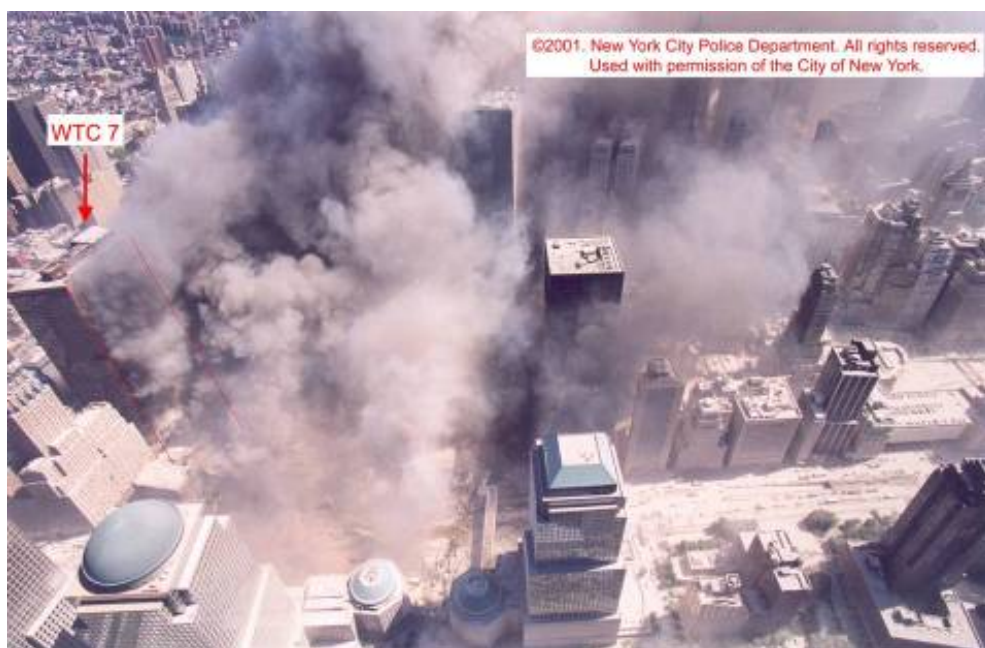
Figure 5–60 shows a long-distance photograph shot from a helicopter just after 12:30 p.m., in which the south face of WTC 7 is partially visible. Red lines have been added indicating the west and east edges of the face. The west edge was easily identified, but, due to the presence of smoke, the east edge line had to be drawn by starting at the upper corner, which is just visible, and assuming the east edge was parallel to the west edge.

**Figure 5–60. Photograph of the WTC site shot around 12:35 p.m. from a helicopter. The red lines identify the west and east edges of the south face of WTC 7.**

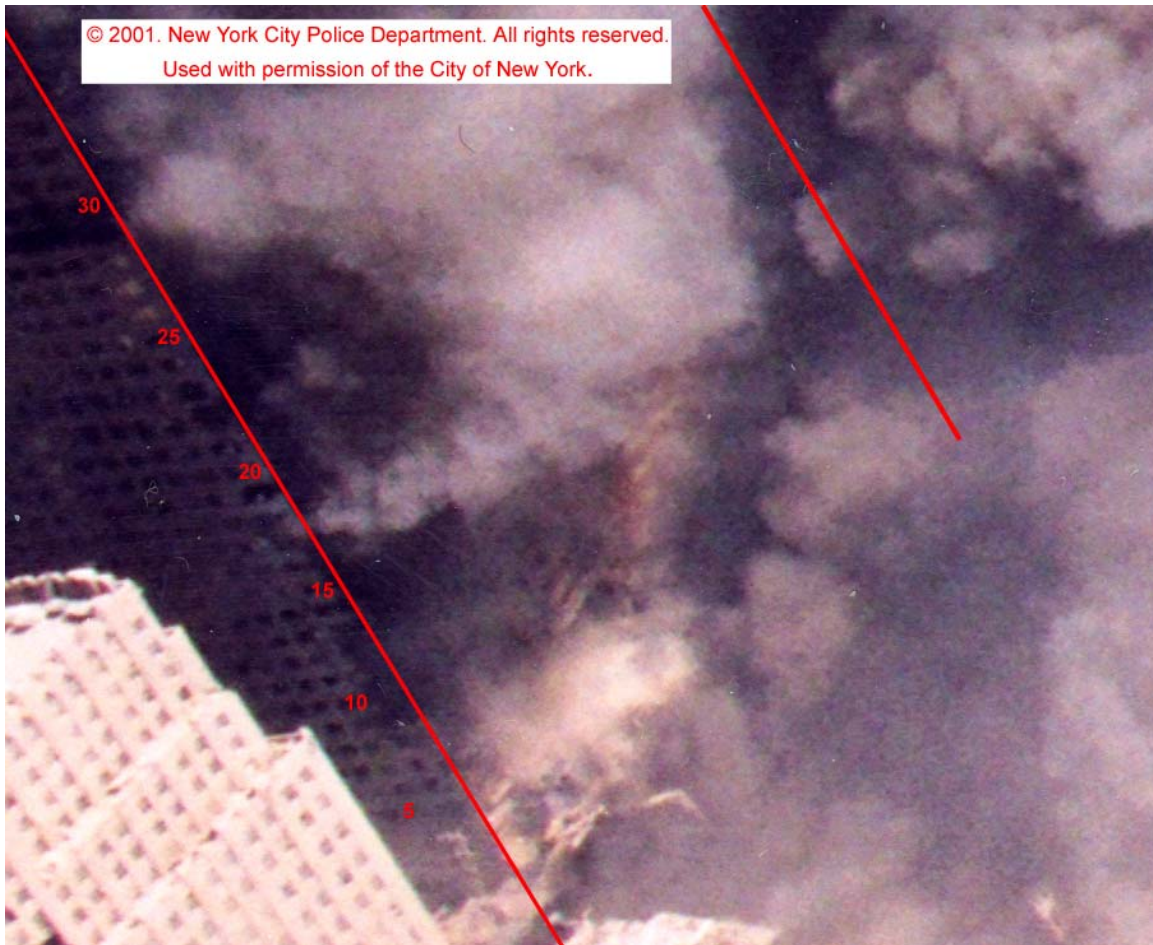
Figure 5–61 is an enlargement of the lower portion of WTC 7 from Figure 5–60. Floor numbers have been added along the southern edge of the west face. Details are difficult to discern due to the distance of the photograph, but it is possible to see parts of the south face that were damaged during the collapse of WTC 1. A dark area extending up to the 14<sup>th</sup> or 15<sup>th</sup> floor can be seen near the center of the face. This location suggests that this is the damage identified earlier near column 22, based on Figure 5–52 to Figure 5–55. This damage appears to extend downward to about the 9<sup>th</sup> floor. As observed earlier, intact spandrels are visible to the right of this opening.

**Figure 5–61. Enlarged portion of Figure 5–60 showing the south face of WTC 7.**  
The section has been enhanced by adjusting the intensity levels. The red lines indicate the west and east edges. Floor numbers have been added.

A second damaged area is apparent just to the left and below that described above. This opening seems to extend down to about the 5<sup>th</sup> floor where it becomes hidden by smoke. The location of this damage is consistent with that identified earlier in Figure 5–47, Figure 5–49, Figure 5–56, and Figure 5–57. There appear to be two spandrels located just above this opening near the 8<sup>th</sup> and 9<sup>th</sup> floors. Closer inspection suggests that these spandrels have been partially dislodged since they do not line up well with the spandrels visible to the right.

There appear to be one or more panel sections lying up against the south face of WTC 7. These seem to be raised off the ground somewhat, but appear to be too low to be on top of the Promenade. It is possible that the Promenade has partially collapsed in this area. There appear to be two openings in the south face of the building immediately above the panel sections. It is not possible to confirm whether the smaller opening on the right resulted from structural damage, since this area was primarily glass enclosed (see Figure 5–20), and the glass may simply have been broken out. On the other hand, the opening on the left seems to extend well above the 4<sup>th</sup> floor, suggesting that some structural damage is present in this area. The granite at this height on the southwest corner appears to have been disrupted, which agrees with damage visible on this corner in Figure 5–47 and Figure 5–49.

There is a dark area in Figure 5–61 extending from the 8<sup>th</sup> floor to the 13<sup>th</sup> floor, where it is difficult to make out the southwest corner of WTC 7. As shown in Figure 5–62 and Figure 5–63 below, the southwest corner was damaged at this location by falling debris from WTC 1.

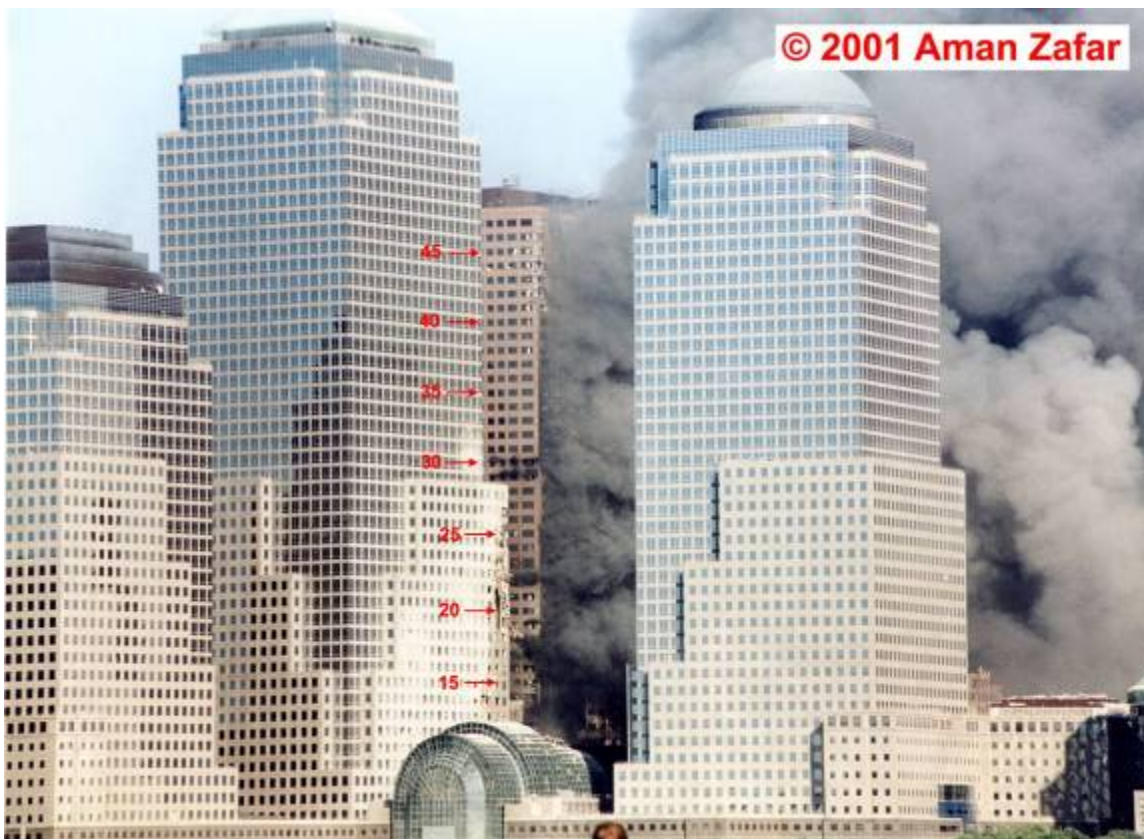
Figure 5–62 was shot from Jersey City on the opposite side of the Hudson River. It shows portions of the southwest corner and adjacent faces of WTC 7, flanked by World Financial Center 3 on the left and by World Financial Center 2 on the right. The Winter Garden lies at the base of WTC 7. The roofline of WTC 6 is visible just above the Winter Garden, and a small corner of the Verizon Building is also visible just to the right of World Financial Center 3. WTC 7 floor numbers have been added to the photograph.

**Figure 5–62. Photograph showing the southwest corner of WTC 7 in the early afternoon.** The buildings visible on the right and left are World Financial Center 2 and World Financial Center 3, respectively. The structure in the foreground is the Winter Garden. The base of WTC 7 is also hidden by WTC 6. Numbers and arrows indicate WTC 7 floors.

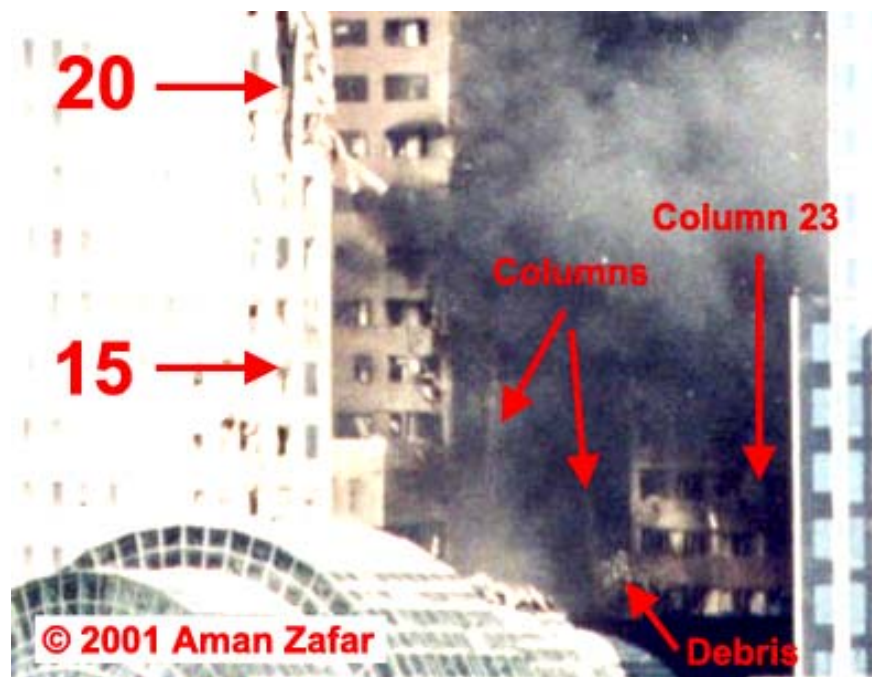
Figure 5–63 shows an enlargement of the region of the lower floors of WTC 7 from Figure 5–62. Floor locations and certain features have been noted. This image of the building reveals considerable detail about the condition of the building at the southwest corner. Consider the feature marked “Debris.” It appears to be an object on the 12<sup>th</sup> floor spandrel. A similar feature is visible on the 12<sup>th</sup> floor spandrel, just to the left of column 20 in Figure 5–49. Four equally spaced sets of columns are easily identified to the immediate right of the debris in Figure 5–63. If the rightmost of these is identified as column 20, there should be space for column 16 to column 19 between this column and the west edge of the face. By simply drawing lines along the corner of the building and along the visible columns in Figure 5–62, it was

possible to confirm that the spacing visible between the building edge and the first column to the right of the debris was consistent with its assignment as column 20.

**Figure 5-63.** Enlargement of the lower part of the southwest corner of WTC 7 from Figure 5-62, with certain features identified. The intensity levels have been adjusted.

In Figure 5-49, the area to the immediate right of column 20 on the 11<sup>th</sup> and 12<sup>th</sup> floors appeared dark, as if it was an opening, while the higher floors were hidden by smoke. However, it is clear from Figure 5-63 that the columns between column 20 and column 23 were intact on the 11<sup>th</sup> through 14<sup>th</sup> floors, along with the spandrel beams and at least part of the granite cladding on the 12<sup>th</sup> through 14<sup>th</sup> floors. In Figure 5-49, the granite cladding appears to be damaged below the 13<sup>th</sup> floor near column 23.

In Figure 5-63, the area between corner column 15 and column 20 appears to be open over the 11<sup>th</sup> floor to the 15<sup>th</sup> floor. Closer inspection reveals what appear to be two columns (marked with arrows) in the opening. They are located near the positions expected for columns 16 and 19. These columns are not parallel to the building edge or columns 20 to 23. The top of the visible section of column 19 is bent inward toward the west, and the bottom of column 16 is bent in the same direction. In Figure 5-49, there is a straight edge visible near the expected location for column 19 on floors 9 and 10 that appears to have been pushed towards column 20. There are no signs of columns 17 or 18 in Figure 5-63.

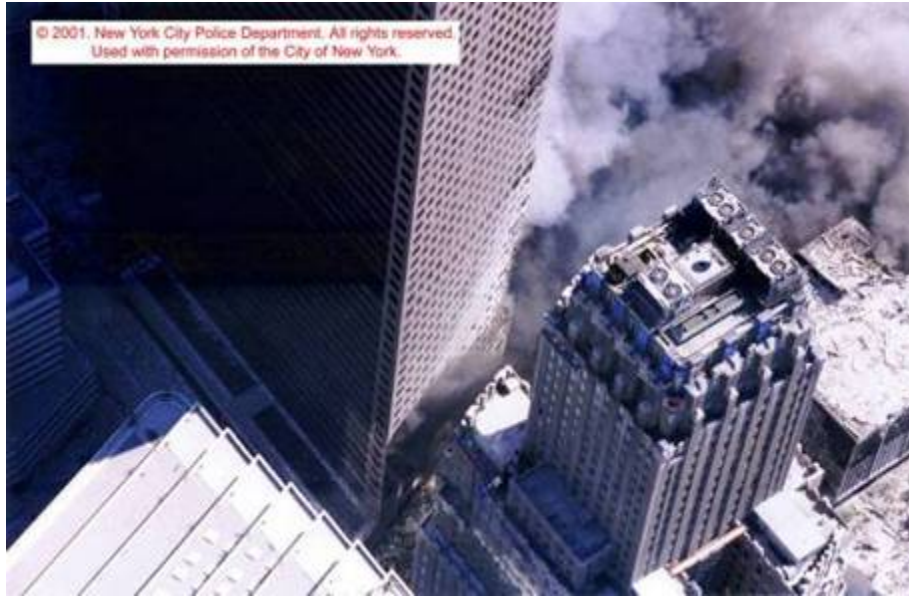
Figure 5-64 shows a photograph of WTC 7 shot from a helicopter between 2:15 p.m. and 2:45 p.m. Damage is visible low on the southwest corner of the building. This area has been enlarged in Figure 5-65, and arrows and numbers have been added that identify the floors corresponding to given rows of windows.

**Figure 5–64.** Photograph showing the north and west faces of WTC 7, shot from a helicopter between 2:15 p.m. and 2:45 p.m.

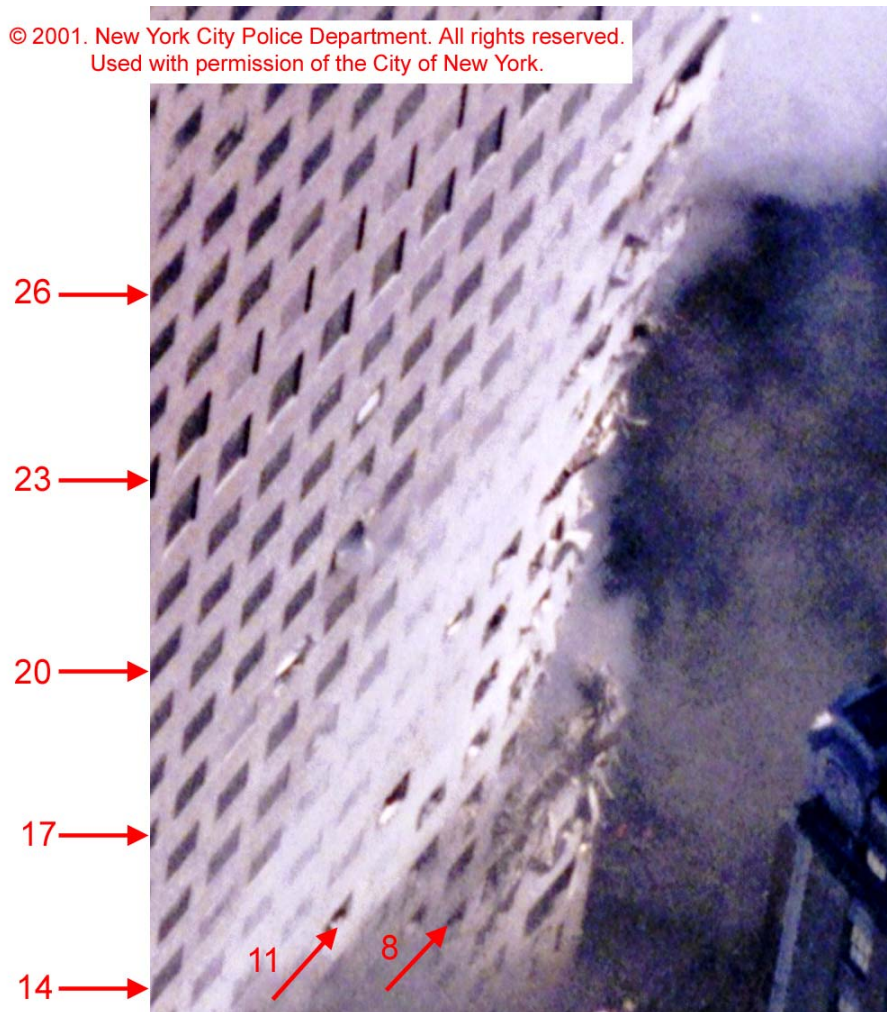
**Figure 5–65.** Enlargement of an area from the photograph in Figure 5–64 showing part of the west face of WTC 7. The image intensity has been adjusted, and arrows and floor numbers have been added for the corresponding rows of windows.

The image shows is considerable damage to the southwest corner, starting at the 17<sup>th</sup> floor and extending downward to at least the 8<sup>th</sup> floor. Below the 17<sup>th</sup> floor, the corner of the building appears to be missing. At a minimum, the granite cladding and its supports have been removed. Figure 5–66 shows a photograph taken at 12:48 p.m. from West Street showing the same area of WTC 7 and an enlargement of the southwest corner. In this image, it is clear that the corner granite has been removed, and it appears that the corner column 15 (Figure 5–20 and Figure 5–26) has been exposed, but is still in place. This column was located just behind the southwest corner. The dull color of the steel indicates that its insulation had been stripped away.

In Figure 5–65, it can be seen that damage to the corner of the 14<sup>th</sup> floor extends further along the west wall than on higher floors. It is clear in Figure 5–68 that the corner at this floor had been pushed inward,

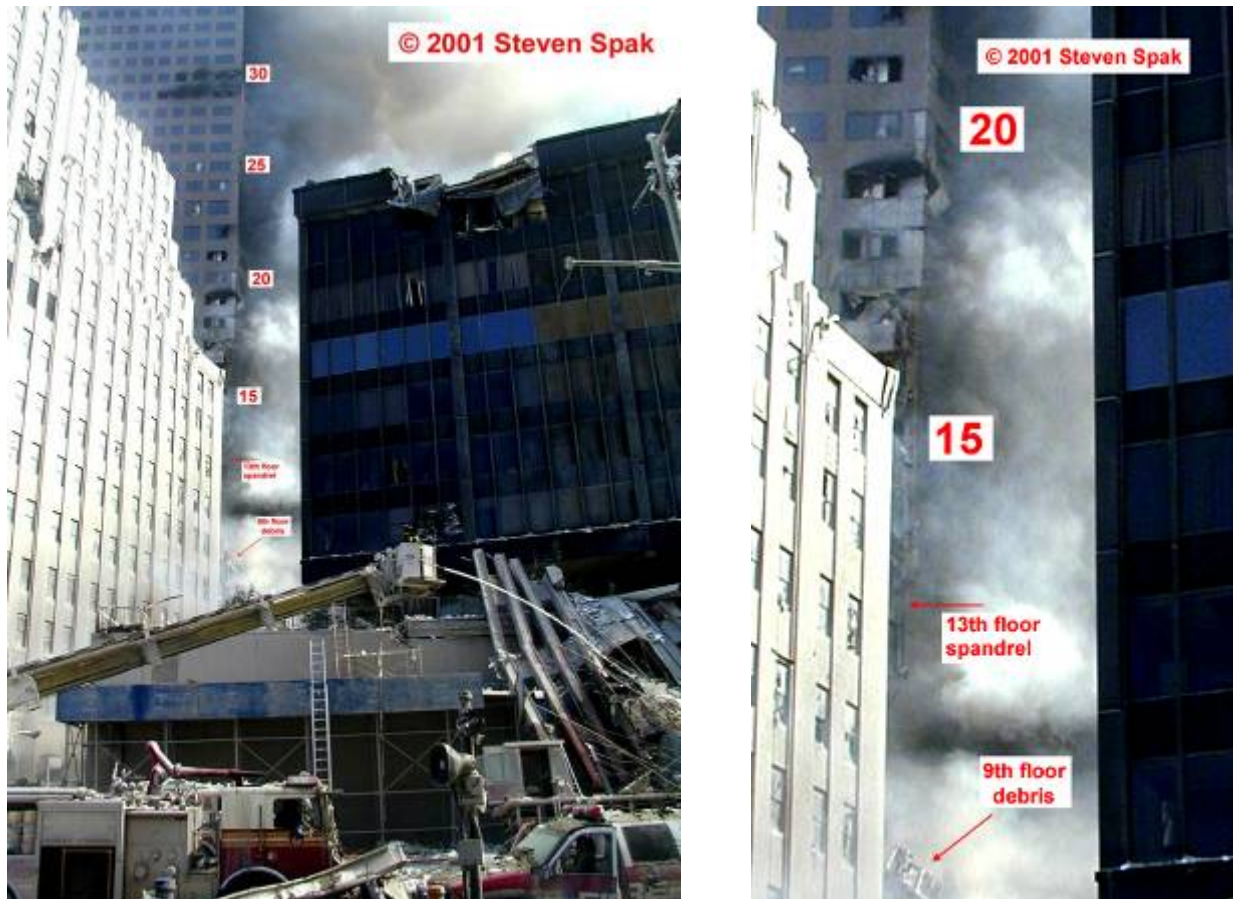
**Figure 5–66. Photographs showing the southwest corner of WTC 7, shot from West Street at 12:47:40 p.m.**

The intensity levels have been adjusted, and floor labels have been added. The area of the corner is enlarged on the right.

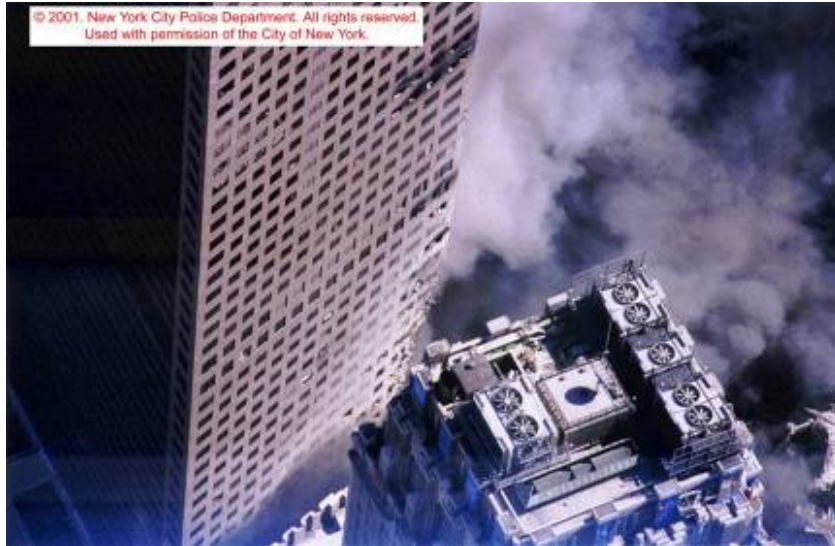
A second aerial photograph (Figure 5–67) provides a partial view of the damaged area from a closer location and a less oblique angle than these in Figure 5–64 and Figure 5–65. The damaged area from this photograph is enlarged in Figure 5–68 with floor numbers indicated. In this image, the end of the horizontal member at the base of the 17<sup>th</sup> floor windows can be seen clearly, and there is no indication that column 15 is attached to it.

**Figure 5–67.** Photograph showing the north and west faces of WTC 7, shot from a helicopter between 2:30 p.m. and 3:00 p.m.

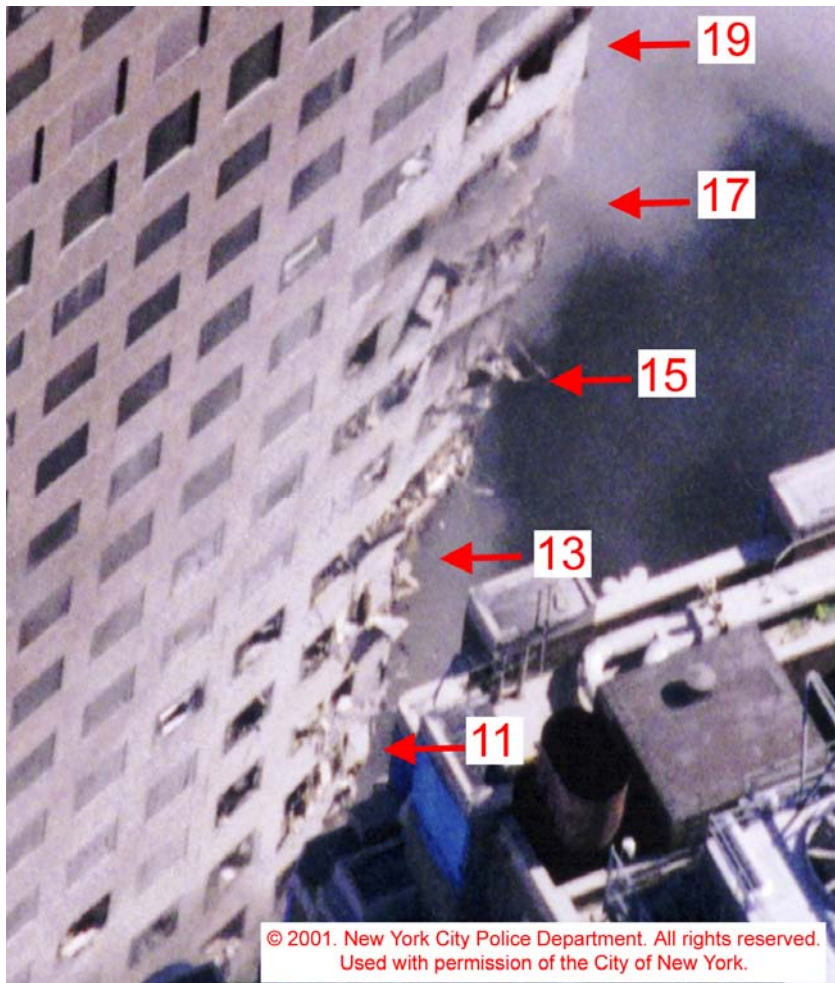
and that there was considerable façade damage. The aerial views in Figure 5–65 and Figure 5–68 suggest that there was substantial damage between column 14 and the south edge on the 13<sup>th</sup> floor. There is no sign of corner column 15 in these images. Although this column appears to be present in ground shots shown in Figure 5–63 and Figure 5–66, it was likely displaced.

**Figure 5–68.** Enlargement of an area from the photograph in Figure 5–67 showing part of the west face of WTC 7.

Arrows and floor numbers have been added for the corresponding rows of windows.

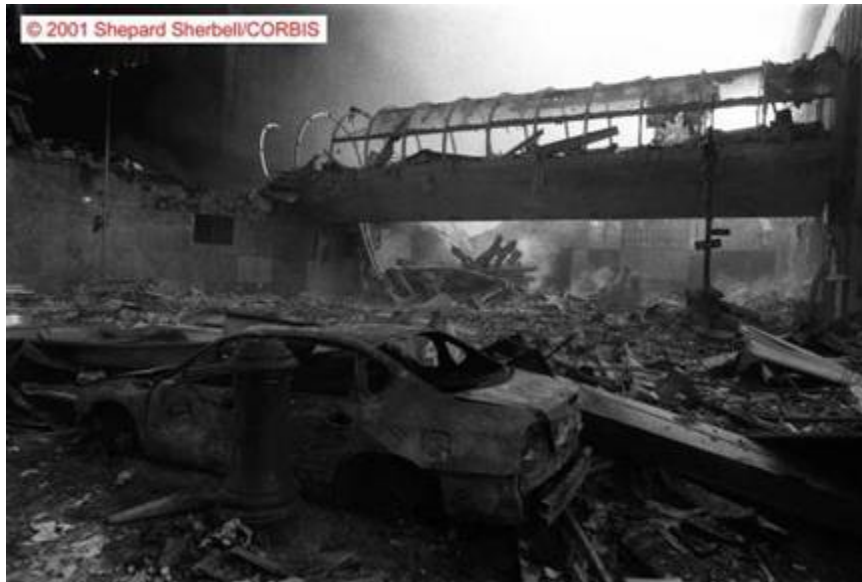
The Promenade is visible behind the Pedestrian Bridge. There is a large pile of steel formed by several panel sections from WTC 1 located between the Pedestrian Bridge and the Promenade near the base of WTC 6 on the south side of the street. There appears to be either a part of or a single panel section located near the center of the street. There is also a single piece of large debris visible near the base of the Pedestrian Bridge that seems to be leaning against the south face. It is not clear if this is structural steel from the towers. These are the only indications of large steel pieces between the Promenade and the corner of West Broadway and Vesey Street. The large pieces of steel observed on Vesey Street from the west are beyond the view of this photograph.

**Figure 5–70. Black and white photograph shot from the corner of Vesey Street and West Broadway looking west down Vesey Street.**

The time of the photograph is unknown, but it was taken prior to the time when flames appeared on the east face of WTC 7 around 2:00 p.m.

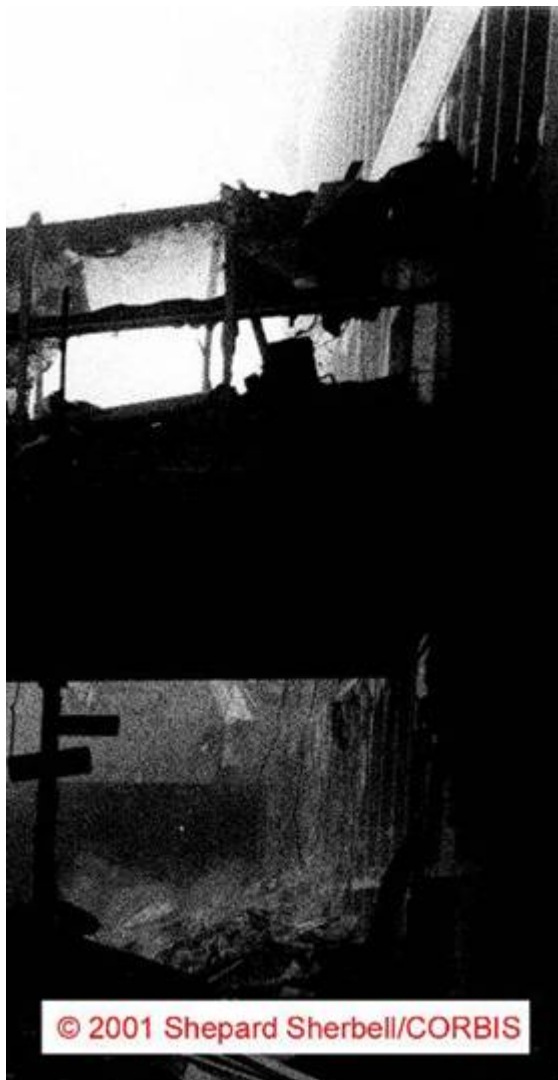
An enlarged and enhanced section of Figure 5–70 showing the south face of WTC 7 is included in Figure 5–71. The debris deposited near the south face of WTC 7 is nearly one story high. Many columns can be discerned on the south face looking under the Pedestrian Bridge. The spacing and size of these columns indicate that these were part of the nonstructural system used to support glass and doors in the four story lobby area. (See Figure 5–15, Figure 5–16, Figure 5–36, and Figure 5–37.) The glass was apparently broken out between the columns based on the depth visible. It is also possible to discern some of the horizontal supports for the glass façade. Even though it is not possible to identify individual columns

**Figure 5–71. Enlargement of the photograph in Figure 5–70 showing the south face of WTC 7.**

The segment has been enhanced by adjusting the intensity levels.

The area visible above the granite in Figure 5–71 starts just to the left of the Pedestrian Bridge and extends towards the west at least as far as the fifteenth support column from the east edge. As can be seen in Figure 5–20, these columns nearly span the distance from the east edge of the face to the Promenade. Structural steel columns 23 to 28 were located on this section of the face (see Figure 5–20). Since these columns were located behind the glass and louver support systems, these observations indicate that there was likely no structural damage to these columns on the 1<sup>st</sup> through 6<sup>th</sup> floors.

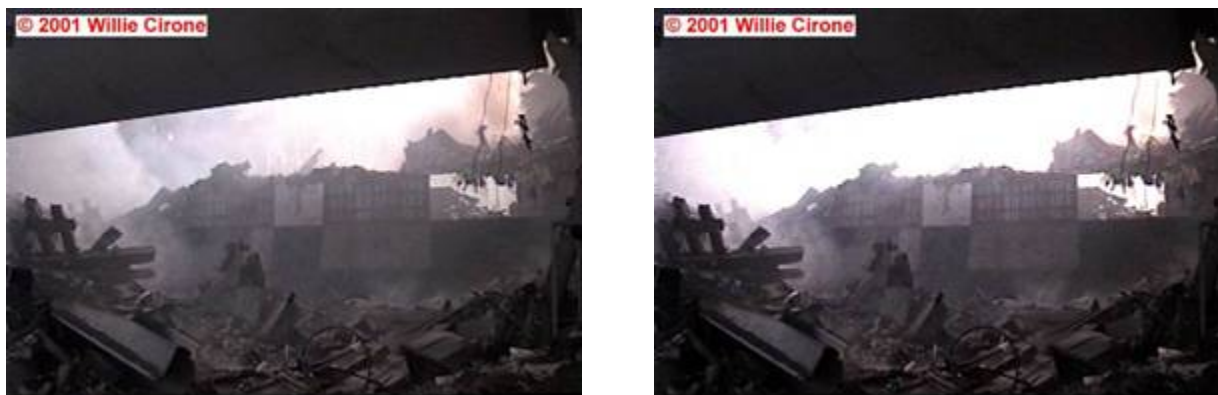
A second view of Vesey Street and the Promenade taken from a short video clip is shown in Figure 5–72. The dark area at the top of the image is the bottom of the Pedestrian Bridge. In the unaltered left view, large amounts of smoke are visible on the far side of the Promenade. In the right view, the intensity levels have been adjusted to emphasize the darker areas in the image. A number of steel panel sections are visible on the left side of the street between the Pedestrian Bridge and the Promenade. It is also possible to see that several panel sections landed on or near the south end of the Promenade, and this end may be partially collapsed. The portion of a panel section near the center of the street is visible, but is not as easily identified as in Figure 5–70. A part of the large piece of debris observed earlier leaning up against the south face of WTC 7 is visible at the far right of the image. The size and shape of the object suggest that it was a steel column or beam. In all, the main portion of the east side of the Promenade, with the possible exception of the far south end, was not collapsed by the steel from WTC 1, although the raised side structures had suffered considerable damage.

**Figure 5–72. Two versions of a frame from a video taken from the corner of Vesey Street and West Broadway in the early afternoon.**

Left: the frame as captured; Right: the image with intensities adjusted to emphasize the darker areas.

The south face of WTC 7 was just beyond the right side of this image. Nonetheless, a pile of debris several stories high is visible rising above the Promenade at the right hand edge of Figure 5–72. Recall that there was evidence of debris in the same area from ground and aerial views taken from the west. The presence of this debris is consistent with the south face damage observed at higher floors at roughly the same location.

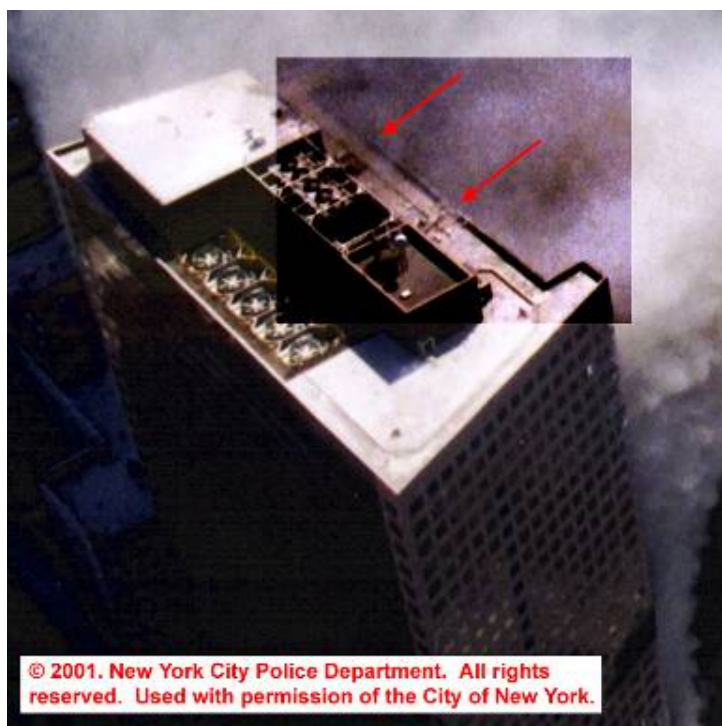
A portion of Figure 5–9 is enlarged in Figure 5–74. Arrows indicate two damaged areas. The lower arrow points to damage on the parapet. Some debris is evident between the parapet and the south penthouse. The second arrow points to an area where the south screenwall connecting the east and west penthouses was damaged.

**Figure 5–74. Cropped photograph, taken from a helicopter, showing the roof of WTC 7 from the northwest.**

A damaged area on the south side has been enhanced by adjusting the intensity levels. Arrows indicate two areas of damage discussed in the text.

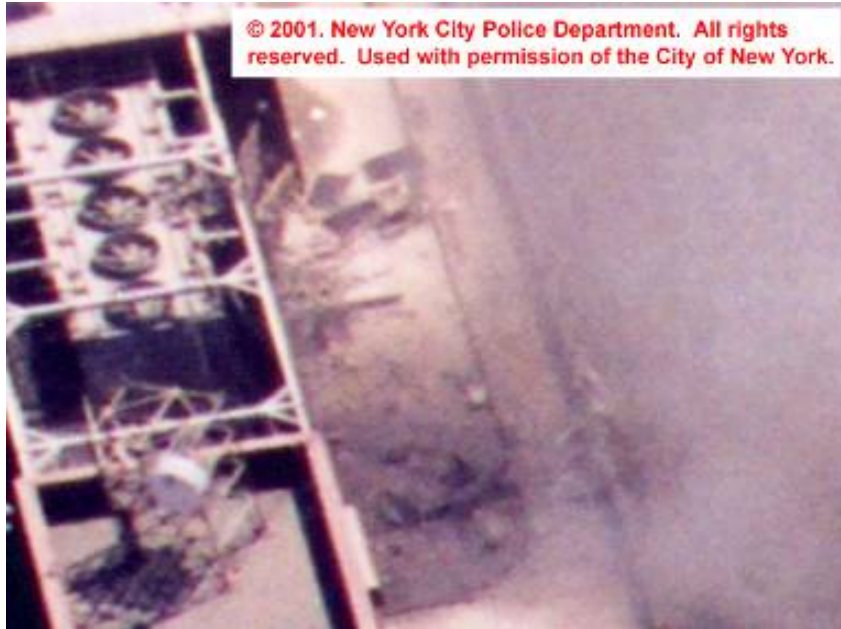
Another view of these two damaged areas, taken from a helicopter, is shown in Figure 5–75. The debris at the location between the south face parapet and the east edge of the west penthouse is better resolved. A large object is visible protruding from the roof. The damage to the south screenwall between the two penthouses seems to consist of displaced wall sections. There appears to be at least one column in the immediate vicinity. The damage indicates that substantial pieces of debris (mostly likely steel) struck the roof of WTC 7 on the south side.

**Figure 5–75. Cropped photograph, taken from a helicopter, showing the roof of WTC 7 from just north of due west.**

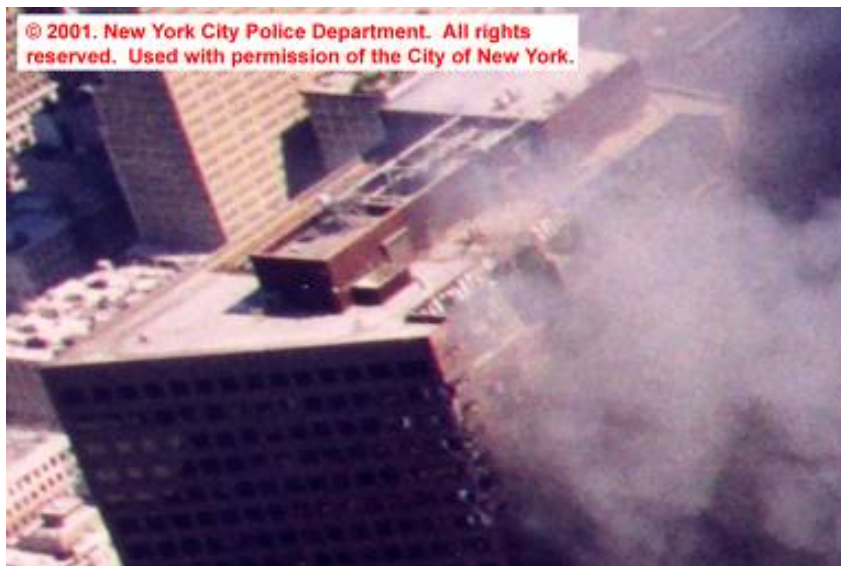
Another view of the upper portion of WTC 7 is shown in Figure 5–76. This is roughly the same view as shown in Figure 5–8, which was taken just prior to the collapse of WTC 1. The two damaged areas on the roof are visible in the later photograph. The debris projecting from the roof appears to consist of at least two separate columns. This suggests that it was a part of a panel section from WTC 1. Comparison of the two photographs indicates that a substantial fraction of the screenwall near the east penthouse was dislodged.

**Figure 5–76. Cropped photograph showing the upper portion of WTC 7 as viewed from the southwest.**

It was shot around 12:30 p.m. from a helicopter.

A large opening in the sloped curtain wall running between the 46<sup>th</sup> and 47<sup>th</sup> floors is apparent in Figure 5–76 immediately below the damaged area on the roof. Less damaged areas are also visible on either side of this opening. The damaged area has been enlarged in Figure 5–77.
