**Federal Building and Fire Safety Investigation of the  
World Trade Center Disaster**

**Structural Fire Response and  
Probable Collapse Sequence of  
World Trade Center Building 7**

**NIST NCSTAR 1-9**

August, 2008

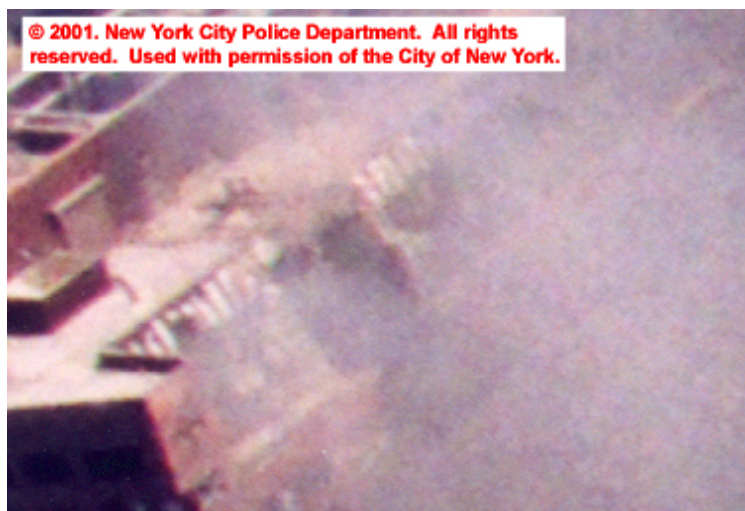
A number of white rectangles are visible running along the upper edge of the face. This is in the area of the 4 ft high parapet where sloped glass had been placed to create the effect of a top row of windows in front of the parapet, as can be seen in Figure 5–8. The different appearances of the area between Figure 5–8 and Figure 5–77 suggests that the glass was broken out during the collapse of WTC 1.

The recessed windows on the south face at floors 46 and 47 allowed the exact locations and sizes of the damaged areas to be determined. The damage began at the 12<sup>th</sup> window opening from the west and extended to the east for roughly eight windows. Based on Figure 5–20, the principal damage falls

**Figure 5–77. Enlargement of the area of damage on the roof and south sides of the 46<sup>th</sup> and 47<sup>th</sup> floors of WTC 7 in Figure 5–76.**

between column 19 and column 21. Smaller openings in the curtain wall are evident at the 5<sup>th</sup> and 6<sup>th</sup> windows from the west and over a width of six windows just to the east of the largest opening. While it is clear that the curtain wall has been removed, it is not possible to discern whether or not structural damage occurred. It appears that the recessed concrete roofline at the base of the 46<sup>th</sup> floor between column 20 and column 21 was cut through.

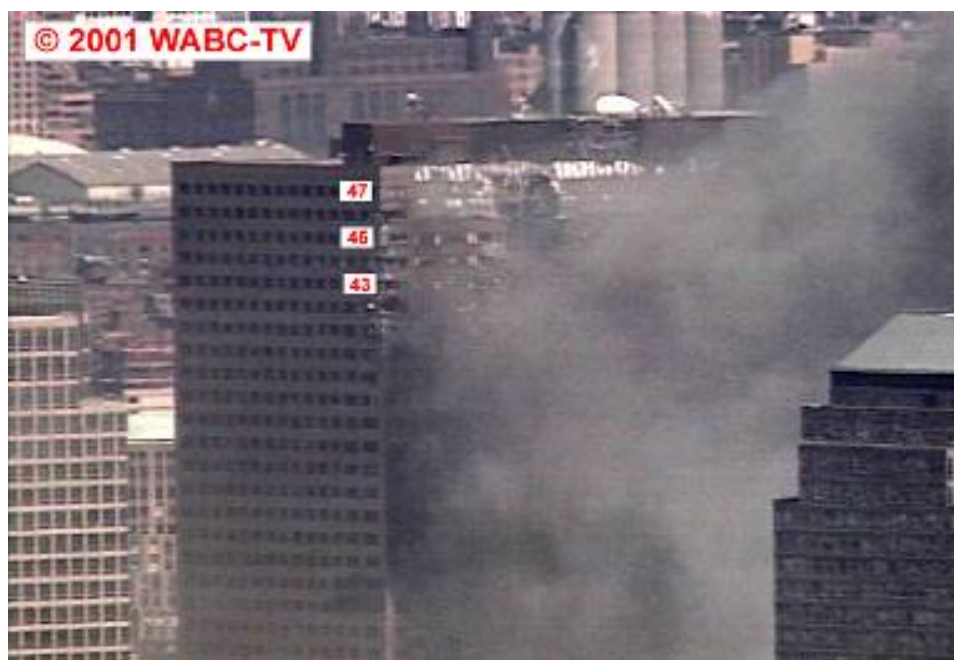
Another view of the damage near the top of the south face of WTC 7 is shown in Figure 5–78. The debris projecting from the roof and the damage to the south screen wall can be discerned. The large opening identified earlier on the 46<sup>th</sup> and 47<sup>th</sup> floors can be seen clearly along with columns and beams inside the hole. In this image, the opening extends at least as far down as the top of the 44<sup>th</sup> floor. The south face

**Figure 5–78. View of the south face of WTC 7 from a video shot from a helicopter located to the southwest of the WTC site, likely after 12:00 p.m. The intensity levels have been adjusted.**

below this point is obscured by smoke. Exterior column 20 and the spandrel beams between this column and columns 19 and 21 are not visible on the 45<sup>th</sup> floor. On this basis, it was concluded that structural damage was present between columns 19 and 21 on the 44<sup>th</sup> through 47<sup>th</sup> floors.

The space between the western edge of the face and column 19 is visible for the 43<sup>rd</sup> to 47<sup>th</sup> floors. Some façade damage is visible on the corner (see discussion below) while elsewhere the façade seems to be intact, with the exception of the window glass that appears to have been broken over this area. A portion of the upper part of the south face is visible to the immediate right of the large damaged area. The glass appears to have been broken at numerous locations along the top row of windows, including the 11 openings to the immediate east of column 21.

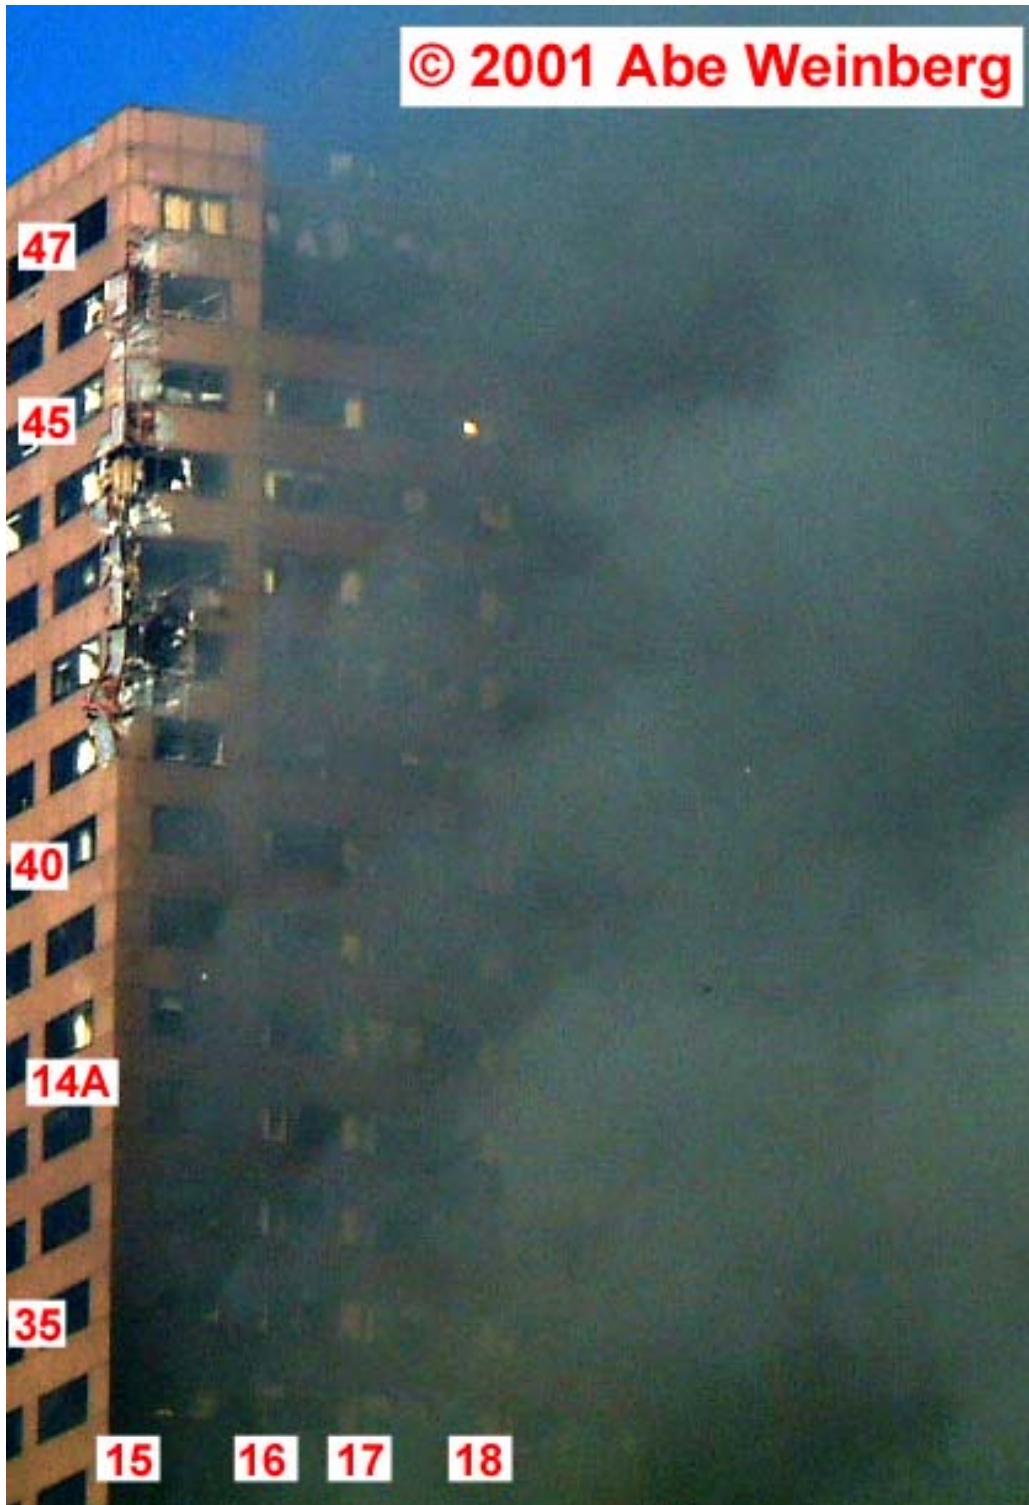
Figure 5–79 shows the upper west side of the south face of WTC 7 around 4:45 p.m. The façade damage on the southwest corner can be clearly seen on the 41<sup>st</sup> to 47<sup>th</sup> floors. The façade damage is particularly heavy on the 42<sup>nd</sup> to 44<sup>th</sup> floors. It appears that an object may have entered window 15A on the 42<sup>nd</sup> floor. The end of the truss that supported the corner granite spandrel cover on the western edge of the face is visible on this floor. It is possible to discern the area between columns 15 and 18 from the 34<sup>th</sup> floor up to the top of the building. While the façade appears to be intact at locations away from the southwest corner, the four columns are visible on most floors, indicating the window glass was broken at most of these locations.

**Figure 5–79. Cropped photograph showing the west side of the south face of WTC 7, taken between 4:30 p.m. and 5:00 p.m. from near the corner of West Street and Liberty Street.**

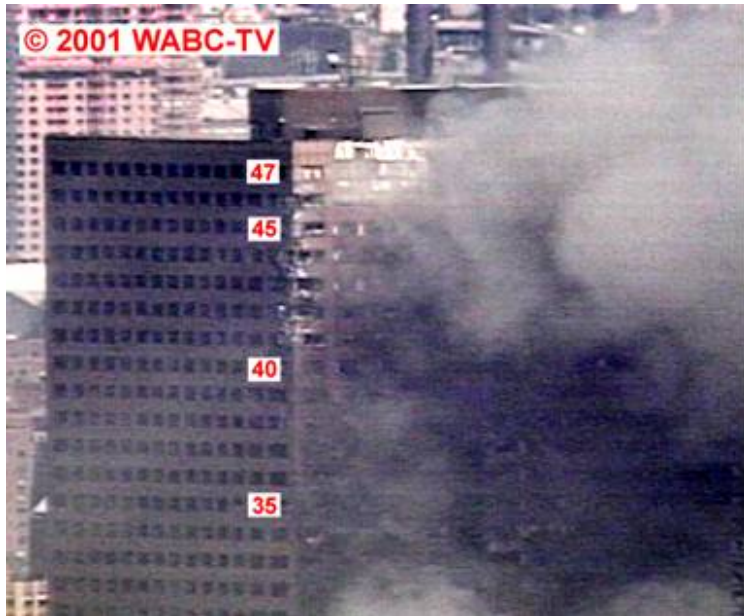
Figure 5–80 shows a similar view of the south face taken from another video shot from a helicopter. Heavy smoke covers part of the face, but portions are visible elsewhere. The vertical dark band between columns 19 and 20 is visible between the 34<sup>th</sup> floor and 37<sup>th</sup> floor. While column 21 is visible on each of these floors to the immediate right of the dark band, it is not clear whether columns 19 and 20 remain in place. The alternating granite panels and windows are visible further to the east. Columns are visible through a limited number of windows in this area.

**Figure 5–80. Cropped view of the south face of WTC 7 taken from a video shot from a helicopter hovering to the southwest of the WTC site around 1:00 p.m.** The intensity levels have been adjusted, and floor numbers have been added.

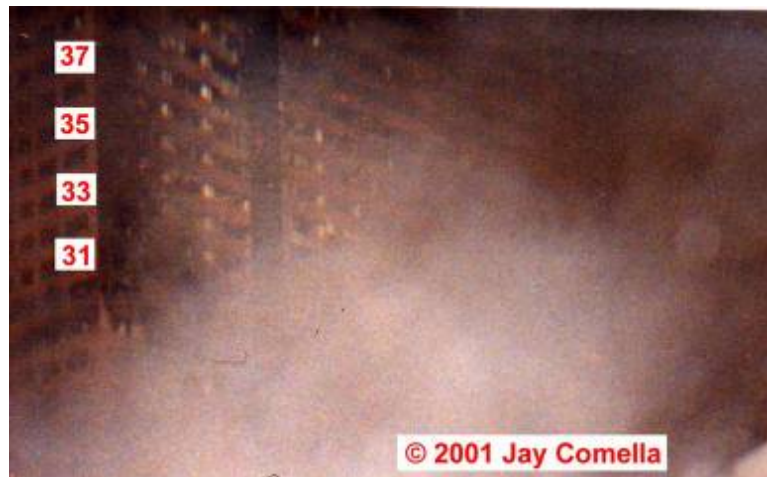
The cropped photograph shown in Figure 5–81 provides a better view of the dark vertical band on the south face of WTC 7. It was taken from West Street at a location north of Liberty Street. The distinct vertical dark band can be seen from the 32<sup>nd</sup> floor to the 40<sup>th</sup> floor. Most of the columns between the band and southwest corner are easily distinguished and confirm that the band lies between columns 19 and 20. It appears that both of these columns are in place on some of these floors, particularly column 19 on the

**Figure 5–81. Cropped photograph showing the south face of WTC 7, shot from West Street in the mid to late afternoon.**

33<sup>rd</sup> and 34<sup>th</sup> floors. At other locations, it is difficult to identify the columns on either side of the dark band. There is no visible indication that the granite spandrel covers are in place between columns 19 and 20, even though the covers on either side are very distinct. Even though the granite spandrel cover between columns 20 and 21 on the 34<sup>th</sup> floor appears to be damaged, in general the granite panel covers seem to be in place to the east of the dark band.

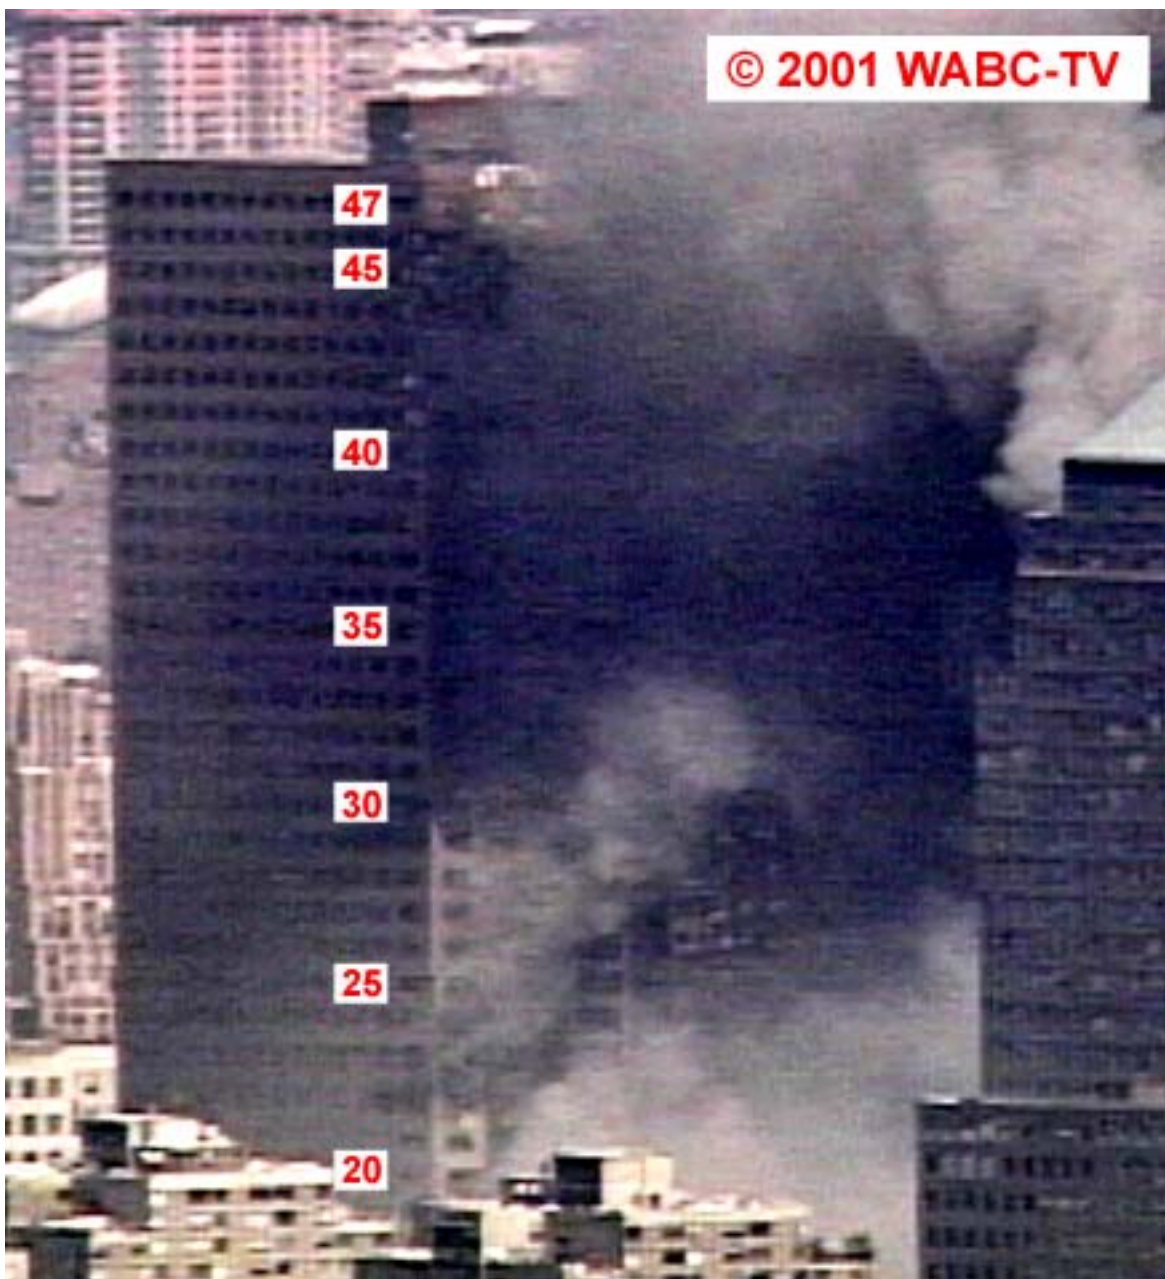
Another aerial view of the south face is shown in Figure 5–82. The vertical dark band is visible extending down to at least the 24<sup>th</sup> floor. A framework is visible to the immediate left on the 23<sup>rd</sup> to 26<sup>th</sup> floors between columns 18 and 19. The spacings between columns are much wider than window openings seen on floors with intact façade, and the columns widths and spandrel heights are smaller. This indicates that the steel in this area has been exposed by removing the granite spandrel covers and their backing trusses.

**Figure 5–82. Cropped view of the south face of WTC 7 taken from a video shot from a helicopter hovering to the southwest of the WTC site around 1:00 p.m. The intensity levels have been adjusted.**

dark band on the upper floors. While it appears as if the vertical dark band between columns 19 and 20 is damage to the building, and the location falls immediately below the opening at the top of the building (see Figure 5–76 to Figure 5–78), images with sufficient detail to confirm this have not been identified. It is also unclear if columns 19 and 20 have been damaged or removed.

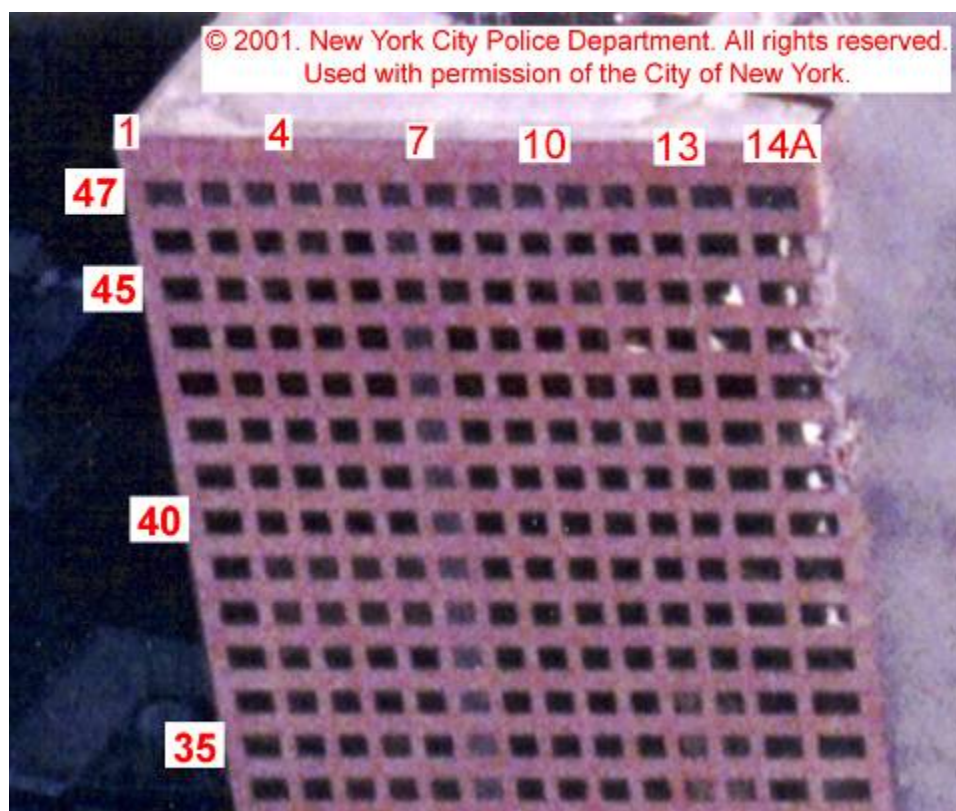
Not surprisingly, the major debris damage to WTC 7 was to the south face, which faced WTC 1. However, as can be seen in Figure 5–63 to Figure 5–69, Figure 5–79, and Figure 5–80, some façade damage and window breakage also occurred on the west face. Figure 5–84 shows the upper portion of the west face in a photograph taken from a helicopter. Floor and column locations are indicated. (See Figure 5–26 for column and window nomenclature.) Façade damage is visible on the southwest corner on floors 40 through 46, and the glass for window 14A was broken on the many floors where column 14A can be seen. With the exception of a few broken windows on the 44<sup>th</sup> and 45<sup>th</sup> floors, the remainder of the façade appears to have been intact on the 34<sup>th</sup> through 47<sup>th</sup> floors.

**Figure 5–84. Cropped photograph showing the west face of WTC 7, taken from a helicopter around 3:00 p.m.**  
The intensity levels have been adjusted.

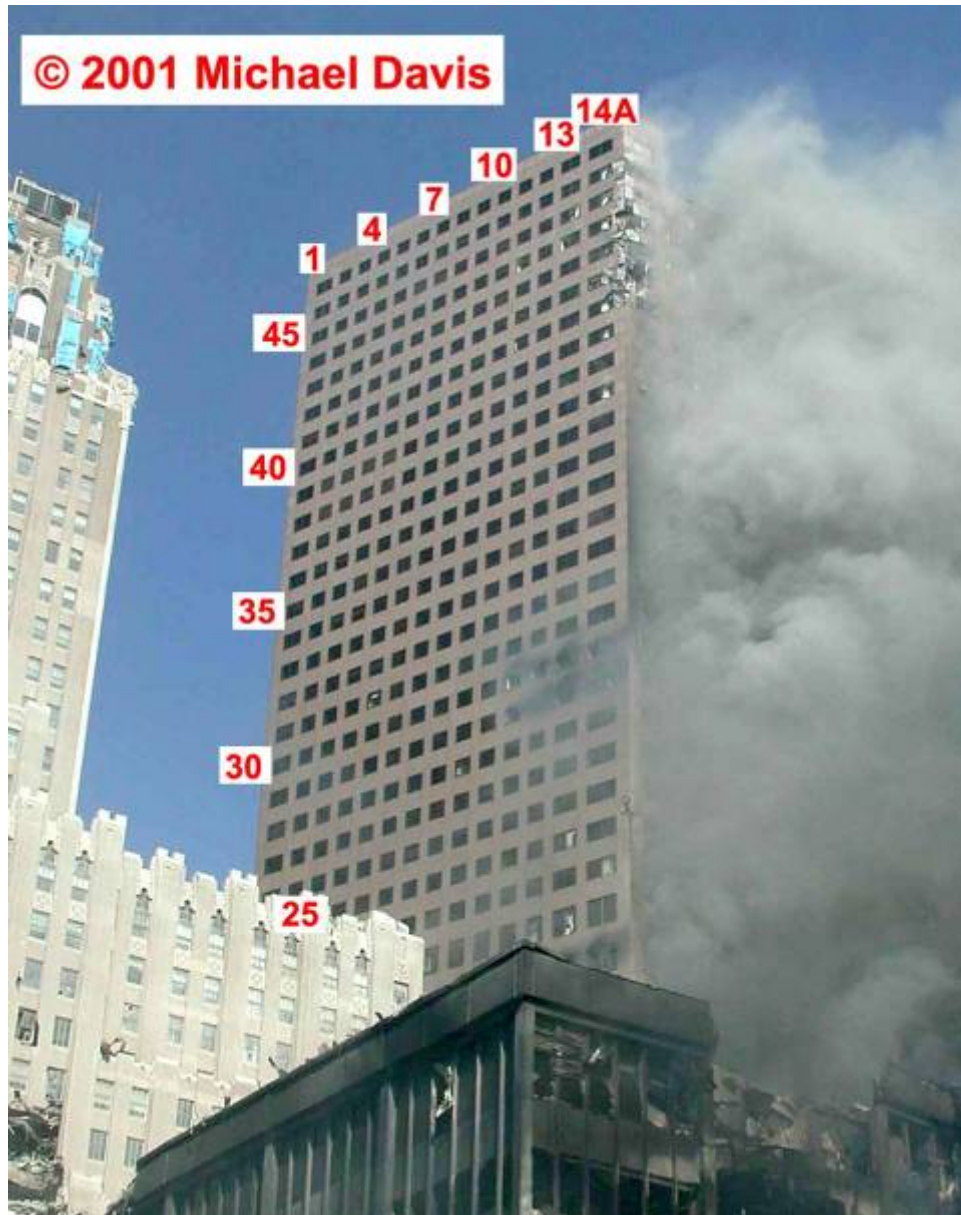
Another photograph showing the upper part of the west face of WTC 7 is reproduced in Figure 5–85. Generally, the damage visible on the 34<sup>th</sup> to 47<sup>th</sup> floors is consistent with that seen in Figure 5–84. One exception is window 11 on the 41<sup>st</sup> floor. A small portion of the glass appears to be broken out in Figure 5–85, which is not evident in Figure 5–84. Most of the granite appears to be intact between the 23<sup>rd</sup> and 33<sup>rd</sup> floors, with only minor damage evident at the southwest corner at the base of the 26<sup>th</sup> floor and on the 25<sup>th</sup> floor. Glass is missing from windows 13A, 13B, 14A, and 15 on the 29<sup>th</sup> and 30<sup>th</sup> floors. As discussed below, fires were observed in these areas, which may have opened up these windows prior to the time when Figure 5–85 was taken. Elsewhere on these floors, glass is missing from isolated windows 31-5, 28-9, 27-14, 25-13B, 24-14A, 23-12, and 23-13B.

**Figure 5–85. Cropped photograph showing the west face of WTC 7, taken shortly after 3:00 p.m. from West Street.**

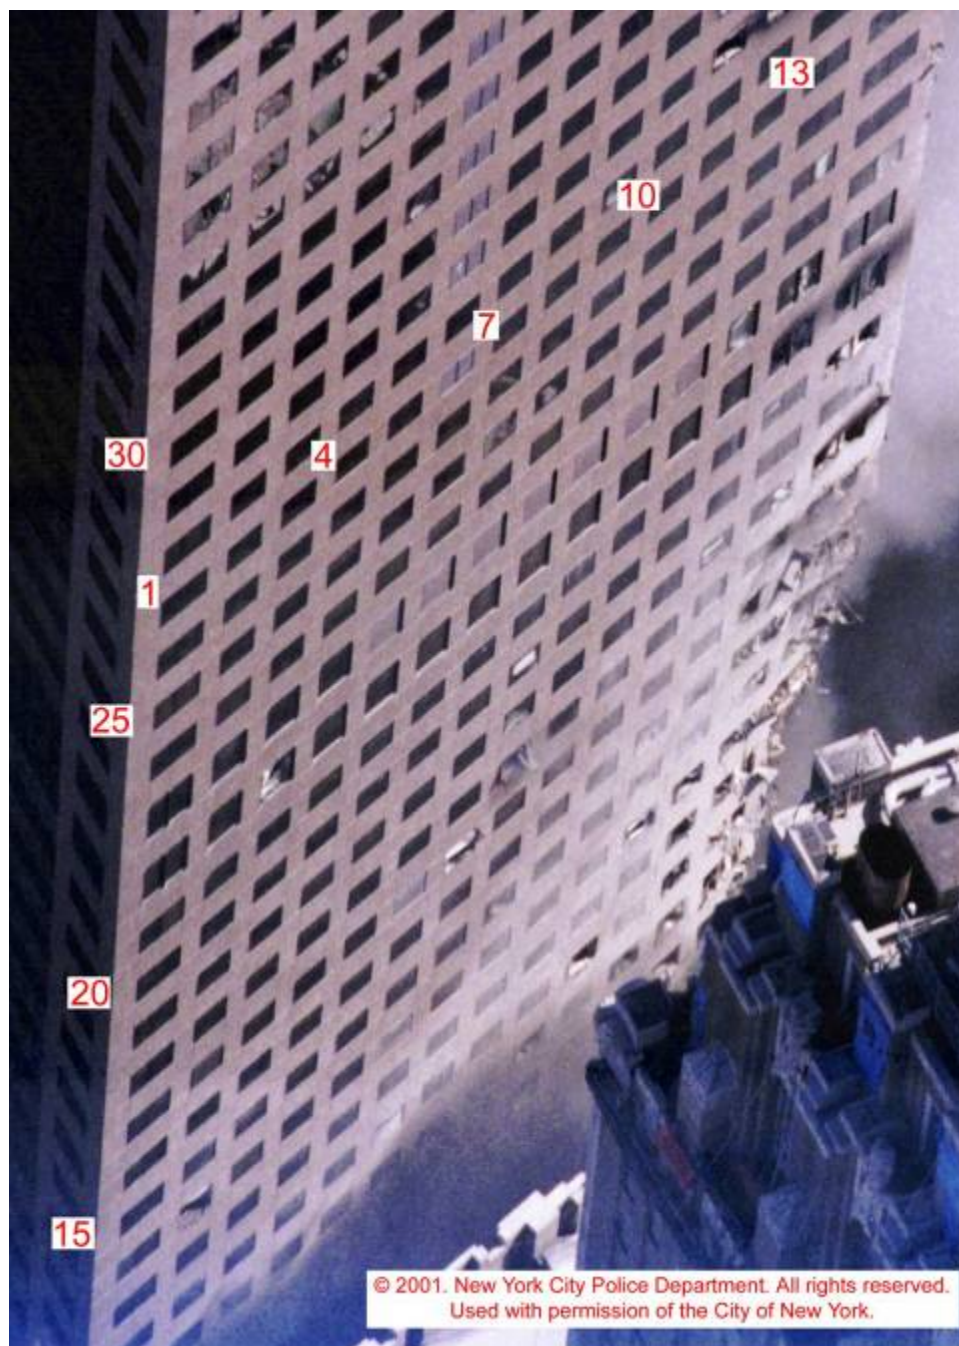
**Figure 5–86. Image, cropped from Figure 5–67, showing the west face of WTC 7, shot from a helicopter between 2:30 p.m. and 3:00 p.m. Column and floor numbers have been added.**

There is no façade damage apparent on the 19<sup>th</sup> to 22<sup>nd</sup> floors, but glass or louvers are broken or missing in multiple windows. On the 22<sup>nd</sup> floor, glass is missing from window 3 and from the four windows near the south edge, where a fire had evidently been present earlier. The earliest photograph of this region in the NIST database was taken just before 12:30 p.m. It shows a fire in window 22-14A, but the window glass further to the north was intact on this floor. The initial condition for window 22-14A is assigned as unknown. The following windows were open or damaged: 21-13A, 21-14, 21-14A, 20-8, 20-14A, 19-8,

19-12, and 19-13B to 19-14A. There are indications that a fire burned in windows 19-14 and 19-14A. Since the window glass immediately below and to the left was broken, it is considered likely that the glass in the two windows closest to the south edge was also broken during the collapse of WTC 1. There appears to be minor façade damage immediately below windows 14 and 14A on the 18<sup>th</sup> floor, which are open. This damage is also visible in Figure 5–66. Windows 18-8 and 18-13B were also broken.

On the 14<sup>th</sup> floor, the structural damage extended further toward the north, reaching at least column 14, and there appears to be façade damage to column 13. Glass in windows 14-2, 14-11, and 14-12 was broken. The damage at the southwest corner of the 13<sup>th</sup> floor was similar to that on the 14<sup>th</sup> floor. The glass in window 13-11 was cracked, and the glass was broken in window 13-12. On the 12<sup>th</sup> floor, the structural damage also appears to reach as far as column 14, with façade damage as far as column 13. Windows 12-10 and 12-12 were broken. On the 11<sup>th</sup> floor, the structural damage at the southwest corner extended beyond column 14, and the façade damage seemed to extend to column 13. All of the windows on the 11<sup>th</sup> floor cannot be seen clearly in Figure 5–86, but it is clear that the glass in windows 11-9, 11-11, and 11-12 was broken.

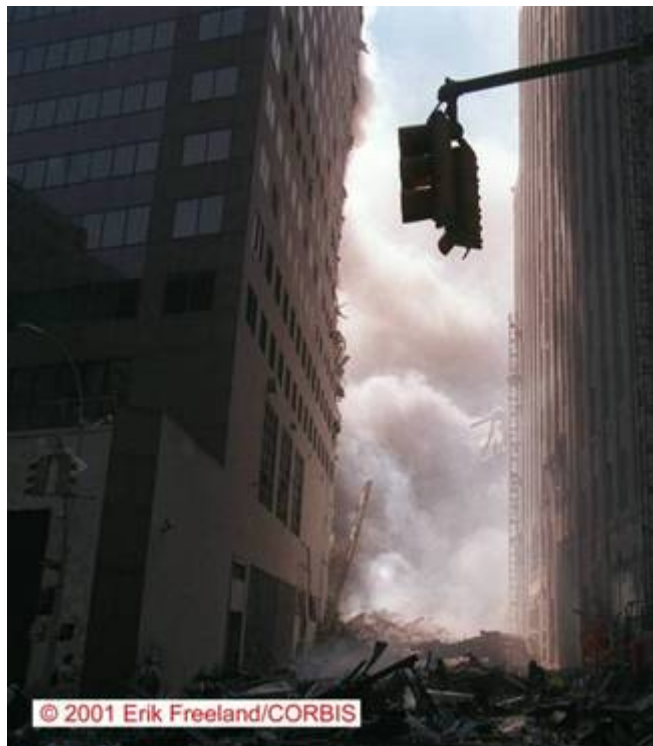
Figure 5–87 shows the lower portion of the WTC 7 west face from the corner of Barclay Street and Washington Street, looking south down Washington Street sometime around or prior to 12 p.m. Figure 5–25 was taken from roughly the same location. A great deal of debris is evident on Washington Street. In particular, a steel panel section can be seen embedded in the ground near the southwest corner of WTC 7. This panel section was also visible in the aerial photograph reproduced in Figure 5–61. There is another panel section lying on its side in the street near the Verizon Building. Additional steel can be seen piled up on Vesey Street beyond the buildings. On September 11, the Verizon Building was undergoing renovation and scaffolding was present on the east side. Some of the supports are still standing, but most of the scaffolding has collapsed, contributing to the debris lying in the street.

**Figure 5–87. Cropped photograph of a partial view of the west face of WTC 7 looking down Washington Street between WTC 7 on the left and the Verizon Building on the right.**

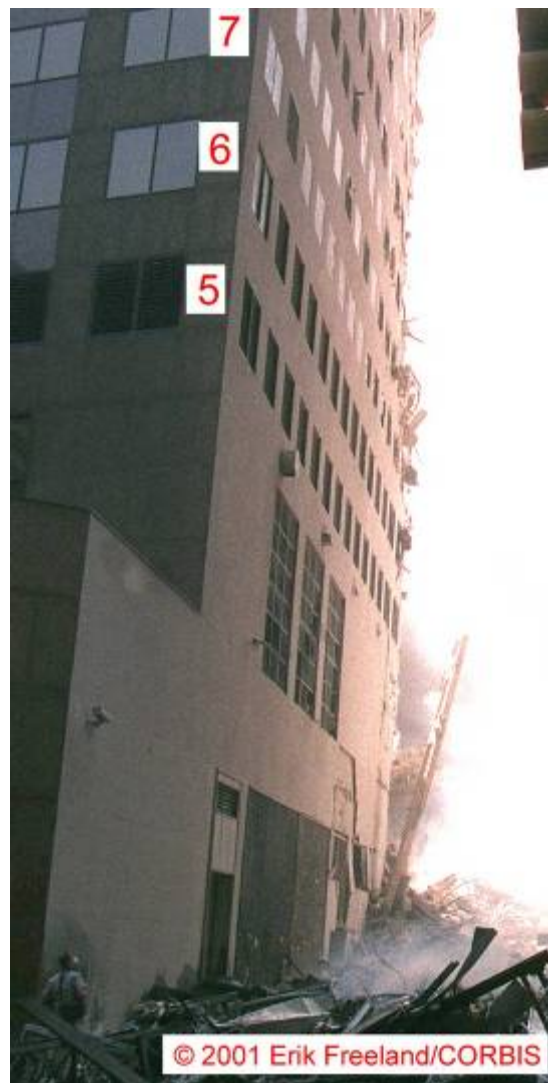
The portion of Figure 5–87 showing the west face of WTC 7 is enlarged in Figure 5–88. The façade damage on the 8<sup>th</sup> floor extends at least as far as window 13A. Façade damage is also evident on the 6<sup>th</sup> and 7<sup>th</sup> floors extending to at least column 14. Window glass or louvers are broken or missing for windows 9-6, 9-7, 9-10 to the south edge on the 9<sup>th</sup> floor, for windows 8-6, 8-8, and 8-10 to the south edge on the 8<sup>th</sup> floor, and for windows 7-5 and 7-9 to the south edge on the 7<sup>th</sup> floor. On the 6<sup>th</sup> floor, most of the windows contained louvers. All seem to be in place except for windows 14 and 14A near the southwest corner. On the 5<sup>th</sup> floor, there is no indication that any louvers were broken.

**Figure 5–88. Enlarged view of the west side of WTC 7 from Figure 5–87. The intensity levels have been adjusted, and floor numbers have been added.**

Some minor façade damage is visible on the southwest corner extending from the 5<sup>th</sup> floor down to the ground. A section of granite was dislodged above the doorway, just to the south of the center of the face. See Figure 5–26 for the configuration in this area. To the left of this doorway, it appears that the underlying truss that held the granite was partially dislodged. Some of the screens in the large windows near the center of the face on the 3<sup>rd</sup> and 4<sup>th</sup> floors were removed, but this is the only evidence of damage to this part of the face.

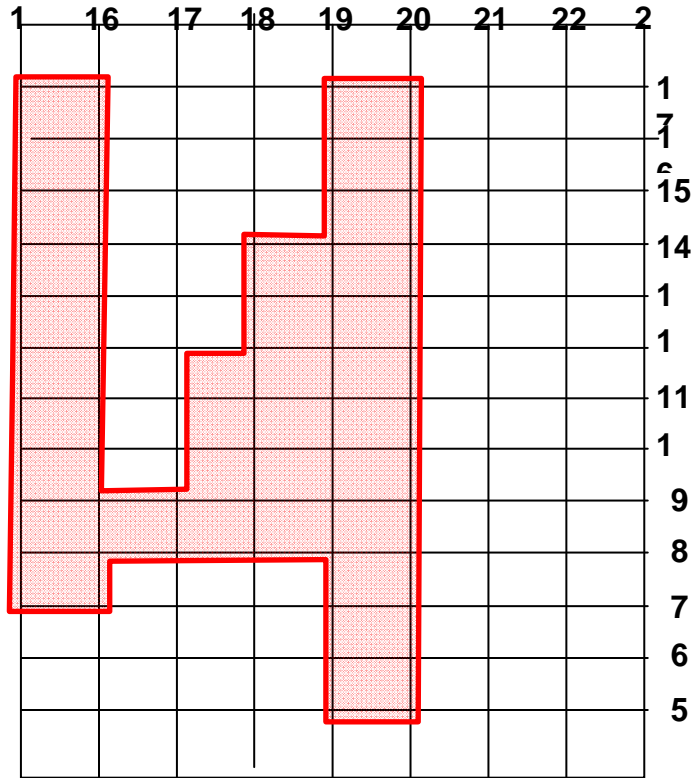
Figure 5-92 and Figure 5-93 show elevation views of the estimated interior damage below Floor 18 in the southwest region, looking from the south and the west directions, respectively. Figure 5-94 through Figure 5-101 show schematics of the damage estimates for each floor, from Floors 5 to 17, and Floor 44 to the roof.

Along the south face, the interior damage was estimated to extend from the south exterior wall toward the core, with increasing interior damage of the south tenant floor between the south face and the core, from Floor 17 down to Floor 7. The core columns and girders were assumed to be structurally undamaged. The following floor damage was estimated at the locations where the exterior columns were damaged:

**Figure 5-92 Elevation view of the estimated debris impact damage for the structural analysis of WTC 7, viewed from the south.**

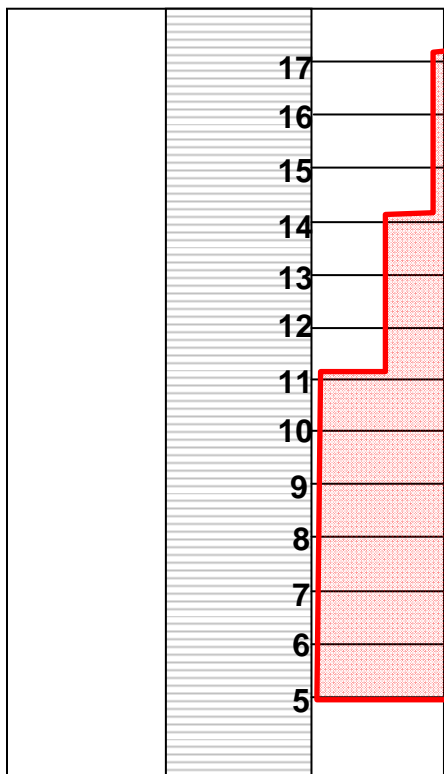
**Figure 5-93 Elevation view of the estimated depth of interior debris impact damage to the south face of WTC 7, viewed from the west.**

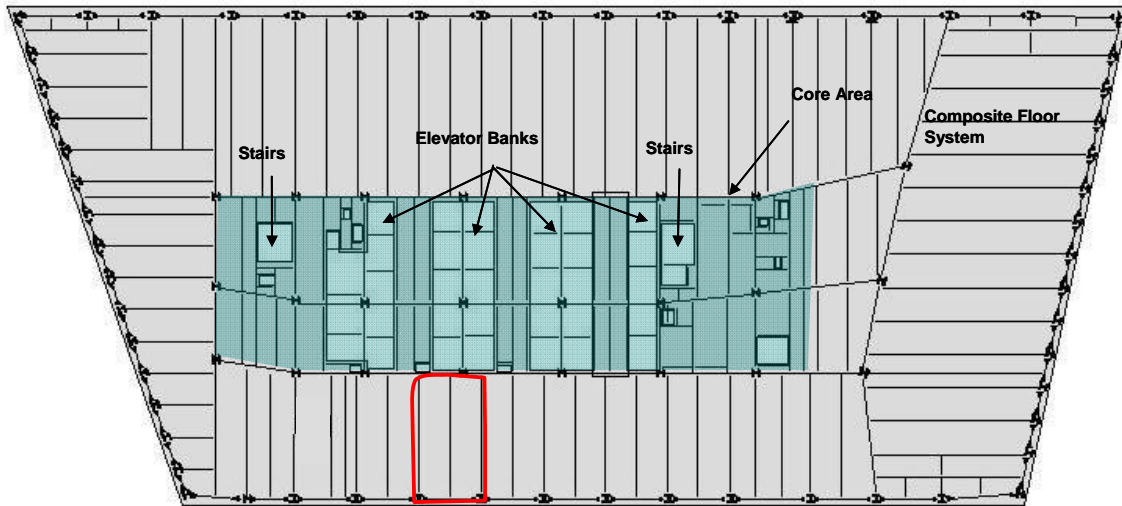
**Figure 5-94 Estimated debris impact damage to Floors 5 and 6 of WTC 7.**  
Marked area indicates removed columns and floor segments.

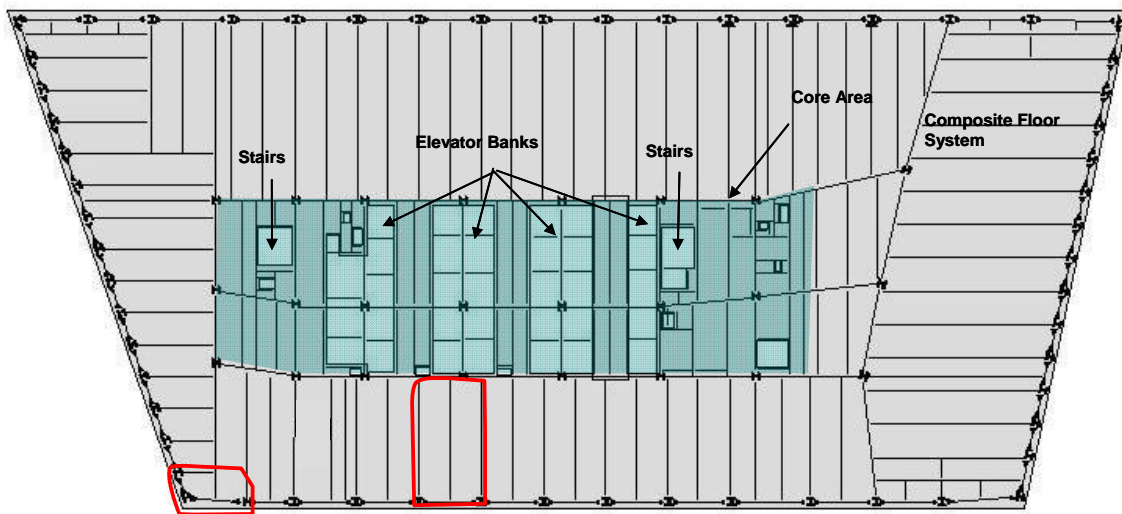
**Figure 5-95 Estimated debris impact damage to Floor 7 of WTC 7.**  
Marked areas indicate removed columns and floor segments.

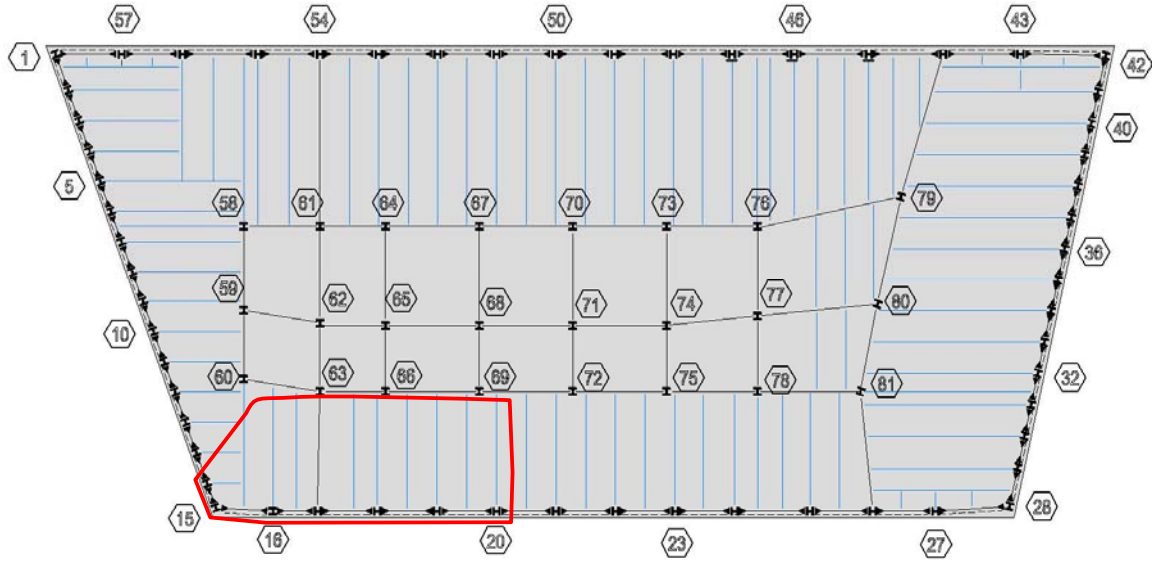
**Figure 5–96 Estimated debris impact damage to Floor 8 of WTC 7.**  
Marked area indicates removed columns and floor segments.

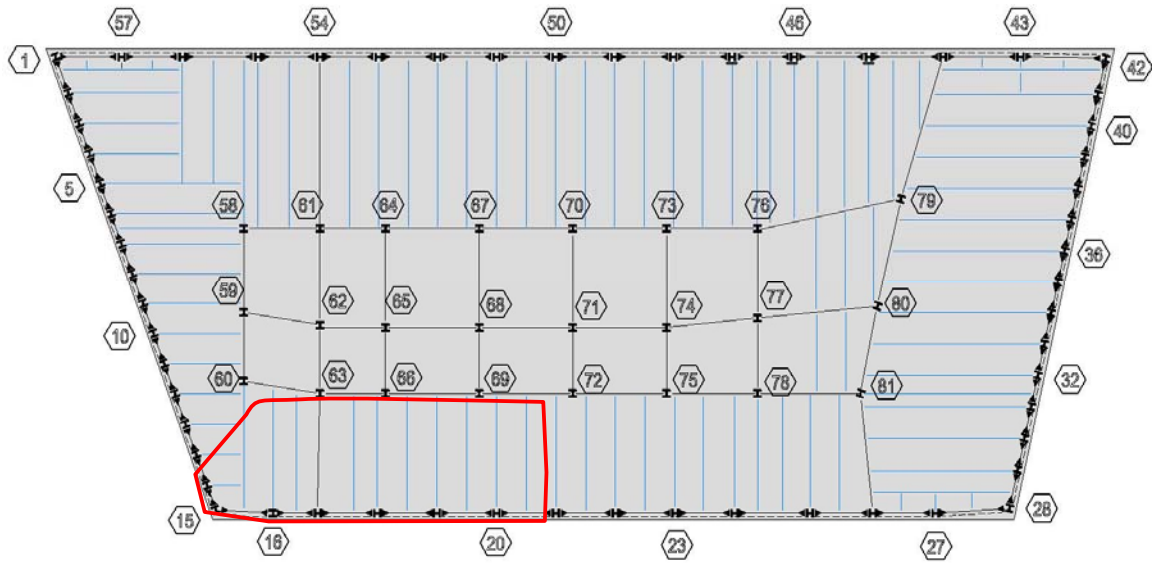
**Figure 5–97 Estimated debris impact damage to Floor 9 of WTC 7.**  
Marked area indicates removed columns and floor segments.

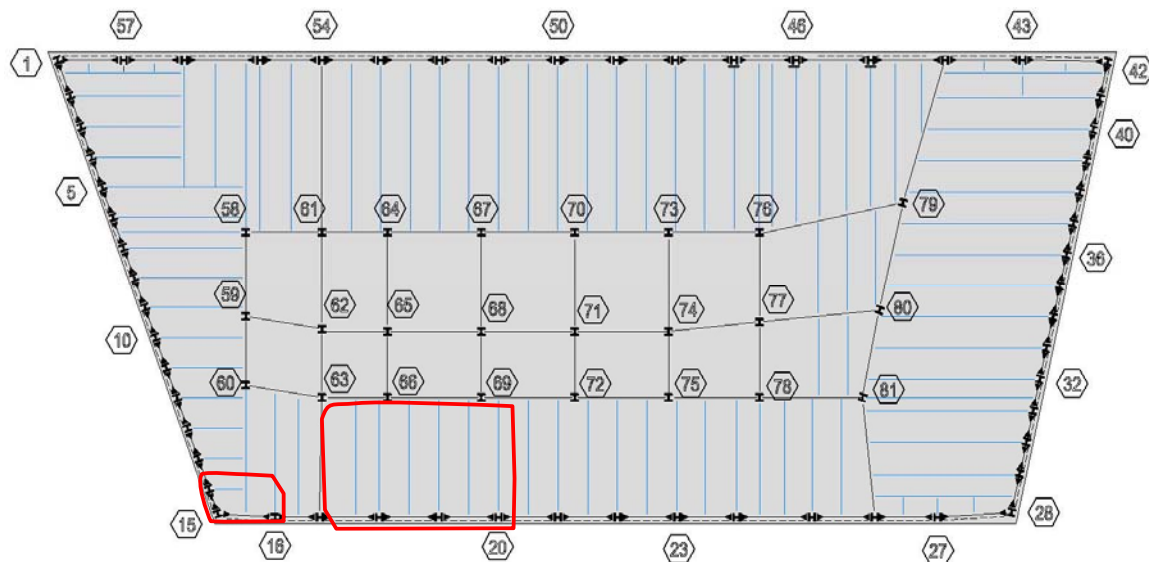
**Figure 5-98 Estimated debris impact damage to Floors 10 and 11 of WTC 7.**  
Marked areas indicate removed columns and floor segments.

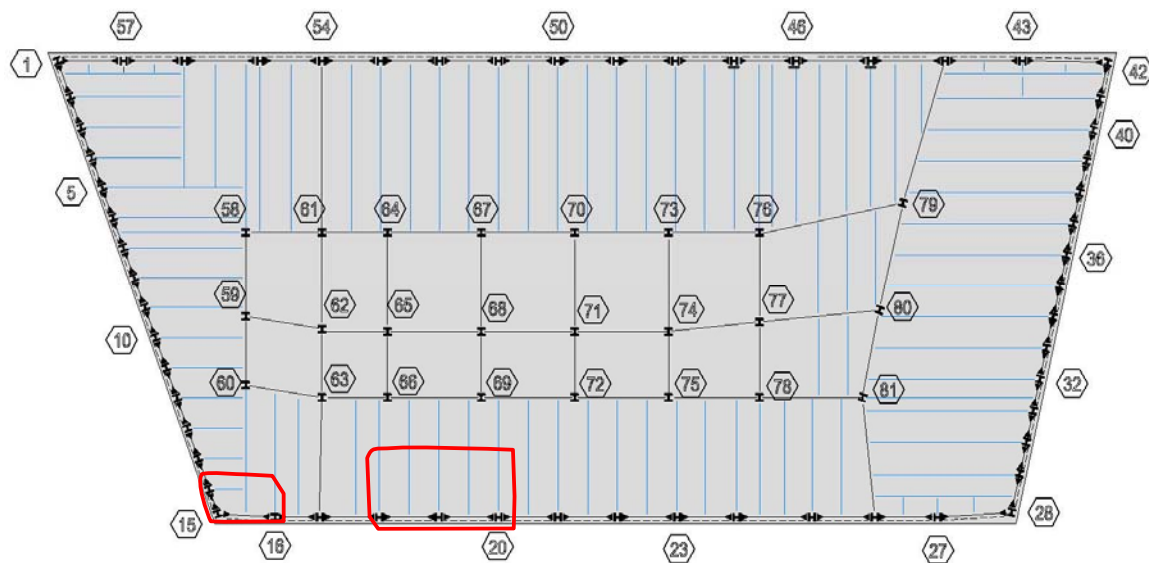
**Figure 5-99 Estimated debris impact damage to Floors 12 to 14 of WTC 7.**  
Marked areas indicate removed columns and floor segments.

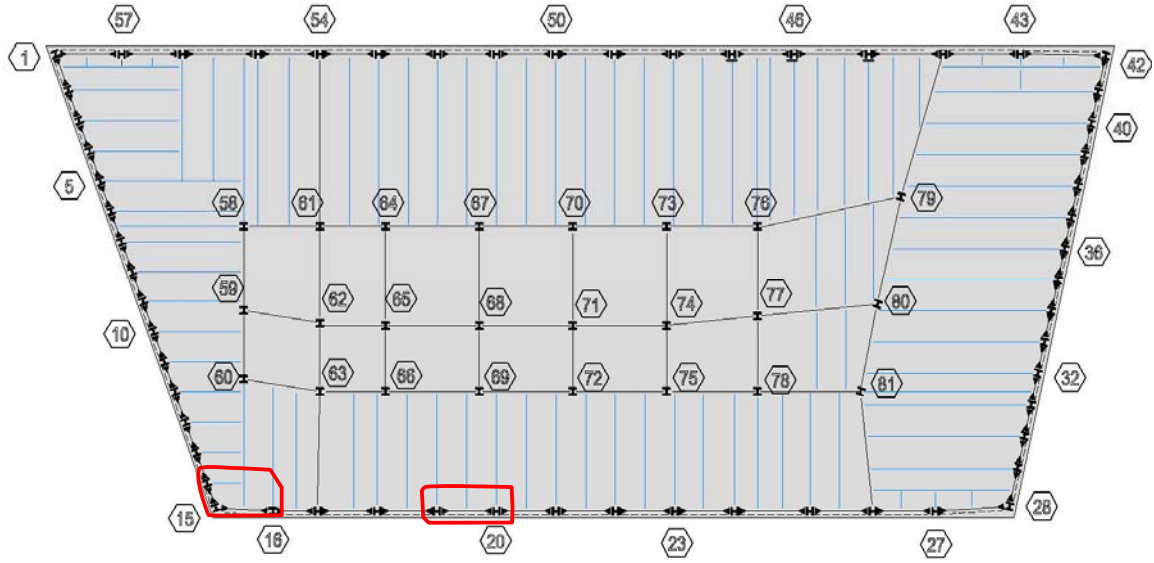
**Figure 5–100 Estimated debris impact damage to Floors 15 to 17 of WTC 7.**  
Marked areas indicate removed columns and floor segments.

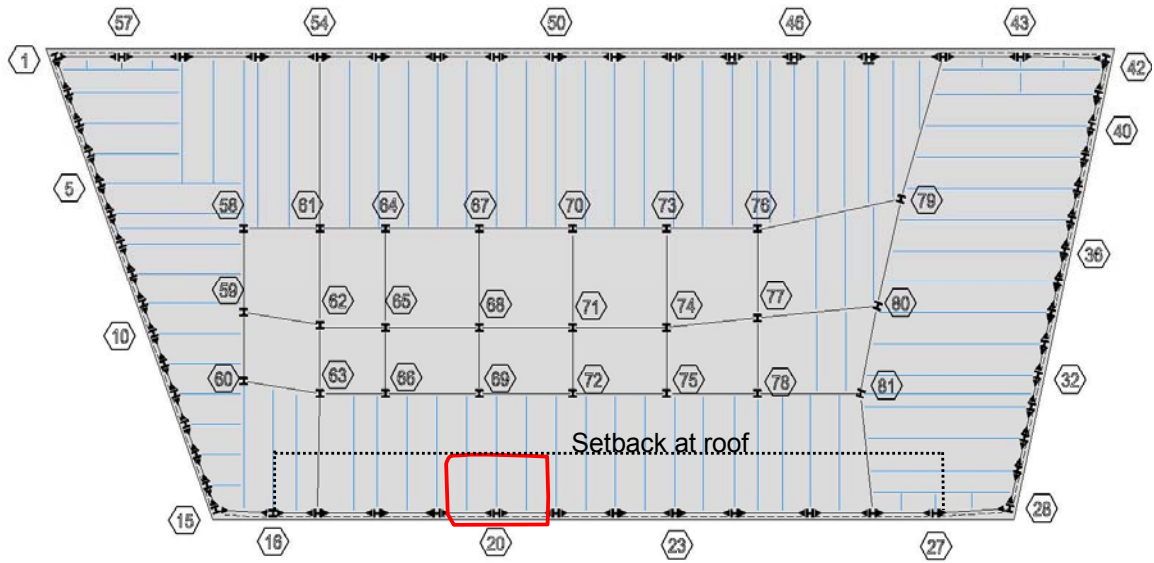
**Figure 5–101 Estimated debris impact damage to Floor 44 to the roof of WTC 7.**  
Marked areas indicate removed columns and floor segments.

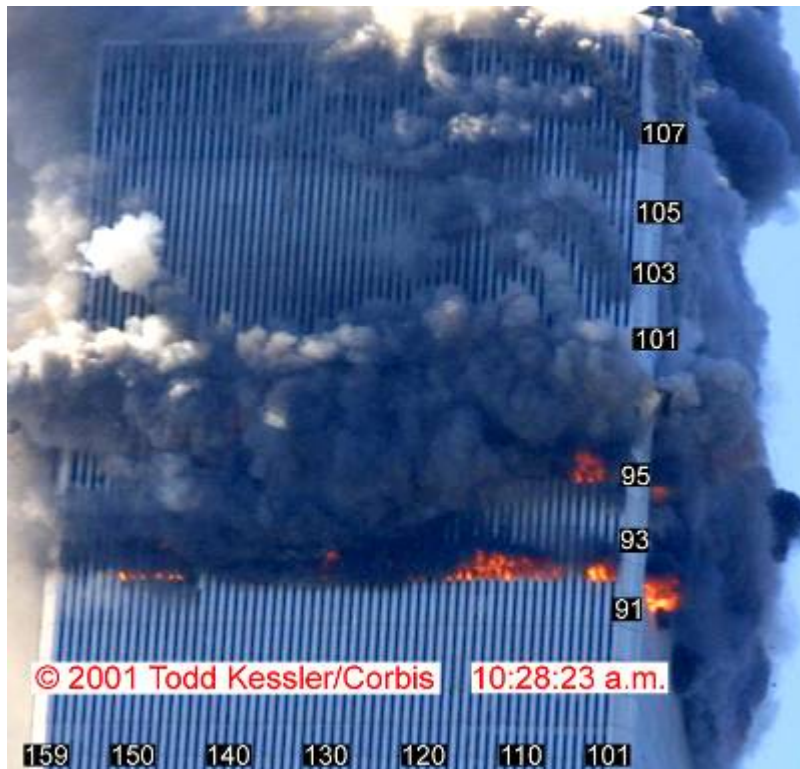
windows, thus revealing the extent of the fires. This is evident in Figure 5–102 which shows the upper floors of WTC 1 roughly one second after the collapse started. The significant fire on the west side of the 92<sup>nd</sup> floor is evident. The expelled flames formed a large fireball before extinguishing.

**Figure 5–102. Cropped photograph showing the north face of WTC 1 at 10:28:23 a.m.**

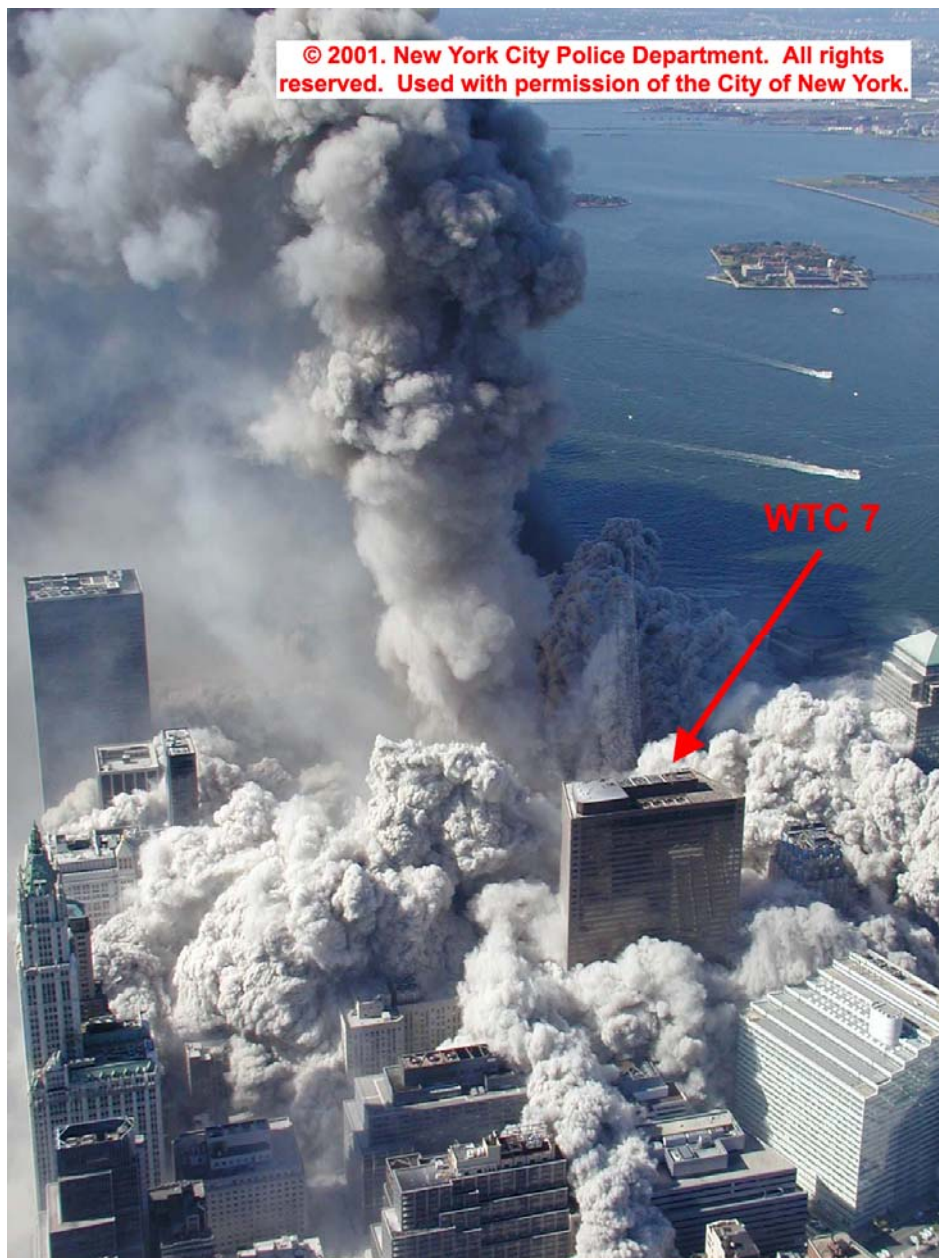
The fires in WTC 1 were likely burning on a wide variety of materials typical of those found in office buildings. These fuels include office paper, furnishings, carpeting, and drapes. Some extinguishing of these burning materials would have occurred during the collapse of the tower, but it is possible that a large number of potential ignition sources (i.e., fire brands) might have survived and been widely distributed with the dust- and debris-laden air around the buildings at the WTC site. In Figure 5–103, it is evident that these dust- and debris-laden flows were many stories tall and that they flowed around WTC 7 and reached well beyond this building.

**Figure 5–103.**  
Photograph showing the dust-laden flows spreading away from WTC 1 following its collapse.
