**Federal Building and Fire Safety Investigation of the  
World Trade Center Disaster**

**Structural Fire Response and  
Probable Collapse Sequence of  
World Trade Center Building 7**

**NIST NCSTAR 1-9**

August, 2008

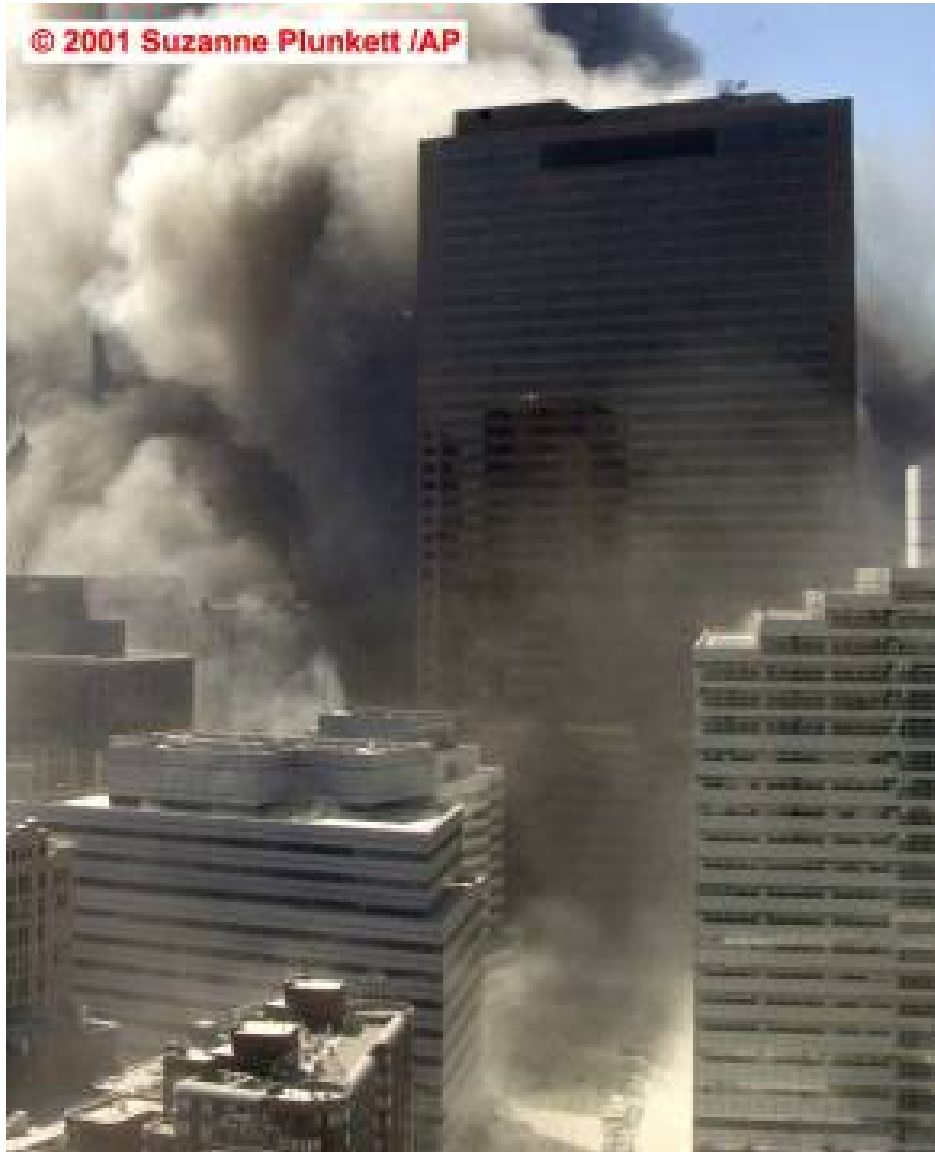
The large dust clouds generated by the collapse of WTC 1 hid the lower portions of WTC 7 from view for over 20 min following the collapse. However, as time passed, the dust began to settle, and the faces became less obscured. Figure 5–104 shows a view of the north face of WTC 7 taken at 11:28:15 a.m., i.e., close to one hour after the collapse of WTC 1. Even though some light dust is evident in front of the face, it is possible to discern the base of the building. There is no sign of fire or heavy smoke on the portion of the north face that is visible.

In Figure 5–104, there appears to be a heavy smoke column rising from an area just to the north and west of WTC 7. The location of the smoke relative to the buildings in the area suggests the smoke was coming from or near West Broadway.

**Figure 5–104.**  
**Cropped**  
**photograph**  
**showing the north**  
**face of WTC 7, shot**  
**at 11:28:15 a.m.**  
**from the upper**  
**story of a nearby**  
**building looking**  
**down Greenwich.**  
The intensity levels  
have been adjusted.

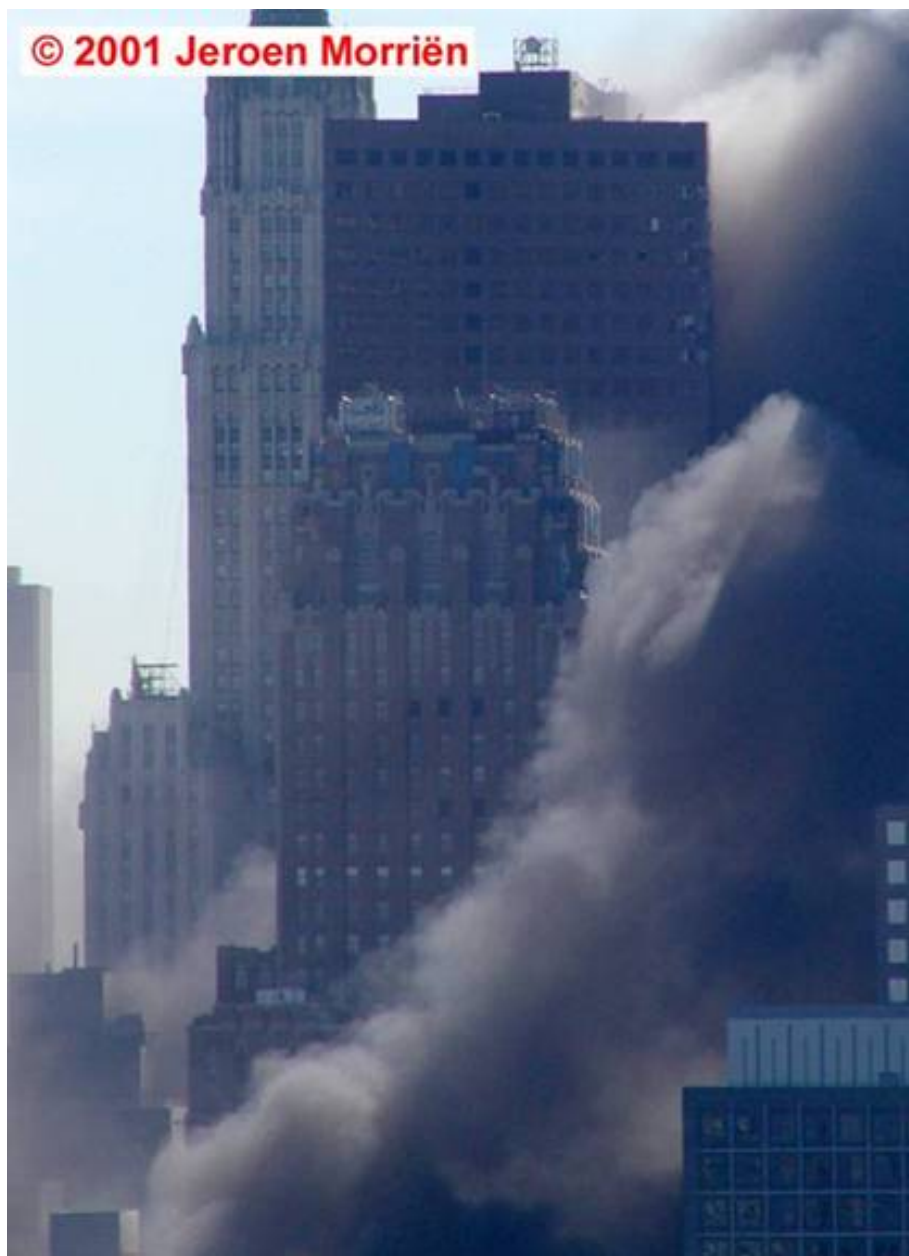
A view of WTC 7 from the west, taken roughly 15 minutes earlier, is shown in Figure 5–105. The upper portion of WTC 7 is visible at the top of the photograph. A heavy smoke plume was passing in front of the Verizon Building at this time. A second smoke plume can be seen beyond the Verizon Building to the north of WTC 7. It is likely that this smoke is coming from the same general area as the plume in Figure 5–104. Photographs taken from the same location show that the heavy smoke to the west of the Verizon Building was present as early as 10:54 a.m. and was observed as late as 11:19 a.m. By 12:10 a.m., the two smoke plumes visible in Figure 5–105 had dissipated, and the areas to the north of the Verizon Building and WTC 7 could be easily seen through a light veil of smoke and/or dust.

**Figure 5–105.**  
Cropped photograph showing the west face of WTC 7, shot at 11:13:51 a.m. from New Jersey looking across the Hudson River. The intensity levels have been adjusted.

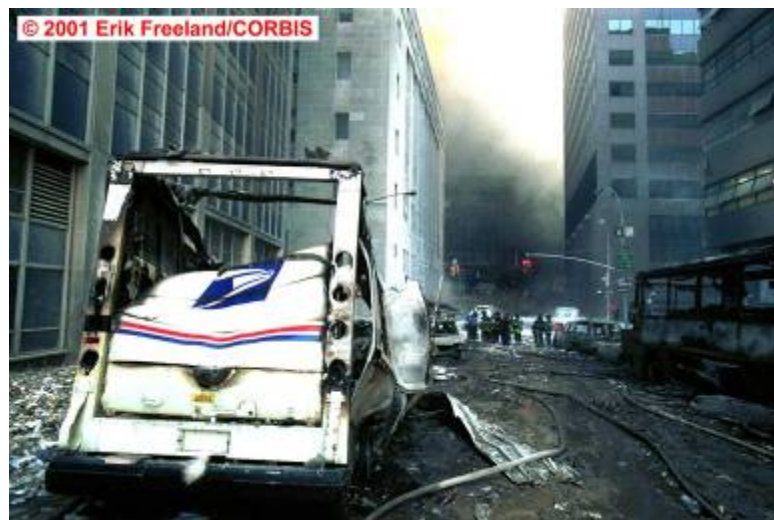
**Figure 5–107.** Photograph taken  
 looking down West Broadway  
 towards WTC 7 from near its  
 corner with Park Place.

Several fire hoses are visible on the street in Figure 5–107. One of the photographers who provided images for the Investigation reported that he was a fireman visiting from out of town and had joined with a FDNY engine company to extinguish the burning vehicles along West Broadway. They started at the corner of Park Place and West Broadway and moved south until they reached Vesey Street. Based on the smoke plume observations, this must have taken place between roughly 11:00 a.m. and 12:00 p.m.

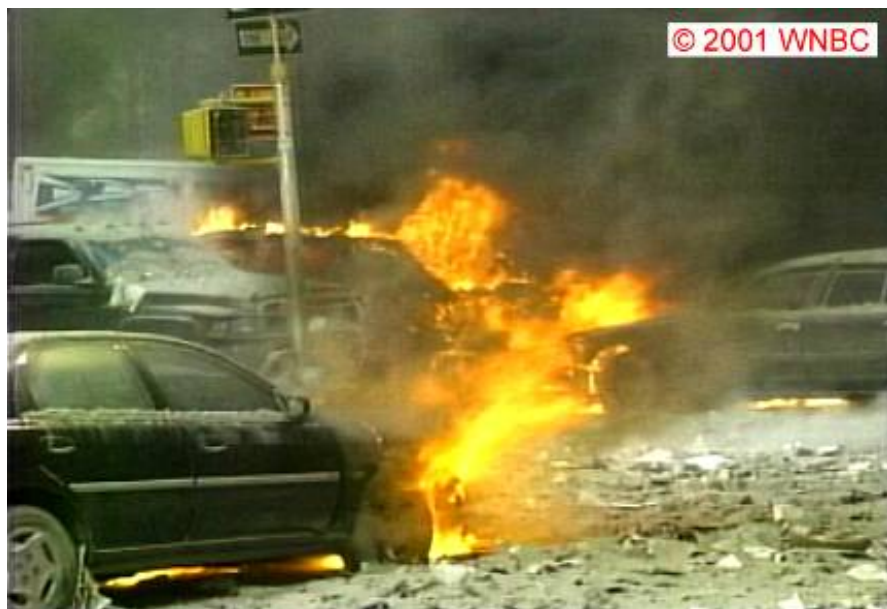
A video crew managed to reach the area of West Broadway and Barclay Street while the vehicles were still burning. Figure 5–108 shows a frame taken from a video recorded looking from the west of the West Broadway/Barclay Street intersection. The exact time is unknown, but it was likely between 11:00 a.m. and 12:00 p.m. Multiple vehicles were burning at this time. This image provides an indication of the burning intensities and smoke generation by these vehicle fires.

**Figure 5–108. Frame taken from a video clip filmed near the corner of West Broadway and Barclay Street showing flames burning on a number of vehicles.**

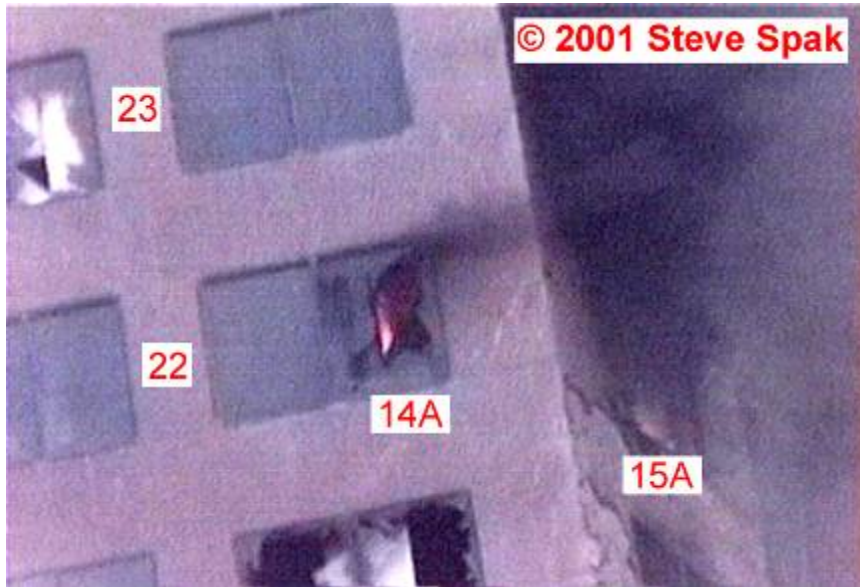
The earliest visual evidence showing flames in WTC 7 is a video clip of the southwest corner that was recorded between 12:10 a.m. and 12:25 p.m. Figure 5–109 is a frame from this video. Flames are visible in open windows 22-14A and 22-15A. Some smoke is visible flowing from both of these windows, with

the heaviest flow on the south face. Windows to the north of window 22-14A were intact at that time. In this close up it is easy to identify column 14 through window 23-13B on the 23<sup>rd</sup> floor and column 14A through windows 21-14 and 21-14A on the 21<sup>st</sup> floor.

**Figure 5-109. Frame from a video clip showing the southwest corner of WTC 7 around the 22<sup>nd</sup> floor.**

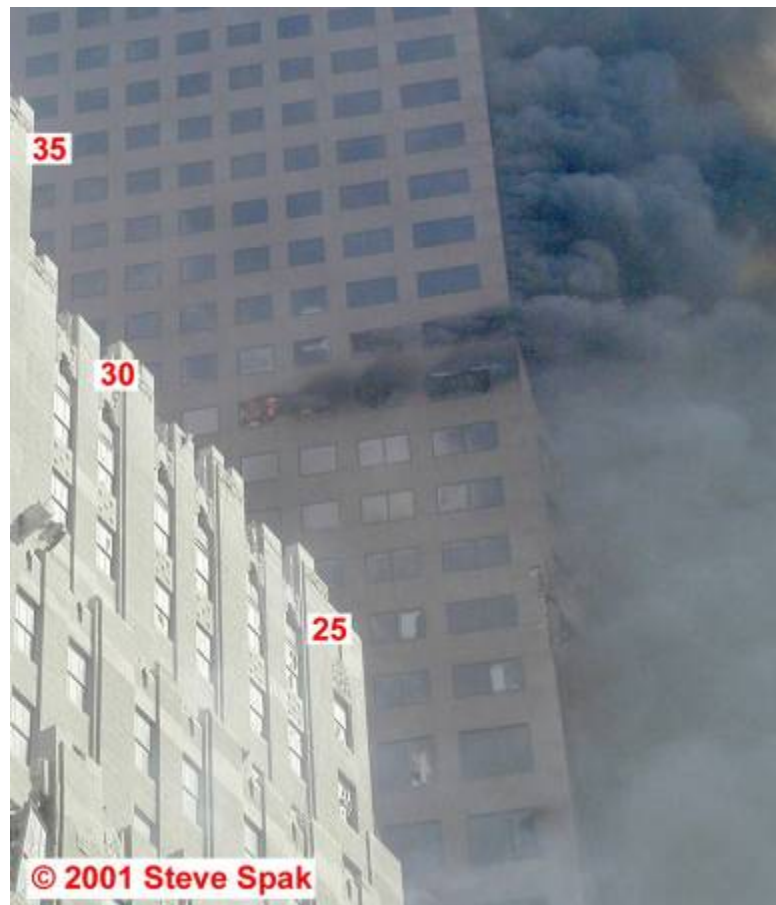
**Figure 5-110. Cropped photograph showing a portion of the west face of WTC 7 near the south edge at 12:27:30 p.m.  $\pm$  1 s from near the corner of Vesey and West Streets.**

A larger area of the west face near the south edge is visible in the photograph shown in Figure 5–110, which was taken shortly after Figure 5–109 at 12:27:30 p.m. At this time flames were not evident in window 22-14A, but light smoke continued to flow from the window. Higher up on the face, smoke was coming from the six adjacent open windows 29-11 to 29-14A on the 29<sup>th</sup> floor, with heavy flames filling windows 29-11 and 29-12. As discussed in Section 5.5.2, the condition of windows 29-13A to 29-14A immediately following the collapse of WTC 1 could not be determined, while the glass was intact in windows 29-11 and 29-12. This suggests that the fire burning on this floor had opened windows 29-11 and 29-12 by 12:27:30 p.m.

Heavy smoke was also coming from open windows 30-13A to 30-14A on the 30<sup>th</sup> floor at this time. This suggests that a fire was also burning on this floor, but flames are not apparent in Figure 5–110. In a long distance view from the same short video clip from which Figure 5–109 was taken, these windows appeared to be intact. This indicates that the fire burning on this floor broke the glass from these windows during the short time period between the times when Figure 5–109 and Figure 5–110 were taken.

The appearance of the smoke on the south side of WTC 7 in Figure 5–110 demonstrates a difficulty that plagued attempts to use smoke to provide qualitative information about fire behavior. There appears to be relatively light-colored smoke on the south face at all of the floors visible in the image, while much denser and darker, rapidly rising smoke appeared to be flowing from windows near the west edge of the 30<sup>th</sup> floor. Due to the wind direction, it was common for smoke to “bank up” against the south face. For this reason, it was usually not possible to differentiate different types of smoke or to identify smoke source locations on the south face. Viewing difficulties resulting from the large amount of smoke on the south face were discussed earlier.

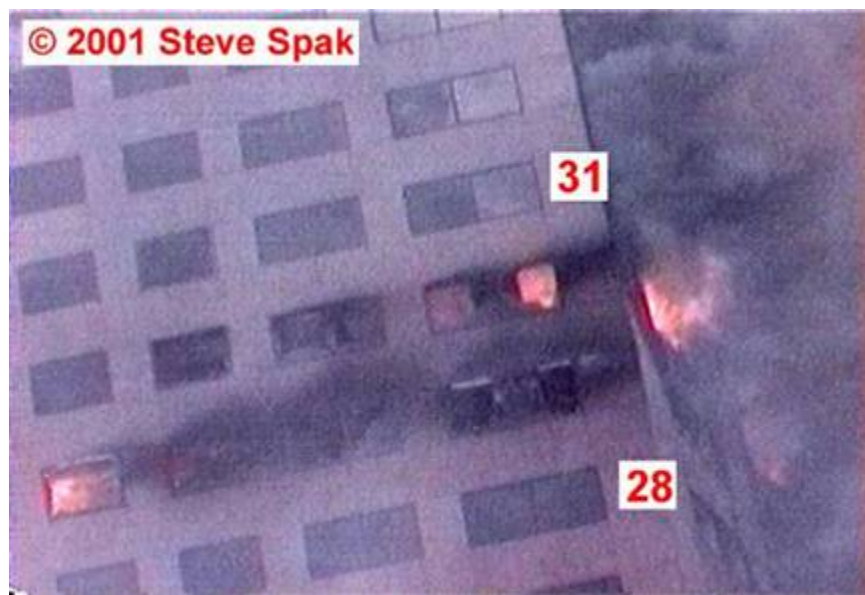
Figure 5–111 shows another view of the fires at the southwest corner on the 29<sup>th</sup> and 30<sup>th</sup> floors taken within a few minutes of Figure 5–110. At this time flames were visible on both floors. The appearance of the fires on the 29<sup>th</sup> floor is similar in both images. However, unlike in Figure 5–110, intense flames are visible on the 30<sup>th</sup> floor. Flames are apparent in windows 30-14, 30-14A, 30-15, and 30-16A to 30-16C. In the video it is clear that flames were coming from multiple windows on the south face. This is an indication that a fully developed flashed over fire was present in the corner of this floor at this time.

**Figure 5–111. Frame from a video clip showing fires near the southwest corner of WTC 7 on the 29<sup>th</sup> and 30<sup>th</sup> floors around 12:28 a.m. ± 3 min.**

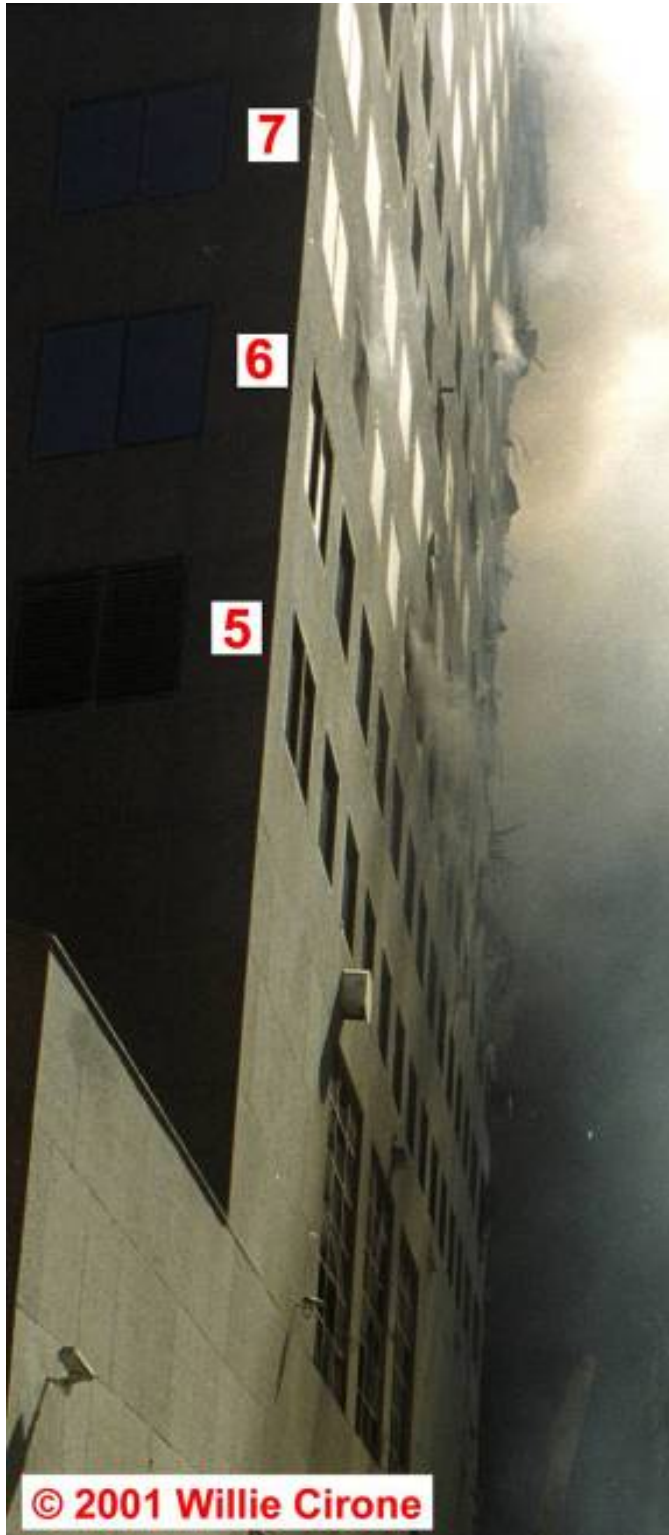
In Figure 5-112 smoke is visible coming from open windows 7-5 and 7-7 on the 7<sup>th</sup> floor, and windows 7-6 and 7-8 appear to be open as well. In the earlier photograph, no smoke was evident coming from windows on this floor, and glass was in place in each of the open windows mentioned above. Light smoke is also visible coming from the louvers in window 7-2 in Figure 5-112. The glass in windows 7-1A, 7-1B, 7-3 and 7-4 was still intact when the photograph was taken. The presence of smoke and additional broken windows indicates that a fire had progressed toward the north edge of the west face on the 7<sup>th</sup> floor by the time the photograph in Figure 5-112 was taken. Even though a fire was present that was capable of breaking out window glass, no flames are visible. It is possible that flames were present

earlier and had died away or that the prevailing wind on the face pushed the flames into the building and that the smoke and possibly flames exited primarily through openings on the south face.

Smoke is also visible coming from open windows at a few other locations on the west face in Figure 5–112. Relatively heavy smoke appears to be coming from an open window on the 8<sup>th</sup> floor near the northwest

**Figure 5–112. Cropped photograph shot from near the corner of Washington and Barclay Streets shows lower floors on the west side of WTC 7 between 1:30 p.m. and 2:30 p.m. The intensity levels have been adjusted, and floor numbers have been added.**

corner. This window was likely 8-10 or 8-11. Smoke is also coming from a window on the 12<sup>th</sup> floor near the same corner. There does not appear to be significant smoke flow from other open windows at this time.

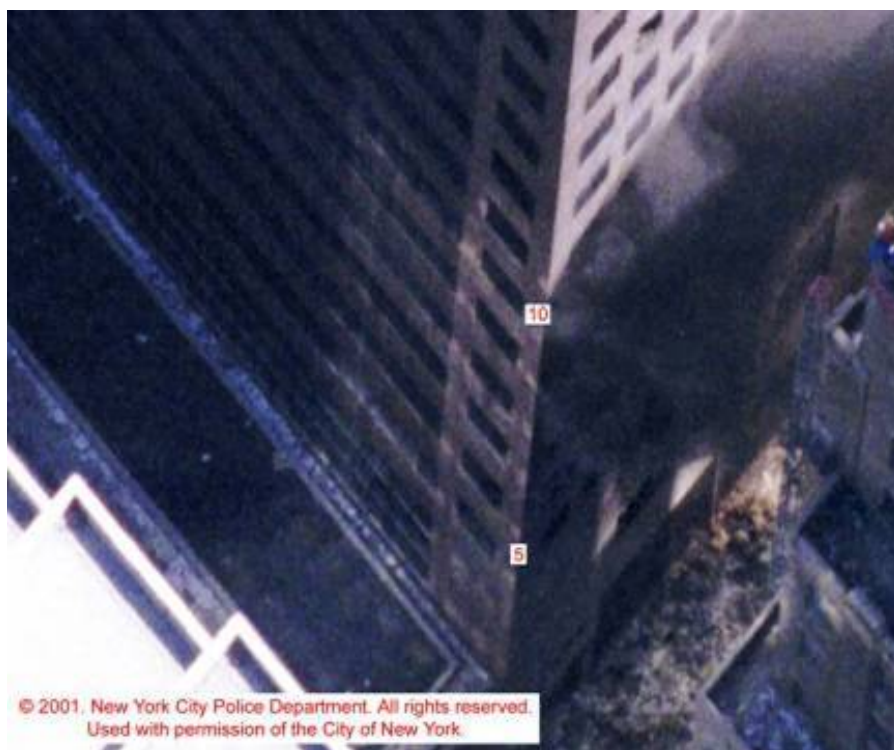
Figure 5–113 shows a portion of the aerial photograph in Figure 5–64, enlarged to emphasize the areas on lower floors near the northwest corner of WTC 7. This image was estimated to have been taken between 2:15 p.m. and 2:45 p.m. by relating it to other photographs taken earlier that show fires on the east side of WTC 7 and the south side of WTC 5 and by using shadows at various locations around the site.

**Figure 5–113.**  
**Enlargement of a**  
**portion of the**  
**photograph shown in**  
**Figure 5–64**  
**emphasizing areas on**  
**the lower floors of WTC**  
**7 near the northwest**  
**corner.**

Heavy smoke is visible passing over the west face, starting at a point close to the north edge of the building. This smoke appears to be coming from windows on the 7<sup>th</sup> or 8<sup>th</sup> floor. It likely was coming from windows on the 7<sup>th</sup> floor, since fire appeared on the north side of this floor shortly after Figure 5–113 was taken, and there were indications of earlier burning to the south of this location on this floor. Note that there were no visual signs of fire or broken windows on the north face at that time.

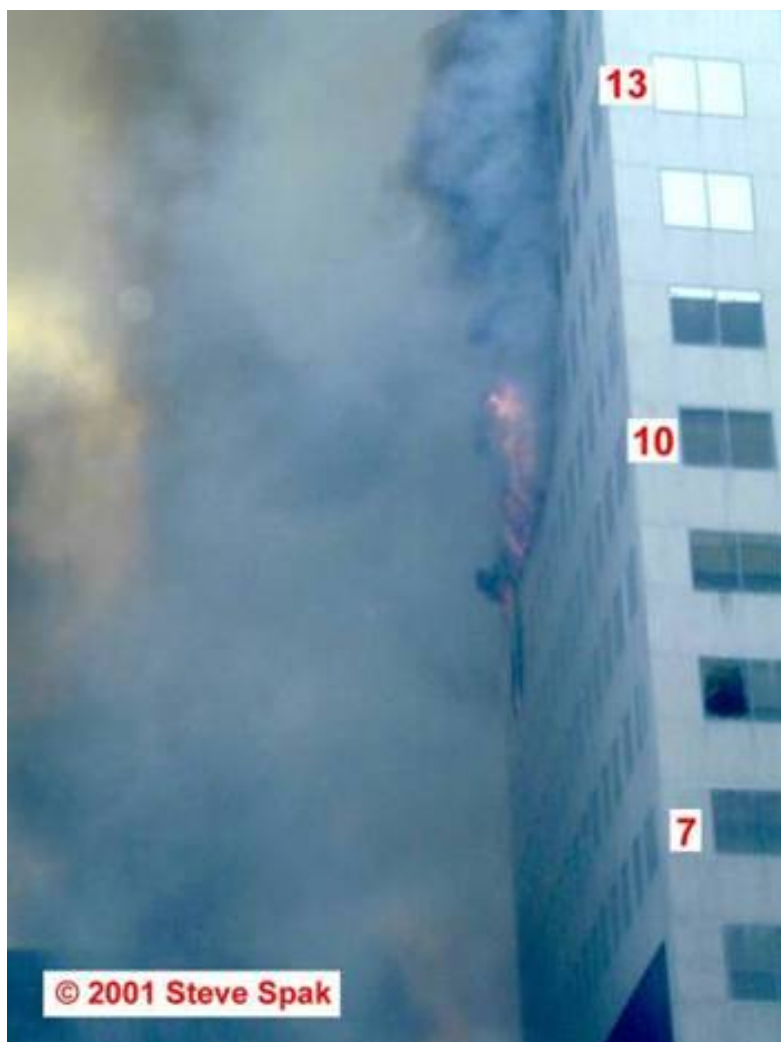
**Figure 5–114. Oblique view of the east face of WTC 7, taken at 2:08:28 p.m. ± 1 s from West Broadway near its corner with Park Place.**

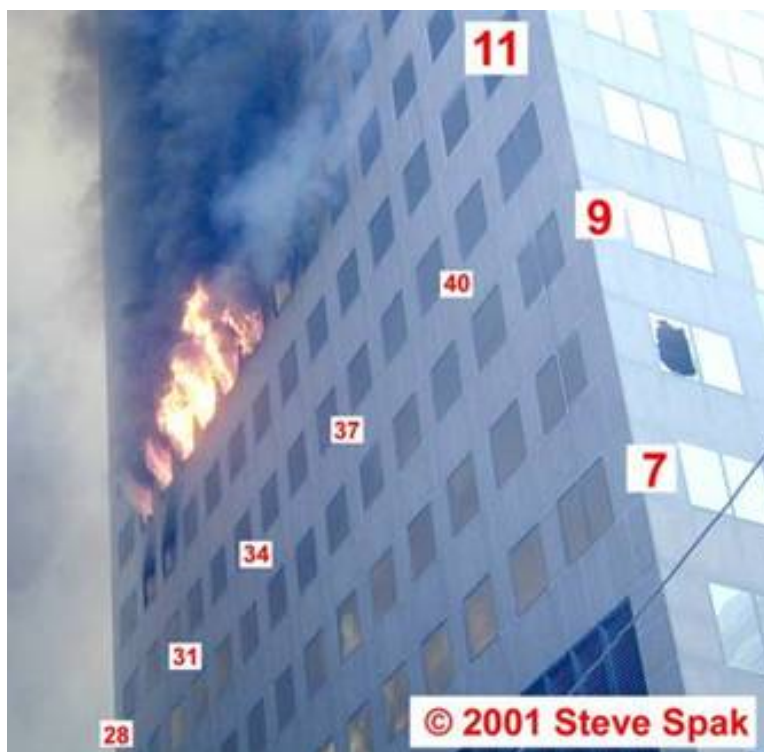
Two windows, 11-29 and 11-30, were also open on the 11<sup>th</sup> floor at 2:11:09 p.m. Upon closer inspection, it is possible to identify a dull red glow through these open windows. The smoke patterns visible above these windows indicate that a more intense fire had burned there earlier and had subsequently died down. The floor plan for the 11<sup>th</sup> floor (Chapter 3) was similar to that for the 12<sup>th</sup> floor, and interior walls were present on either side of these two windows. Apparently, these walls slowed the fire spread into enclosed spaces on either side.

**Figure 5–115. Cropped photograph showing fires on the east face of WTC 7 at 2:11:09 p.m. ± 1 s.**

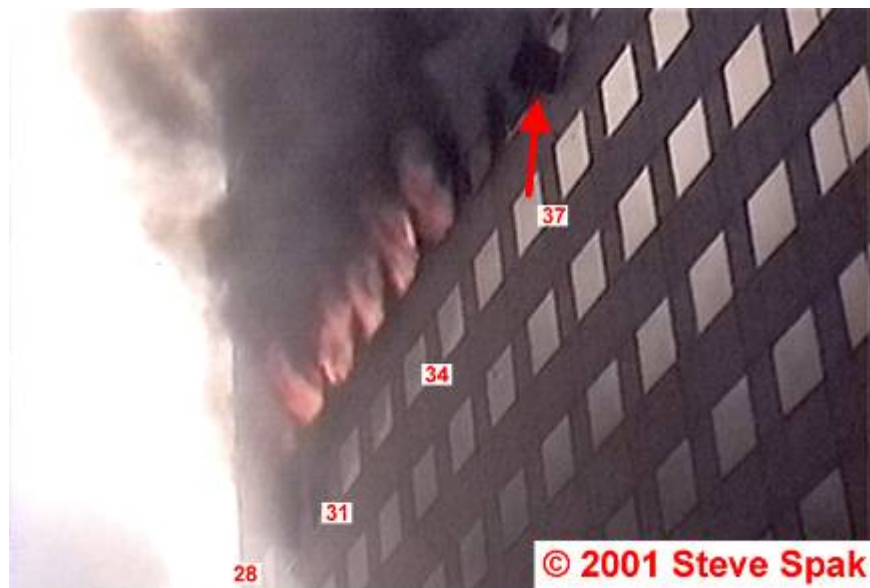
Several video clips showing the east face of WTC 7 are available between 2:15 p.m. and 2:29 p.m. The exact times for these clips are not known. In the clip shot immediately after the one shown in Figure 5–116, window 11-32 on the 11<sup>th</sup> floor had already broken, and the glass in window 11-33 suddenly fell outward. Low intensity flames appeared in window 11-32 shortly afterwards. By the time the next clip started, windows 11-31 and 11-34 were open, and growing flames were visible through windows 11-31 to 11-34. In this clip, heavy smoke appeared, and flames erupted from window 11-34, likely an indication that flashover occurred at that time. Heavy smoke and flames continued to come from these four windows over the next several minutes.

**Figure 5–116. Frame from a video showing a portion of the east face of WTC 7 between 2:15 p.m. and 2:27 p.m.**

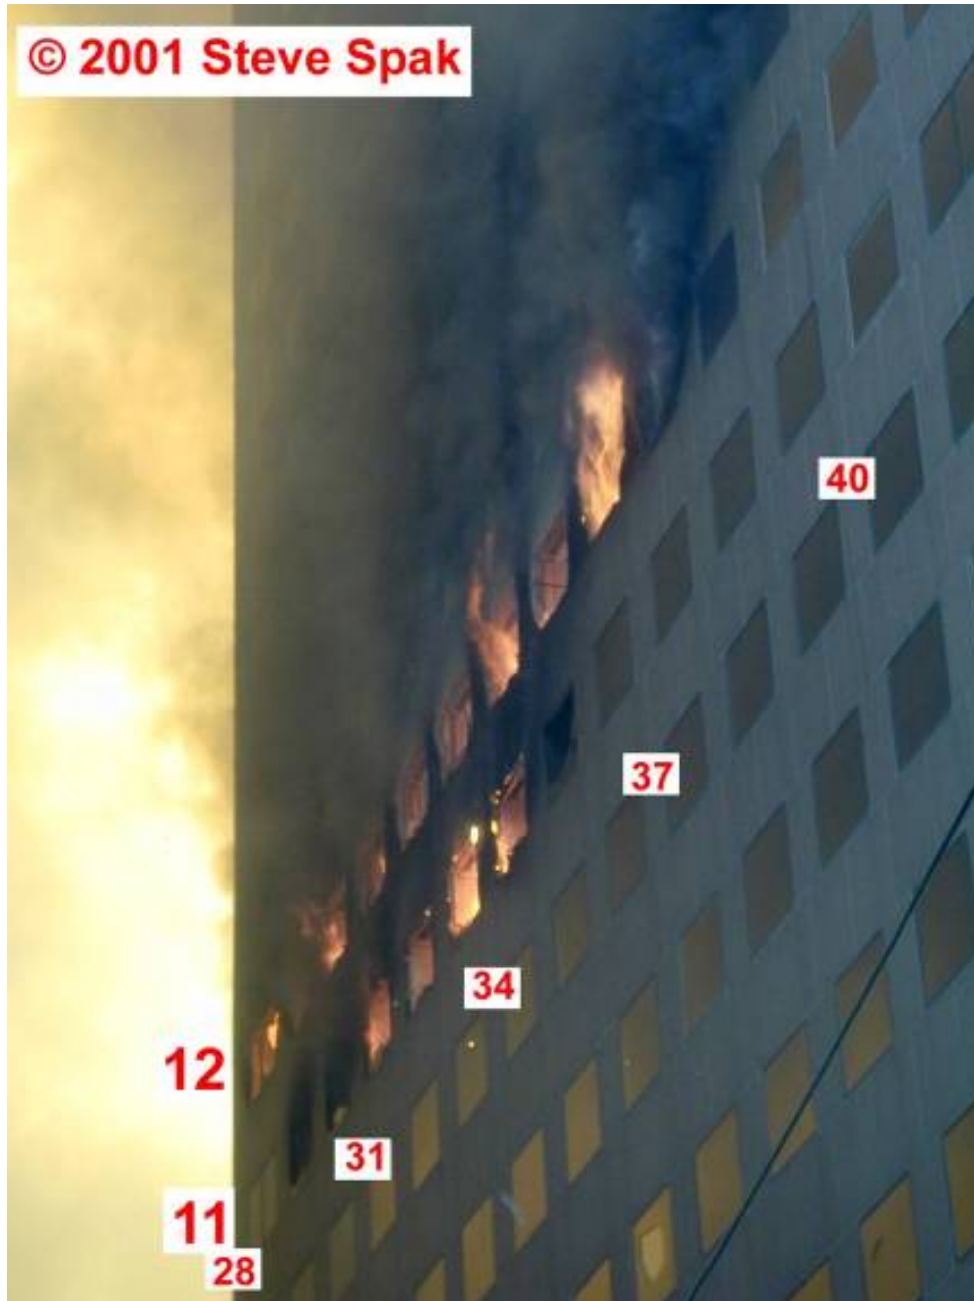
**Figure 5–117.** Photograph showing fires on the east face of WTC 7 at 2:28:43 p.m. ± 1 s. The intensity levels have been adjusted, and column and floor numbers have been added.

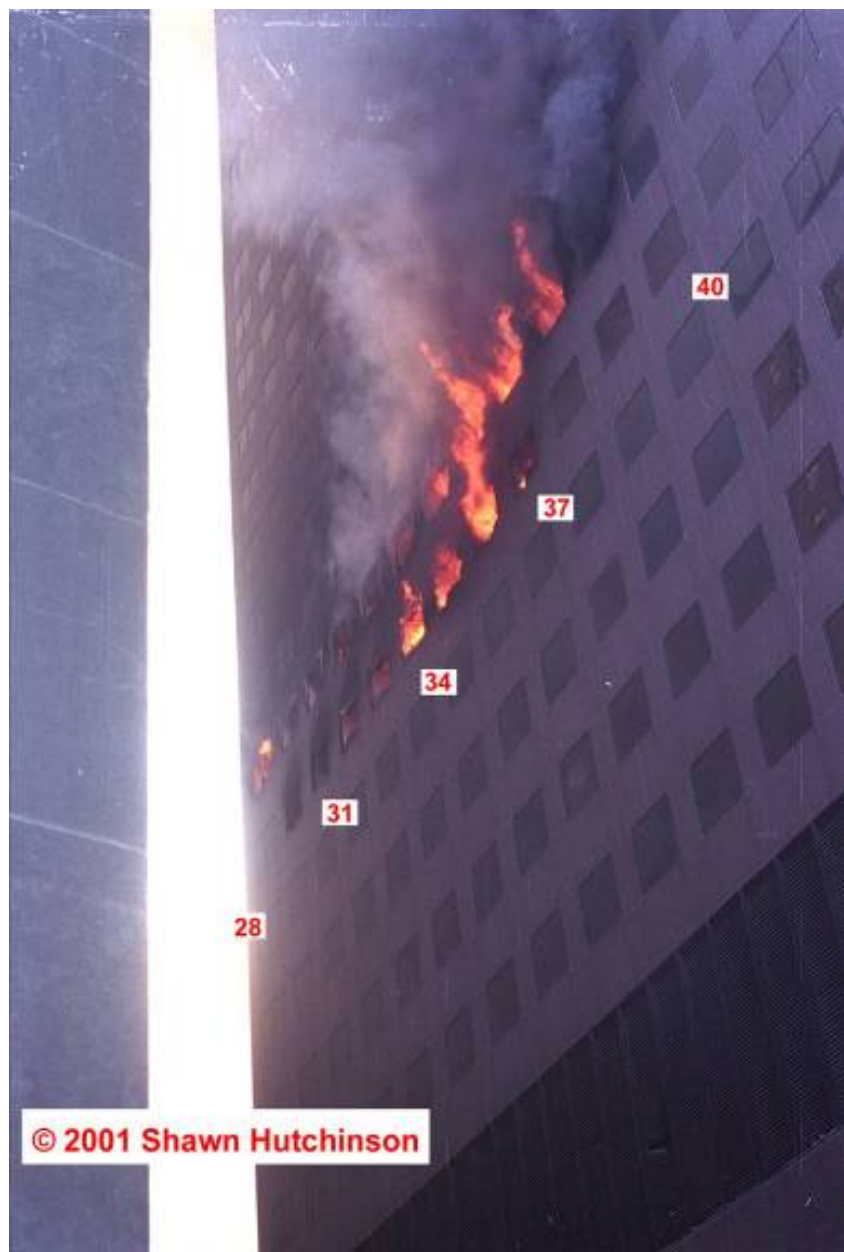
Closer inspection of Figure 5–118 reveals that three windows appear to be open on the 13<sup>th</sup> floor. The glass in window 13-31 is missing, while there appears to be fire visible in windows 13-33 and 13-34. These are the first indications that a fire may be growing on the east side of the 13<sup>th</sup> floor, in addition to

those evident on the 11<sup>th</sup> and 12<sup>th</sup> floors. Since windows 13-28A to 13-30 seem to be intact, it is possible that these fires spread in the interior from fires on the south side of the building or that the window breakage and fire ignitions on the 13<sup>th</sup> floor were due to heat transfer from flames extending upward from open windows on the 12<sup>th</sup> floor.

In Figure 5–118, no smoke or fire is evident on floors below the 11<sup>th</sup> floor. This includes the 5<sup>th</sup> and 6<sup>th</sup> floors, where intake and exhaust louvers were located. (See floor diagrams in Chapter 3.) It is possible to see windows along the south edge of the building up to the 22<sup>nd</sup> floor. There are no indications of open windows between the 14<sup>th</sup> and 22<sup>nd</sup> floors.

**Figure 5–118. Photograph of the east face of WTC 7 taken at some time after 2:28:43 p.m. from near the corner of West Broadway and Barclay Street.**

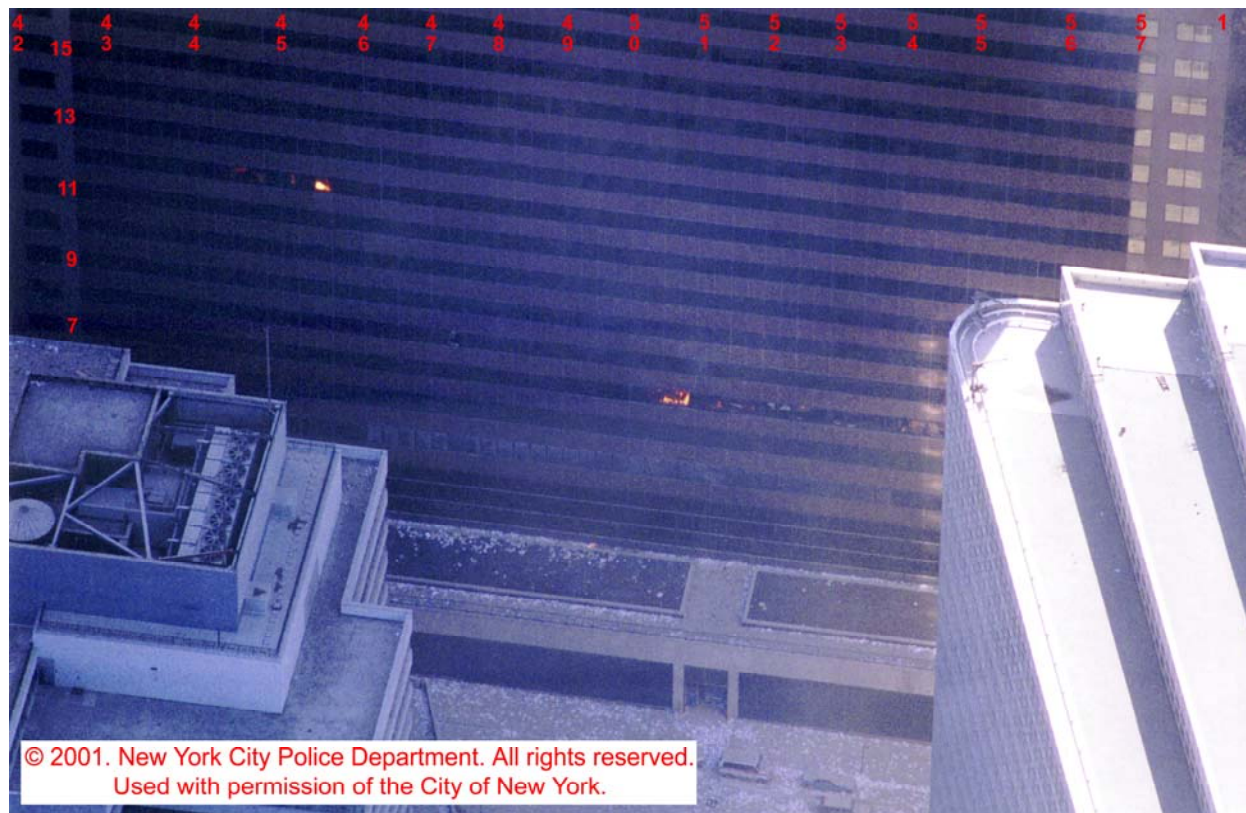
**Figure 5–119. Photograph showing the north face of WTC 7 taken from a helicopter around 2:57 p.m. ± 5 min.**

Only very light smoke can be seen coming from the open windows on the 7<sup>th</sup> and 12<sup>th</sup> floors. Even though the fires were relatively small, they would be expected to release much more smoke than was observed. It is likely that this smoke was being vented elsewhere from the building, perhaps at locations on the east or south faces. This would be the expected behavior if internal flow pathways were available to these faces due to the positive pressure created at the open windows on the north side by the ambient wind flowing over this face and the corresponding low pressure areas created on the leeward faces.

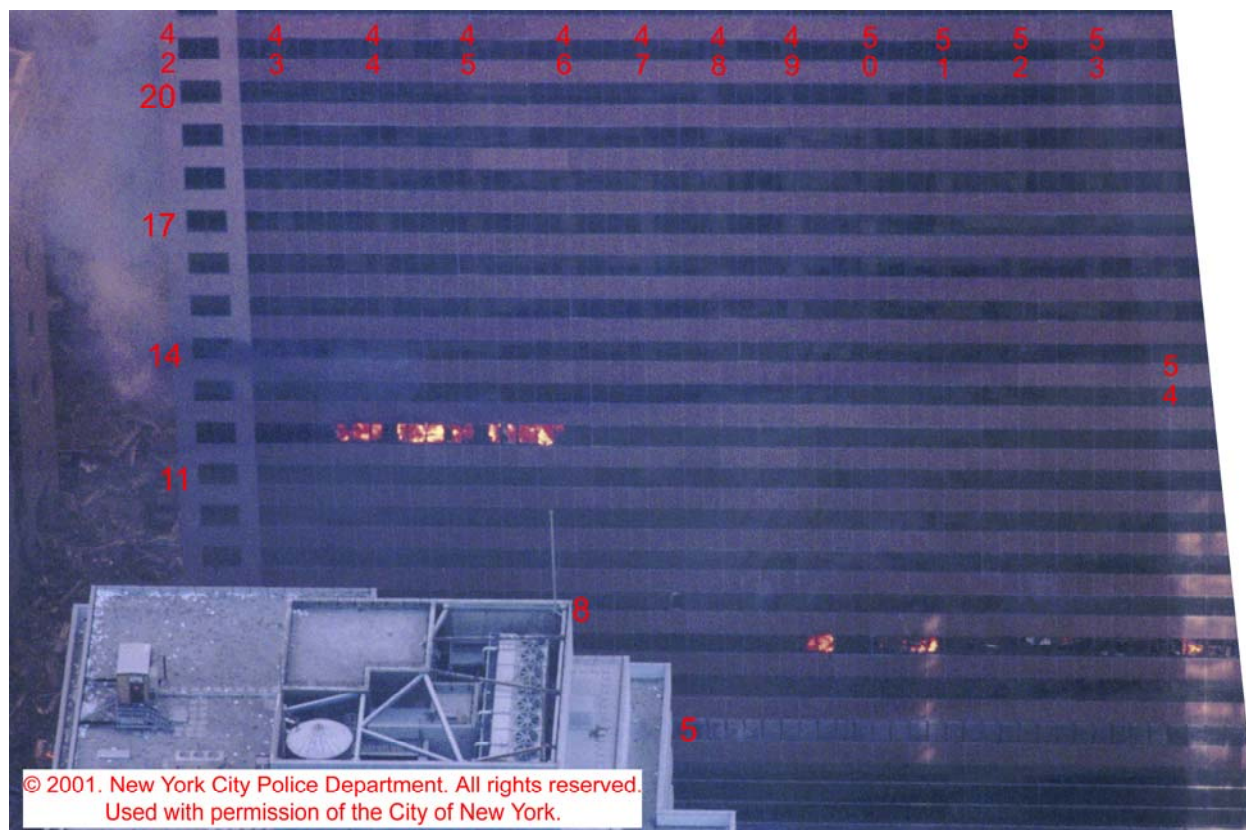
**Figure 5–121. Cropped photograph of the north face of WTC 7, taken from a helicopter around 3:05 p.m. ± 5 min.**

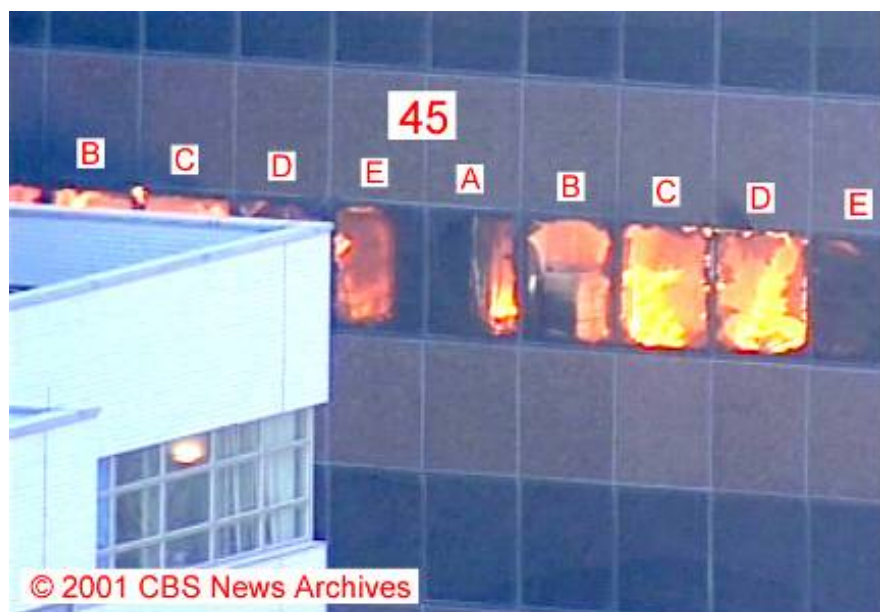
A closer view of the fires burning on the 12<sup>th</sup> floor around this time is shown in Figure 5–122. The flames appear to fill the space over the several windows that are visible. Some details are evident inside the building. There appears to be a large file cabinet visible against a wall through window 12-45B. Flames are visible behind window 12-45E, but only a small section of glass seems to have broken out.

Reference to the floor plan in Chapter 3 indicates that the fires on the 12<sup>th</sup> floor extended over at least four different offices at this time. The fires appeared to be fully developed, completely filling the open windows, suggesting that they were flashed over. Even so, relatively little smoke and flames were coming from the open windows. This behavior can be contrasted with the large flame extensions observed earlier from open windows on the east face of this floor. As discussed above, these differences are likely due to the ambient wind field.

**Figure 5–122. Frame taken from a video clip shot looking down on WTC 7 from a building to the northwest shows the fires along a length of the north side of the 12<sup>th</sup> floor of WTC 7.**

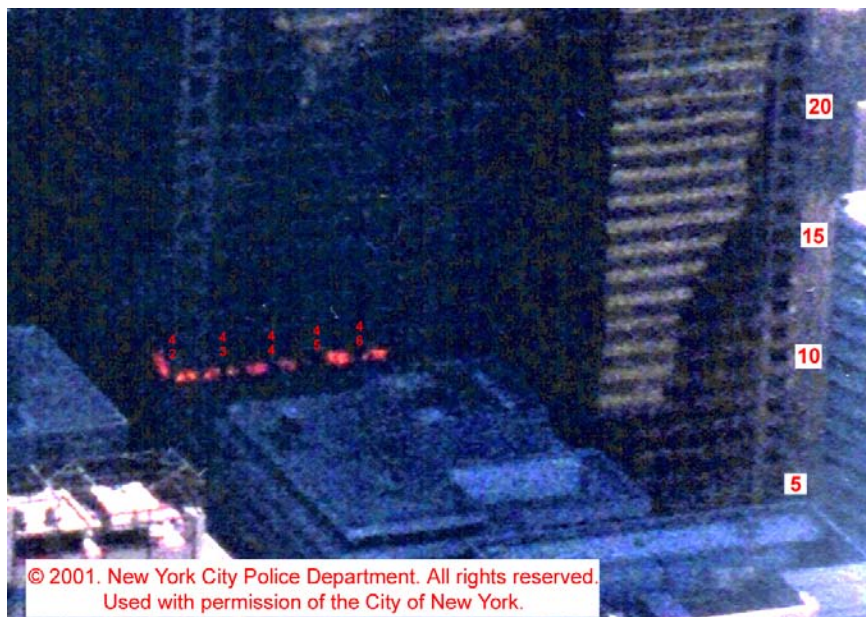
An aerial view of the north face of WTC 7 taken from a much longer distance than Figure 5–119 and Figure 5–121 is shown in Figure 5–123. The time of this photograph was estimated in the same way as the earlier aerial shots as 3:10 p.m. with a  $\pm 5$  min uncertainty. Flames were only visible on the 12<sup>th</sup> floor from this distance and angle. The fire had spread to the east and west in the roughly 5 min period following the photograph in Figure 5–121. The flames had spread all the way to the east face.

**Figure 5–123. Enlarged section of a long distance aerial shot of the north face of WTC 7 taken around 3:10 p.m. ± 5 min.**

The fires on the north side of the 12<sup>th</sup> floor were extensive, covering a length running approximately from window 12-41A to 12-46C, and intense. Close inspection of Figure 5–123 shows that the fire in the vicinity of windows 12-44C to 12-44E had begun to die down. This area is close to where the fires first appeared just before 3:00 p.m., indicating that, for this location, the period of intense burning lasted for roughly 15 min.

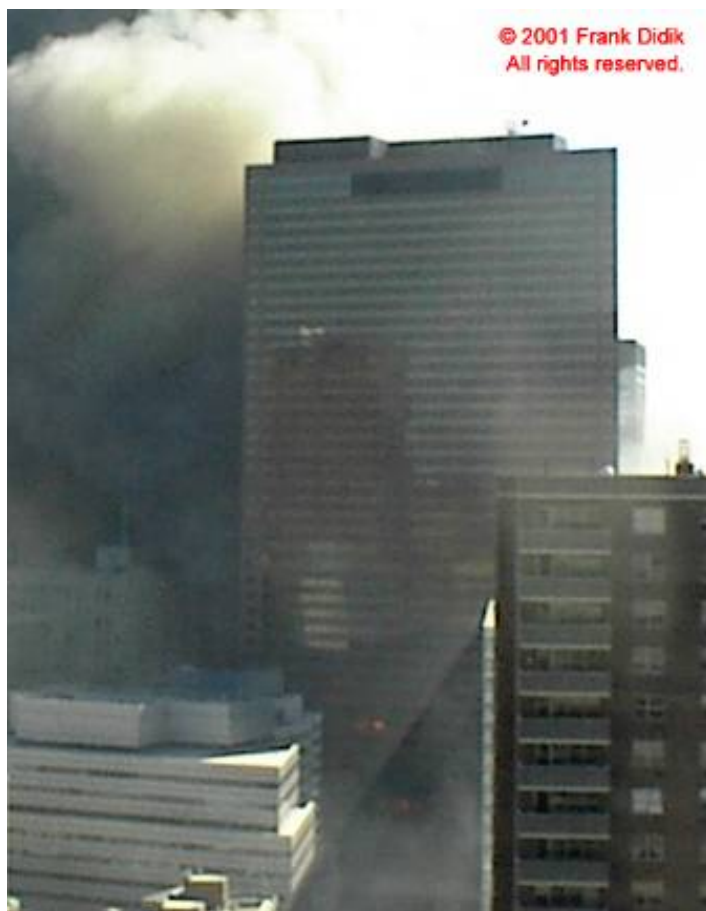
Figure 5–124 provides a view of the north face of WTC 7 taken from the northwest at 3:10:46 p.m. It shows an example of the shadow and sunlight distributions on the roof of the building at 70 Murray Street (the stepped white building at the lower left of the photograph) used for timing the aerial photographs described earlier. Flames are visible on the 7<sup>th</sup> and 12<sup>th</sup> floors of the north face of WTC 7. Light smoke or dust is visible on the north side of the building. Heavy smoke is also visible rising from the east face, indicating that fires were burning near by or that the effluent from more distant fires was being vented through the face.

**Figure 5–124. Cropped photograph of the north face of WTC 7 taken from a building located to the northwest looking down Greenwich Street at 3:10:46 p.m. ± 3 s. The intensities were adjusted.**

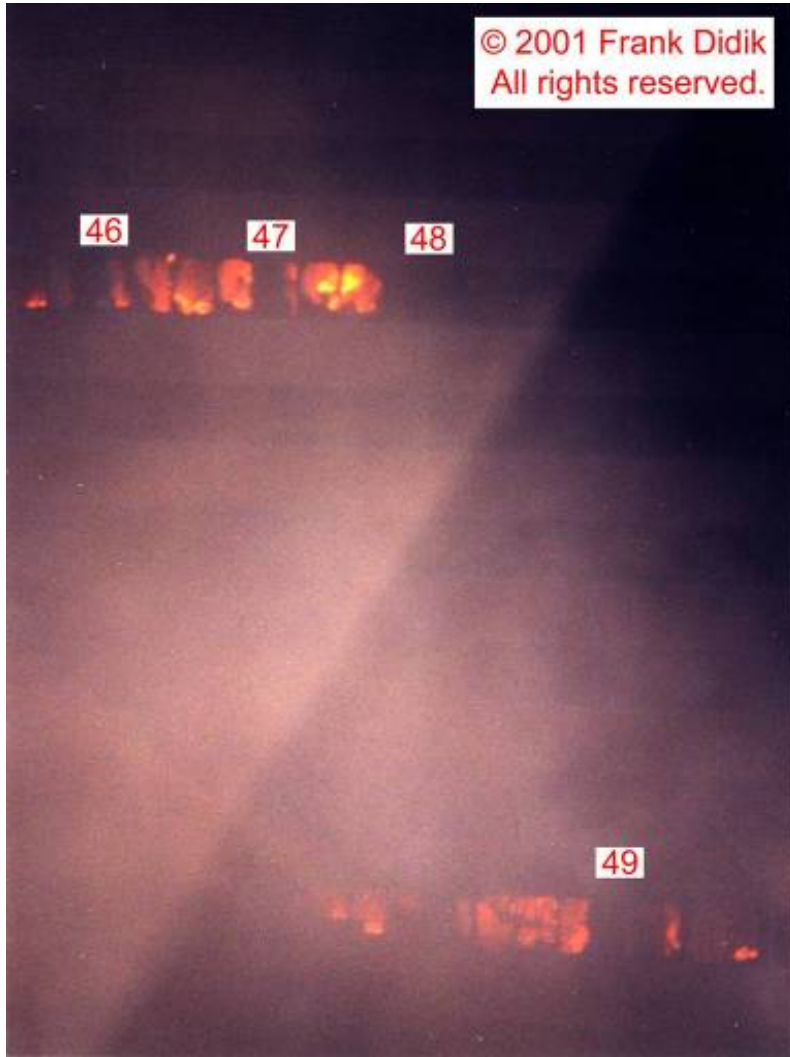
A much closer view of the fires visible on the north face in Figure 5–124 is provided by the photograph reproduced in Figure 5–125, which was taken within a few minutes of Figure 5–124. The north face is partially obscured by smoke or dust, but it is possible to make out fires in individual windows on the 7<sup>th</sup> and 12<sup>th</sup> floors. Columns are visible inside the windows, and these have been identified on the image. On the 7<sup>th</sup> floor, windows are open, and flames are visible from windows 7-47B to 7-49C. In Figure 5–121, which was taken at roughly 3:05 p.m., fires on this floor had reached only as far east as window 7-49A. Longer distance photographs indicate that the extended area of intense fire to the east of column 49 became visible between 3:09:42 p.m. and 3:10:46 p.m. Clearly, fire was continuing to spread toward the east on the 7<sup>th</sup> floor at this time.

On the 12<sup>th</sup> floor, intense flames are visible in Figure 5–125 as far west as window 12-47C, indicating that this image was taken shortly after the photograph shown in Figure 5–123, in which flames were not yet evident to the west of column 47. The flames completely fill the open windows, suggesting that flashover had taken place within the offices at these locations. As noted earlier, very little smoke or flames are coming from the open windows on this floor, again suggesting that the smoke was venting elsewhere from the building due to the ambient wind direction.

**Figure 5–125.** Cropped close-up photograph of the north face of WTC 7 taken within a few minutes of the image in Figure 5–124.

Fires are visible on the 7<sup>th</sup> and 12<sup>th</sup> floors. Column numbers are indicated, and the intensity levels were adjusted.

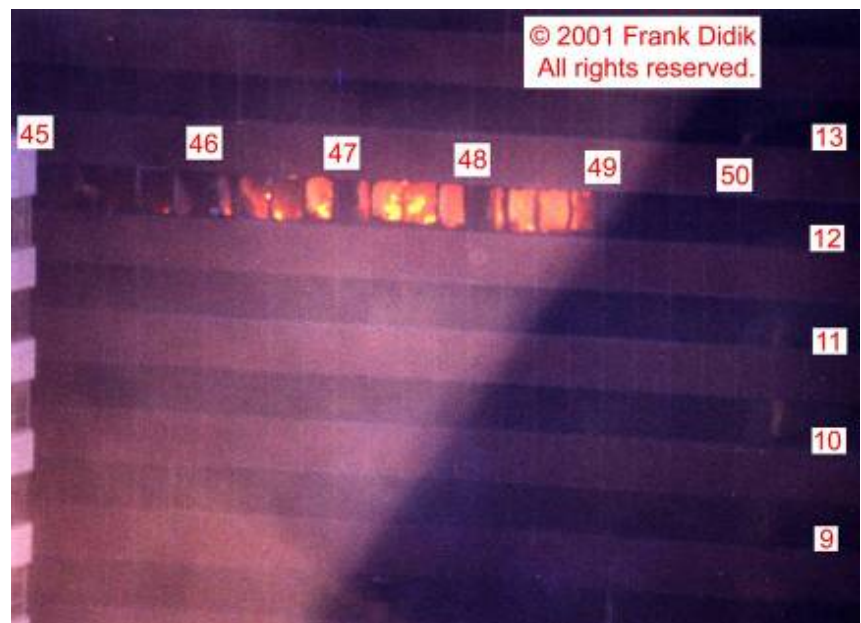
Another close up view of the north face taken from a building to the northwest between 3:11:15 p.m. and 3:16:51 p.m. is shown in Figure 5–126. The fires on the 12<sup>th</sup> floor are visible, but the image did not extend low enough to show the 7<sup>th</sup> floor. During the short period between when the images in Figure 5–125 and Figure 5–126 were taken, the fires on the 12<sup>th</sup> floor broke windows 12-48A to 12-48D, and heavy flames appeared. This indicates that the fires on this floor were continuing to spread toward the west.

**Figure 5–126.** Cropped close-up photograph of the north face of WTC 7 taken between 3:11:15 p.m. and 3:16:51 p.m.

Fires are visible on the 12<sup>th</sup> floor. Column and floor numbers are indicated, and the intensity levels were adjusted.

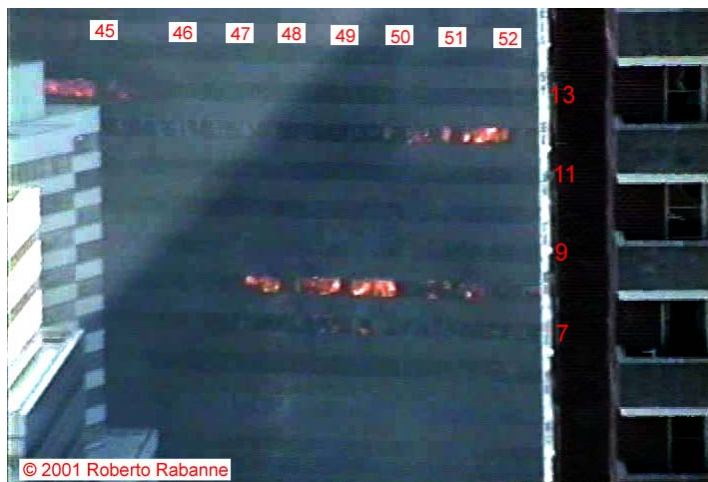
An overhead view of the north face looking down Greenwich Street from a building to the northwest is shown in Figure 5–128. It was taken around 3:42:30 p.m.  $\pm$  2 min. Fires are visible on the 8<sup>th</sup> floor between columns 47 and 52, with the most intense burning toward the east, on the 12<sup>th</sup> floor between columns 50 and 52, and on the 13<sup>th</sup> floor between columns 44 and 46, with intense burning visible between columns 44 and 45. The greatest length of fire is on the 8<sup>th</sup> floor. An earlier frame from the same video shows fire present on this floor at least one minute earlier. This was the earliest observation of a fire present on the 8<sup>th</sup> floor.

Close inspection shows that a dull red glow is visible in windows 13-45C to 13-45E on the 13<sup>th</sup> floor. These windows can just be seen at the side of the building at 30 West Broadway, which hides windows further to the east. This image provides the earliest visual evidence that fires on the 13<sup>th</sup> floor, which were identified much earlier on the east face, had spread to the north side of WTC 7. Based on Figure 5-128, it is likely that fire was present to the east between columns 44 and 45 at this time.

**Figure 5-128.** This frame from a video shot from a building to the northwest of WTC 7 was taken around 3:42:30 p.m. with an uncertainty of  $\pm 2$  min.

The intensities have been adjusted and column and floor numbers added.
