**Federal Building and Fire Safety Investigation of the  
World Trade Center Disaster**

**Structural Fire Response and  
Probable Collapse Sequence of  
World Trade Center Building 7**

**NIST NCSTAR 1-9**

August, 2008

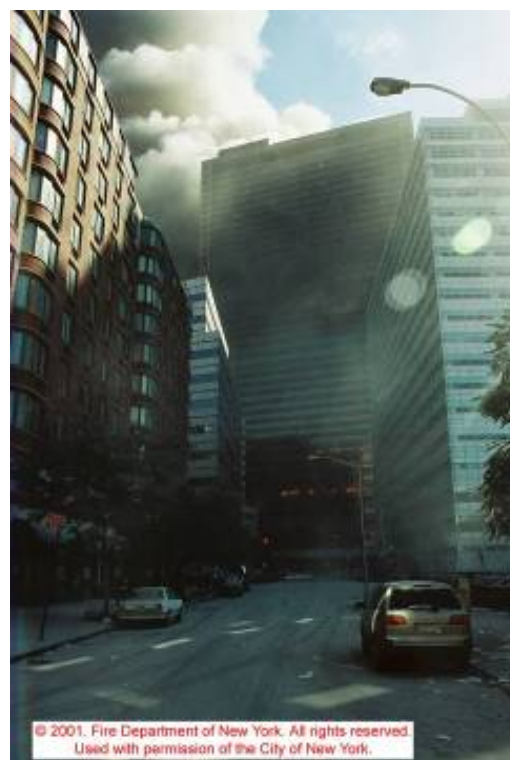
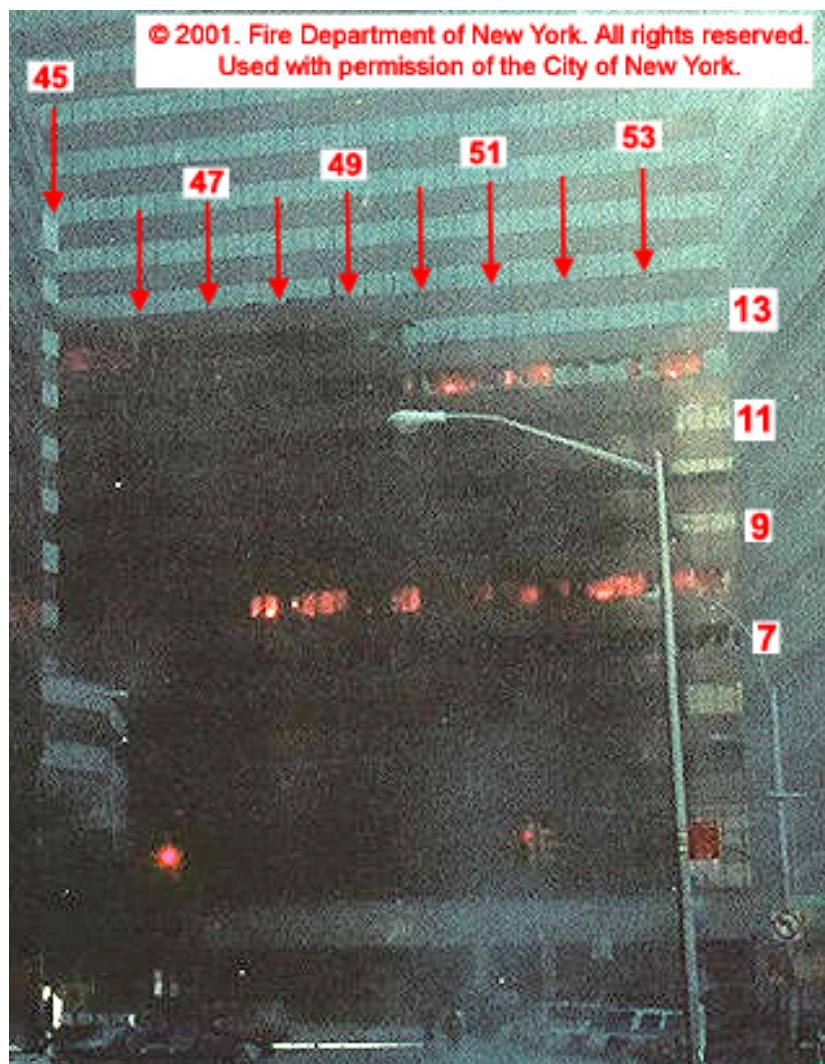
Flames are also visible through open windows on the 12<sup>th</sup> floor. At around 3:14 p.m., fires on this floor were observed as far west as window 12-48D, and the distribution was little changed roughly 5 min later. In Figure 5–130, fire had spread at least as far west as window 12-53C during the roughly 20 min between close up images. At the later time, flames are only visible as far east as window 12-48D, indicating that the fires visible earlier had mostly died down. The flames visible on the 12<sup>th</sup> floor around

3:41 p.m. seem to fill the open windows, suggesting flashover conditions, but several windows still appear to have glass in place. This may be an indication that the fire on the north face is not spreading systematically to the west, but at times jumped over adjacent offices which then ignited somewhat later.

**Figure 5-129.** Photograph showing the north face of WTC 7 shot looking down Greenwich Street from near the corner of Greenwich and Warren Streets at around 3:41 p.m.

**Figure 5–130. View of the north face of WTC 7 taken around 3:41 p.m. ± 3 min, enlarged from Figure 5–129. The intensities have been adjusted, and column and floor numbers have been added.**

While difficult to discern in Figure 5–130, a number of windows are open on the 7<sup>th</sup> floor. Most, if not all, of the windows between window 7-47A and 7-53D are open. There is no indication of fire on the floor in this photograph. Apparently, fire present in this area around 3:13 p.m. had stopped spreading and had died down by 3:41 p.m.

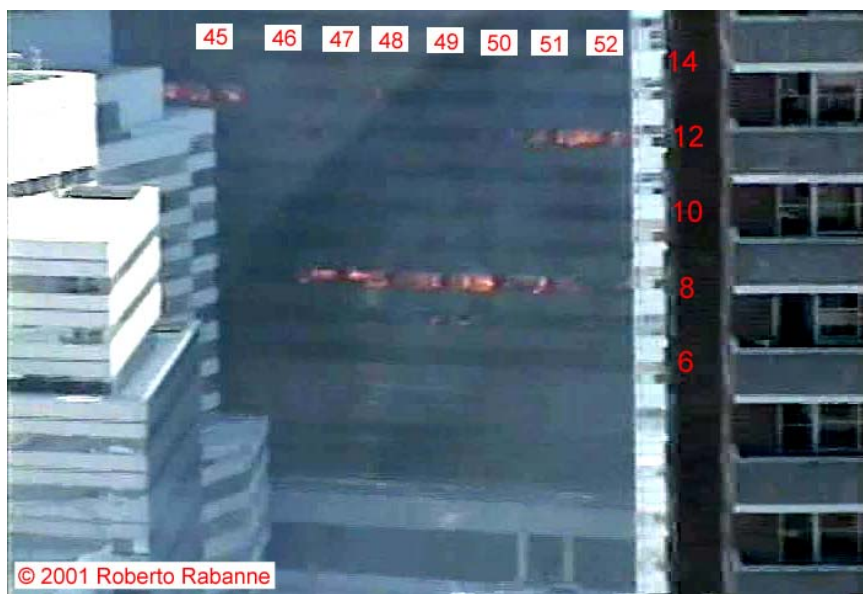
Figure 5–131 shows a view of the central region of the north face taken from the video shot from a building to the northwest of the site looking down Greenwich Street at a time estimated as 3:50:13 p.m. with an uncertainty of ± 3 min. During the approximate 7 min 45 s period between the time when Figure 5–128 and Figure 5–131 were taken, the fire on the 8<sup>th</sup> floor had spread towards the east and was burning vigorously between columns 46 and 47 at the later time. Windows on this floor around column

**Figure 5–131.** This frame from a video shot from a building to the northwest of WTC 7 was taken around 3:50:13 p.m. with an uncertainty of  $\pm 3$  min. The intensities have been adjusted and column and floor numbers added.

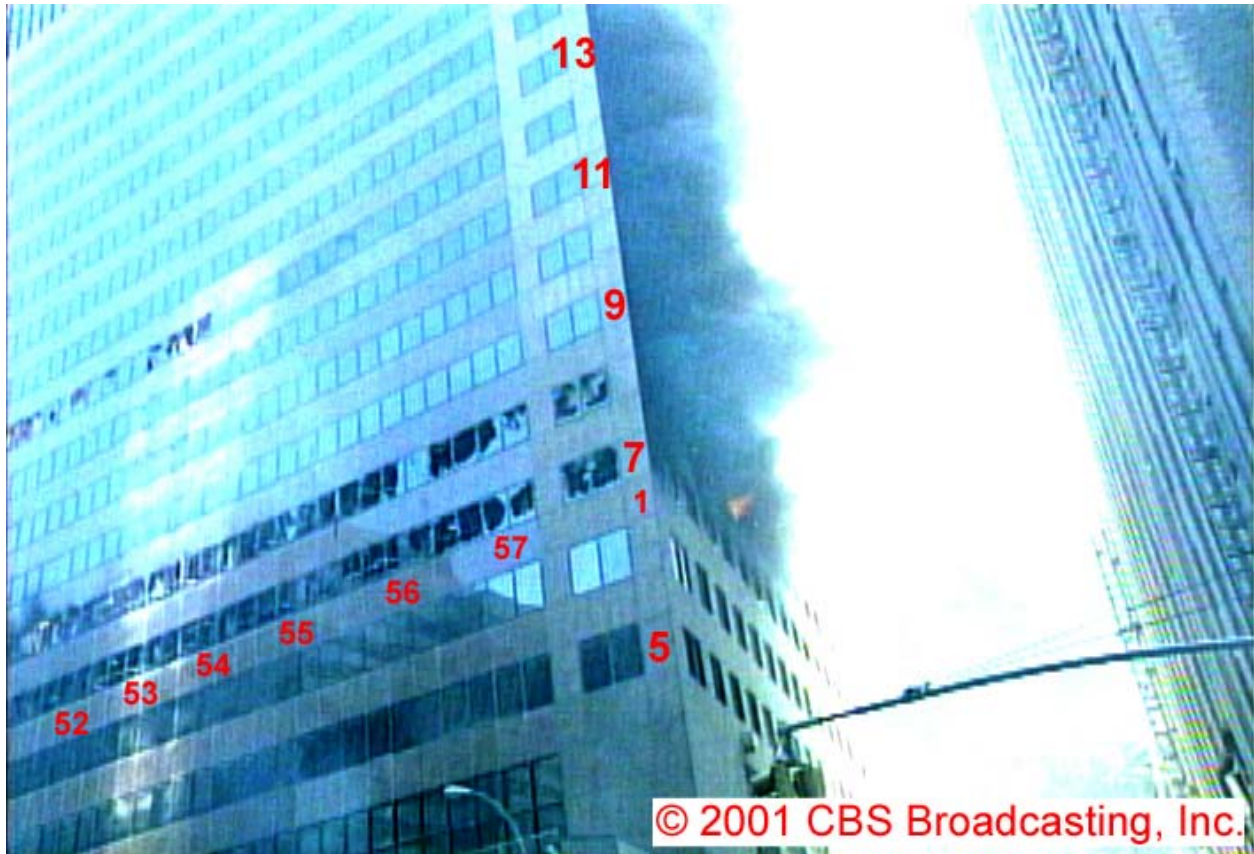
**Figure 5–132. View of the northwest corner of WTC 7 from a video recorded from inside the lobby of 123 Barclay Street around 3:42 p.m. ± 5 min.**

The intensities have been adjusted, and column and floor numbers have been added.

On the north face, every window on the 7<sup>th</sup> and 8<sup>th</sup> floors to the west of column 51, with the exception of window 8-56A, was open at the time Figure 5–132 was taken. This is the first visual evidence that fires had burned on these floors between column 54 and the west edge of the face. The only locations where flames can be seen are near column 51 on the 8<sup>th</sup> floor. Other clips shot around the same time show fire in windows 8-57B and 8-57C. In Figure 5–130, intense burning was present between columns 51 and 54. The fact that these fires had died down by the time of the later video clip indicates that many minutes separate the images in Figure 5–130 and Figure 5–132. This is consistent with the assigned times.

Even though the open windows on the north sides of the 7<sup>th</sup> and 8<sup>th</sup> floors visible in Figure 5–132 were clearly subjected to high temperatures, little blackening of the building façade above the windows is evident. The only substantial blackening was near column 51 on the 8<sup>th</sup> floor. As observed at other

Closer inspection of Figure 5–132 reveals that while the glass in window 12-55C was still in place, it had apparently cracked. This is an early indication that fire was nearby. Another video clip taken from the same location a short while later shows that windows 12-55B and 12-55C had opened and flames filled both windows. After a brief lull, the fires burning on the north side of the 12<sup>th</sup> floor continued their spread to the west. As noted earlier, the fires on this floor seemed to occasionally skip some closed windows and appear further west. This suggests that instead of spreading continuously along the north edge, the fires were penetrating a series of offices and then growing to the point where windows were broken. Each of these office fires was apparently somewhat independent, which is consistent with the floor plan shown in Chapter 3.

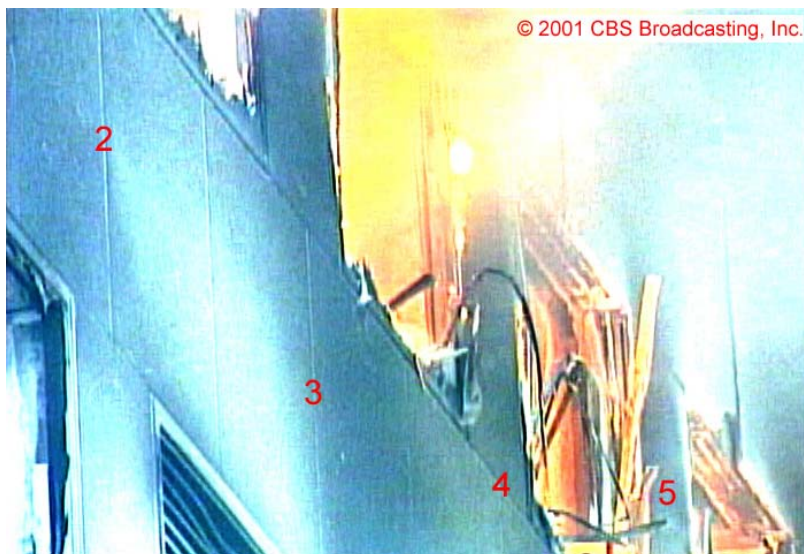
**Figure 5–133. View of the west face of WTC 7 taken from a video recorded from inside the lobby of 123 Barclay Street around 3:41:30 ± 5 min.**

The intensities have been adjusted, and column locations are indicated.

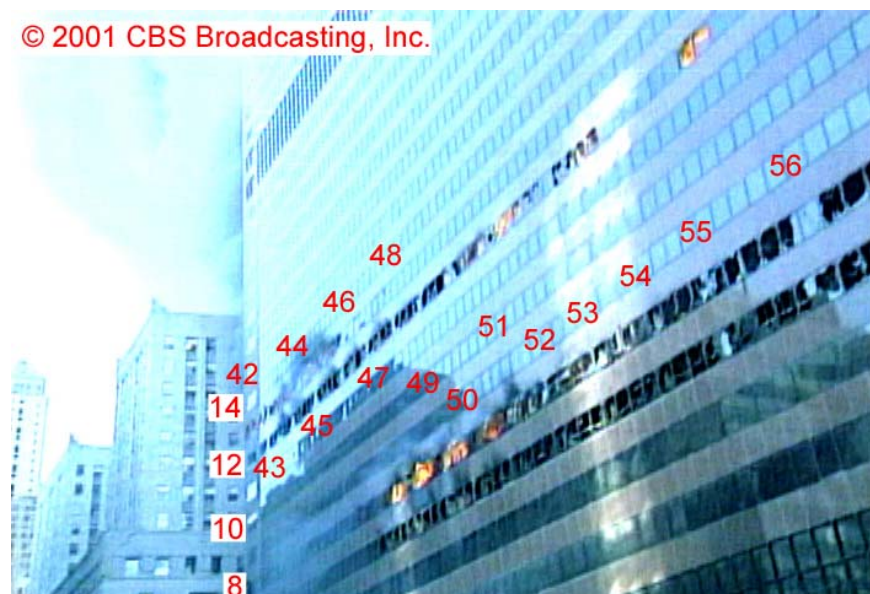
Figure 5–132 and Figure 5–134 together show that every window on the 7<sup>th</sup> floor between column 47 and the western edge of the north face was broken out at this time. No flames are visible on this floor in either image. As shown by Figure 5–127, fire had spread as far east as window 7-47A as early as 3:13 p.m. No further eastward fire spread was observed over the following 45 min, and the fires appear to have died down.

On the 8<sup>th</sup> floor, heavy flames are visible between columns 47 and 51 in Figure 5–134. Comparison with Figure 5–130, which was taken somewhere between 2 min to 10 min earlier, indicates that the flaming area had not moved further east during the intervening time, but that substantial fires, present earlier between columns 51 and 54, had died down. Several windows that earlier had glass in place between columns 49 and 51 were open at the later time. Even though no fire is evident to the east of column 47 in Figure 5–134, there are indications that window glass in several windows to the east of this point had

begun to break. Despite the heavy fire on this floor, only light white smoke was coming from the open windows.

**Figure 5–134. View of the north face of WTC 7 taken from a video recorded from inside the lobby of 123 Barclay Street at 3:44 p.m. ± 4 min.**

The intensities have been adjusted, and floor and column numbers have been added.

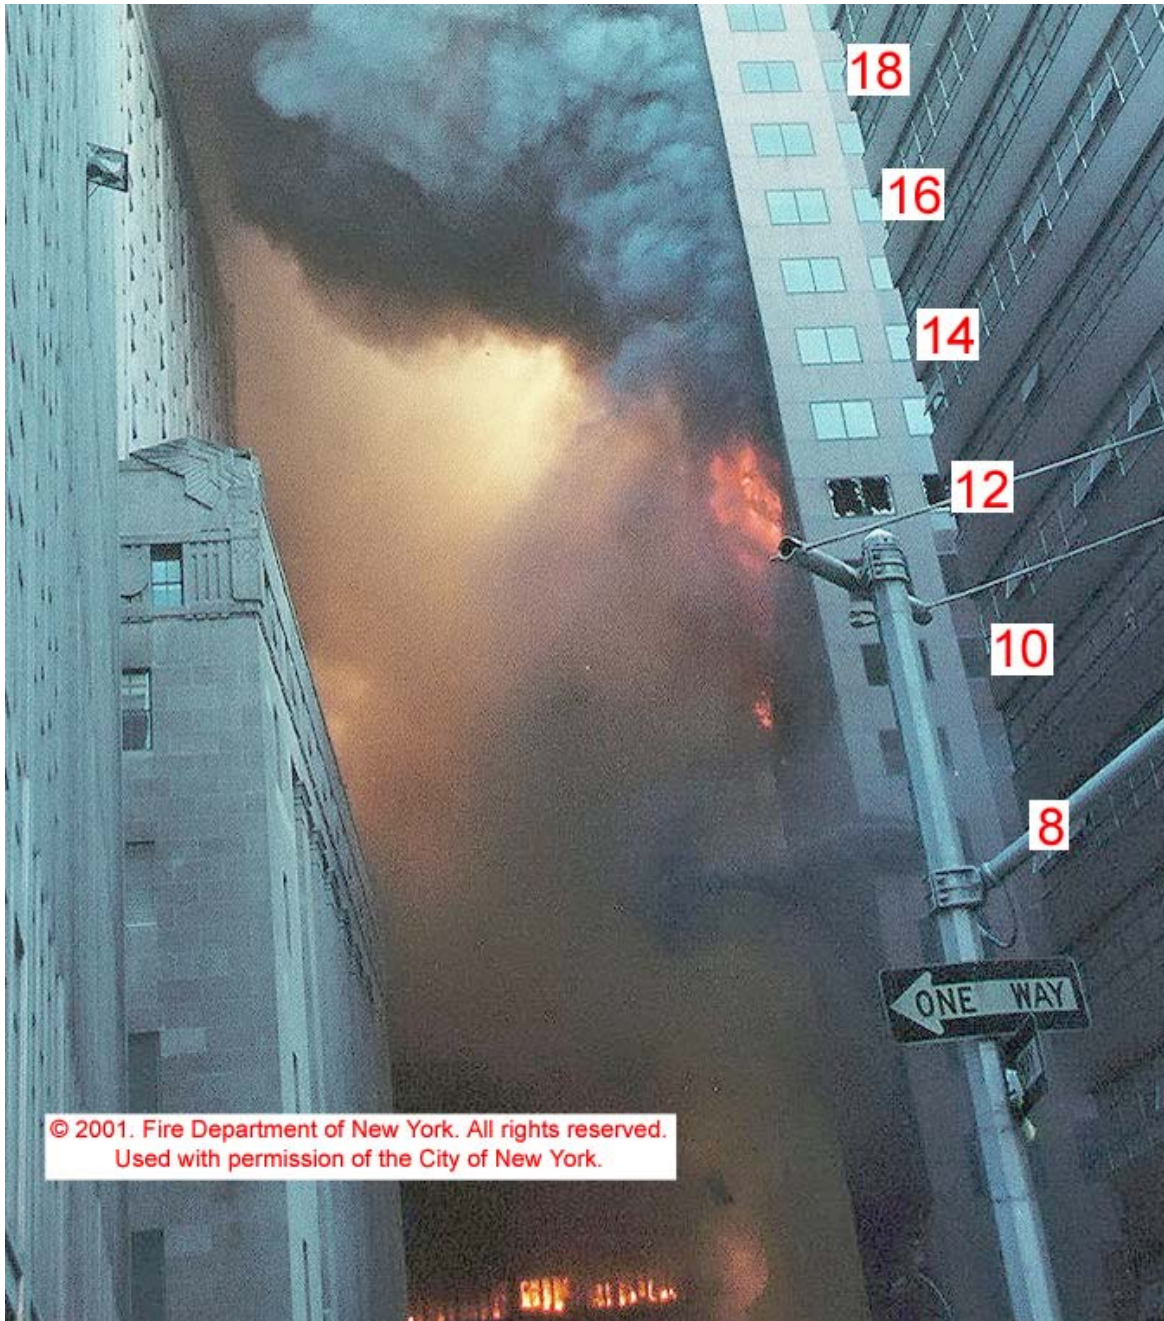
It is difficult to identify how fire moved onto the north side of the 13<sup>th</sup> floor from Figure 5–130 and Figure 5–134. A photograph (Figure 5–135) taken at an unknown earlier time, estimated as between 3:20 p.m. and 3:40 p.m., provides an important clue. This image, shot from near the corner of West Broadway and Park Place, shows an oblique view of the east face. Intense flames appear to be coming from windows 13-39 to 13-41 on the 13<sup>th</sup> floor. A much smaller flame can be seen in window 13-41A. Despite the steep viewing angle, there seems to be a line of flames extending across most of the east face on the 13<sup>th</sup> floor. Heavy smoke is rising from these fires. There also appears to be lighter smoke lower down on the east face, but it is not possible to identify its source.

Windows at the east edge of the north face are also visible in Figure 5–135. Windows 13-42A to 13-42C still have glass in place on the 13<sup>th</sup> floor, which means that this image was taken prior to Figure 5–134. The heavy smoke pouring from open window 8-42A on the 8<sup>th</sup> floor indicates that a significant fire was burning on this floor at this time, even though it is clear from Figure 5–134 that nearby windows still have intact glass. Windows 12-42A to 12-42C are open on the 12<sup>th</sup> floor with no sign of flames nearby, indicating that this photograph was taken well after the aerial view in Figure 5–123, which was taken around 3:10 p.m. and shows heavy flames in these corner windows.

**Figure 5–135. Cropped photograph showing the east edge of the north face and an oblique view of the east face of WTC 7, taken from near the corner of West Broadway and Park Place.**

It was likely taken between 3:20 p.m. and 3:40 p.m. The buildings burning in the background are WTC 5 (left) and WTC 6 (right), and the U.S. Post Office is on the left. Floor numbers have been added and intensity levels have been adjusted.

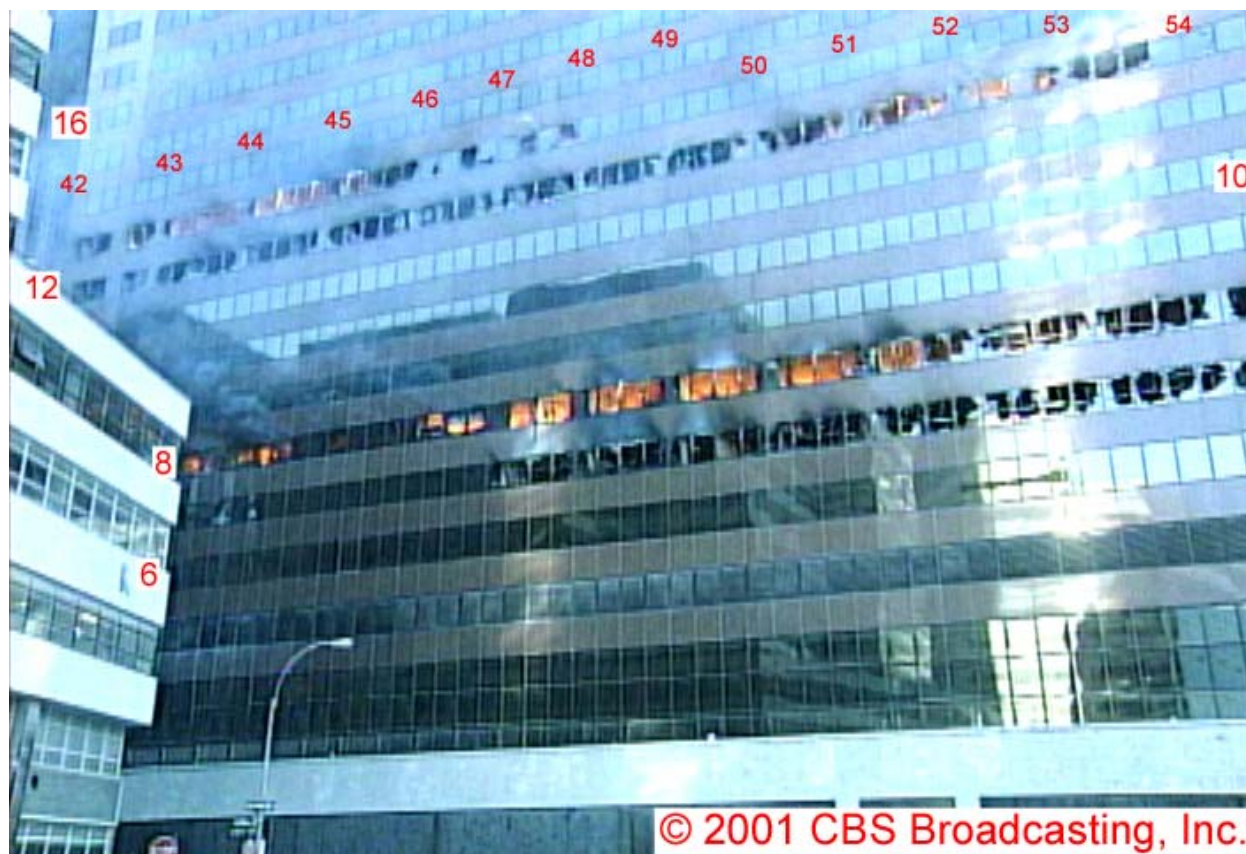
**Figure 5–136. Frame taken from a video shot from near the corner of Greenwich Street and Park Place showing the north face of WTC 7 between 3:49 p.m. and 3:54 p.m.**  
The building on the left is 30 West Broadway. The intensities have been adjusted, and column and floor numbers have been added.

Figure 5–136 also provides good views of the 12<sup>th</sup> and 13<sup>th</sup> floors. On the 12<sup>th</sup> floor, every window glass pane between the east edge and window 12-52C is broken. It is easy to identify the column locations due to the intact glass in place in front of the columns. Flames are visible through the open windows from window 12-49D to window 12-52 D. Comparison with Figure 5–134 shows that the fire between columns 52 and 53 had grown substantially. Additional glass has broken in windows 12-51D to 12-52B, and the flames are much brighter. Window 12-52C still has glass in place. Even though fire had spread earlier to a location between columns 55 and 56, there is no indication of a fire in windows 12-53D to 12-54C.

Figure 5–136 provides a better view of conditions on the east side of the 13<sup>th</sup> floor than is available in Figure 5–134. All of the window panes between the east edge and column 46 have been broken. Several windows between columns 46 and 48 are also open. Comparison with Figure 5–134 shows that much of the breakage between columns 46 and 48 occurred during the approximately 5 min period between the two frames. An active area of fire is visible extending from window 13-43A to 13-45B. The fires to the immediate west seem to have already died down, as have those between columns 42 and 43 at the east edge. The observations suggest that the fires on the north face of the 13<sup>th</sup> floor are burning similarly to

those on the 12<sup>th</sup> floor, i.e., by spreading somewhat erratically through the rooms located along the face. (See Chapter 3.)

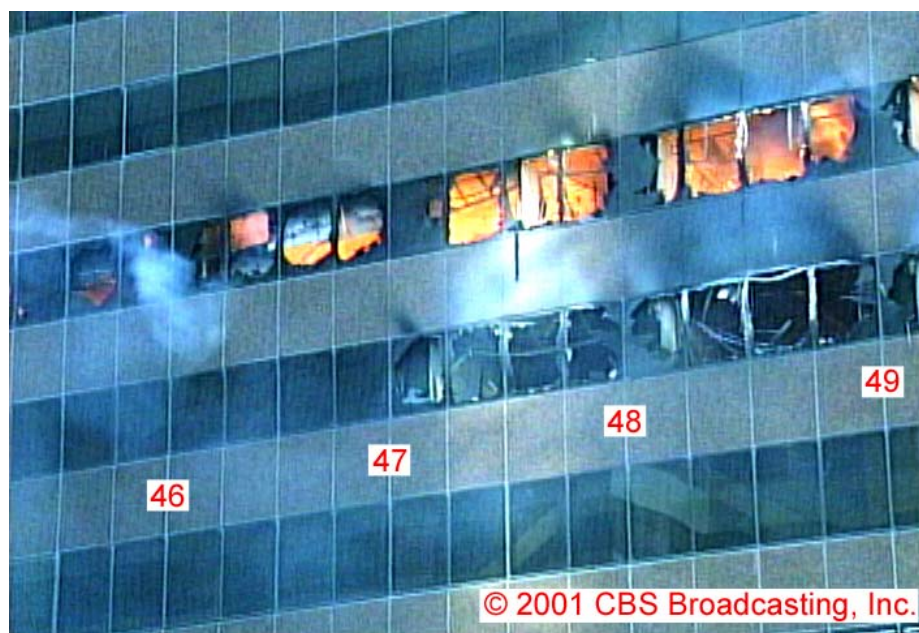
A closer view of the 7<sup>th</sup> and 8<sup>th</sup> floors, taken from a video clip recorded shortly after the one from which Figure 5–136 was taken, is shown in Figure 5–137. The frame includes the location on the 7<sup>th</sup> floor where fire spread had stopped. There appears to be a wall visible through windows 7-47A and 7-47B that terminates at column 47. If this wall extended far enough inward, it might have stopped the fire as it spread eastward across the north face. The glow through the open windows on the 8<sup>th</sup> floor reveals the presence of a substantial fire within this area. However, the only actual flames that could be seen were in window 8-48D. Either the flames responsible for the glow were hidden below the window sill or were located further inside the building. It does not appear that the upper portion of the interior space near the windows was filled with flame. It is thus not possible to identify whether this fire was flashed over.

**Figure 5–137. Close up of the 6<sup>th</sup> through 9<sup>th</sup> floors of the north face of WTC 7 from a video shot between 3:49:30 p.m. and 3:54:30 p.m. near the corner of Greenwich Street and Park Place.**

The image intensities have been adjusted, and column locations are indicated.

Some light smoke is visible coming from open windows on the 8<sup>th</sup> floor in Figure 5–137, but it is not as dense as would be expected for the amount of fire present. Light blackening of the façade above windows on the 7<sup>th</sup> and 8<sup>th</sup> floors suggests that only light smoke had come from the area earlier. Support for the hypothesis that smoke was being vented elsewhere comes from Figure 5–138. Smoke is visible rising upward in windows 8-47B and 8-47D, while flames are visible in 8-47B. Even though this internal smoke is easily seen, the only smoke flowing from the nearby open windows is coming from small flames

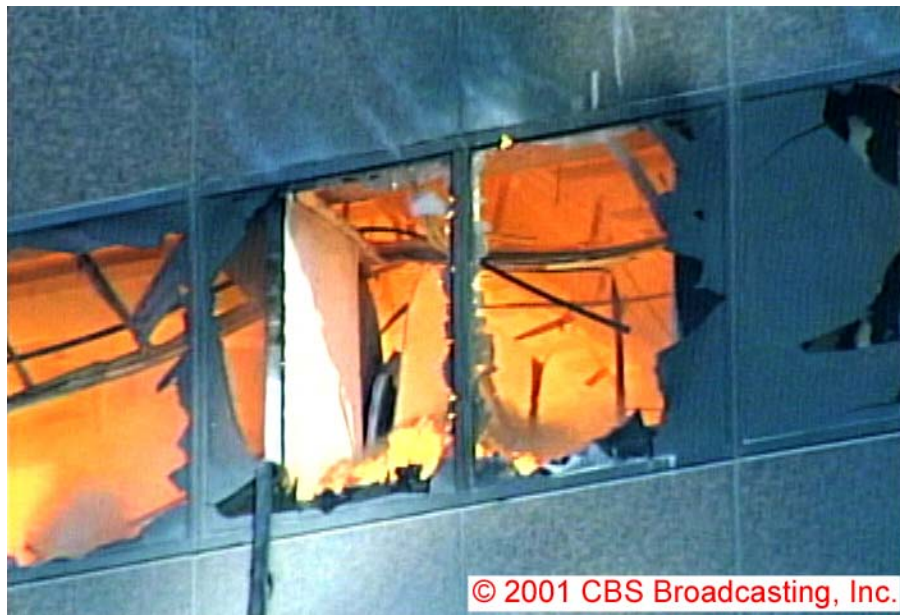
**Figure 5–138. Frame taken from a video shot from near the corner of Greenwich Street and Park Place showing windows 8-47B to 8-48A between 3:49 p.m. and 3:54 p.m. The intensities have been adjusted.**

Additional details concerning the local effects of the fires can be seen in Figure 5–138. For instance, the distorted frame that had held the drop ceiling for the area is still in place above the windows. The ceiling tiles have been dislodged. Further inside, it is possible to see the floor slab for the 9<sup>th</sup> floor. There appears to be a wall partition visible through window 8-47C. It seems to terminate at the drop ceiling. For this reason, it would have been unlikely to have been an effective fire barrier.

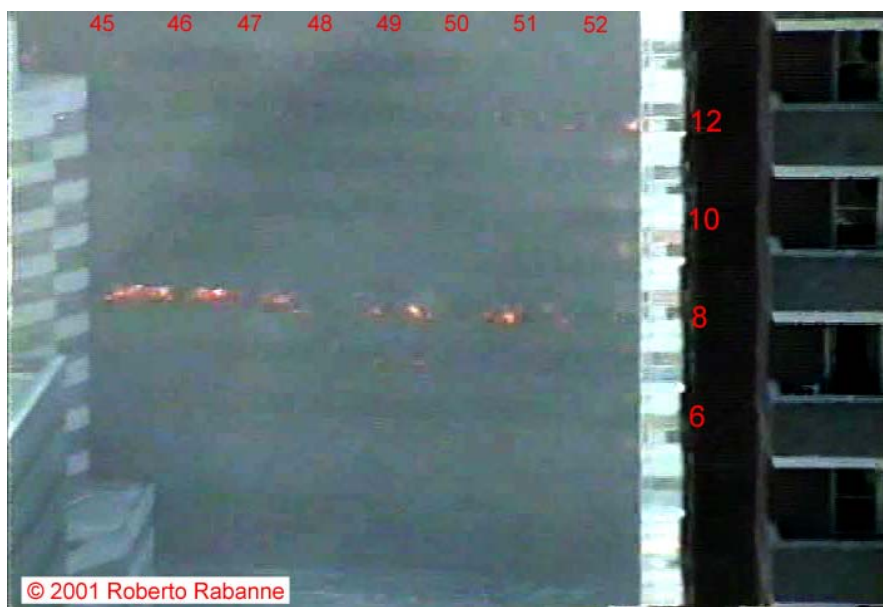
Figure 5–139 shows another view of the WTC 7 north face looking down Greenwich Street from a building to the northwest of WTC 7. The time for this video frame is estimated as 3:54:14 p.m. with an uncertainty of 3.5 min. Comparison with Figure 5–131 indicates that the fire on the 8<sup>th</sup> floor has moved to the east in the roughly 4 minutes between the two video frames, with an intense fire now visible in windows 8-45a to 8-45e. Note that the time assignment for Figure 5–139 is consistent with the times assigned for Figure 5–136 to Figure 5–138 since window glass was still in place in these windows when those video clips were recorded.

**Figure 5–139.** This frame from a video shot from a building to the northwest of WTC 7 was taken around 3:54:14 p.m. with an uncertainty of  $\pm 3.5$  min. The intensities have been adjusted and column and floor numbers added.

The intensity of the fires on the 8<sup>th</sup> floor between columns 48 and 50 decreased markedly during the same period. Similar decreases in fire intensity are evident on the 12<sup>th</sup> floor between columns 51 and 52 and on the 13<sup>th</sup> floor between columns 44 and 46.

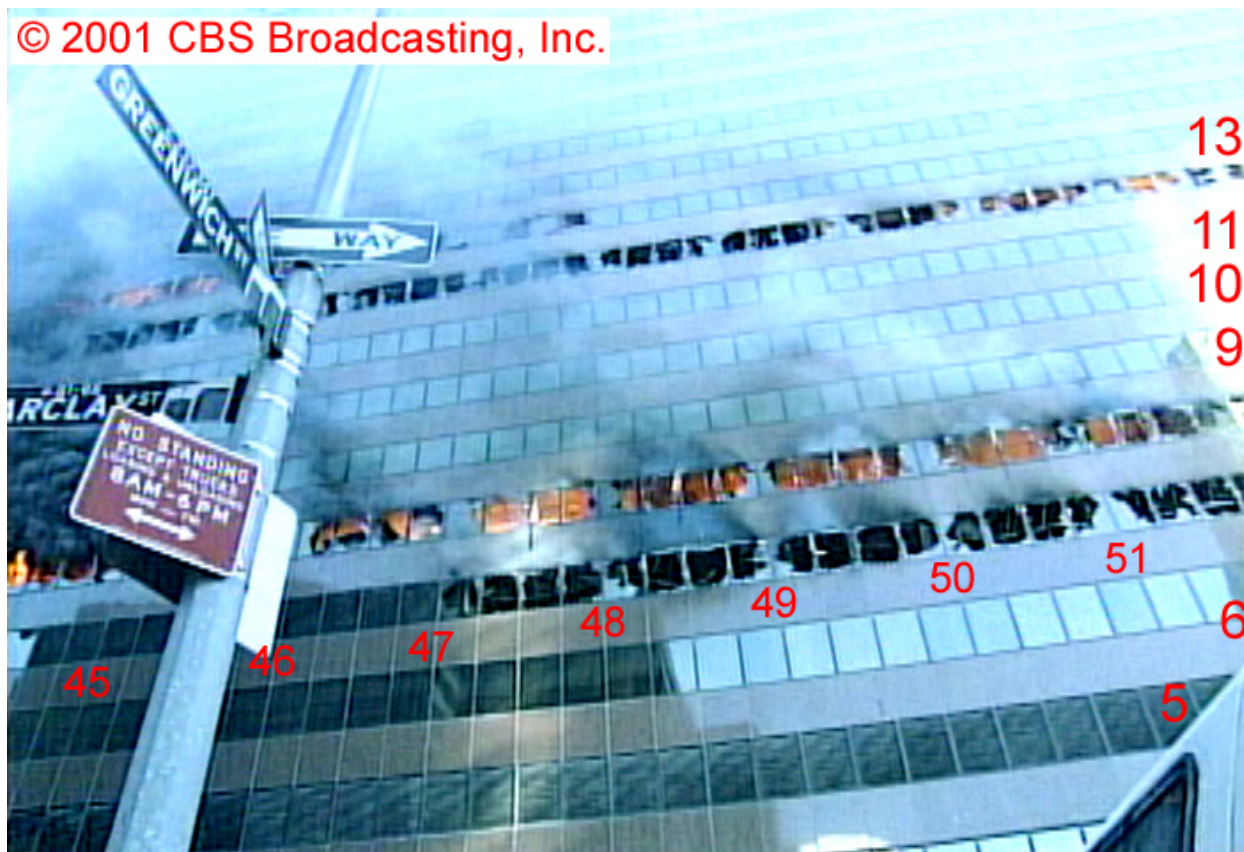
The appearances of the open windows and fires on the face are similar in Figure 5–136 and Figure 5–140, with one major exception. In the later frame, extremely heavy flames and dense smoke are coming from windows 8-44B to 8-44E. This is the first observation of large amounts of effluent flowing from fires on the north side of the 8<sup>th</sup> floor and suggests that an internal flow pathway to the east or south faces from these windows was available. This intense fire had grown rapidly, since in the earlier clip only relatively small fires were evident through windows 8-44B and 8-44D, and the glass for window 8-44E, along with window 8-45A, was still in place. Unfortunately, the view of windows 8-45A to 8-45E is blocked by a

street sign. Determining whether or not these windows were open at this time would have allowed the time uncertainty for this clip to be reduced somewhat.

**Figure 5–140. Frame taken from a video shot from near the corner of Greenwich and Barclay Streets showing the north face of WTC 7 between 3:51 p.m. and 3:58 p.m.**  
The intensities have been adjusted, and column and floor numbers have been added.

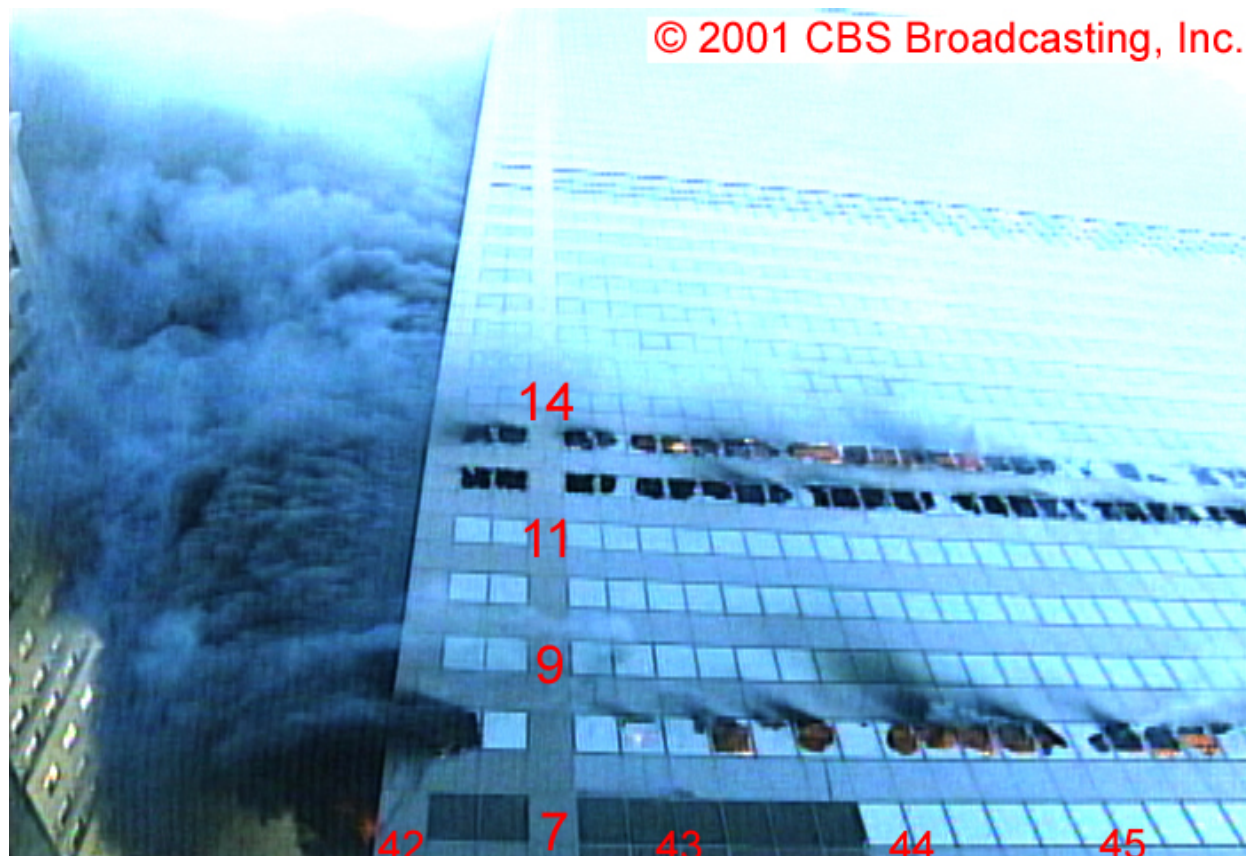
**Figure 5–141. Frame from a video shot from near the corner of West Broadway and Barclay Street showing the eastern side of the north face of WTC 7 between 3:53 p.m. and 4:02 p.m.**

The fire spreading to the east on the 8<sup>th</sup> floor had apparently reached the east face by the time Figure 5–141 was recorded. Multiple window panes are broken, heavy fire is visible between columns 43 and 44, and window 8-42D is open at the top with flames visible through the remaining glass. A small flame has also appeared on the east face, indicating windows were beginning to break on this side of the 8<sup>th</sup> floor. Within a few seconds this small flame grew much more intense.

Flames are also visible on the 13<sup>th</sup> floor in Figure 5–141. Review of the video clips indicated that flames were periodically observed from window 13-42C to window 13-45C. Only light smoke is coming from the open windows on the north side of this floor. As observed earlier, there is no indication of fires burning on the east side of the 12<sup>th</sup> floor at this time. Elsewhere, window glass on the east side of the north face on the 7<sup>th</sup> floor, 9<sup>th</sup> through 11<sup>th</sup> floors, and above the 13<sup>th</sup> floor is intact.

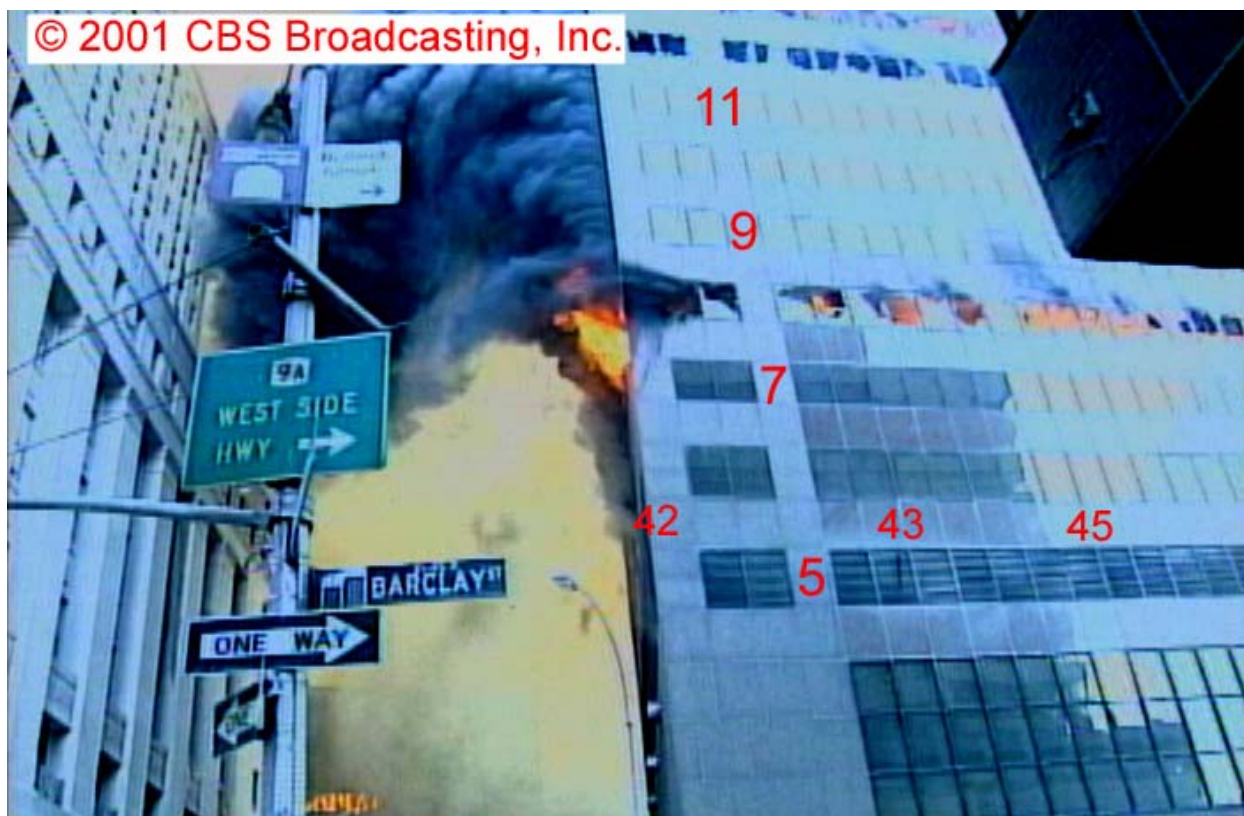
Another frame from a video clip recorded roughly 2 min later showing the lower northeast corner of WTC 7 is reproduced in Figure 5–142. The changes on the north side of the 8<sup>th</sup> floor were substantial over this short period. Additional windows have opened near the eastern edge, and the fires have grown substantially in intensity. While not readily apparent in Figure 5–142, flames were visible in window 8-42A during the short video clip.

**Figure 5–142. Frame taken from a video shot near the corner of West Broadway and Barclay Street showing the lower northeast corner of WTC 7 between 3:55 p.m. and 4:04 p.m.**

Some of the more interesting observations from Figure 5–142 are on the east face. Very intense flames were coming from multiple windows on the 8<sup>th</sup> floor at this time. A close-up of these flames, taken from a video clip recorded about a minute later is shown in Figure 5–143. Note that additional glass has broken out of window 8-42C during the short period between the two frames. Comparison of the flames near the northeast corner on the north and east faces provides a vivid demonstration of the different burning behaviors on these two faces. On the north face, the flames are mostly inside the windows, which was generally true for fires observed on this face, while very intense external burning, similar to that observed on the east side of the 12<sup>th</sup> floor much earlier, is taking place on the east face. These observations provide additional evidence that pressure differences generated by the ambient wind affected the local fire behaviors observed on different faces.

Closer inspection of Figure 5–142 reveals what appears to be a relatively light plume of white smoke rising from near the top of the louvers that spanned the 5<sup>th</sup> and 6<sup>th</sup> floors on the east face. It was not possible to identify the exact location of the plume relative to the edge of the building. At a minimum, the presence of this plume suggests that smoke had been transported to the 5<sup>th</sup> or 6<sup>th</sup> floors before being vented. It is also possible that the source of the smoke was a fire burning somewhere on these two floors. The available imagery does not provide evidence indicating which of these two alternatives is correct.

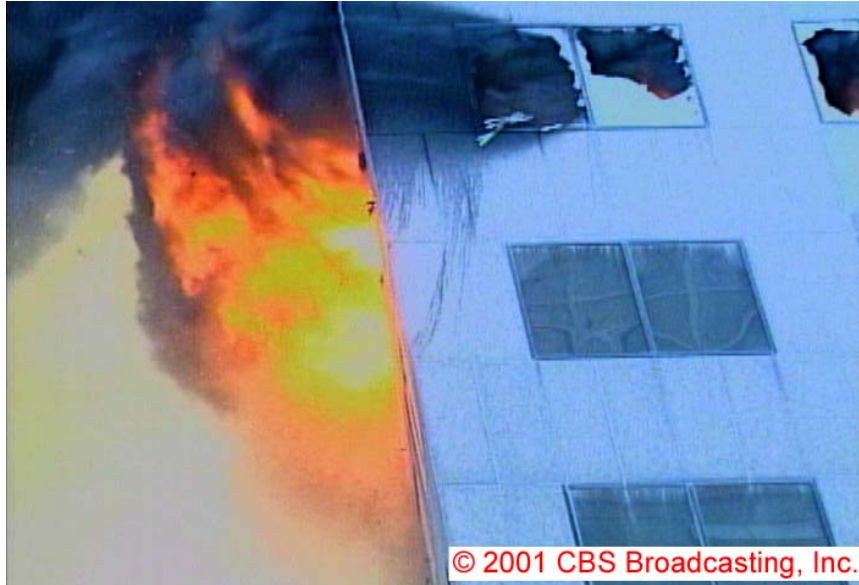
**Figure 5-143. Frame from a video shot near the corner of West Broadway and Barclay Street showing a close up of the northeast corner of WTC 7 at the 8<sup>th</sup> floor between 3:56 p.m. and 4:05 p.m.**

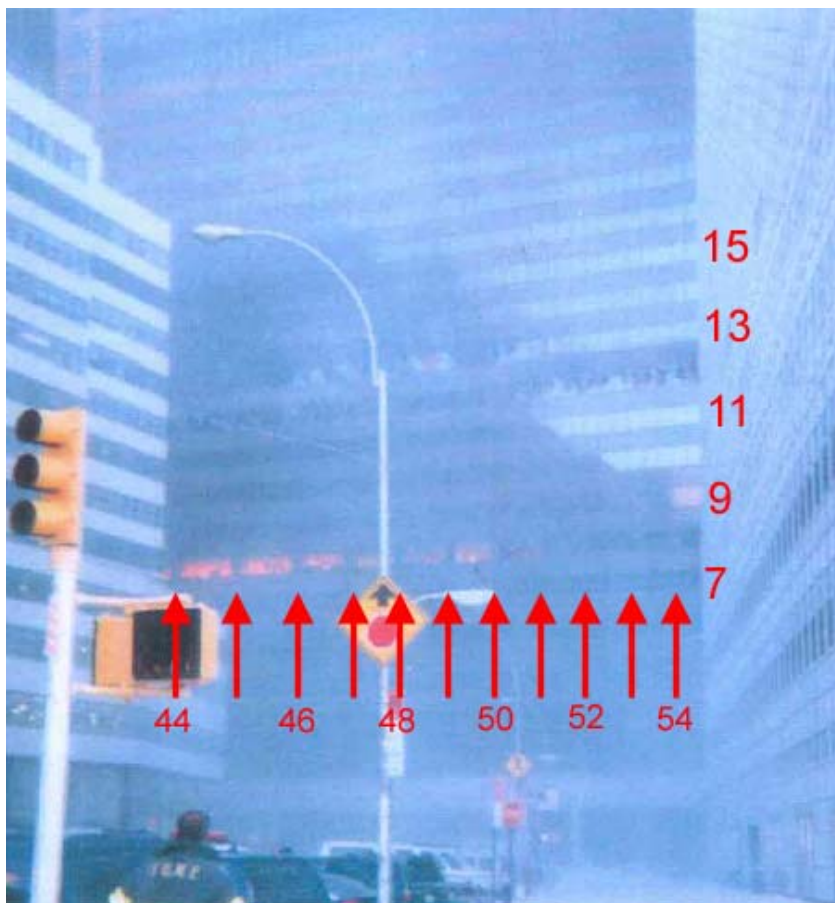
**Figure 5-144. Cropped photograph showing the north face of WTC 7, shot from near the corner of Murray and Greenwich Streets near 3:55 p.m.**

On the 12<sup>th</sup> floor, windows 12-53D, 12-54A, and 12-54B were opened between the times when Figure 5-136 and Figure 5-144 were taken. Recall that at the earlier time, flames had been observed further to the west. Apparently, the burning was filling in offices that the fire had previously bypassed. Only light burning is apparent in the immediate vicinity. On the 13<sup>th</sup> floor, windows appear to be open as far west as column 50 in Figure 5-144, with flames visible to the west of column 48. In Figure 5-136, the open windows only extended as far west as column 48. Clearly, the fire on this floor was continuing to spread to the west.

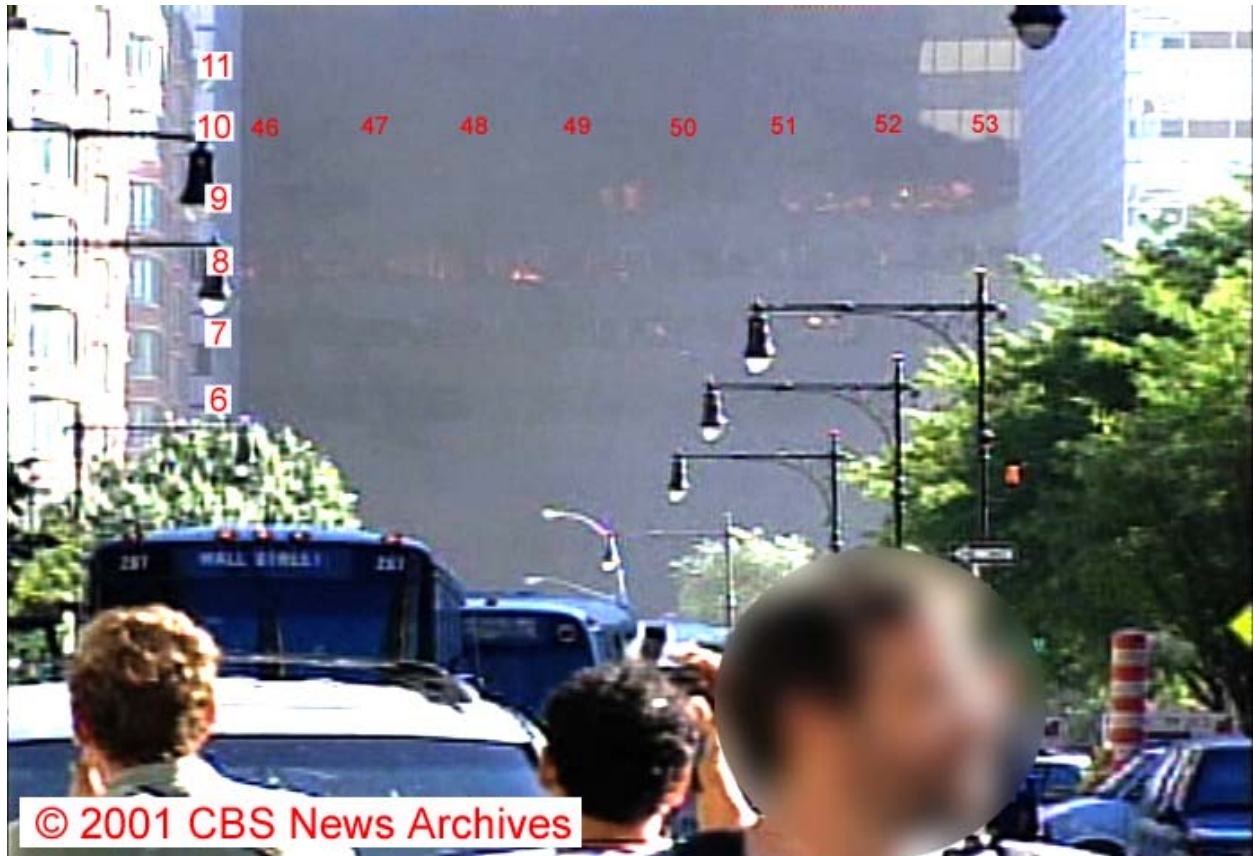
A frame from a video clip taken from a location much further up Greenwich Street than the view in Figure 5-144 is reproduced in Figure 5-145. The fire distribution indicates the clip was taken later than the photograph in Figure 5-144. Relatively low intensity flames are visible on the 8<sup>th</sup> floor from window 8-45E to window 8-49B. In Figure 5-144, the flames were in general more intense and extended to window 8-50D. Since fully developed fires typically burn intensely for about 20 min, it is likely that the time between the two images was less than 20 min. Assuming a 15 min difference yields an estimated time of 4:10 p.m. with at least a 5 min uncertainty.

The most dramatic change in the fire distributions between the two images is on the 9<sup>th</sup> floor. In the earlier image, there was evidence of a fire growing in windows 9-54A and 9-54B. In the later image, flames and heavy smoke are visible between windows 9-51A and 9-53B. In the video clip and others recorded around the same time, it can be seen that significant external burning was taking place. Such burning was not typical of most locations on the north face. This observation not only suggests that the fire had flashed over at this location, but also that there was no internal path available within WTC 7 for the fire effluent to vent on the east or south face. In Figure 5-145, isolated flames have reached as far east as windows 9-49B and 9-49C, indicating that the fire was spreading from west to east.

Small isolated flames are evident at several locations on the 7<sup>th</sup> floor in Figure 5-145. This is somewhat surprising since the fires on this floor had stopped spreading and died down much earlier. There is still no indications that a fire has spread to the east beyond column 47. No fires or broken windows are apparent on the 6<sup>th</sup>, 10<sup>th</sup>, and 11<sup>th</sup> floors.

**Figure 5–145. Frame taken from a video clip shot from near the corner of Greenwich and Jay Streets around 4:10 p.m. ± 5 min.**

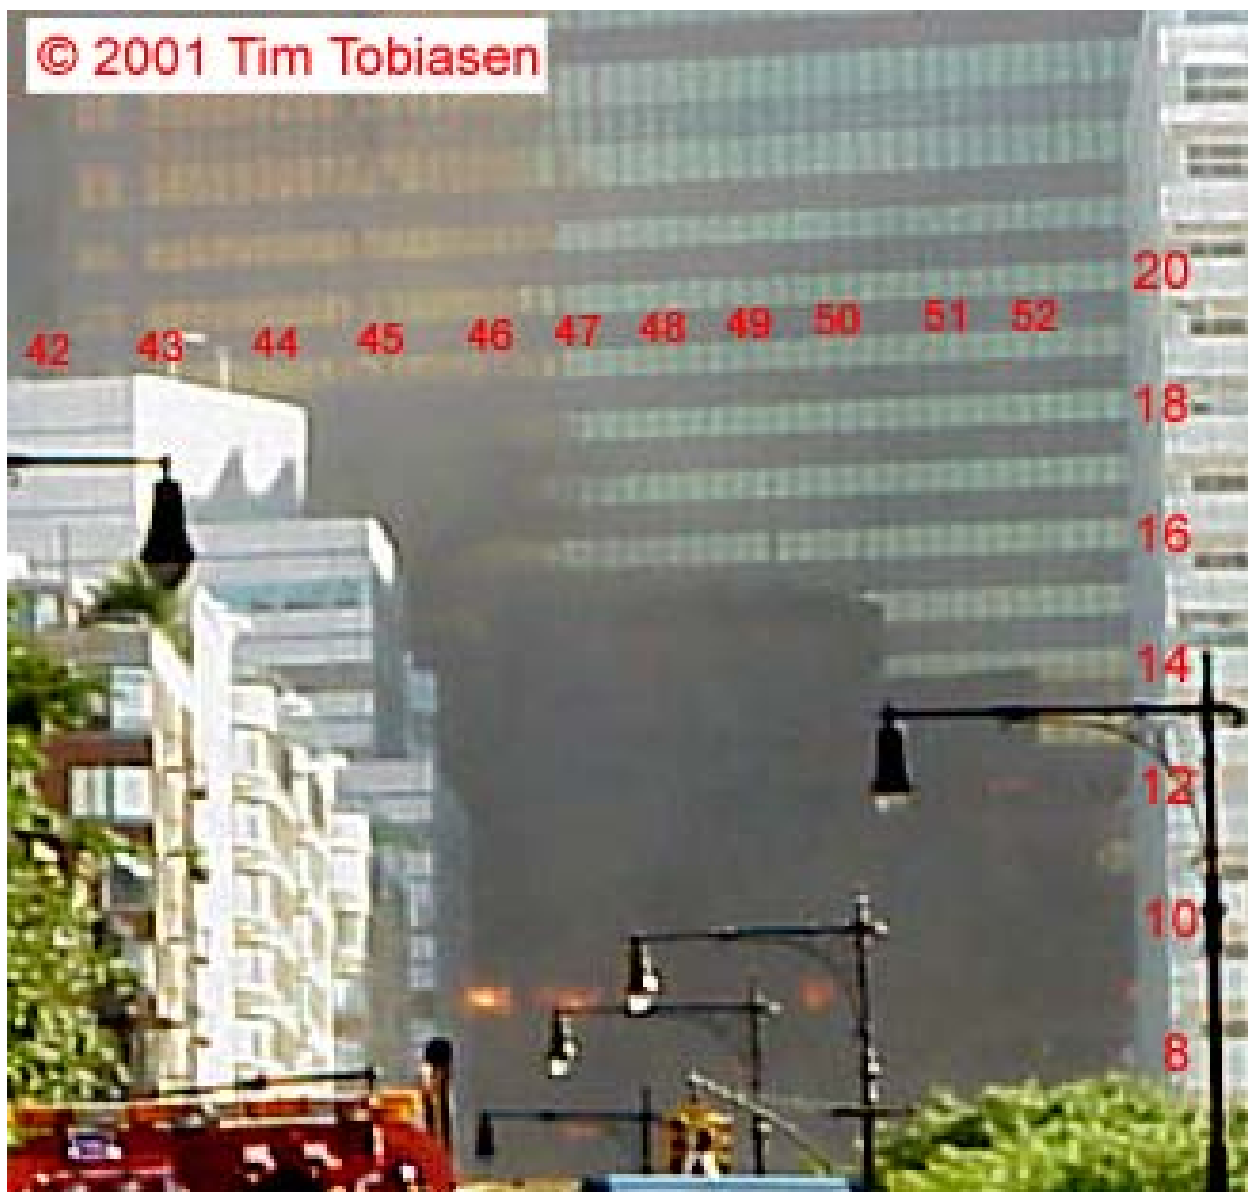
The north face of WTC 7 can be seen in the photograph reproduced in Figure 5-146. The time for this image could not be accurately determined, but it was clearly taken after the photograph shown in Figure 5-145. Even though the photograph was taken from a long distance, it provides useful information about the fire distributions. The most intense fires are on the 9<sup>th</sup> floor. Flames can be seen on this floor at both ends of the visible length running from window 9-45C to 9-52D. Continuous flames are present between columns 45 and 50. Apparently, the fire observed between columns 49 and 50 in Figure 5-145 grew and spread rapidly to the east. Interestingly, there is still no sign of fire between columns 50 and 51. This may be an indication that there was a room in that location that had not yet been breached by the fire. As seen earlier, heavy smoke is rising from the fire on this floor.

Low intensity flames continue to burn on the 8<sup>th</sup> floor between columns 47 and 49. Similar flames are also visible on the 12<sup>th</sup> floor between columns 51 and 52. In Figure 5–145 it appeared that some of the glass was still in place for some of these windows. This seems to be no longer the case in Figure 5–146.

Close inspection of Figure 5–146 reveals that there is an area of flame on the 7<sup>th</sup> floor between columns 46 and 47. After a long period of inactivity, fire has clearly made its way to the other side of the obstacle that had earlier halted its spread across the face. Note that there is no indication of how fire arrived at this location. It could have spread from the west, south, or east.

**Figure 5–146. Cropped photograph showing the north face of WTC 7 from near the corner of Greenwich and Harrison Streets at a roughly estimated time of 4:15 p.m. The intensities have been adjusted, and column and floor numbers have been added.**
