**Federal Building and Fire Safety Investigation of the  
World Trade Center Disaster**

**Structural Fire Response and  
Probable Collapse Sequence of  
World Trade Center Building 7**

**NIST NCSTAR 1-9**

August, 2008

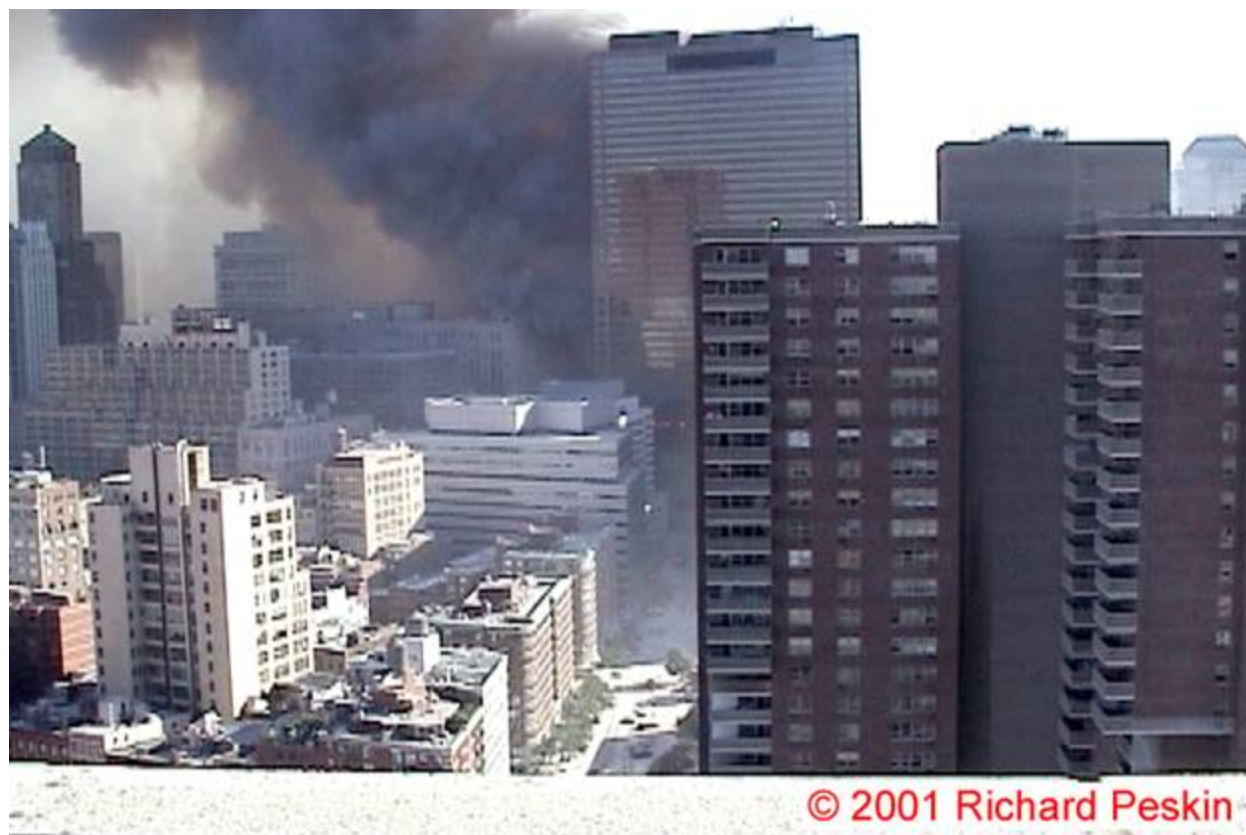
Figure 5–147 provides a view of the north face of WTC 7. The image is a frame taken from a digital video that was accurately timed. This frame was recorded just before 4:38 p.m. Even from the long distance from which the video was filmed, it is possible to see a heavy fire burning on one of the floors. Little or no smoke is evident on the north face, but dense black smoke is rising from the east face. This appears to be another example of fires burning on the north face exhausting through openings on a different face of the building.

**Figure 5-147. Frame from a video clip shot from the top of a nearby building, providing a view of the north face of WTC 7 at 4:37:46 p.m. ± 1 s.**

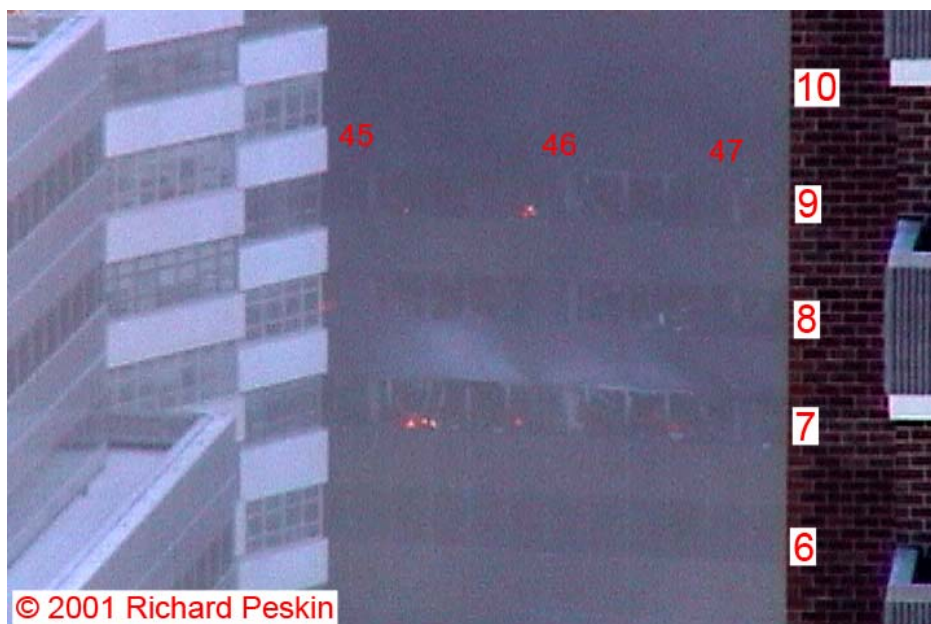
The videographer zoomed in on the north face of WTC 7 during the same clip from which the frame in Figure 5-147 was taken. Figure 5-148 and Figure 5-149 are two spatially overlapping close-up frames that, taken together, show portions of the 6<sup>th</sup> through 14<sup>th</sup> floors just after 4:38 p.m. In Figure 5-149, the visible lengths of the floor extend from just east of column 45 to just west of column 47. All of the visible windows on the 7<sup>th</sup>, 8<sup>th</sup>, and 9<sup>th</sup> floors were open at this time, while all of the windows on the 6<sup>th</sup> and 10<sup>th</sup> floors still had glass in place. Small spot fires are visible at numerous locations on the three floors with open windows.

In Figure 5-146, intense fires were visible on the 7<sup>th</sup> and 9<sup>th</sup> floors in the same windows visible in the video around 4:38 p.m. A less intense fire was also present on the 8<sup>th</sup> floor. All of these fires had died down significantly by the time Figure 5-148 was recorded roughly 25 min later. Since the typical intense burning cycle for most of the fires observed in WTC 7 lasted about 20 min, it seems safe to conclude that the photograph shown in Figure 5-146 could not have been taken later than 4:28 p.m., consistent with the estimate of 4:15 p.m for the earlier image.

**Figure 5–148. Frame from a video clip showing a close up view of the north face of WTC 7 at 4:38:11 p.m. ± 1 s.** The video was shot from the same location as the frame in Figure 5–147. The image intensities were adjusted, and column and floor number have been added.

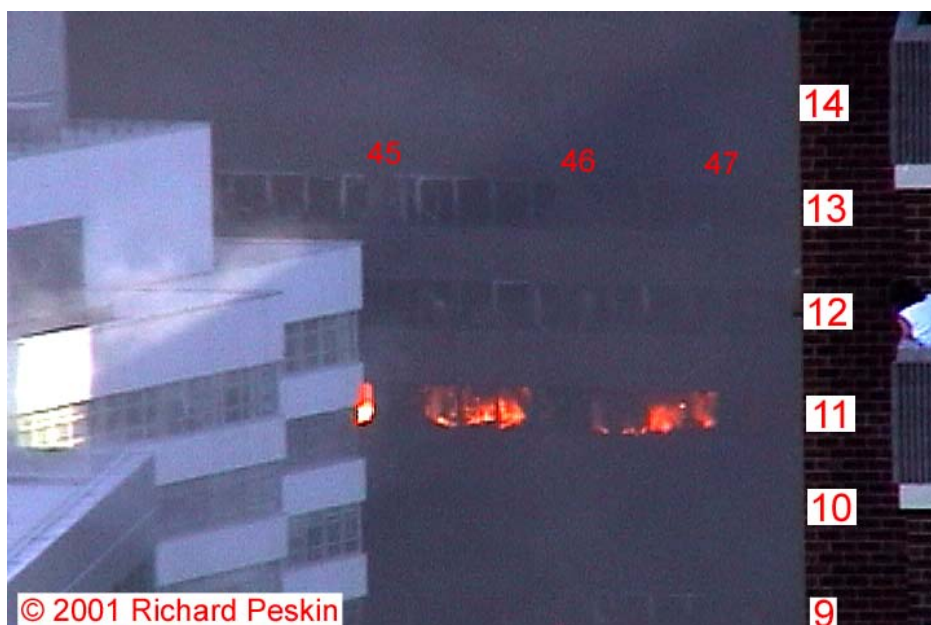
**Figure 5–149. Frame from a video clip showing a close up view of the north face of WTC 7 at 4:38:14 p.m. ± 1 s.** The video was shot from the same location as the frame in Figure 5–147. The image intensities were adjusted, and column and floor number have been added.

Figure 5–149 shows the visible portions of the 9<sup>th</sup> to 14<sup>th</sup> floors. The most prominent feature is the extensive fire present on the 11<sup>th</sup> floor between windows 11-44E and 11-46D. A dull red glow is visible through window 11-47A. This image provides the earliest evidence that the fire on this floor had reached the north face. There was no sign of a fire on this face in earlier images. Recall that a growing fire was observed on the east side of this floor as early as 2:08 p.m. It is remarkable that nearly two and a half hours were required for fire to finally appear on the north side. Even though there is substantial fire present on the floor, no smoke is visible coming from the open windows. This is another example where the fires were venting elsewhere.

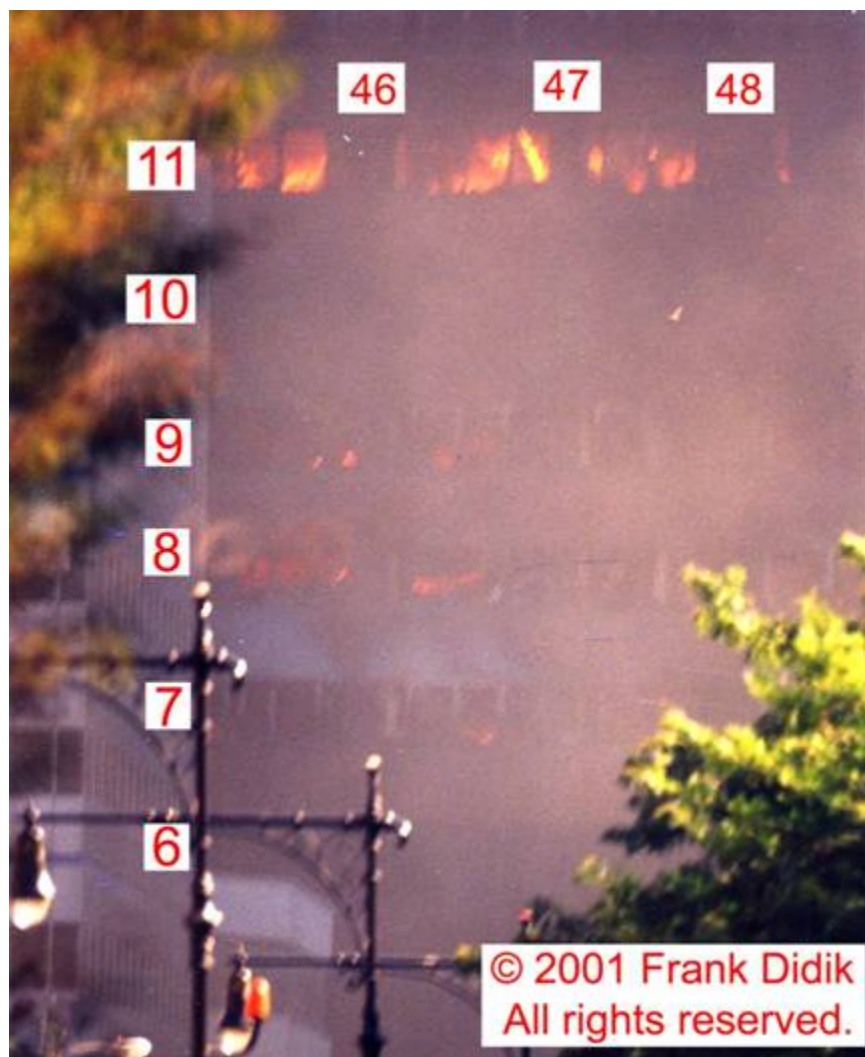
Another partial view of the north face taken from street level at nearly the same time as Figure 5–148 and Figure 5–149 is shown in Figure 5–150. The photograph was shot on film, so a precise time could not be assigned. However, the same photographer shot an accurately timed digital photograph from nearly the same location at 4:39:19 p.m. The time for the film picture was therefore assigned as 4:39 p.m. with an uncertainty of  $\pm 2$  min. In Figure 5–149, the intense fire on the 11<sup>th</sup> floor did not extend beyond column 47, while in Figure 5–150 it appears to have moved beyond column 48, suggesting that the photograph may actually have been shot after the video frames.

More flames are evident on the 7<sup>th</sup>, 8<sup>th</sup>, and 9<sup>th</sup> floors in the ground-level photograph than in the video frames shot looking down on the face. In Figure 5–150, the flames on these floors appear to be reddish and to be well removed from the windows. It is possible that these fires were actually so deep inside the building that they were hidden from the view looking down through the windows. As before, there are no indications of burning on the 10<sup>th</sup> floor in Figure 5–150.

**Figure 5–150. Cropped photograph showing part of the north face of WTC 7, shot from near the corner of Harrison and Greenwich Streets at 4:39 p.m.  $\pm 120$  s.**

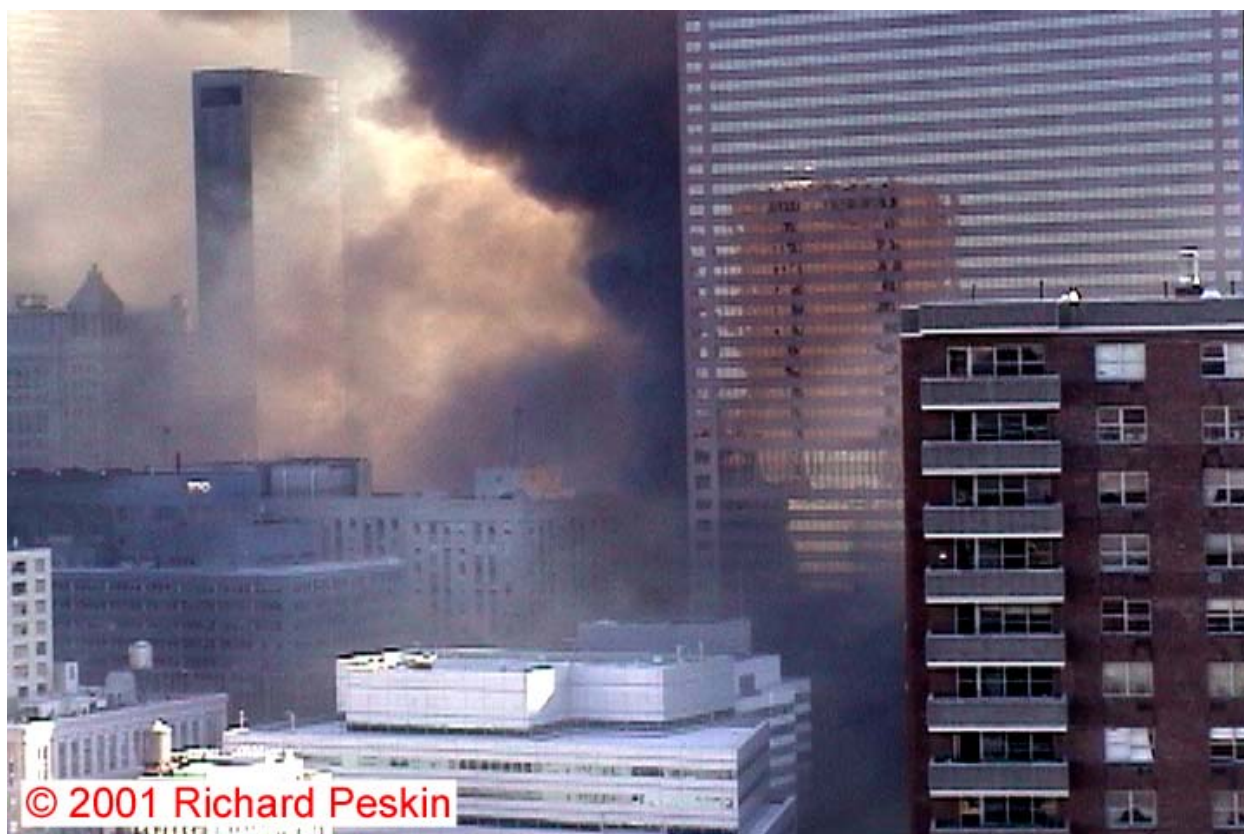
After roughly 4:40 p.m., imagery in the Investigation database showing the north face of WTC 7 is more limited. Figure 5–151 shows a long distance shot of the north face of WTC 7 taken at 4:52:24 p.m. from the same vantage point as Figure 5–147. In the video clip it can be seen that smoke is passing across the lower part of the north face. Unlike Figure 5–147, there is no fire visible on the north face from this distance. It seems the fires on the 11<sup>th</sup> floor have died down, but it is possible that fire was present, but hidden by the smoke. Heavy, dark smoke is still visible rising from the east face of the building.

**Figure 5–151. Frame from a video clip shot from the top of a nearby building, showing the north face of WTC 7 at 4:52:24 p.m. ± 1 s.**

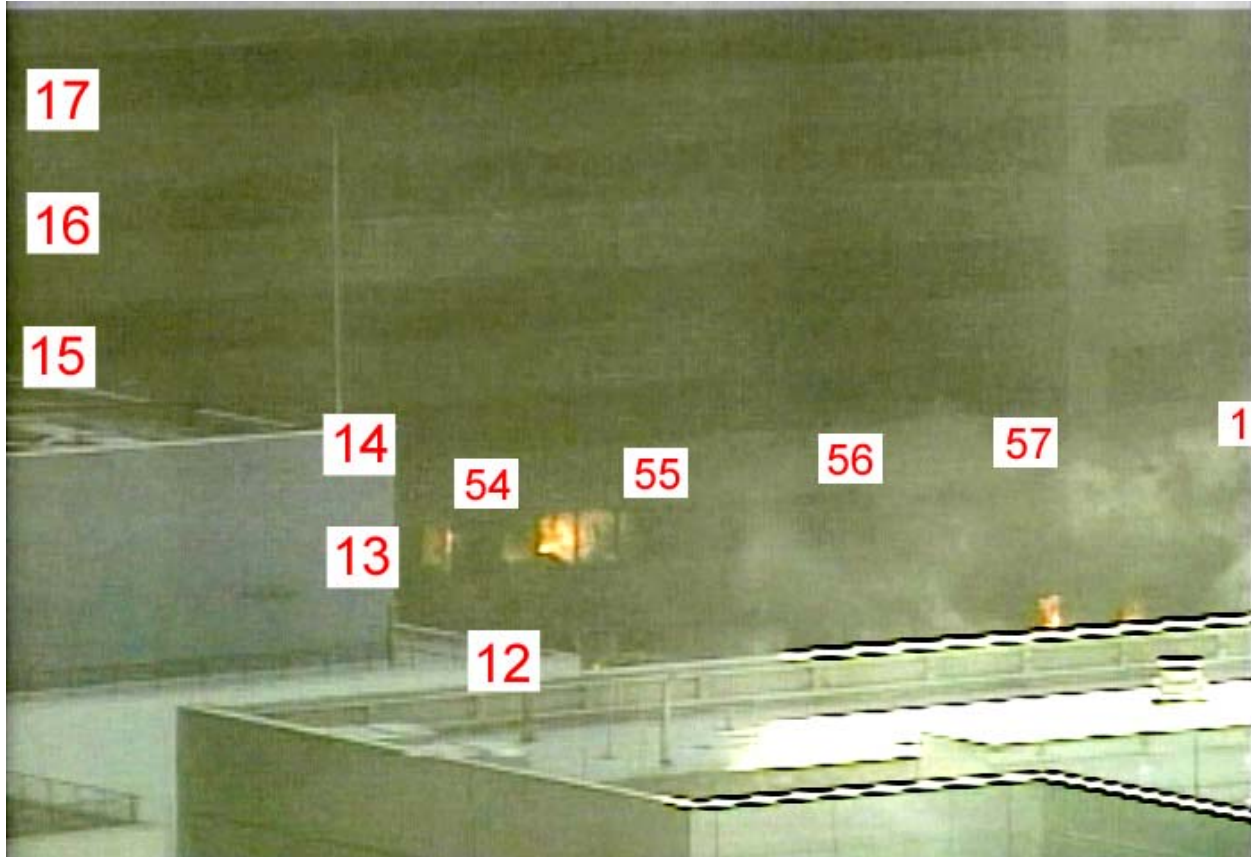
Figure 5–152 shows a limited view of the north face shot from the northeast over the tops of the two buildings to the north of WTC 7. The time was crudely estimated as being around 5:00 p.m. based on the pattern of sunlight and shadow on the building to the immediate north of WTC 7. Only the 12<sup>th</sup> to 17<sup>th</sup> floors are visible. Fires are burning on the 12<sup>th</sup> and 13<sup>th</sup> floors. On the 12<sup>th</sup> floor, the fires that were slowly spreading across the north face to the west have reached the northwest corner, with flames barely visible in windows 12-57A and 12-57B. Recall that fire was observed between columns 55 and 56 around 4:00 p.m. At 2:00 p.m., the 12<sup>th</sup> floor was burning near the southeast corner. Apparently it took roughly three hours for fire to spread all of the way from the southeast corner to the northwest corner.

**Figure 5–152. Frame taken from a video clip shot over the buildings at 30 West Broadway and 70 Murray Street, showing the western edge of the north face of WTC 7 at about 5:00 p.m.**

The fire on the 13<sup>th</sup> floor has burned westward as far as column 55. In Figure 5–144, which was estimated to have been taken around 3:55 p.m., flames were observed as far west as column 50. This fire was continuing to work its way to the west. There are no indications of fire burning in this area on floors higher than the 13<sup>th</sup> floor. In the video clip, some light smoke was visible blowing across the north face, but there was apparently little smoke coming from the open windows on the 12<sup>th</sup> and 13<sup>th</sup> floors, consistent with earlier observations that the effluent for fires on these floor vented at remote locations on other faces.

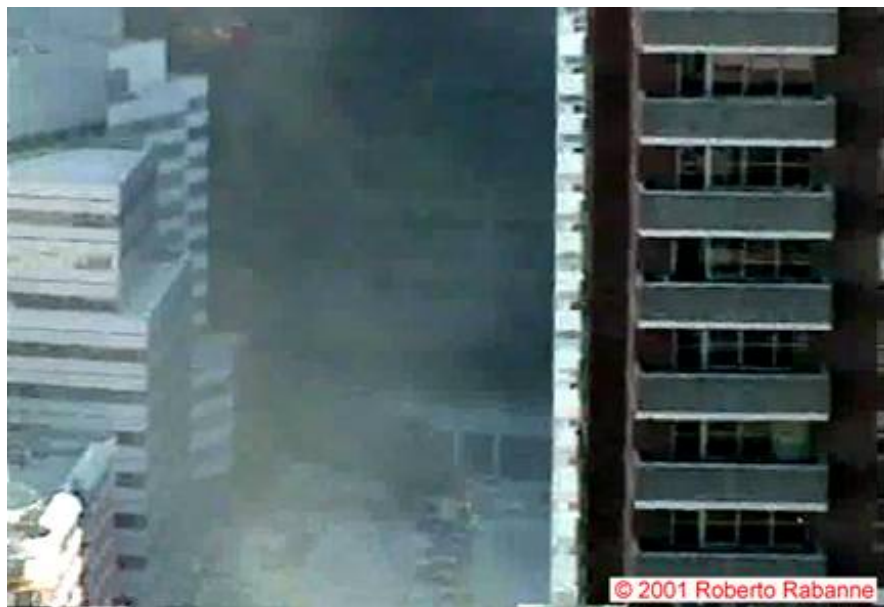
Figure 5–153 shows a view of the north face of WTC 7 looking down Greenwich Street at 5:03:00 pm.  $\pm$  2 min. The image is from a digitized video converted from film and is noisy. For this reason, column and floor numbers have not been added. Nonetheless, by comparison with Figure 5–139, which was shot from roughly the same location, some details concerning the fires can be discerned. Flames are only visible at one location on the face, namely near the top of the frame on the left side near the building at 30 West Broadway. Reference to Figure 5–139 suggests that this location is on the 14<sup>th</sup> floor between columns 45 and 46. If correct, this represents the first and only visual indication of a fire on this floor.

**Figure 5–153.** This frame from a video shot from a building to the northwest of WTC 7 was taken around 5:03:00 p.m. with an uncertainty of  $\pm 120$  s.

Light smoke is apparent, moving across the face from west to east in Figure 5–153. From the video, it is clear that this smoke is rising from the street just in front of WTC 7. In the figure flames are barely visible on a vehicle parked near the center of the building on Barclay Street. There is no indication of when or how this vehicle was ignited.

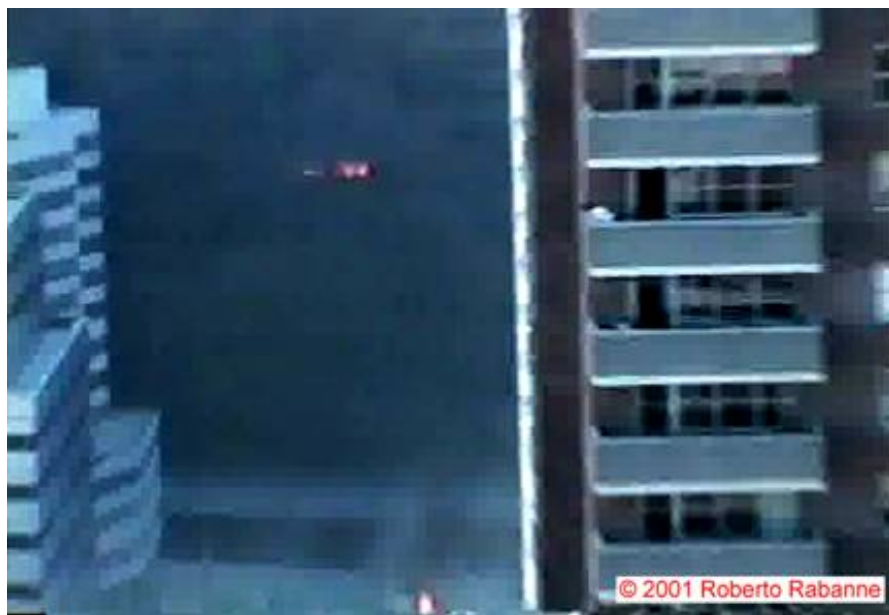
Another frame from the same video as Figure 5–153 is shown in Figure 5–154. This view is somewhat clearer. It was shot from roughly the same location at 5:09:03  $\pm 120$  s., or roughly 6 min later. In this image the fire present at the upper left-hand corner is no longer apparent, but a fairly intense fire has appeared further down on the face near the center of the visible area. Comparison with Figure 5–139 suggests this fire was located on the 11<sup>th</sup> floor near column 49. This location is just to the west of windows where fire was observed on the same floor in Figure 5–150 at 4:39 p.m. Apparently the fire on this floor paused briefly before continuing its movement to the west. Smoke can still be seen rising from the vehicle fire on the street below the face.

**Figure 5–154.** This frame from a video shot from a building to the northwest of WTC 7 was taken around 5:09:03 p.m. with an uncertainty of  $\pm 120$  s.

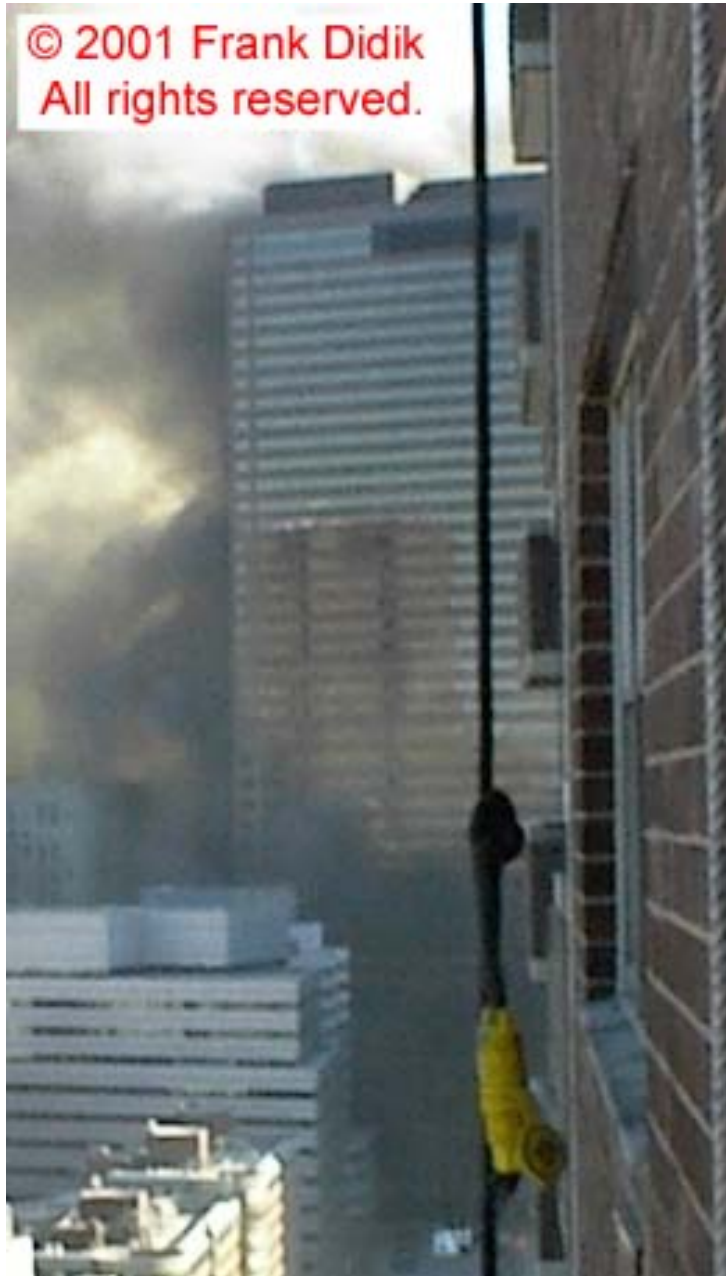
**Figure 5–155. Cropped photograph of the north face of WTC 7, taken from a building located to the northwest looking down Greenwich Street at 5:13:58 p.m.  $\pm$  3 s.**

A long distance partial view of the north face of WTC 7 shot at 5:13:58 p.m. is shown in Figure 5–155. No flames are visible except on the street at the base of the north face. While some smoke is visible passing over the north face, it is possible to discern the alternating granite spandrel covers and windows on the lower floors. This suggests that no major fires were present over the visible width of the floors. Smoke is still visible rising from the east face, but comparison with earlier similar views indicates that the smoke flow had decreased markedly.

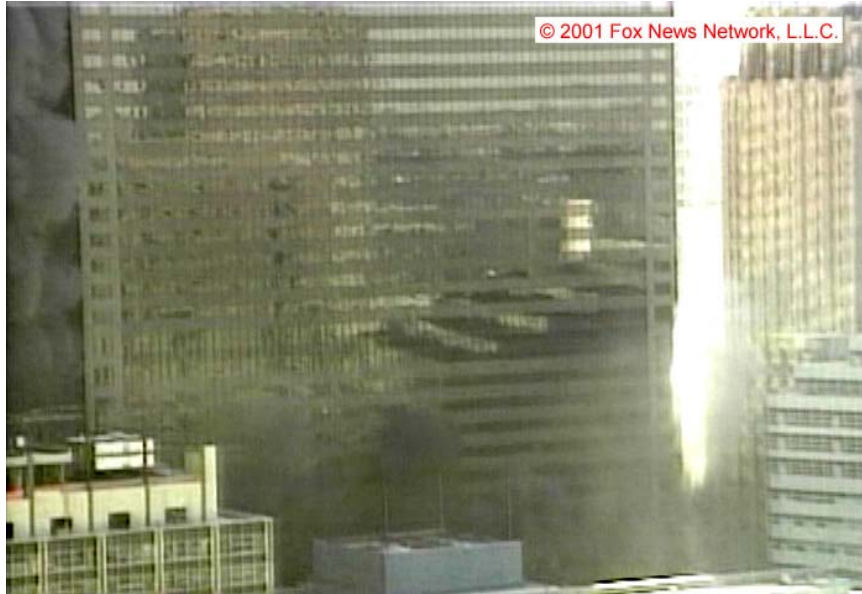
**Figure 5–157.** Frame taken from a video clip shot from the northeast, showing the north face of WTC 7 within a few minutes of the WTC 7 collapse at 5:20:52 p.m. The intensity levels were adjusted.

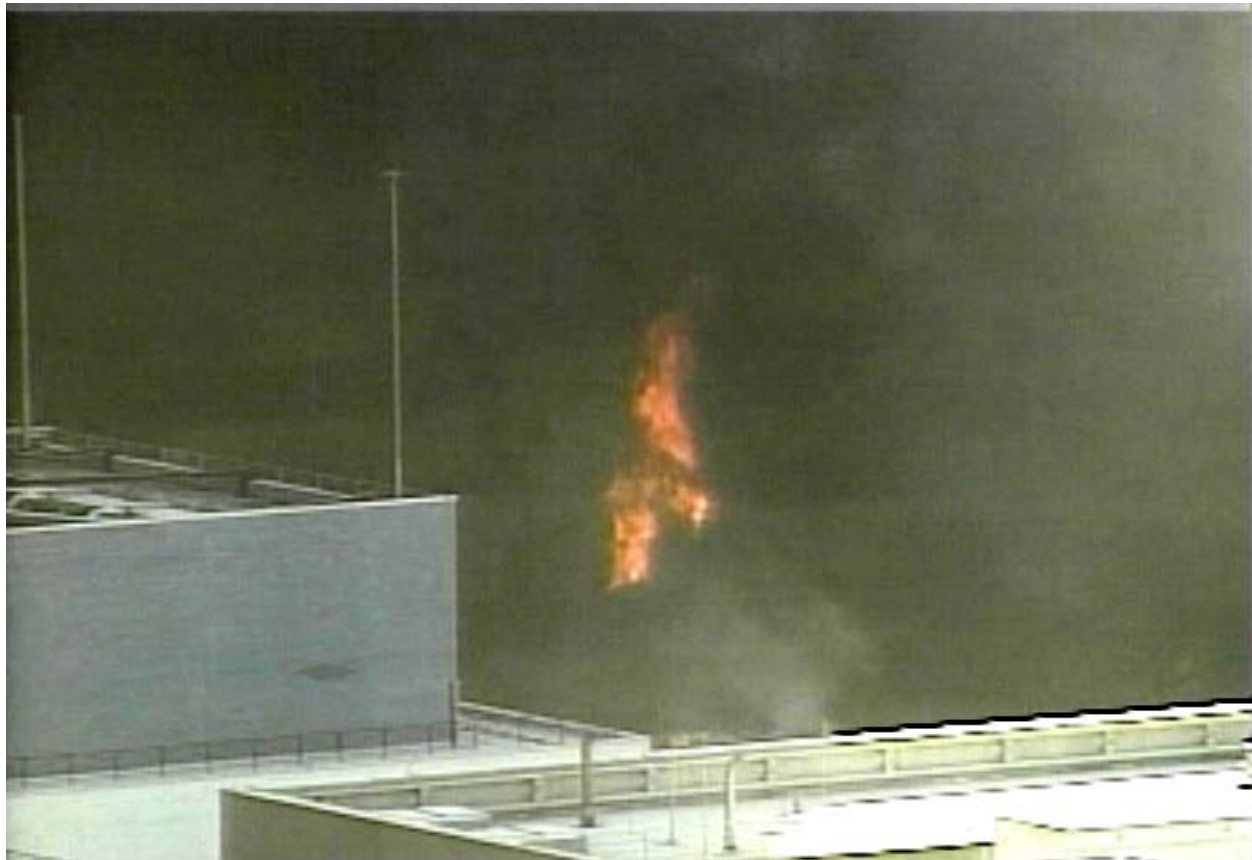
**Figure 5–158.** Frame taken from a video clip shot over the buildings at 30 West Broadway and 70 Murray Street, showing the western edge of the north face of WTC 7 within a few minutes of the WTC 7 collapse at 5:20:52 p.m.

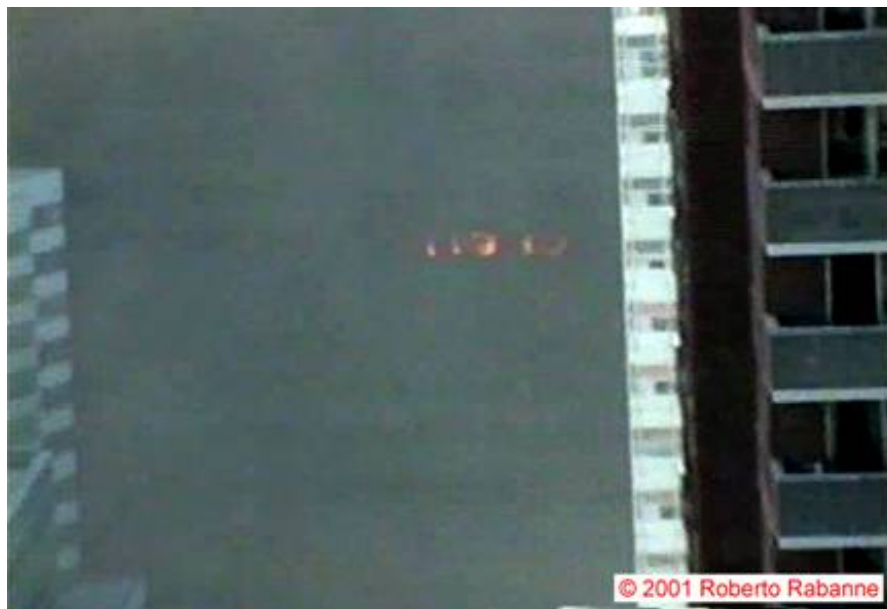
Figure 5–159 shows a view of the north face of WTC 7 just seconds before it began to collapse. It is a frame from a video clip shot from the northwest at 5:20:17 p.m.  $\pm 15$  s. Comparison with Figure 5–139 indicates that the fires visible in the image were located on the 11<sup>th</sup> floor between columns 50 and 52, showing that the fire on this floor was continuing to spread to the west just prior to the collapse of the building.

**Figure 5–159. This frame from a video shot from a building to the northwest of WTC 7 was taken around 5:20:17 p.m. with an uncertainty of  $\pm 15$  s. The intensities have been adjusted.**

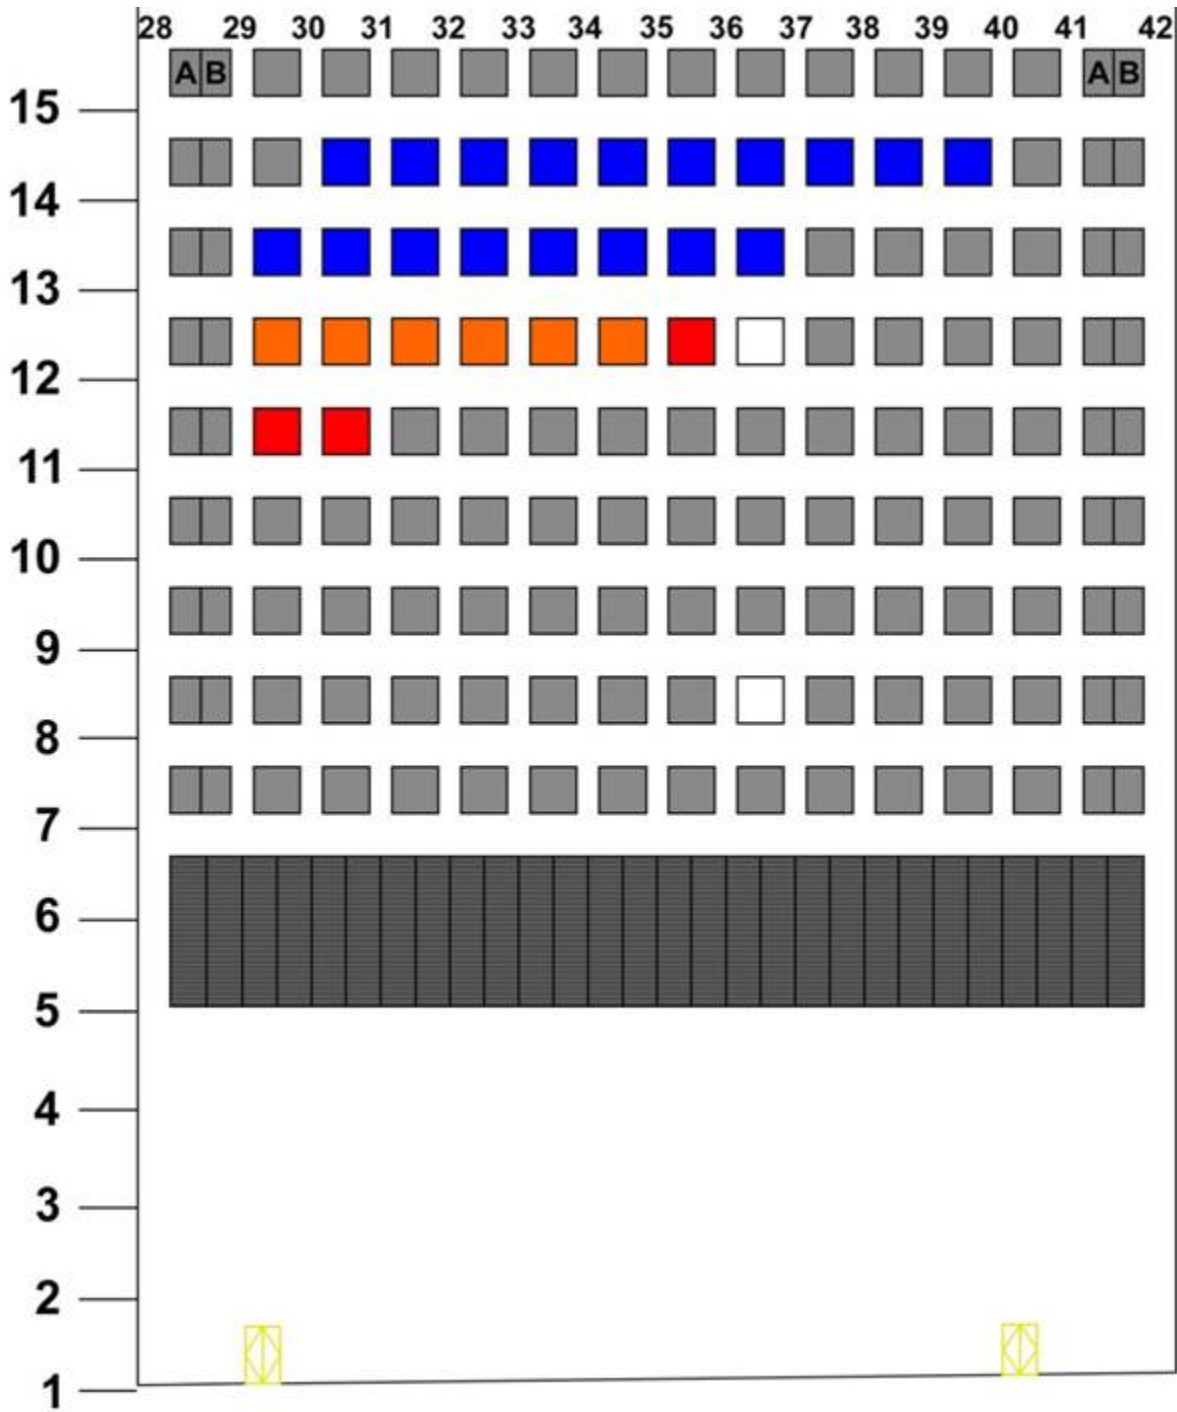
Figure 5–160. Façade map summarizing observations of fires and open windows on the east face of WTC 7 around 2:10 p.m. It is based on Figure 5–115 and a second photograph taken 15 s earlier.

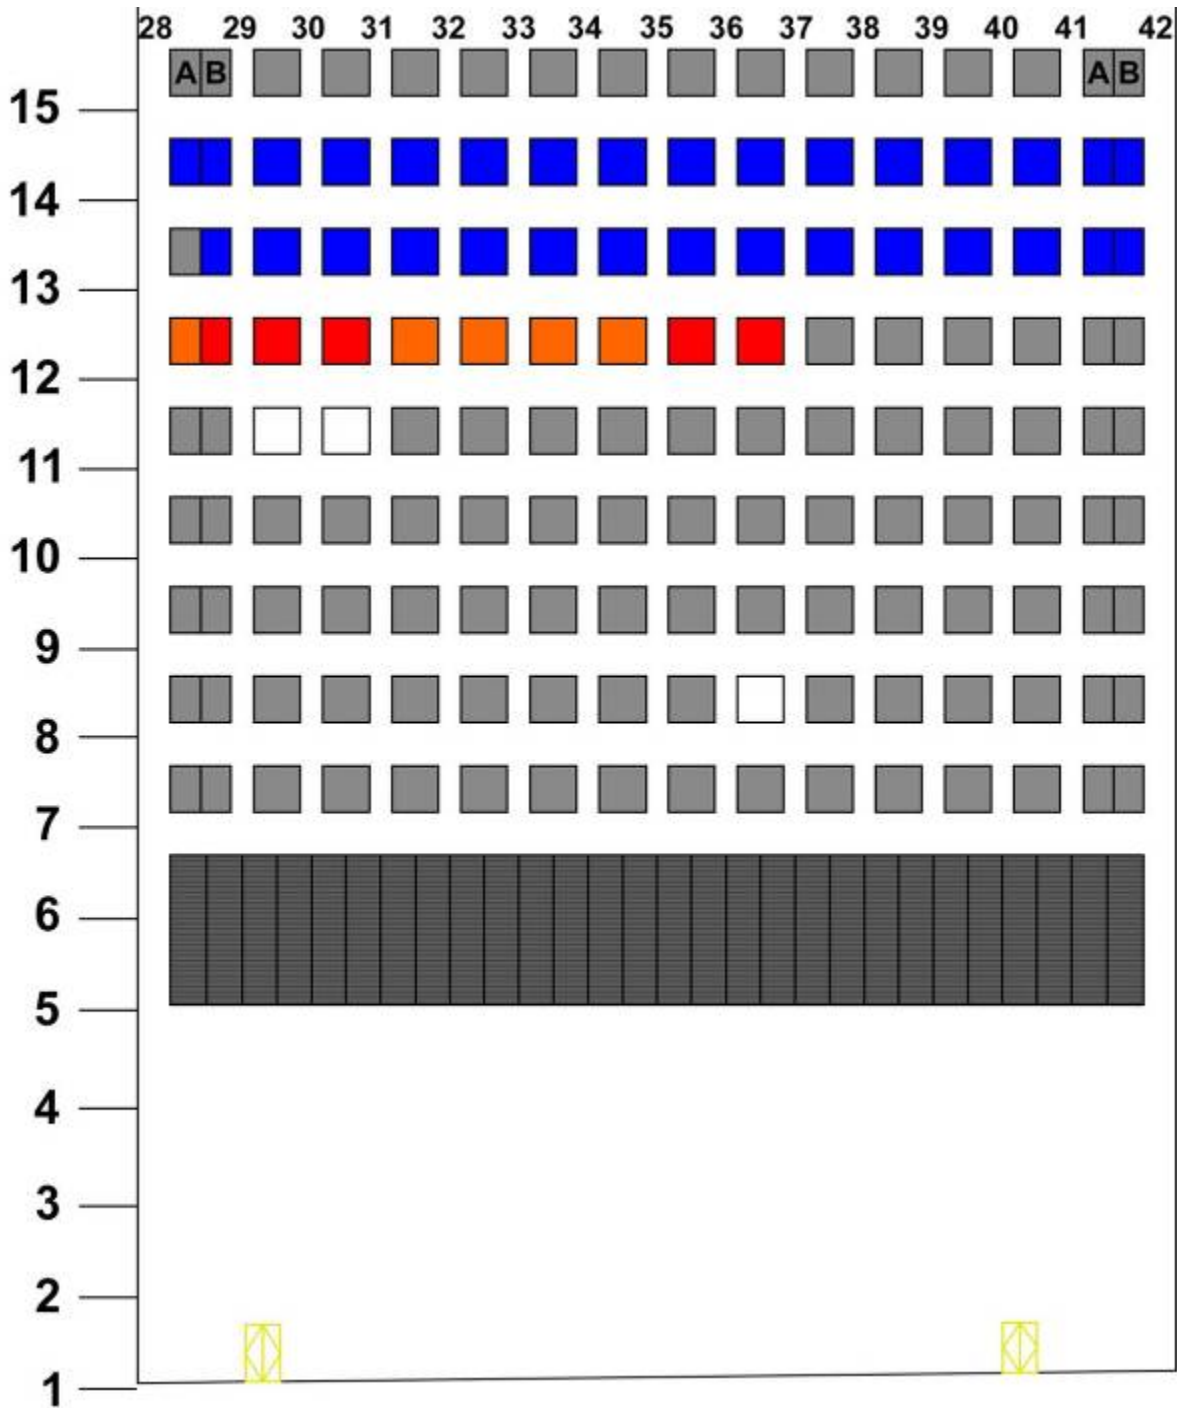
**Figure 5–161. Façade map summarizing observations of fires and open windows on the east face of WTC 7 around 2:14 p.m.**  
 It is based on two photographs taken within a few seconds of each other.

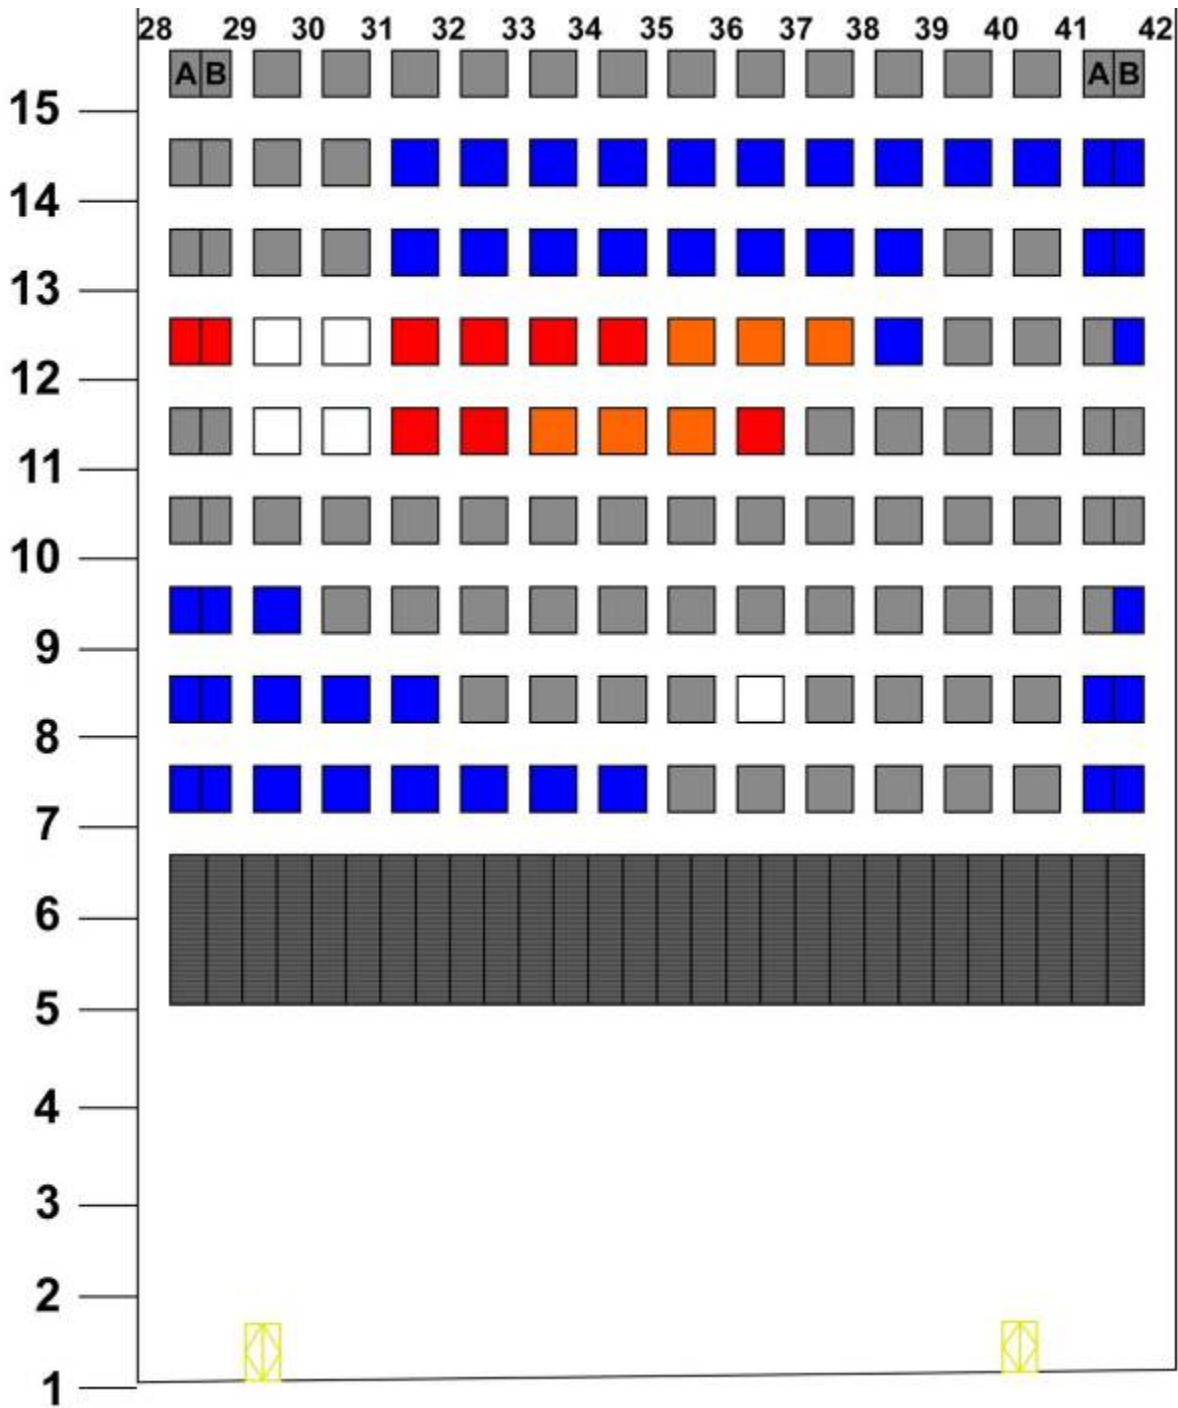
Figure 5–162. Façade map summarizing observations of fires and open windows on the east face of WTC 7 around 2:30 p.m. It is based on Figure 5–117.

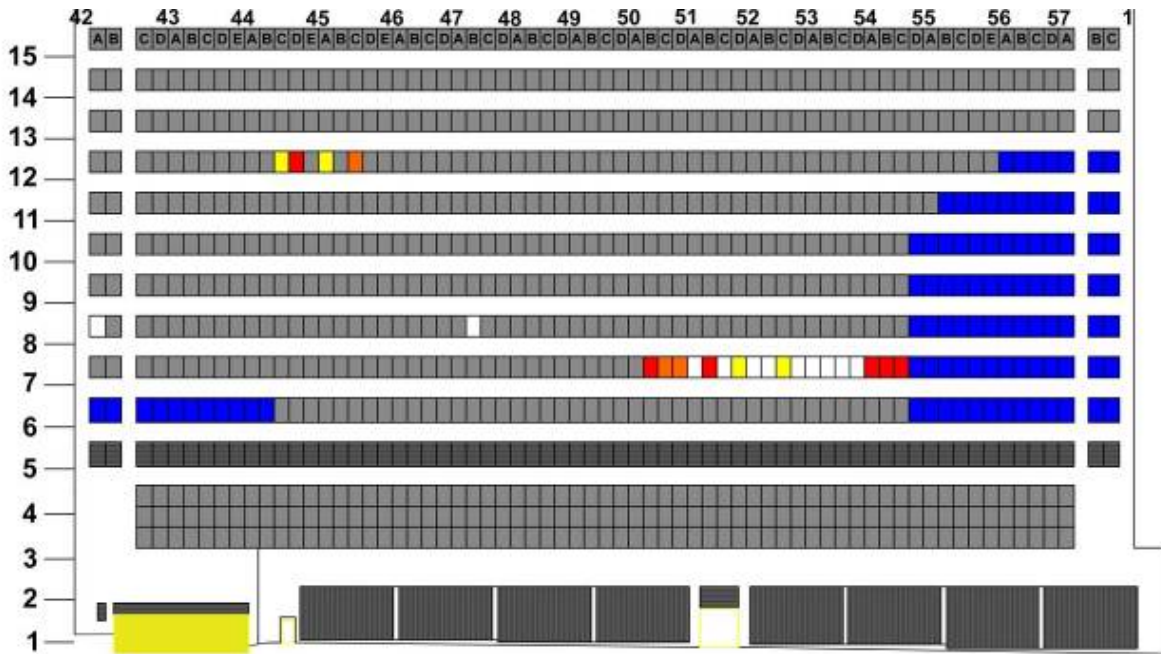
Figure 5-163. Façade map summarizing observations of fires and open windows on the north face of WTC 7 around 2:57 p.m.  
It is based on Figure 5-119.

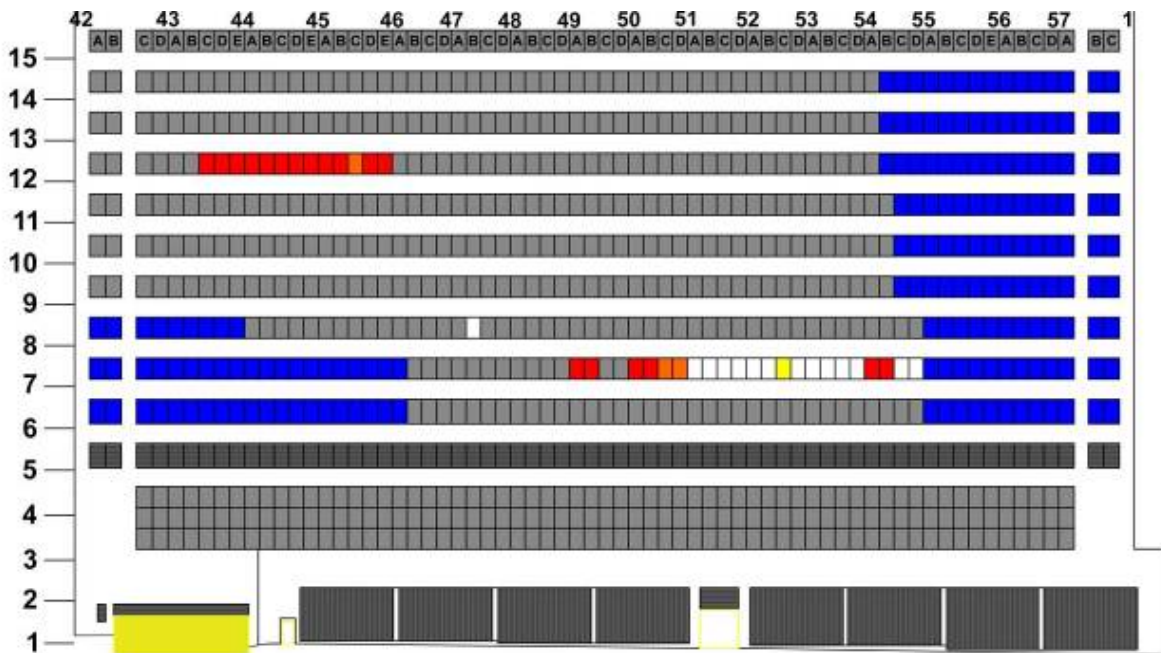
Figure 5-164. Façade map summarizing observations of fires and open windows on the north face of WTC 7 around 3:05 p.m.  
It is based on Figure 5-121.

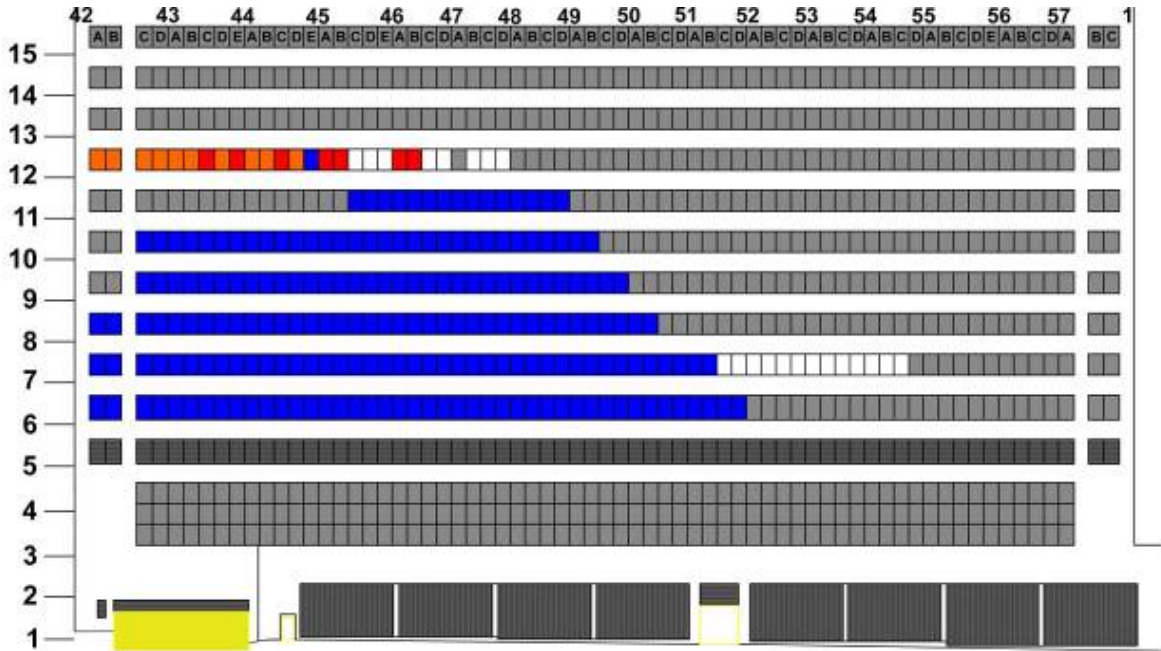
**Figure 5–165.** This façade map summarizes observations of fires and open windows on the north face of WTC 7 around 3:10 p.m.  
It is based on Figure 5–123.

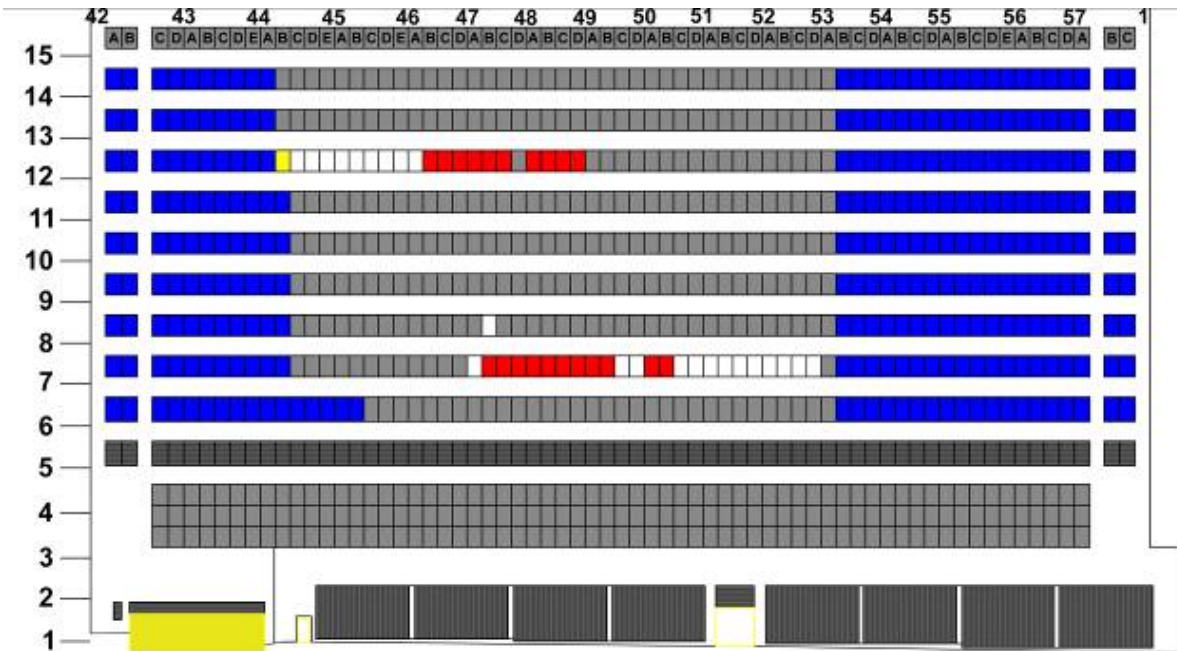
**Figure 5–166.** Façade map summarizing observations of fires and open windows on the north face of WTC 7 around 3:13 p.m.  
It is based on Figure 5–127.

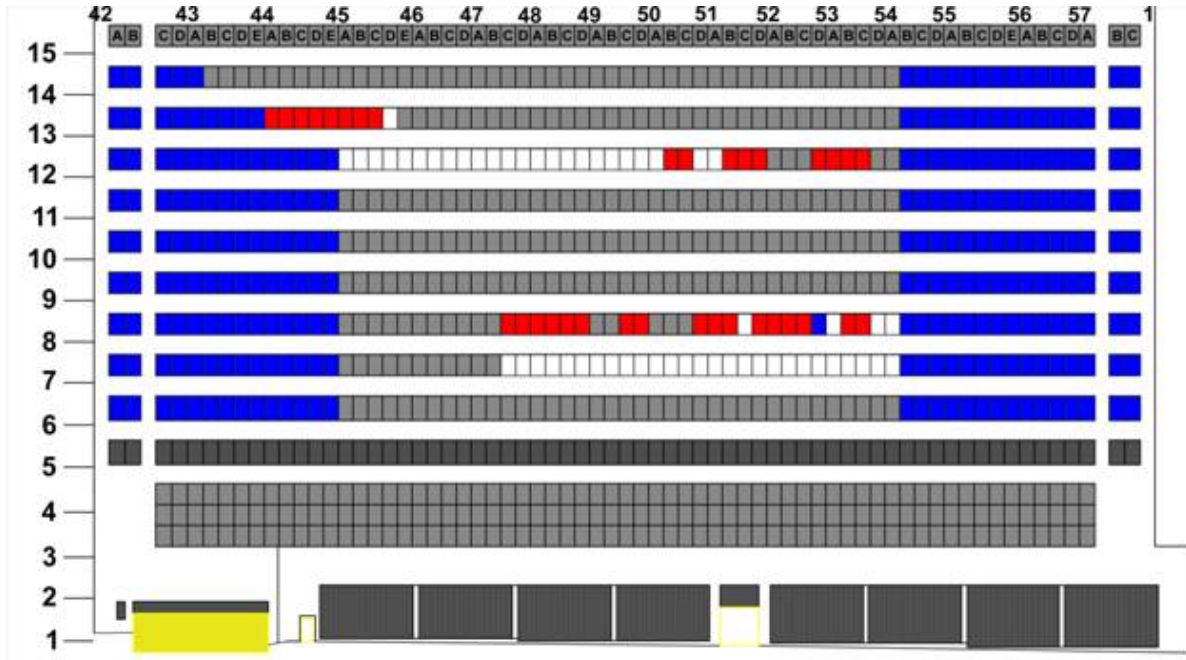
**Figure 5-167. Façade map summarizing observations of fires and open windows on the north face of WTC 7 around 3:42 p.m.**  
It is based on Figure 5-128 and Figure 5-130.

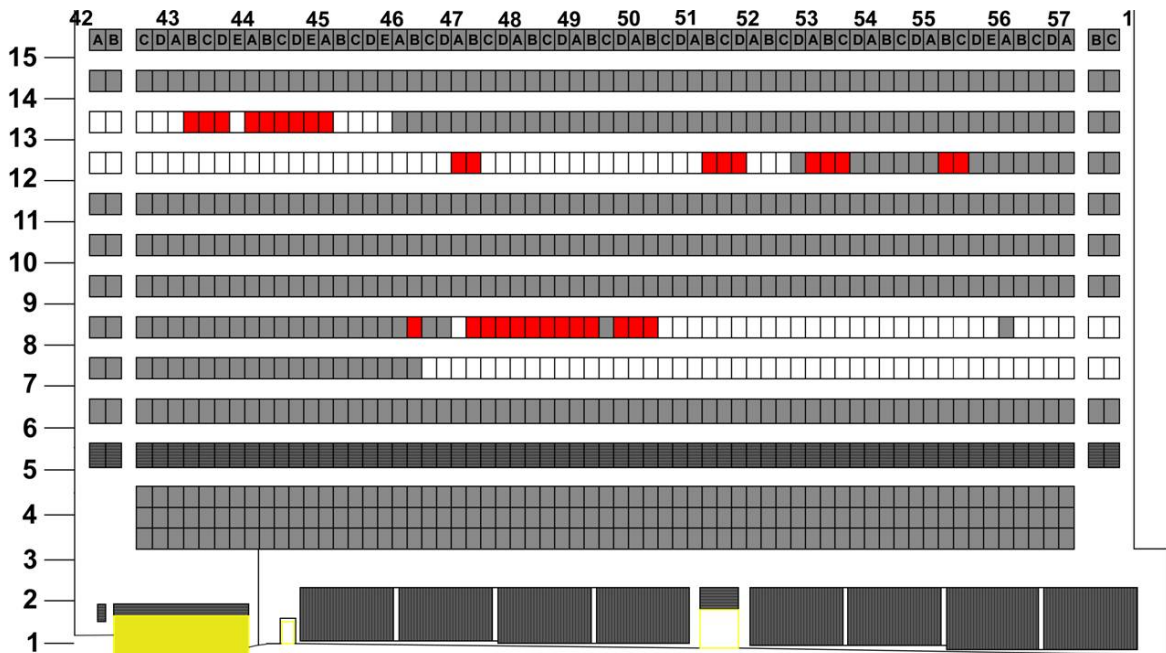
**Figure 5-168. Façade map summarizing observations of fires and open windows on the north face of WTC 7 around 3:44 p.m.**  
It is based on Figure 5-134 and the video clip from which it was taken.
