**Federal Building and Fire Safety Investigation of the  
World Trade Center Disaster**

**Structural Fire Response and  
Probable Collapse Sequence of  
World Trade Center Building 7**

**NIST NCSTAR 1-9**

August, 2008

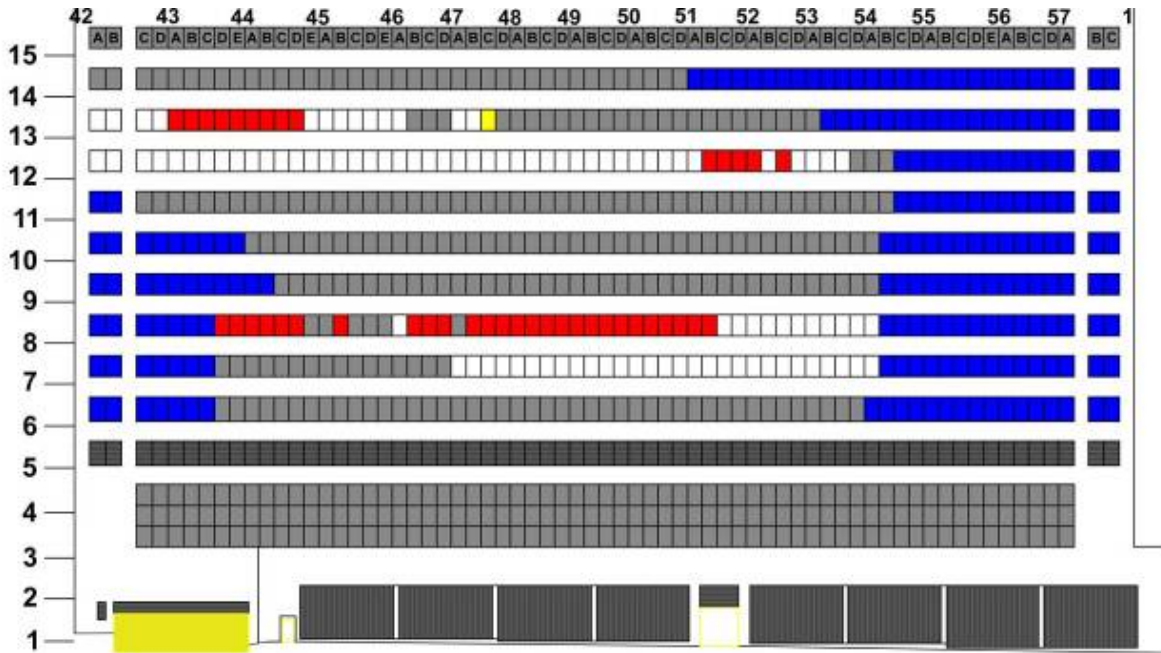
**Figure 5–169. Façade map summarizing observations of fires and open windows on the north face of WTC 7 around 3:52 p.m.**

It is based on Figure 5–136 and the video clip from which it was taken.

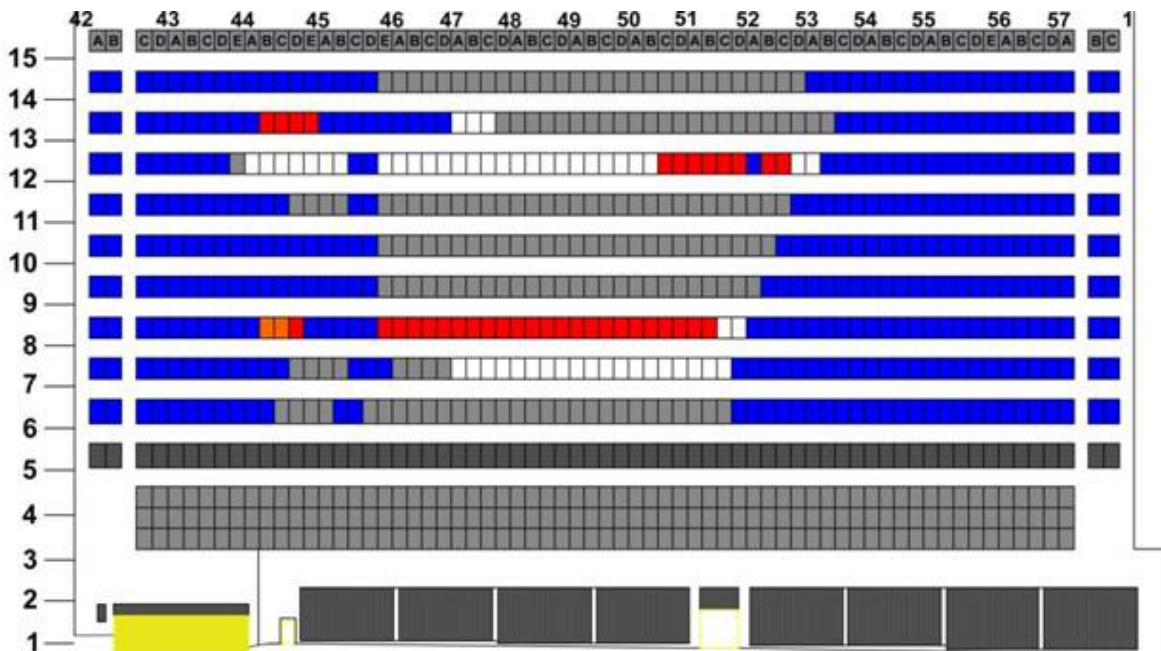
**Figure 5–170. Façade map summarizing observations of fires and open windows on the north face of WTC 7 around 3:55 p.m.**

It is based on Figure 5–140 and the video clip from which it was taken.

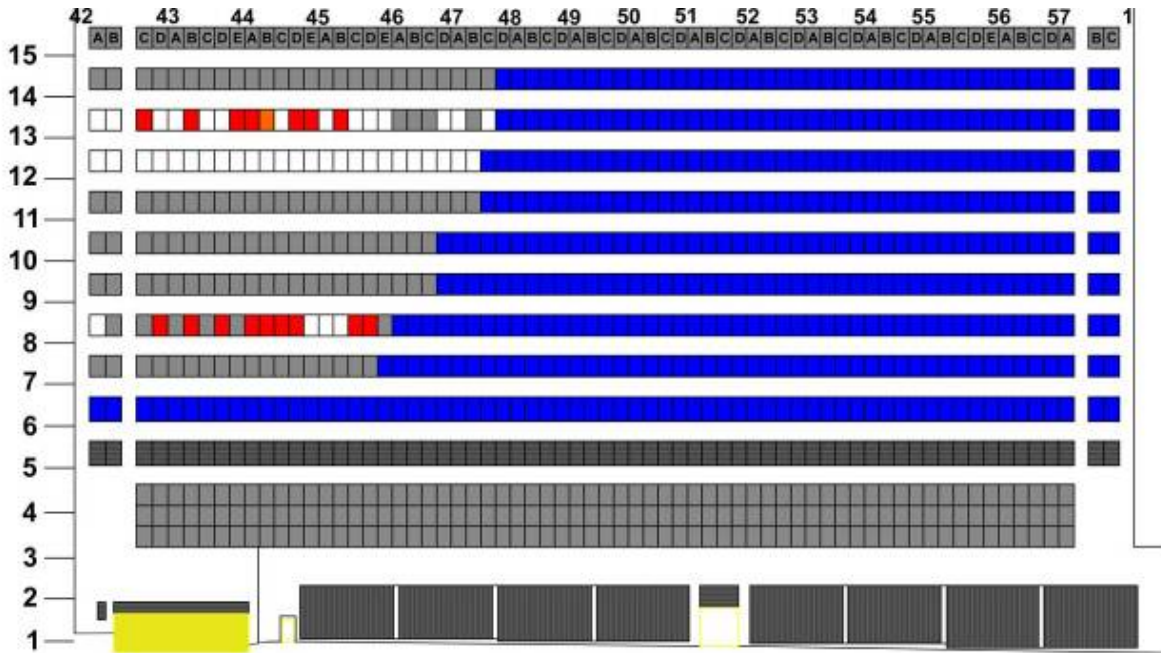
**Figure 5–171. Façade map summarizing observations of fires and open windows on the north face of WTC 7 around 3:57 p.m.**

It is based on Figure 5–141 and the video clip from which it was taken.

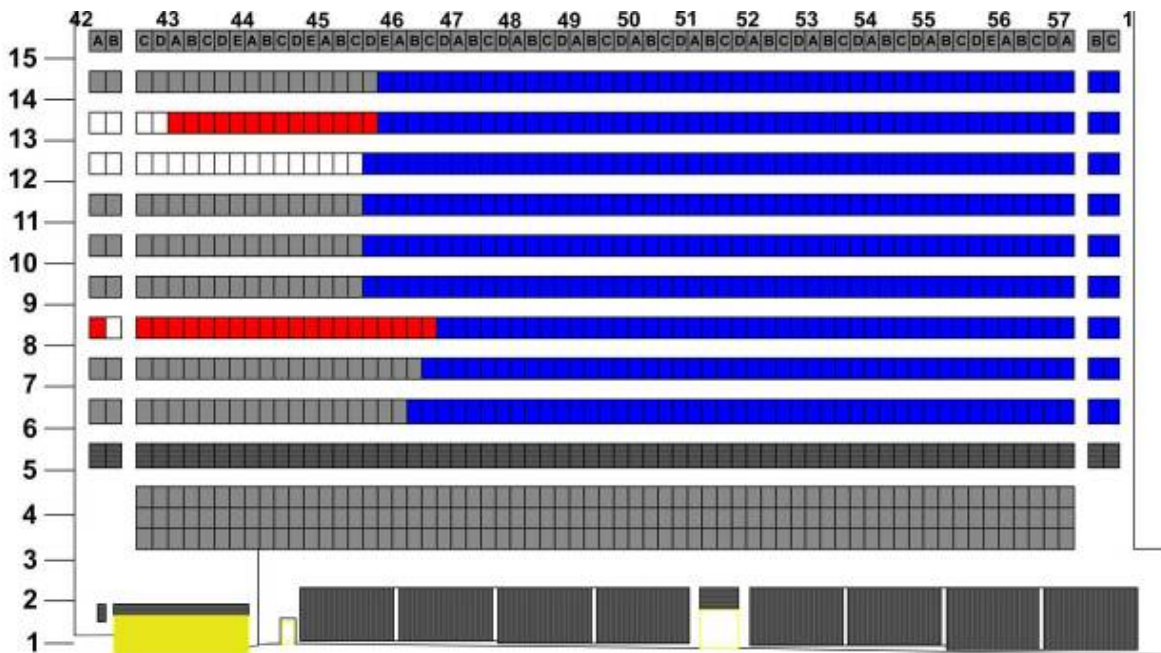
**Figure 5–172. Façade map summarizing observations of fires and open windows on the north face of WTC 7 around 4:00 p.m.**

It is based on Figure 5–142 and the video clip from which it was taken.

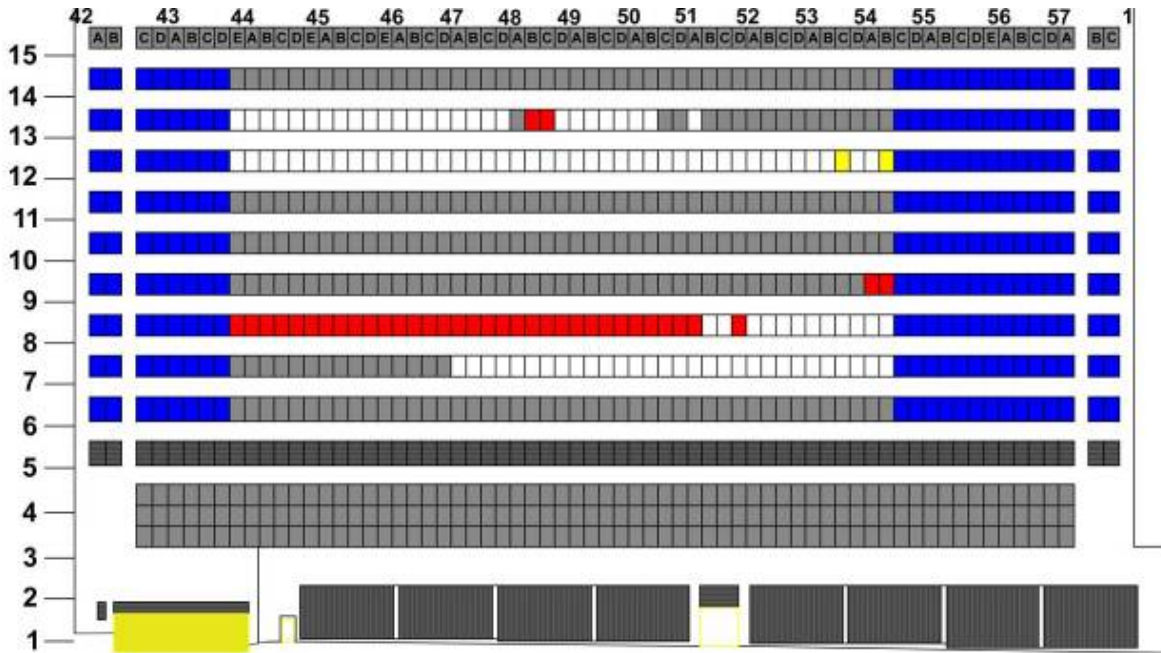
**Figure 5–173. Façade map summarizing observations of fires and open windows on the north face of WTC 7 around 3:55 p.m.**

It is based on Figure 5–144.

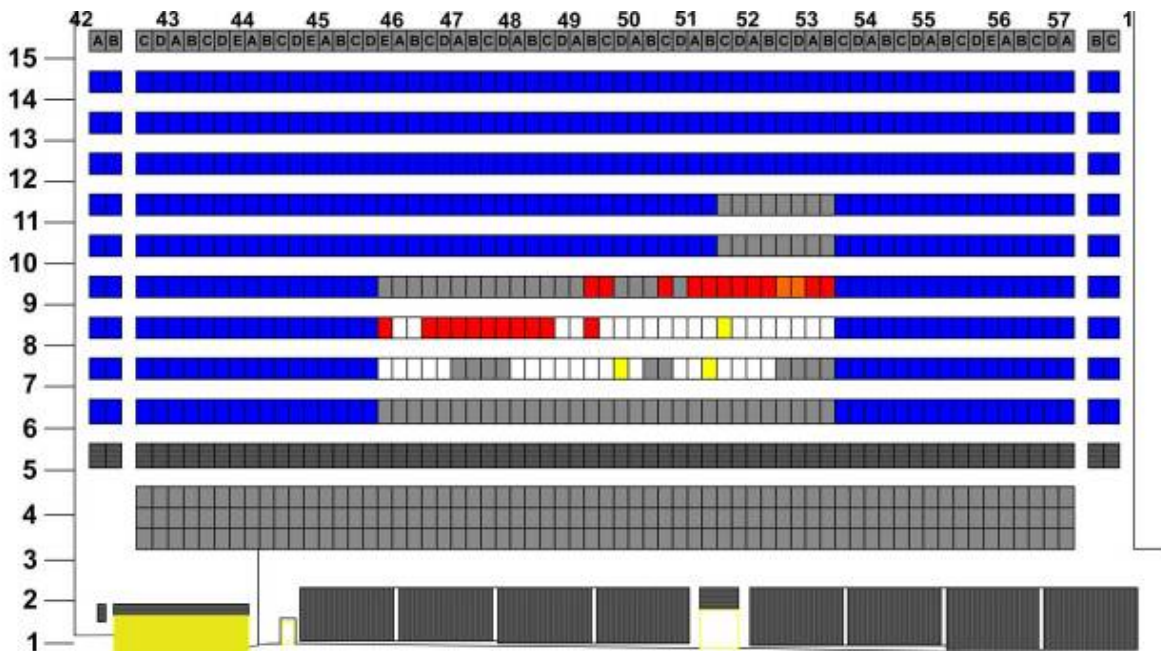
**Figure 5–174. Façade map summarizing observations of fires and open windows on the north face of WTC 7 around 4:10 p.m.**

It is based on Figure 5–145 and the video clip from which it was taken.

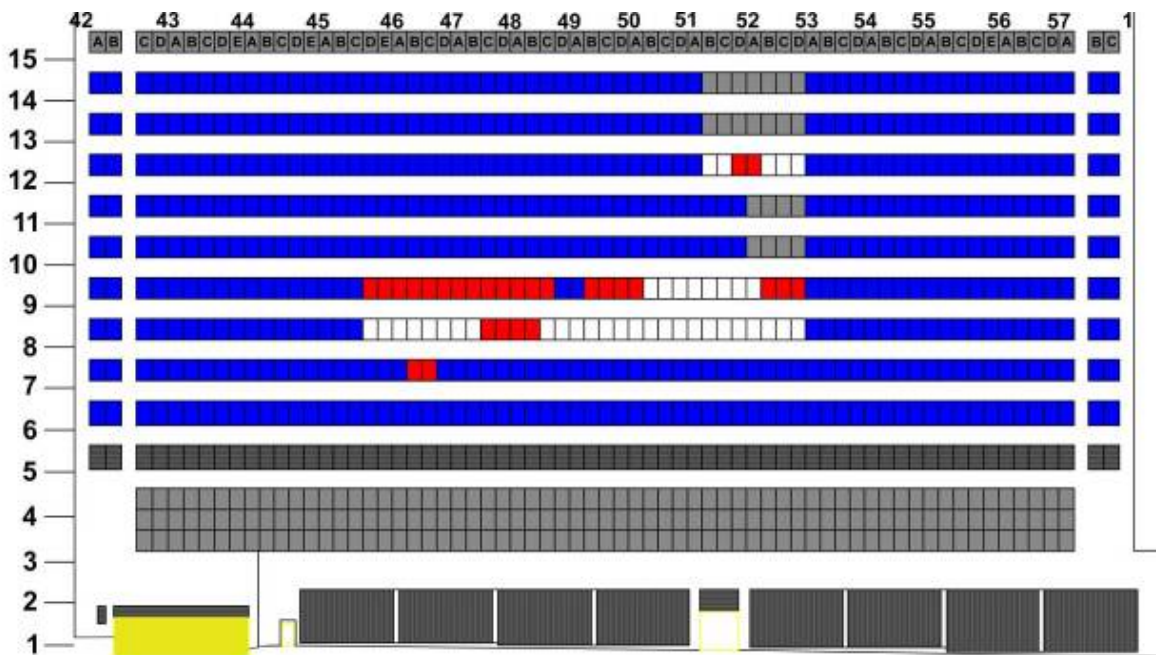
**Figure 5-175. Façade map summarizing observations of fires and open windows on the north face of WTC 7 around 4:15 p.m.**  
 It is based on Figure 5-146 and a second photograph taken at roughly the same time.

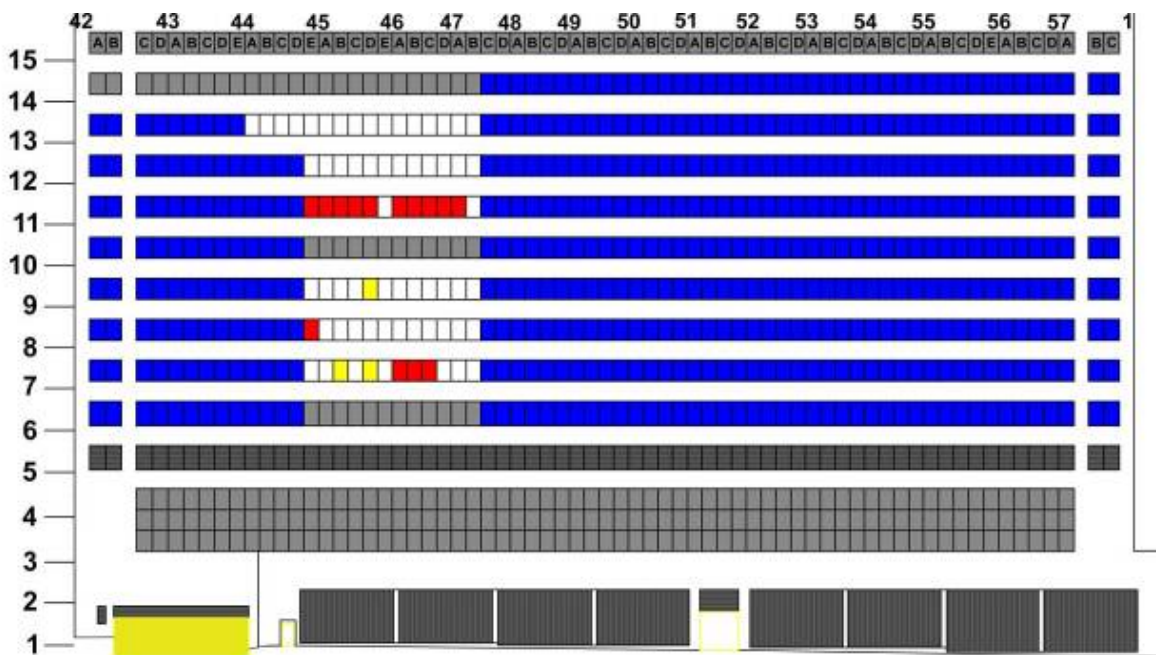
**Figure 5-176. Façade map summarizing observations of fires and open windows on the north face of WTC 7 at 4:38:11 p.m.**  
 It is based on Figure 5-148 and Figure 5-149 and the video clip from which these frames were taken.

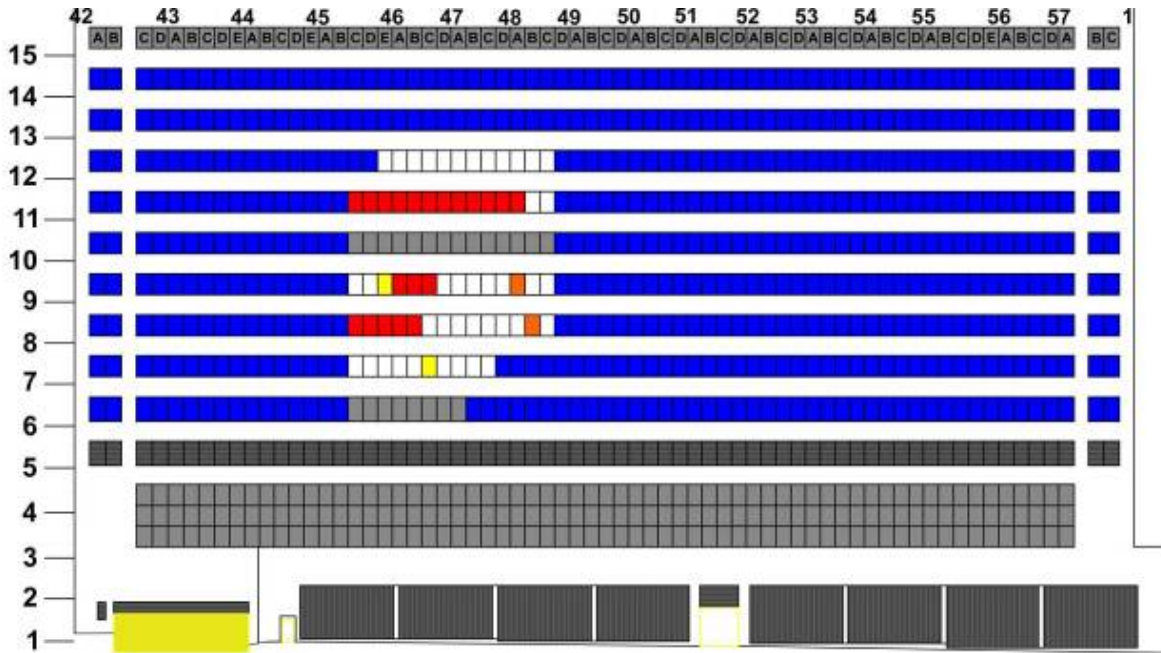
**Figure 5-177. Façade map summarizing observations of fires and open windows on the north face of WTC 7 around 4:39 p.m.**

It is based on Figure 5-150.

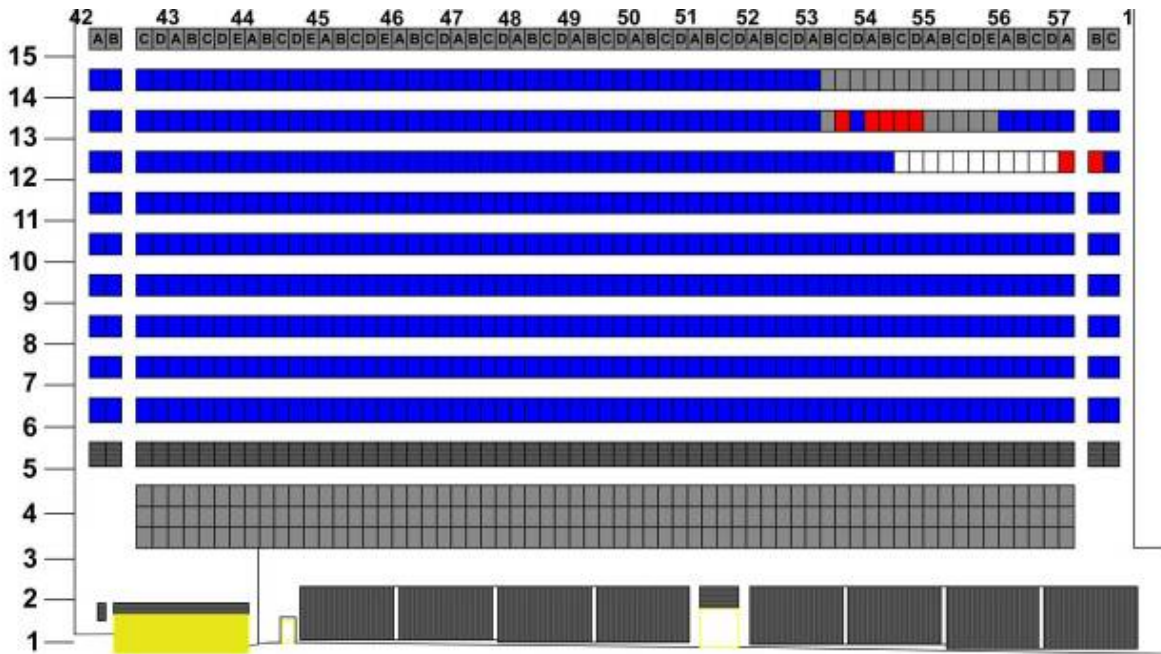
**Figure 5-178. Façade map summarizing observations of fires and open windows on the north face of WTC 7 around 5:00 p.m.**

It is based on Figure 5-152 and the video clip from which it was taken.

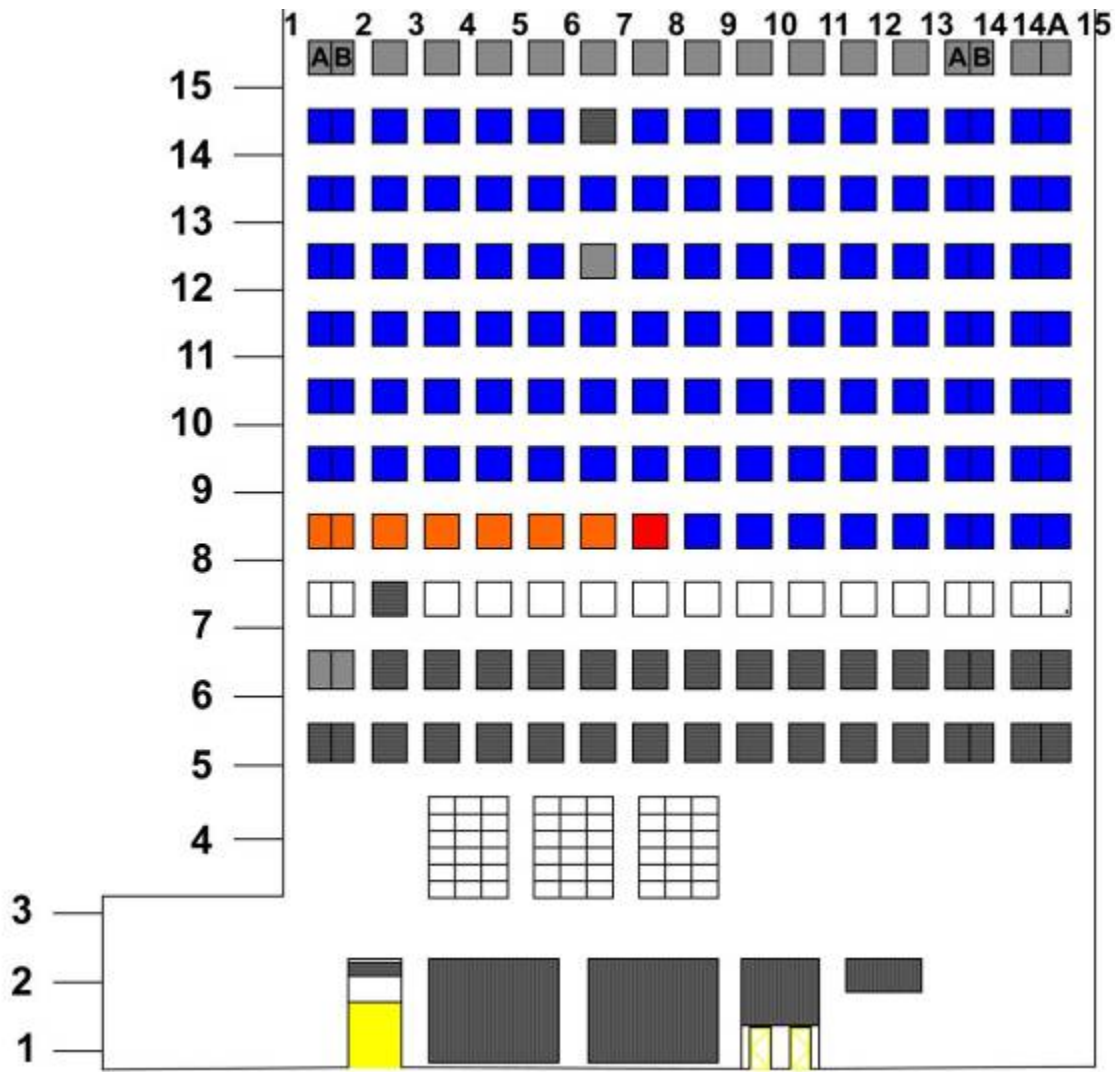
**Figure 5–179. This façade map summarizes observations of fires and open windows on the west face of WTC 7 around 3:52 p.m.**  
 It is based on several video clips including the one from which Figure 5–132 and Figure 5–133 were taken.

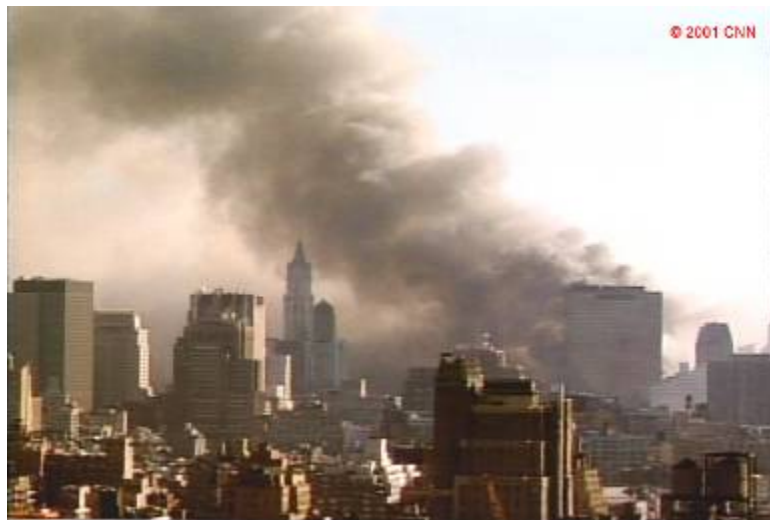
**Figure 5–184.** Frame from the Camera 1 video, showing the north face of WTC 7 (on right) seconds before the east penthouse began to fall into the building.

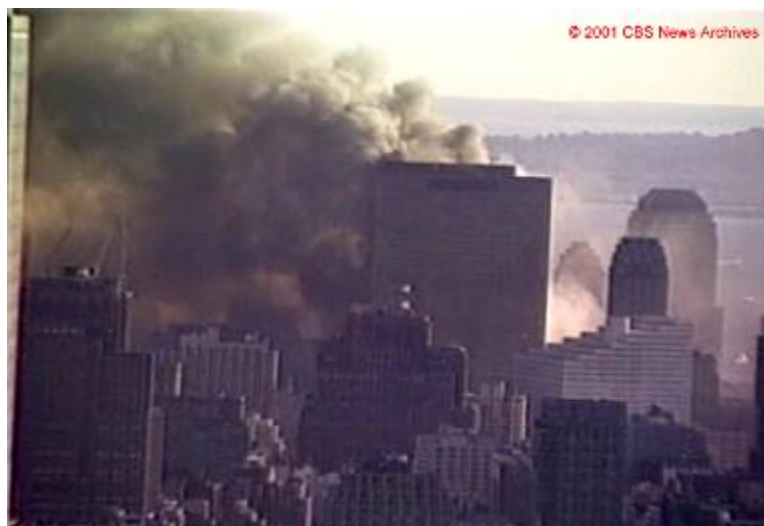
**Figure 5–185.** Frame from the Camera 2 video, showing the north face of WTC 7 (just right of center) seconds before the east penthouse began to fall into the building. The intensity levels were adjusted.

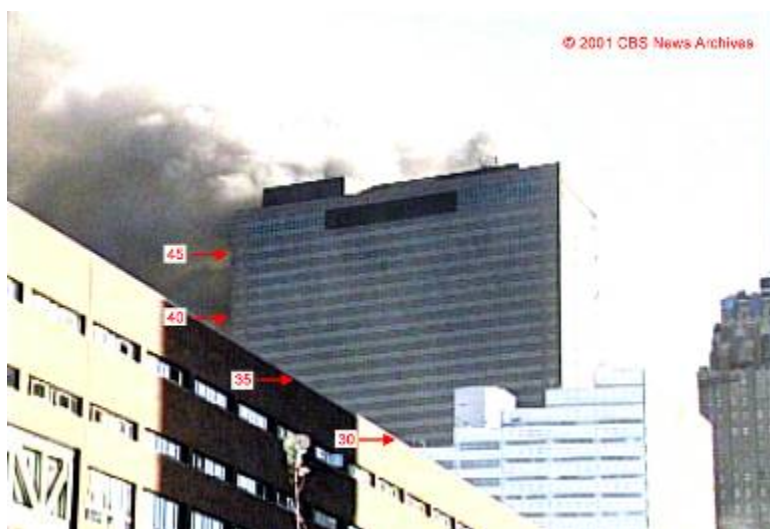
**Figure 5–186.** Frame from the Camera 3 video showing the north face of WTC 7 (in center) seconds before the east penthouse began to fall into the building.

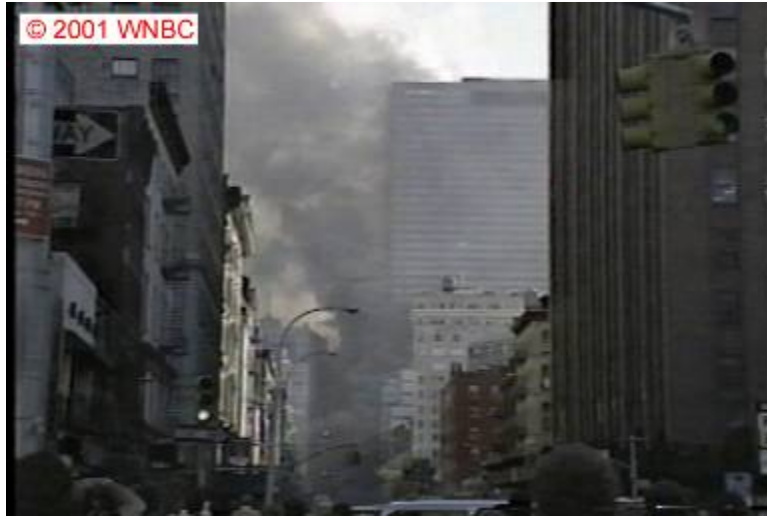
**Figure 5–187. Earliest frame from the Camera 4 video, showing the north face of WTC 7.**

It was shot  $3.7 \text{ s} \pm 0.2 \text{ s}$  after the east penthouse began to sink into the building. The intensity levels have been adjusted.

Perhaps the most interesting feature of Figure 5–187 is the flow of what appears to be dark smoke across the visible part of the northeast corner as high as the 23<sup>rd</sup> floor. The actual composition of the material is not known. It could have been smoke from the fires on lower floors and/or escaping dust generated within the building by ongoing structural changes. Later during the WTC 7 collapse, a debris flow similar to those generated by the collapses of the towers (see Figure 5–27, Figure 5–34, Figure 5–35, and Figure 5–42) formed due to the dust released by the collapse. Due to the shadowing of the area, the dust cloud had a very similar appearance to the dark flow in Figure 5–187. The flow in Figure 5–187 appears to extend out to and across West Broadway and perhaps even somewhat north along this street.

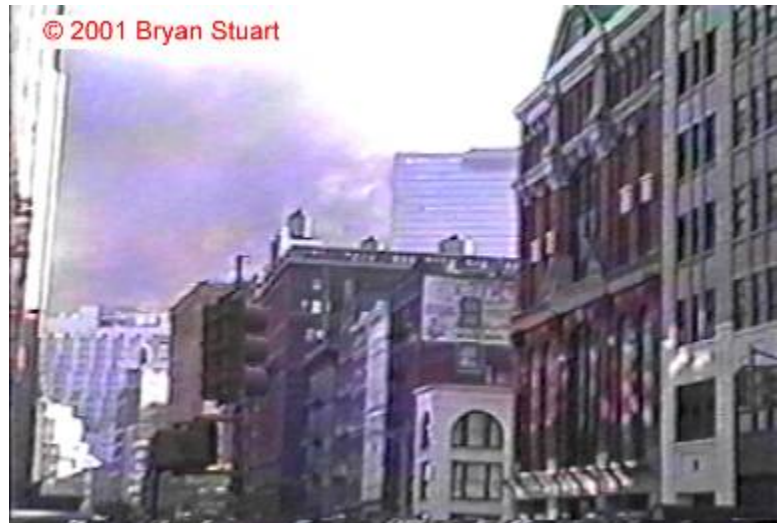
**Figure 5–189. Earliest frame from the Camera 6 video, showing the north face of WTC 7.**

It was shot  $7.2 \text{ s} \pm 0.2 \text{ s}$  after the east penthouse began to sink into the building. The intensity levels have been adjusted.

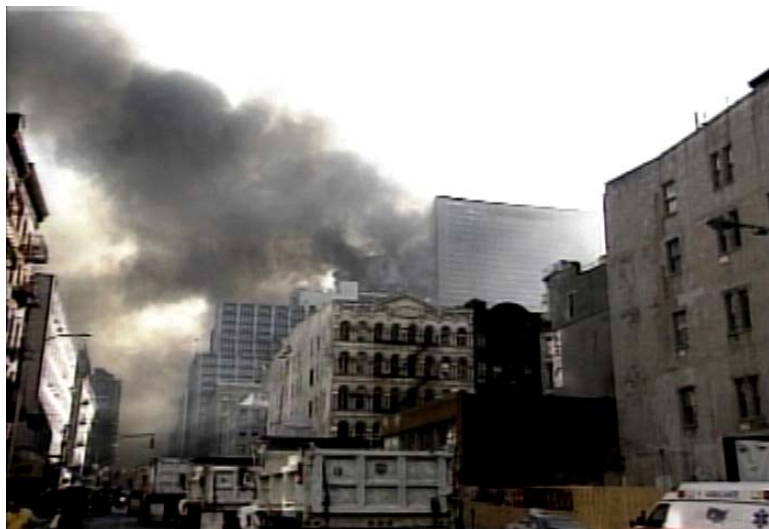
**Figure 5-190. Earliest frame from the Camera 7 video, showing the north face of WTC 7.**

It was shot  $7.7 \text{ s} \pm 0.2 \text{ s}$  after the east penthouse began to sink into the building. The intensity levels have been adjusted.

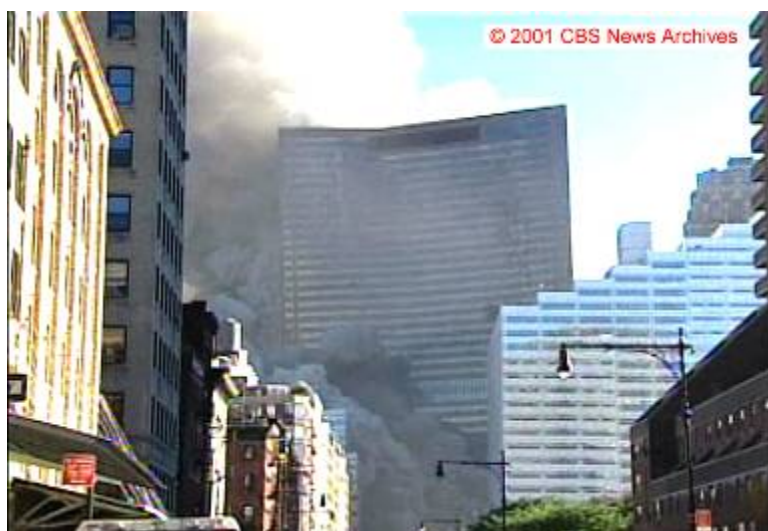
**Figure 5-192. Earliest frame from the Camera 9 video, showing the north face of WTC 7.**

It was shot  $9.4 \text{ s} \pm 0.2 \text{ s}$  after the east penthouse began to sink into the building. The intensities were adjusted.

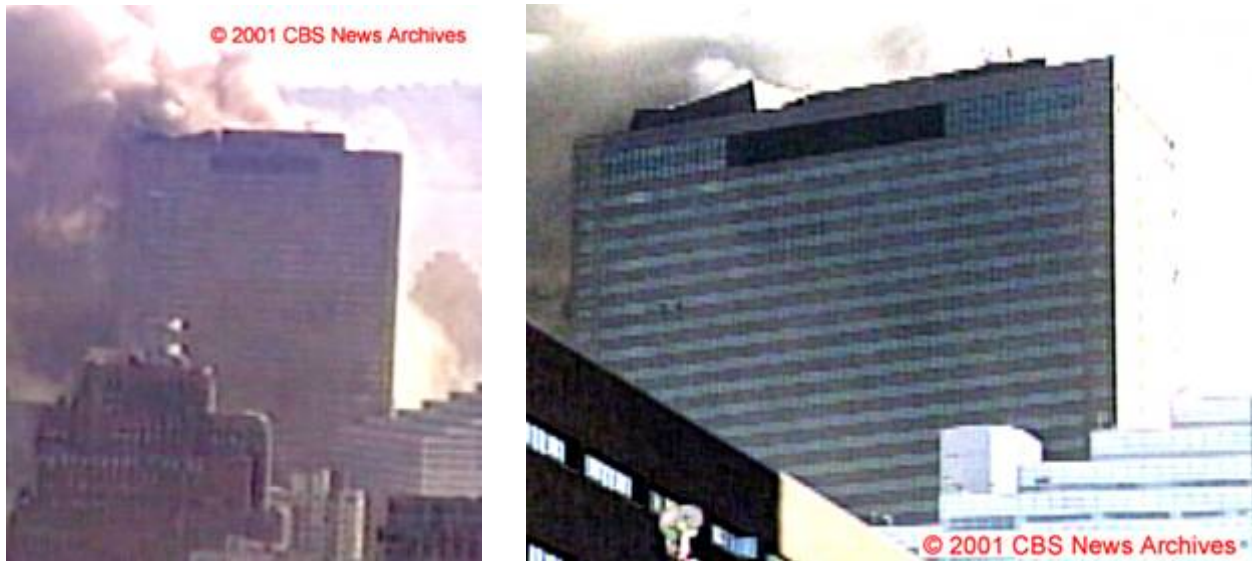
**Figure 5–193. Cropped frames from the Camera 2 video clip and the Camera 3 video clip, showing the north face of WTC 7  $1.0 \text{ s} \pm 0.1 \text{ s}$  after the east penthouse began to move downward.**  
The intensities have been adjusted.

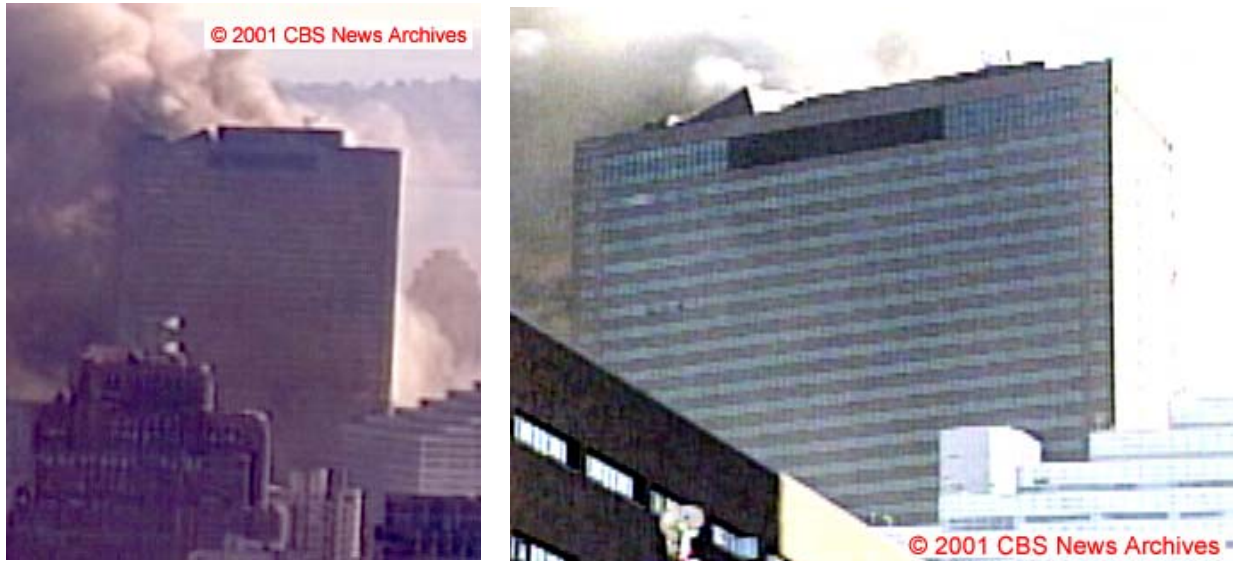
**Figure 5–194. Cropped frames from the Camera 2 video clip and the Camera 3 video clip, showing the north face of WTC 7  $1.3 \text{ s} \pm 0.1 \text{ s}$  after the east penthouse began to move downward.**  
The intensities have been adjusted.

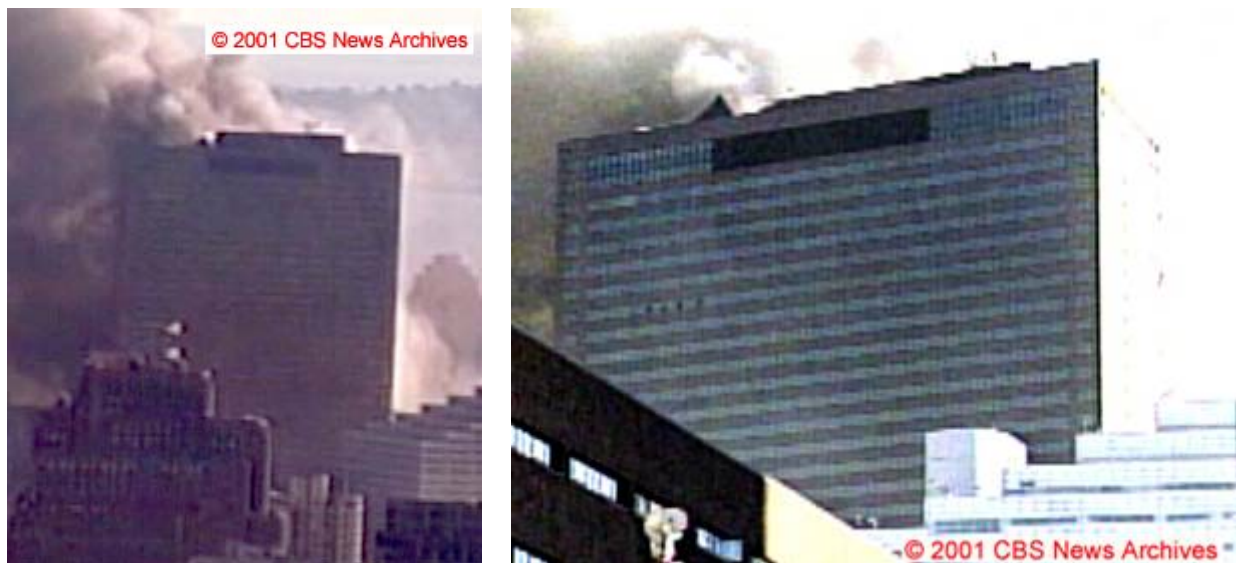
**Figure 5–195. Cropped frames from the Camera 2 video clip and the Camera 3 video clip, showing the north face of WTC 7  $1.7 \text{ s} \pm 0.1 \text{ s}$  after the east penthouse began to move downward.**

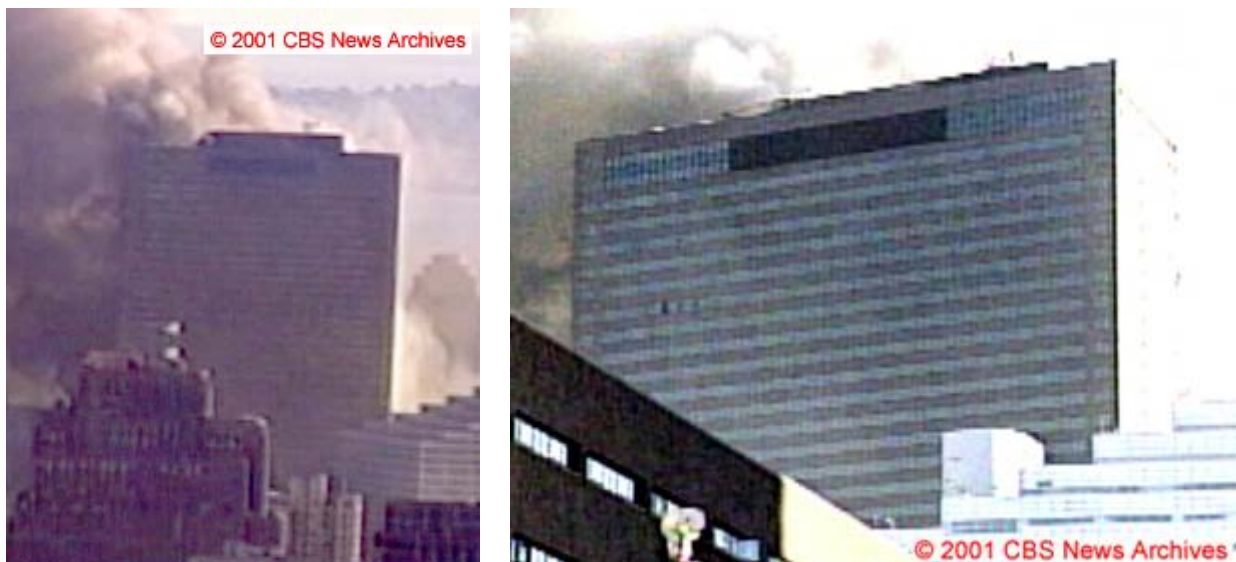
**Figure 5–196. Cropped frames from the Camera 2 video clip and the Camera 3 video clip, showing the north face of WTC 7  $2.0 \text{ s} \pm 0.1 \text{ s}$  after the east penthouse began to move downward.**

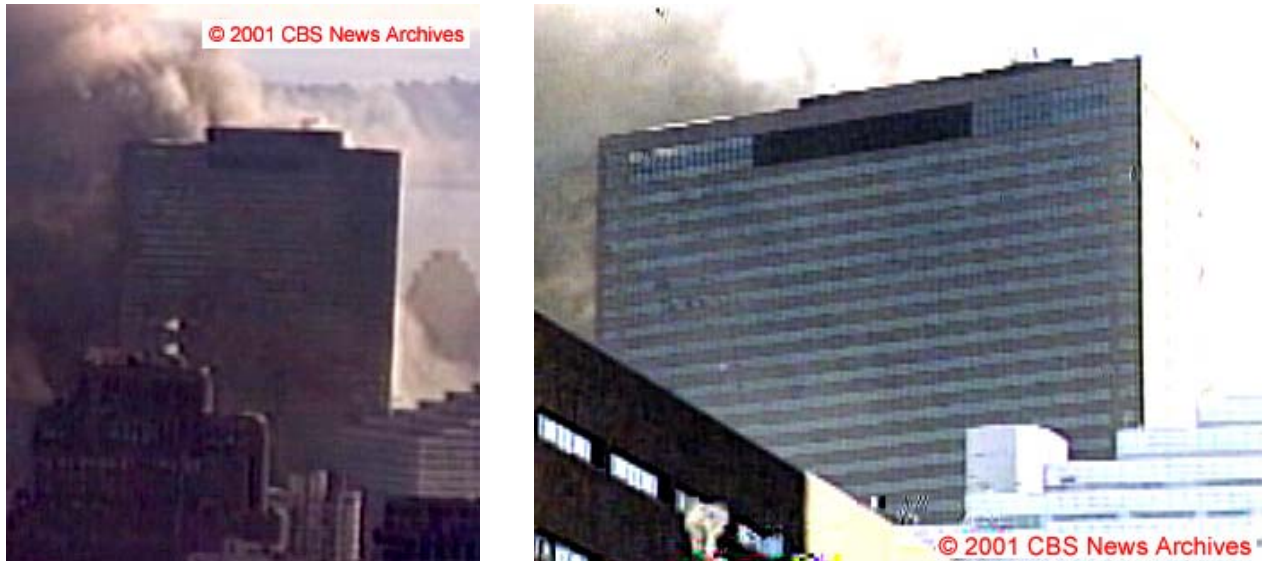
**Figure 5-197. Cropped frames from the Camera 2 video clip and the Camera 3 video clip, showing the north face of WTC 7  $3.5 \text{ s} \pm 0.1 \text{ s}$  after the east penthouse began to move downward.**

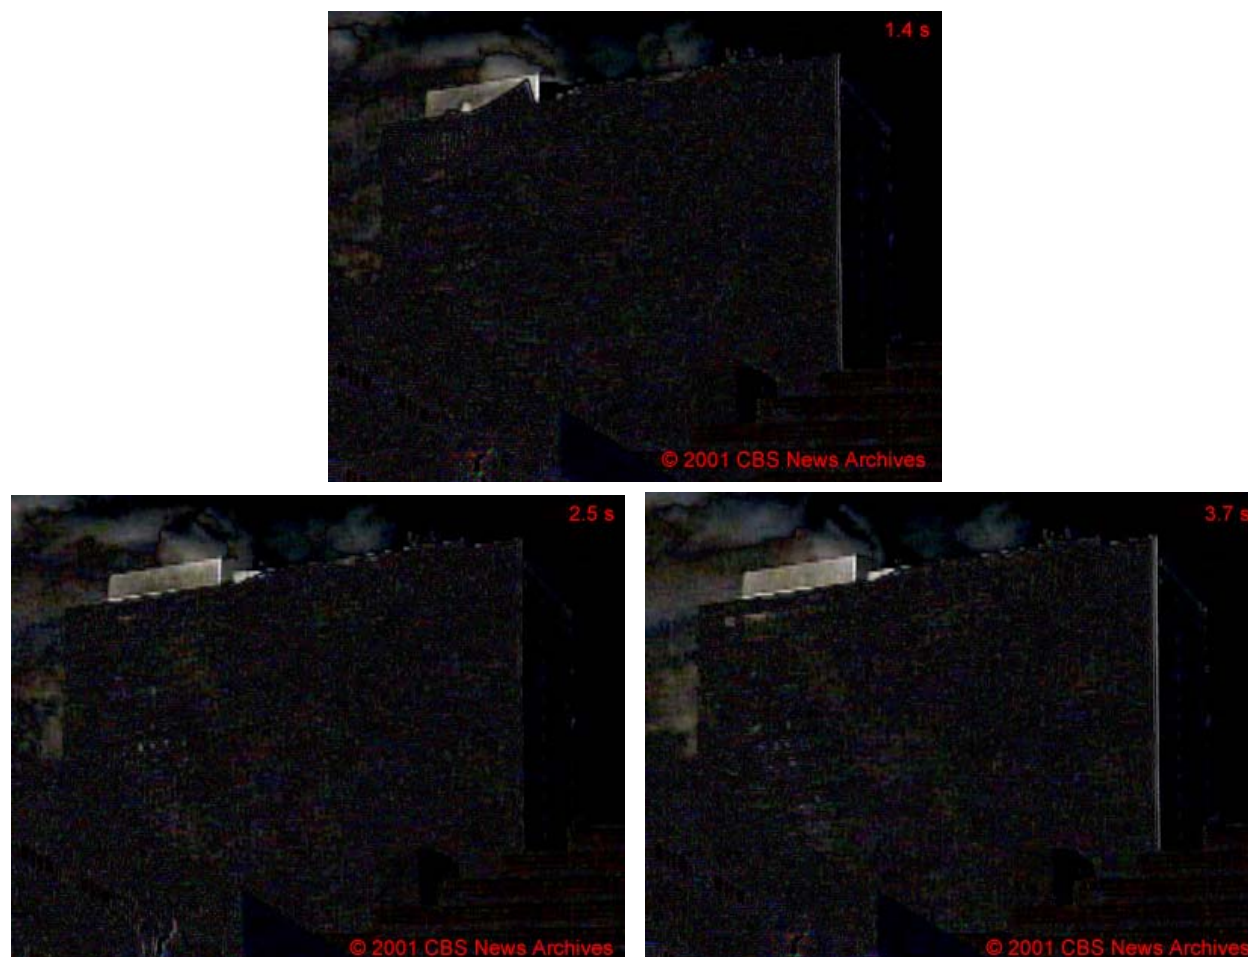
**Figure 5–198. Three cropped difference frames based on the Camera 3 video clip shown in Figure 5–186 created by subtracting a frame from before the east penthouse started downward from each frame in the clip.**

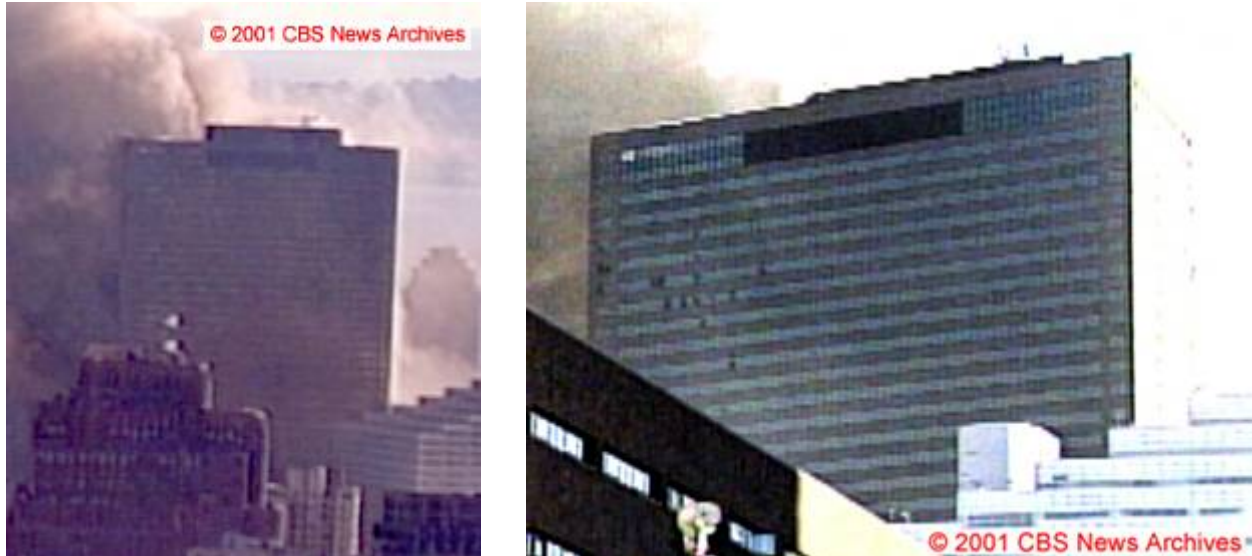
Figure 5–199 shows the north face 5.0 s after the east penthouse began moving downward. These two frames were taken from the Camera 2 long distance and Camera 3 West Street views. The time is 1.5 s after the corresponding views shown in Figure 5–197. There have been relatively minor changes in the appearance of the north face over this period. In the Camera 3 shot, it can be seen that additional glass has broken out of windows on the east side of the face. Open windows are visible at multiple locations from the 37<sup>th</sup> floor to the 43<sup>rd</sup> floor. The light coming through the open roof is apparent for windows on the 46<sup>th</sup> and 47<sup>th</sup> floors. In the longer distance view, the top of the tear-drop shaped light area that was observed moving down the north face is just visible above the buildings in the foreground. Most of the shape has already moved out of view. No other major visible changes were evident over the 1.5 s period.

**Figure 5–199. Cropped frames from the Camera 2 video clip in Figure 5–185 and the Camera 3 video clip in Figure 5–186, showing the north face of WTC 7 5.0 s  $\pm$  0.1 s after the east penthouse began to move downward.**

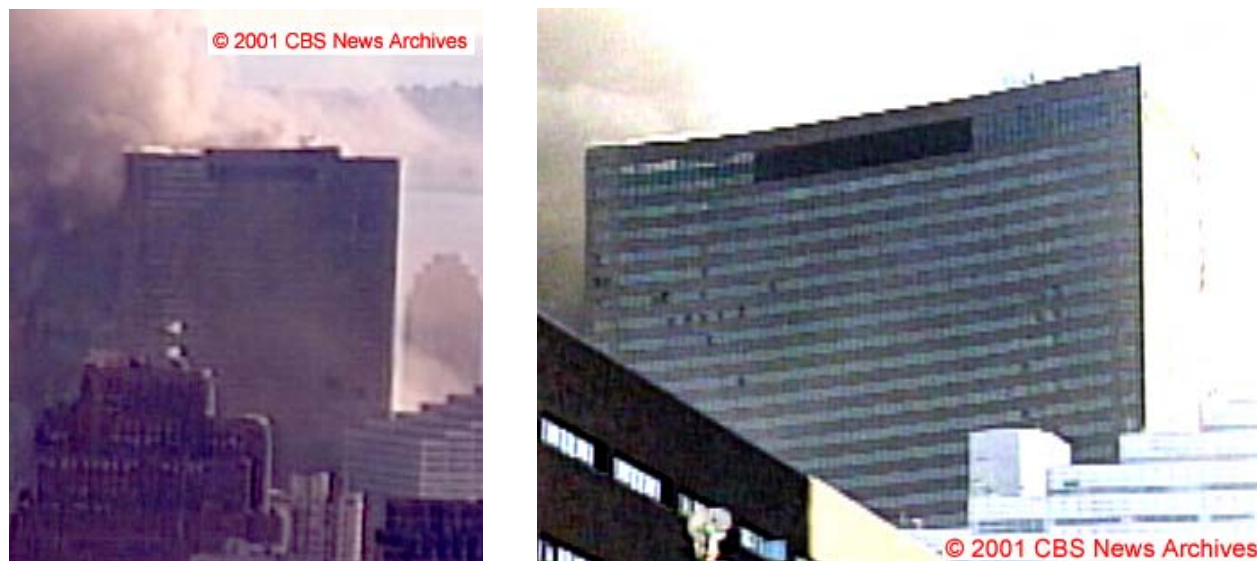
Direct comparison of Figure 5–200 and Figure 5–202 shows that WTC 7 moved downward during the  $0.6 \text{ s}$  period between the images. It also appears that the east end of the north face is rotating to the north relative to the rest of the north face.

It is clear from the distant view in Figure 5–202 that, even though the screenwall and west penthouse have partially sunk into the building, they are still well above the roof and parapet. Close inspection of this image reveals a darker area at the eastern end of the sloping line formed by the screenwall and the west penthouse on the roof. This dark area is the falling object that is about to disappear into the building. On the east side there is a white cloud rising above the roofline. Later frames reveal that this is a dust cloud that is being pushed upward from the opening in the roof as the building collapses.

**Figure 5–202. Cropped frames from the Camera 2 video clip in Figure 5–185 and the Camera 3 video clip in Figure 5–186, showing the north face of WTC 7 8.1 s  $\pm$  0.1 s after the east penthouse began to move downward.**

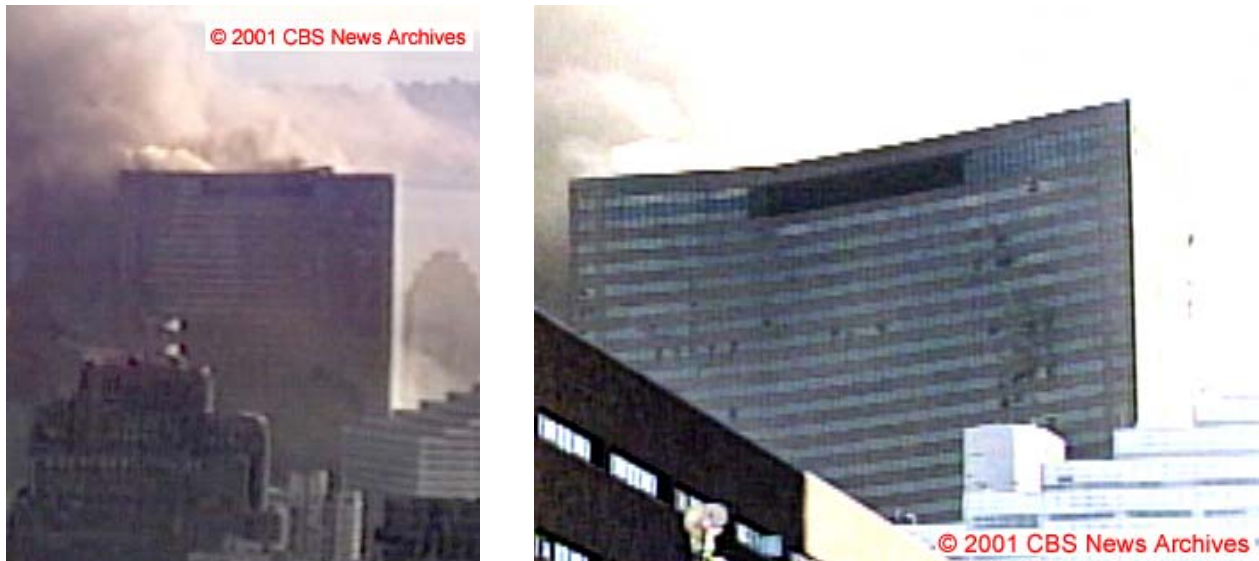
Camera 2 and Camera 3 views of the north face of WTC 7 recorded 0.9 s after those in Figure 5–202, i.e., 9.0 s after the east penthouse began to move, are shown in Figure 5–203. By this time, the entire north face that is visible above the foreground buildings was clearly falling as a unit. By counting the visible floors above the foreground building in the view from West Street, it was found that WTC 7 had fallen nearly two stories in the 2.1 s since the global collapse started. The façade damage on the west side of the face has increased and seems to extend over most of the visible floors between columns 54 and 55. What appears to be dust has begun to flow from the open windows. A few additional windows have opened near the center of the face since the frame in Figure 5–202 was taken. The distribution of open east-side windows looks similar at the two times. The rotation of the east edge of the north face has become more evident, and a distinct kink has begun to develop just to the left of the east end of the louvers on the 46<sup>th</sup> and 47<sup>th</sup> floors. This location is close to perimeter column 47.

**Figure 5–203. Cropped frames from the Camera 2 video clip in Figure 5–185 and the Camera 3 video clip in Figure 5–186, showing the north face of WTC 7 9.0 s  $\pm$  0.1 s after the east penthouse began to move downward.**
