**Federal Building and Fire Safety Investigation of the  
World Trade Center Disaster**

**Structural Fire Response and  
Probable Collapse Sequence of  
World Trade Center Building 7**

**NIST NCSTAR 1-9**

August, 2008

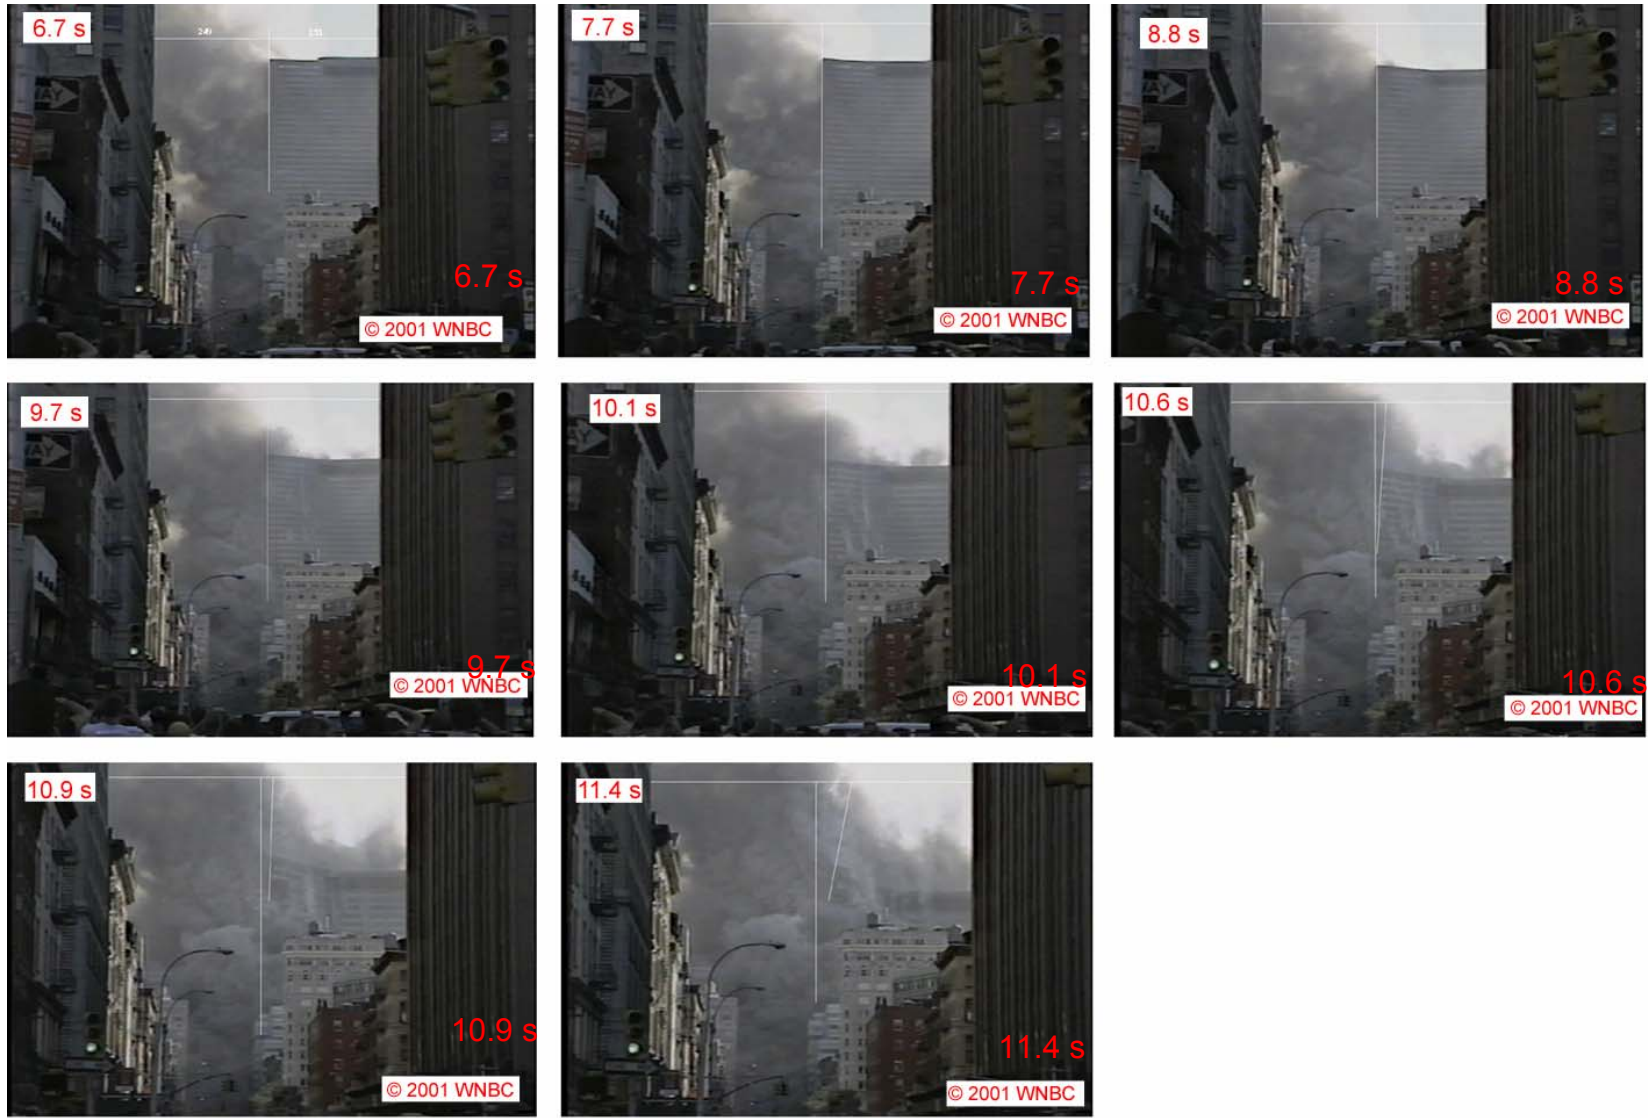
By utilizing video clips from the Camera 3 and Camera 4 videos it was possible to characterize the motions of the northeast and northwest edges of WTC 7 in more detail. A sequence of images from the Camera 4 video is shown in Figure 5–204. This camera was hand held, and during the collapse the camera moved and the operator began to zoom in. As a result, the line corresponding to the pre-collapse location of the northeast edge of WTC 7 moved within the video frames with time. However, the two buildings in the foreground were fixed and provided a means to identify this location in frames after the collapse began. In the first image of Figure 5–204, a vertical line has been drawn tracing the northeast edge of WTC 7, and a horizontal line was drawn to the two buildings in the foreground. Using the foreground building edges as guides, these same lines were imposed on subsequent frames, in effect

identifying the original location of the northeast edge in the frame. Onto each subsequent image, the same lines have been added that trace the evolving location of the northeast edge of the building. In the first five frames the original line and the edge of WTC 7 at the later time coincide within the resolution of the image, showing that the visible northeast edge had not moved perpendicular to a line running between the camera position and the edge of the building. During this time, WTC 7 had begun to collapse, and the roofline had already descended about 10 stories. Thus, well into the building collapse, the northeast corner of the building fell either straight down, directly toward, or directly away from the video camera. In the next frame at 10.6 s following initial movement of the east penthouse, the top of the northeast corner of the building has tilted sharply to the west, and it appears that the building has begun to break apart. This motion continued to grow until the northeast edge became hidden by the rising dust cloud.

Figure 5–204. Images from the Camera 4 video clip showing relative movement of the northeast edge of WTC 7 during its global collapse.

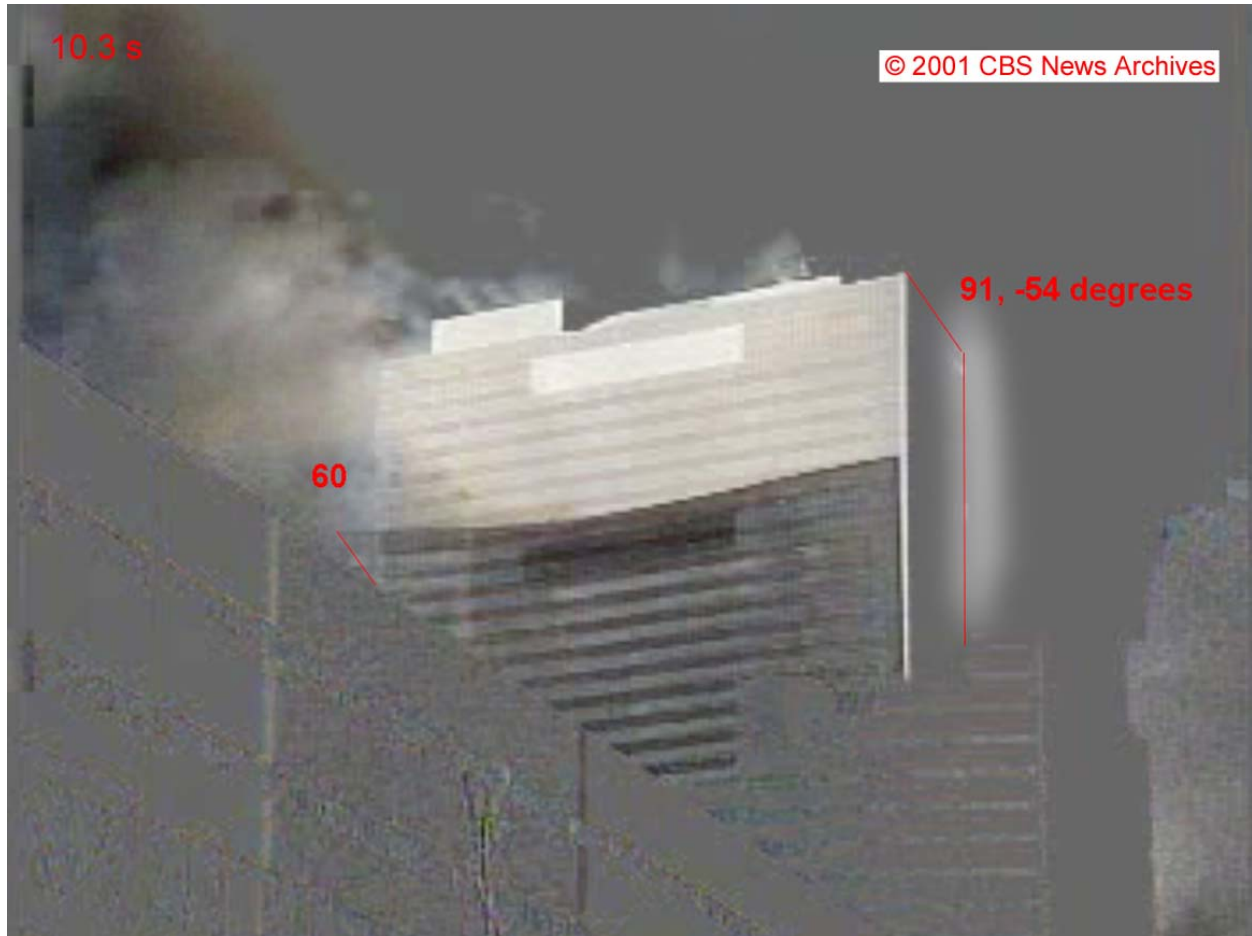
The extent of the northeast edge motion was estimated using the Camera 3 video frame in Figure 5–206, at which time the top of the building had descended about seven stories. The two red lines on the right trace the west roofline and the southwest edge of WTC 7. The red line at the left is parallel to the west roofline and passes through the top of the northeast corner of the descending roofline. A geometric calculation was performed, involving the angle between these two lines, the dimensions of the building, the distance between the camera and the building, and the viewing angles of the northeast and southwest corners. The calculation led to an estimate that, at this point in the collapse, the top of the northeast corner roofline was displaced  $11 \text{ m} \pm 3 \text{ m}$  from its original footprint. In combination with observations from Figure 5–204, it is possible to determine that the motion was primarily due north.

**Figure 5–206. Heavily processed difference frame from the camera 3 video, used to estimate the lateral distance the northeast corner of WTC 7 moved from its original footprint during the collapse.**

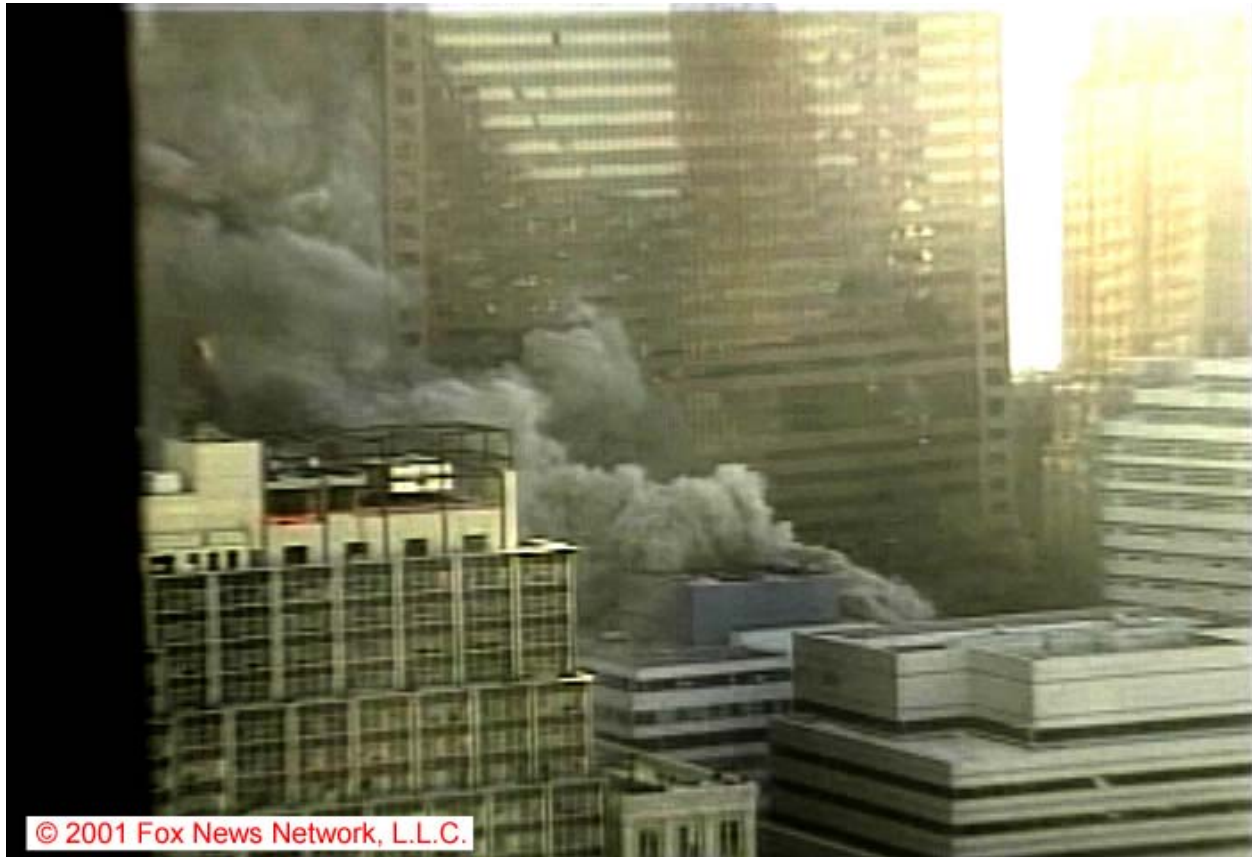
The Camera 6 videographer, who shot the clip from which Figure 5–189 was taken, zoomed in on the north face of WTC 7 as it collapsed. Figure 5–207 shows a frame taken from this clip at about the same time ( $\pm 0.2$  s) that the frames in Figure 5–203 were recorded. In this image, there appears to be both smoke (black) and dust (white) flowing across the north face just above the building in the foreground. Most of the material appears to be dust. It is possible to make out the window damage on the west side of the face between columns 54 and 55. This damage extends at least as far down as the 22<sup>nd</sup> floor. Only a few open windows are visible on the east side of the face.

**Figure 5–207. Frame from the Camera 6 video clip in Figure 5–189, showing the north face of WTC 7  $9.0 \text{ s} \pm 0.2 \text{ s}$  after the east penthouse began to move downward.**

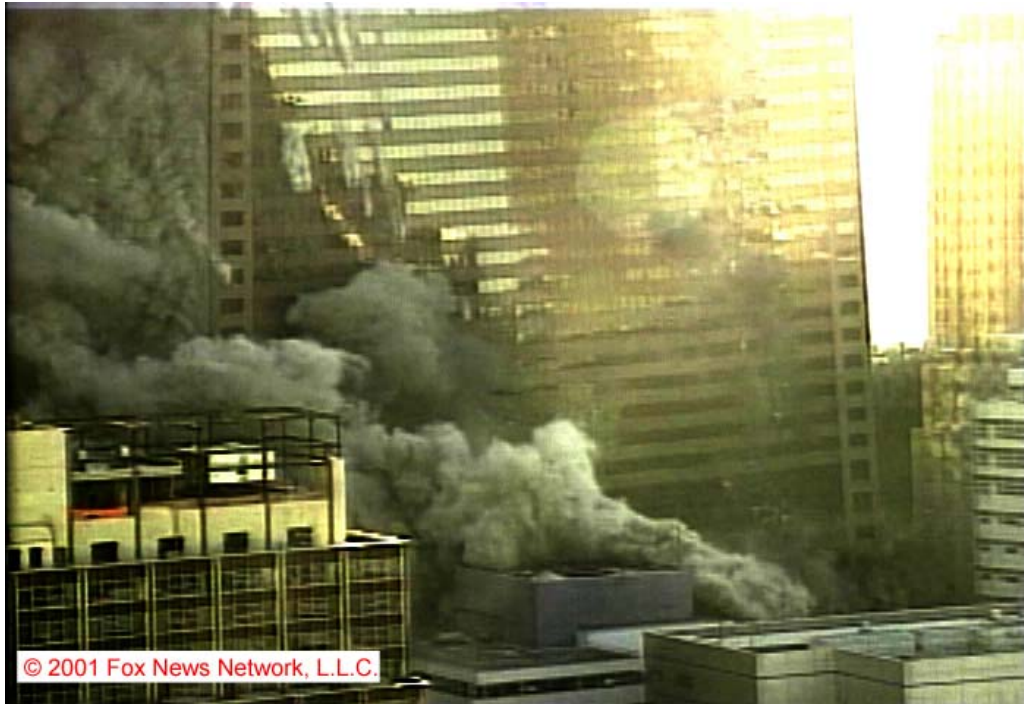
Figure 5–209 shows a frame from Camera 6 of the north face of WTC 7 recorded 10.0 s after the east penthouse began to collapse. Dust trails are flowing from the open windows on the east and west sides of the building. Numerous windows are open near the center of the face, but no dust flows are evident from these windows. The kink in the face near column 47 observed near the top of building in Figure 5–208 appears to extend at least as far down as the mechanical floors on the 22<sup>nd</sup> and 23<sup>rd</sup> floors.

**Figure 5–209.** Frame from the Camera 6 video clip in Figure 5–189, showing the north face of WTC 7  $10.0 \text{ s} \pm 0.2 \text{ s}$  after the east penthouse began to descend. The intensities have been adjusted.

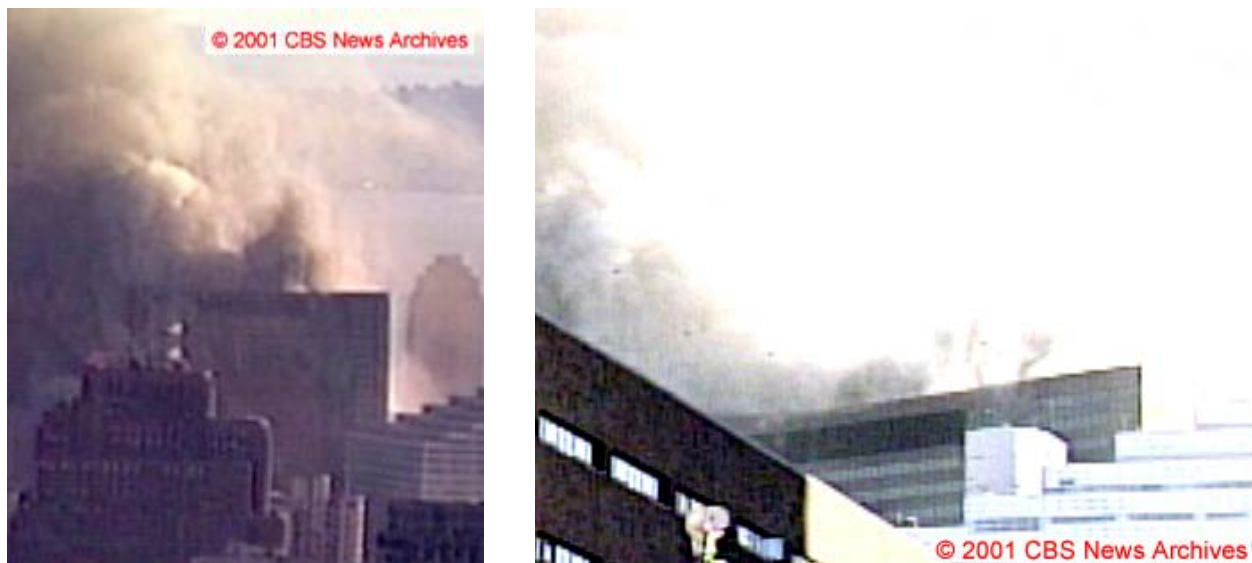
During the next second, the north face of WTC 7 moved downward nearly 6 stories. Figure 5–211 shows the Camera 2 distant and Camera 3 West Street views at 11.0 s following the initial downward movement of the east penthouse. WTC 7 is just about to pass out of sight behind the foreground building in the West Street view. While dust clouds continue to pass over the face, it is remarkable how many windows are still intact at the top of the building. The amount of dust pouring from the open windows of the falling north face is more evident in the distant view. It is also clear that a large amount of dust has been ejected through the roof at the two locations on the east side and near the center.

**Figure 5–211. Cropped frames from the Camera 2 video clip in Figure 5–185 and the Camera 3 video clip in Figure 5–186, showing the north face of WTC 7  $11.0 \text{ s} \pm 0.1 \text{ s}$  after the east penthouse began to move downward. The intensities have been adjusted.**

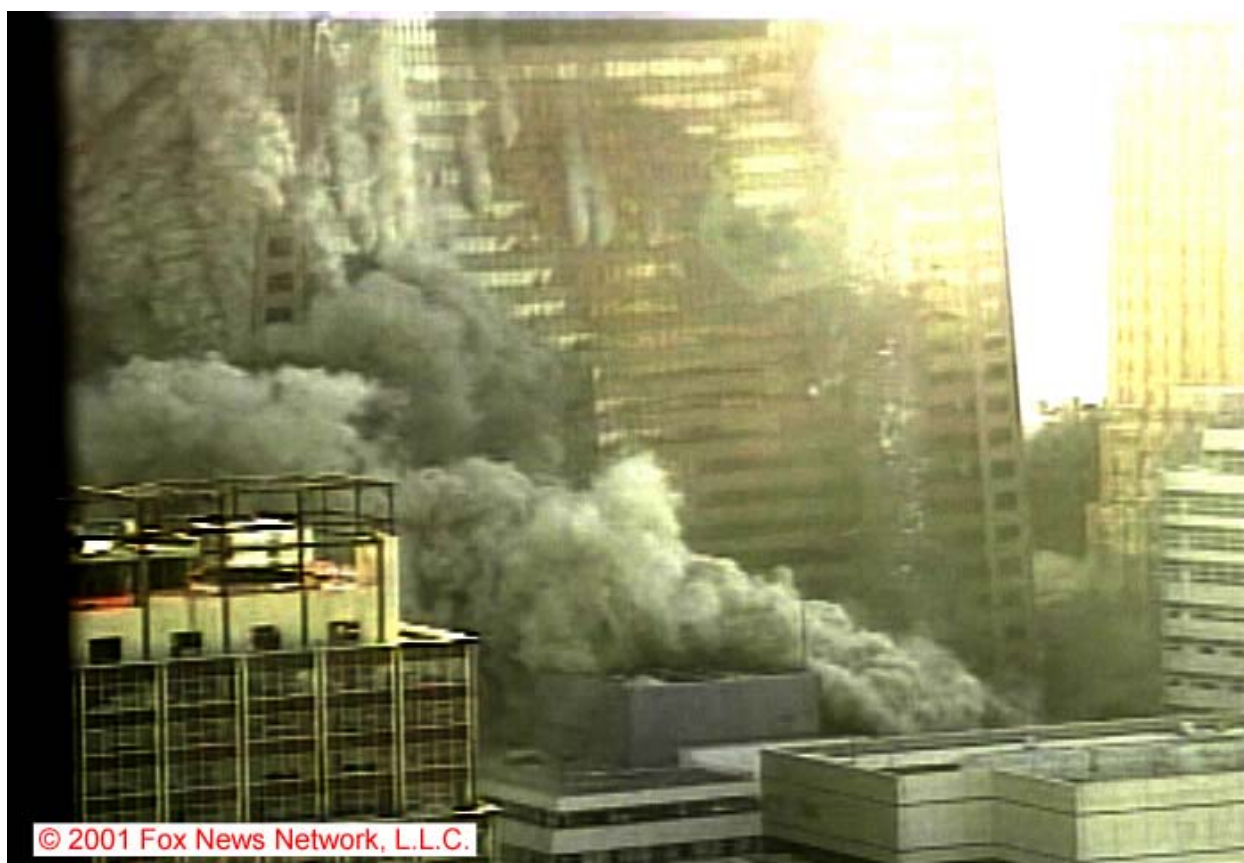
**Figure 5–212. Frame from the Camera 6 video clip in Figure 5–189, showing the north face of WTC 7  $11.0 \text{ s} \pm 0.2 \text{ s}$  after the east penthouse began to move downward. The intensities have been adjusted.**

Figure 5–212 and Figure 5–213 show frames from the northeast (Camera 6) and Greenwich Street (Camera 9) video clips for the same time as the images in Figure 5–211. In both frames, the distortions of the falling building stand out. The kink near column 47 is prominent in Figure 5–213, while in Figure 5–212, a strong distortion is present near the east edge of the north face. Both frames also show the large amount of dust being pushed out of open windows higher up in the building and the huge dust clouds forming near its base. In Figure 5–212, large amounts of dust have been pushed from near the base of the building on the east, north, and west sides. A prominent feature in Figure 5–213 is the large pulses of dust flowing upward through the roof on the east side and near the center.

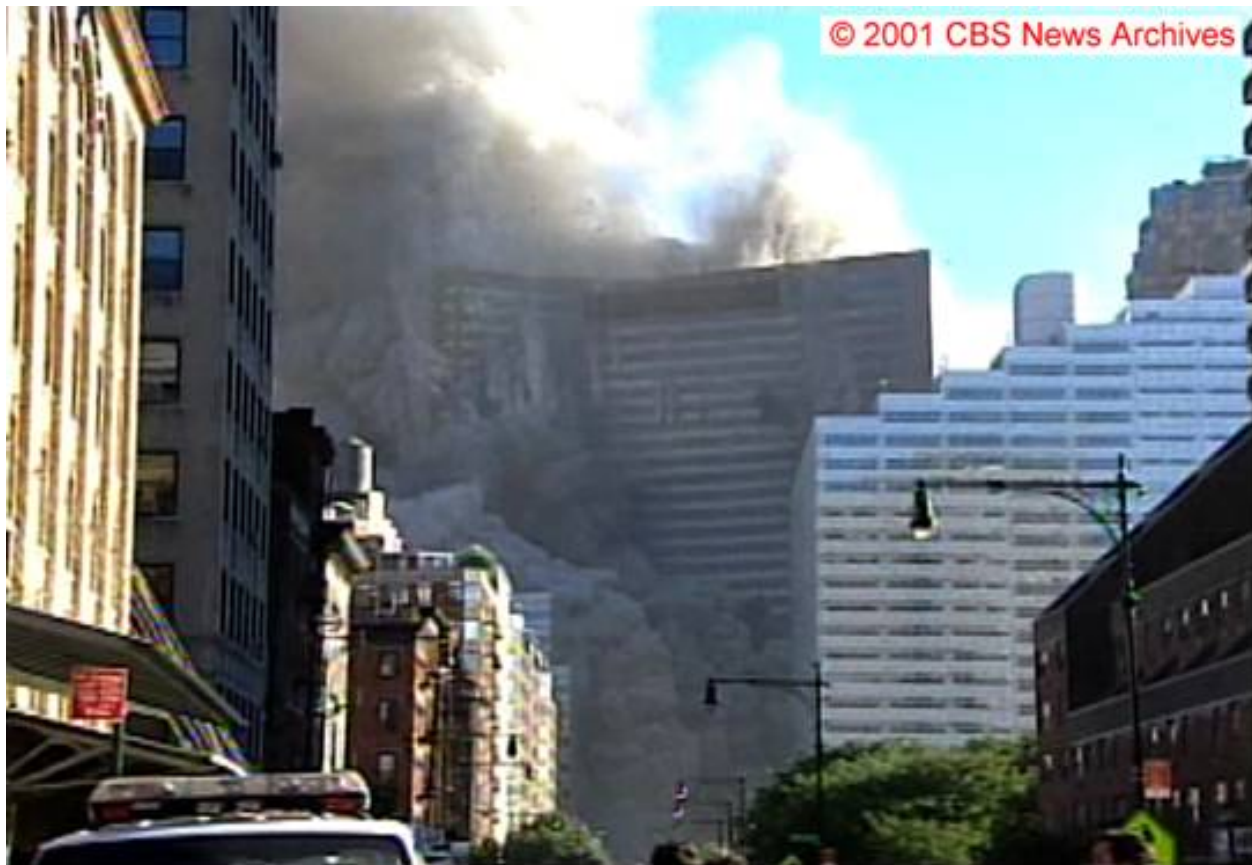
**Figure 5–213.** Frame from the Camera 9 video clip in Figure 5–192 shows the north face of WTC 7  $11.0 \text{ s} \pm 0.2 \text{ s}$  after the east penthouse began to move downward.

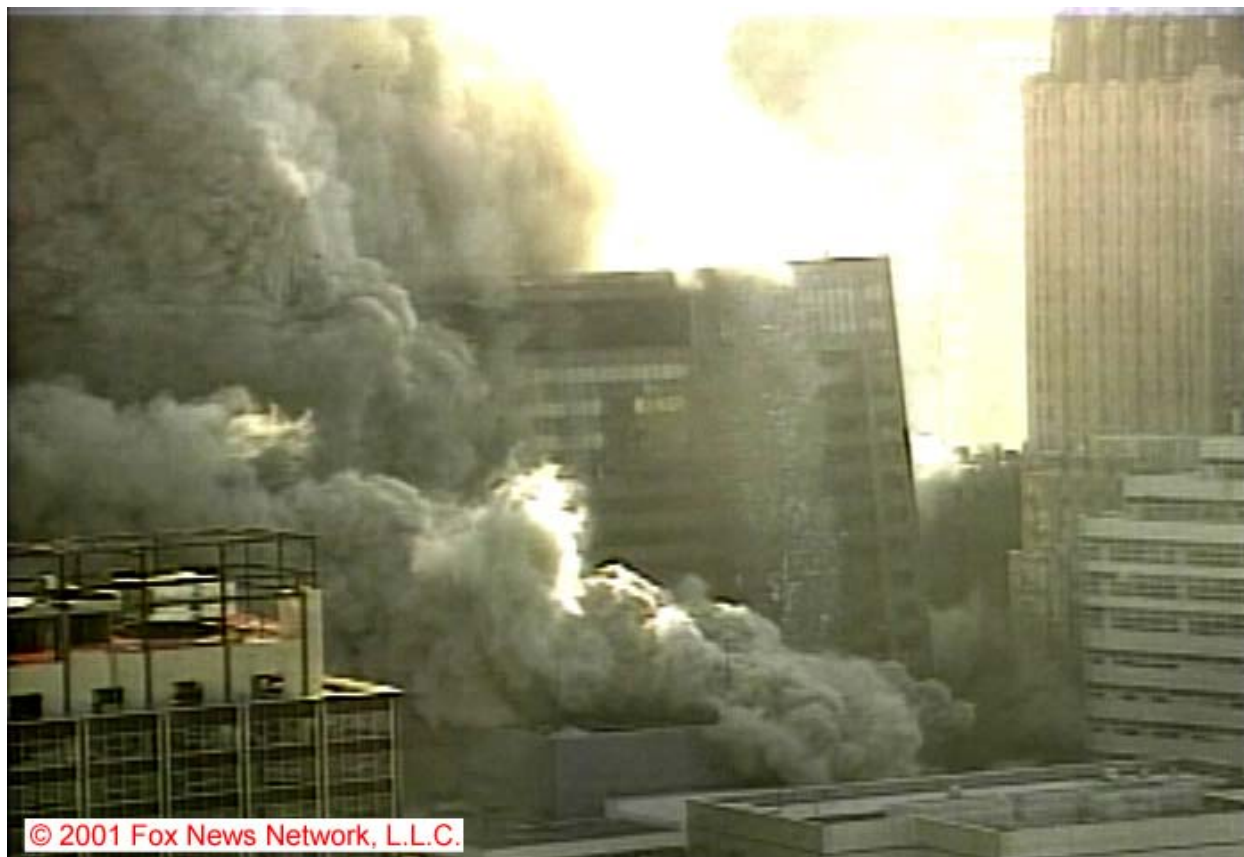
Between 11 s and 12 s following the initial movement of the east penthouse, WTC 7 fell an additional eight stories. By 12 s, there is clear evidence that the collapsing building is breaking apart. Figure 5–214 shows the northeast Camera 6 view of the north face 12 s after the east penthouse began to move. Several sections of the parapet on the west side of the building are missing and light is streaming through the openings. The building appears to be breaking apart on the west side of the north face. A large amount of dust and debris is coming from this area. The Camera 9 view of the building from Greenwich Street at the same time is shown in Figure 5–215. A section of the northeast corner of WTC 7 (indicated by an arrow) is visible well above the remaining roofline for the building. As suggested by the image in Figure 5–212, this corner apparently separated from the remainder of the building and collapsed at a different rate.

**Figure 5–214. Frame from the Camera 6 video clip in Figure 5–189, showing the north face of WTC 7 12.0 s  $\pm$  0.2 s after the east penthouse began to move downward. The intensities have been adjusted.**

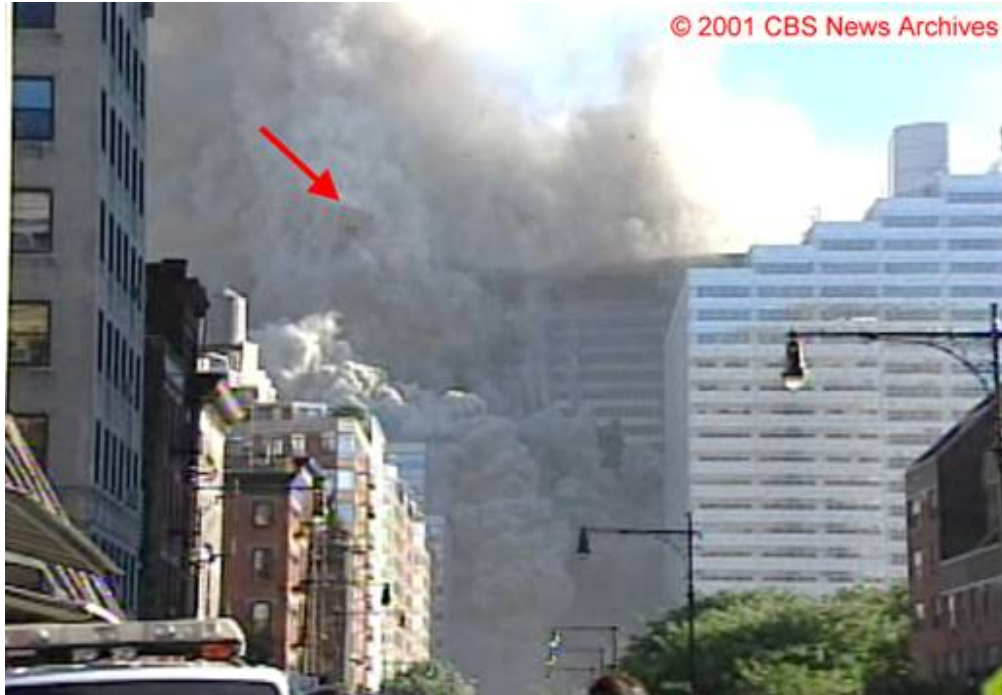
**Figure 5-215.** Frame from the Camera 9 video clip in Figure 5-192, showing the north face of WTC 7  $12.0 \text{ s} \pm 0.2 \text{ s}$  after the east penthouse began to move downward. The arrow indicates a section of the northeast corner of the building that has broken away from the main section of the building. The intensities have been adjusted.

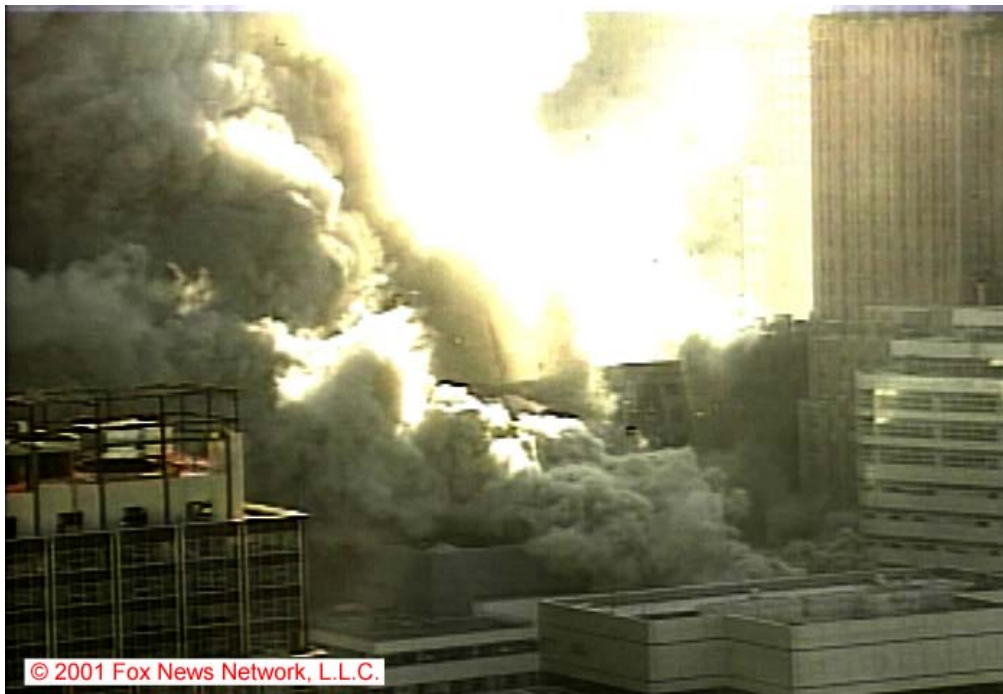
Figure 5–216 shows a frame taken from the Camera 6 video shot looking at WTC 7 from the northeast. It was recorded 13 s following the initiation of east penthouse movement. The remainder of WTC 7 is just about to disappear into the dust cloud. Shortly after most of the building disappeared into the dust cloud, a piece of debris several stories tall appeared from the east side (where it had been hidden by the dust cloud) and fell toward the center of the building. This section of WTC 7 may have come from the northeast corner which had earlier separated from the remainder of the building.

**Figure 5-216.** Frame from the Camera 6 video clip in Figure 5-189, showing the north face of WTC 7  $13.0 \text{ s} \pm 0.2 \text{ s}$  after the east penthouse began to move downward. The intensities have been adjusted.

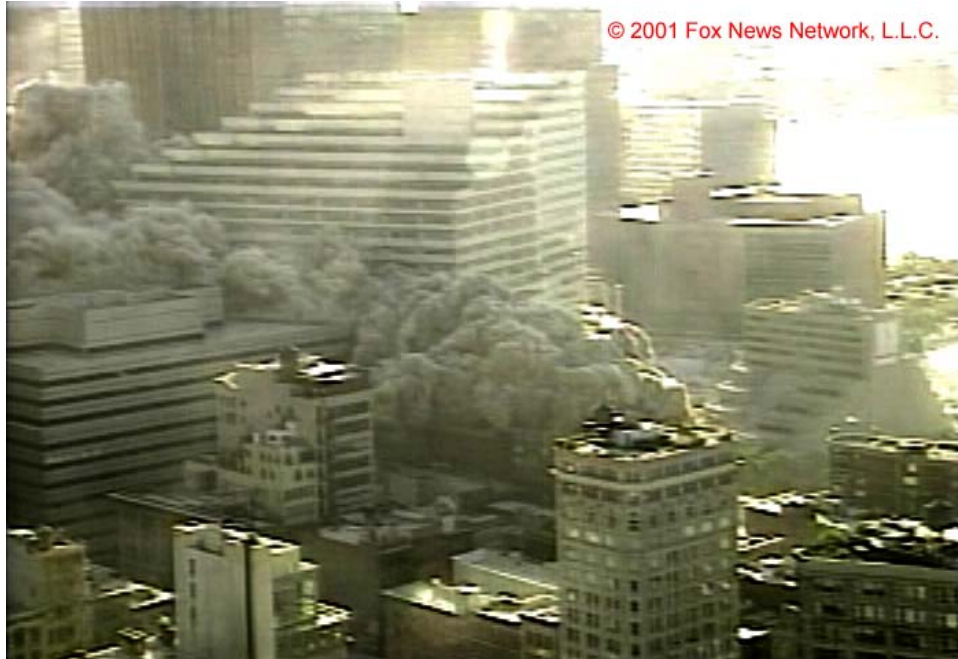
When WTC 7 collapsed, the dust that was generated mixed with air to create a dense mixture that flowed away from the site. The resulting dust- and debris-laden flow spread over many blocks of lower Manhattan. Figure 5–217 and Figure 5–218 show two views of the dust cloud as it spread northward along Greenwich Street after being channeled between the taller buildings at 123 Barclay Street on the west side and 30 West Broadway and 70 Murray Street on the east side.

**Figure 5–217.** Frame from the Camera 6 video clip in Figure 5–189, showing the dust-laden flow generated by the collapse of WTC 7,  $22.0\text{ s} \pm 0.2\text{ s}$  after the east penthouse began to move downward. The intensities have been adjusted.

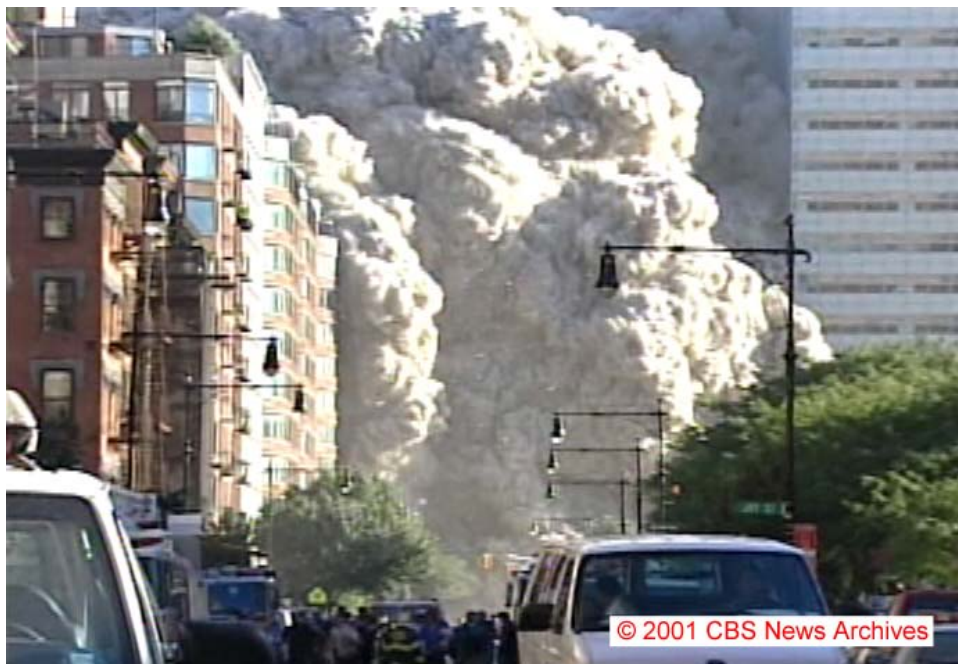
**Figure 5–218.** Frame from the Camera 9 video clip in Figure 5–192, showing the dust-laden flow created by the collapse of WTC 7,  $22.0\text{ s} \pm 0.2\text{ s}$  after the east penthouse began to move downward. The intensities have been adjusted.

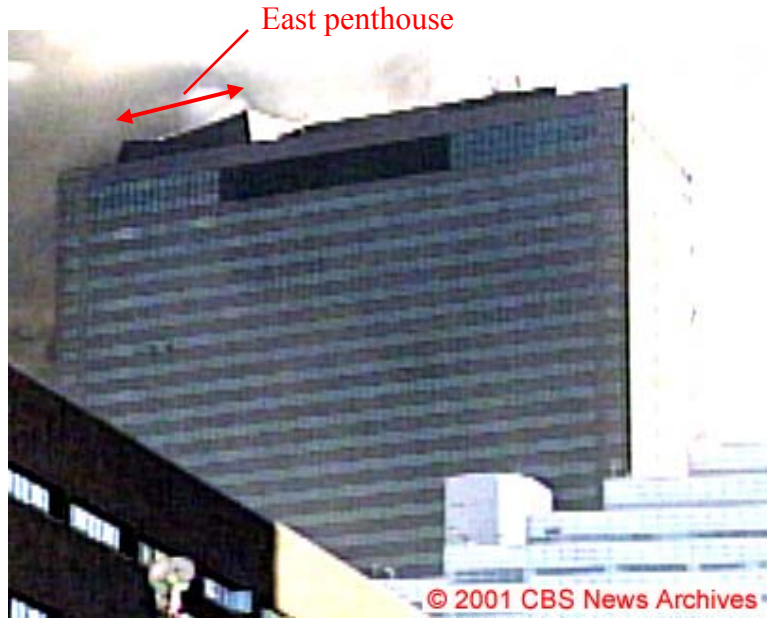
Figure 8–1. East penthouse kinks and begins to collapse.

A video taken from essentially due north was used to measure the location of the “fold” that formed in the north wall of the east penthouse at the onset of collapse (Section 5.7.2). The kink formed approximately 40 percent of the distance from the east edge of the penthouse to the west edge of the penthouse (Figure 8–1). Plotting this location on the penthouse framing plan shows that the kink was located essentially at Post 17 (indicated as “P17” in Figure 8–7). This post was supported directly on the roof girder spanning between Column 79 on the interior of the building and Column 44 on the exterior. This indicated that the girder supported on Columns 79 and 44 likely failed at that instant; and, since exterior column 44 was observed in the video to not fail, and the entire penthouse collapsed, not just the north portion, it was likely that initiation of the collapse of the east penthouse was preceded by collapse of Column 79.

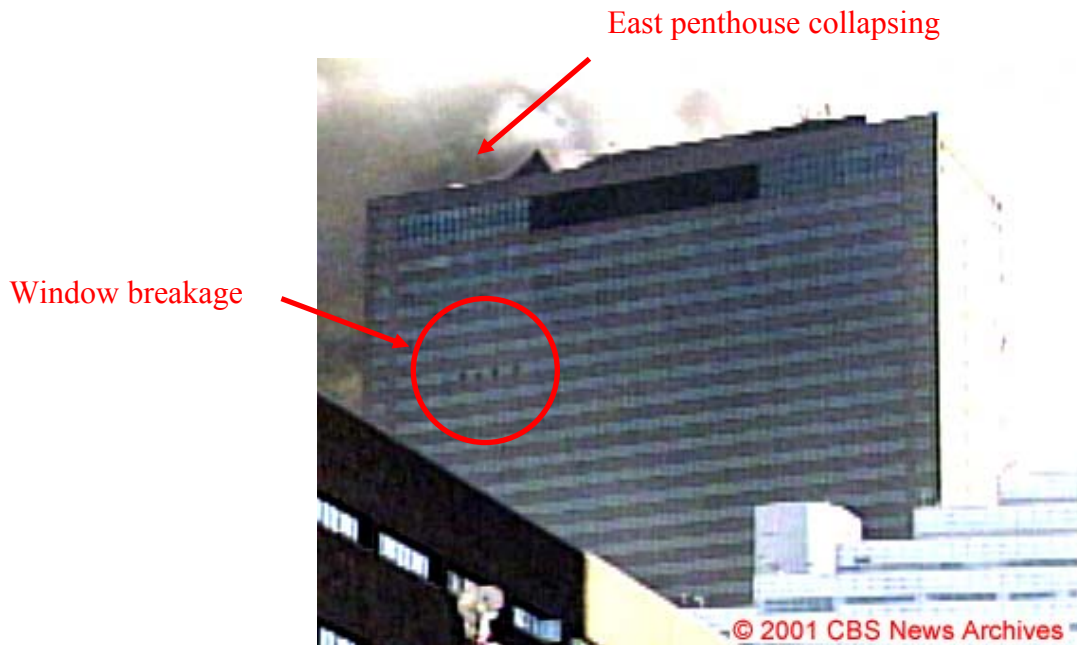
Figure 8–2. East penthouse collapses as roof gives way – windows break between column lines 43 and 45.

As evidenced by the breaking glass in the upper stories (Figure 8–2 and Figure 8–4), collapse on the east side of the building was not limited to the roof and penthouse. Collapses were likely occurring on many floors below with sufficient energy to cause the 47 story building to move laterally in its strong (east-west) direction (Figure 8–3). An analysis of one of the videos using frame subtraction to highlight differences between two video frames (Appendix C), revealed that the northwest edge of the building showed horizontal motion of around 15 in. peak-to-peak oscillation as the east penthouse collapsed (Figure 8–8). Measurable, though smaller, vibrations (about  $\pm 2$  in.) were detected at least 6 s before the east penthouse began to collapse. This suggested that a major disturbance occurred within the building prior to visible evidence of collapse (movement of the east penthouse) from available video recordings.

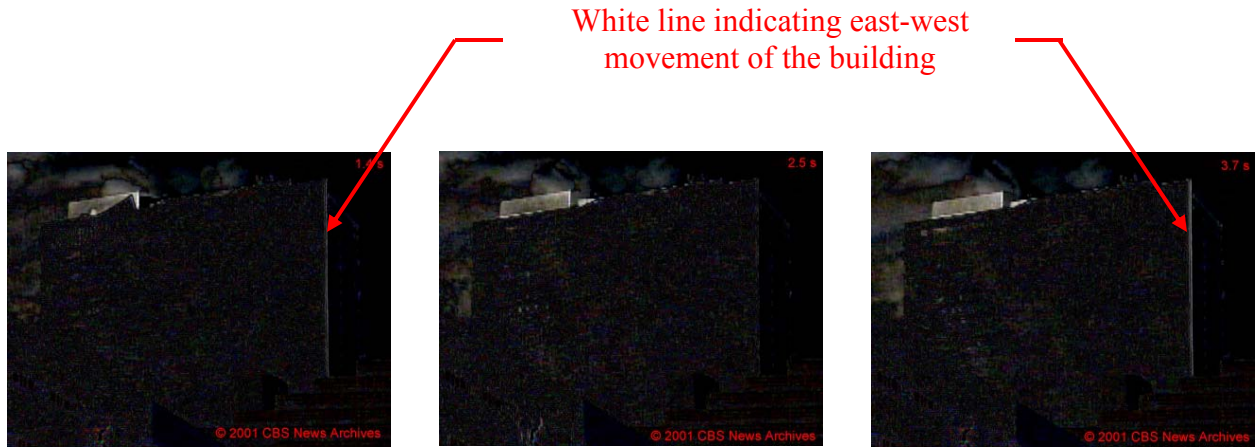
Figure 8–3. Motion of northwest edge of building detected by video frame subtraction.

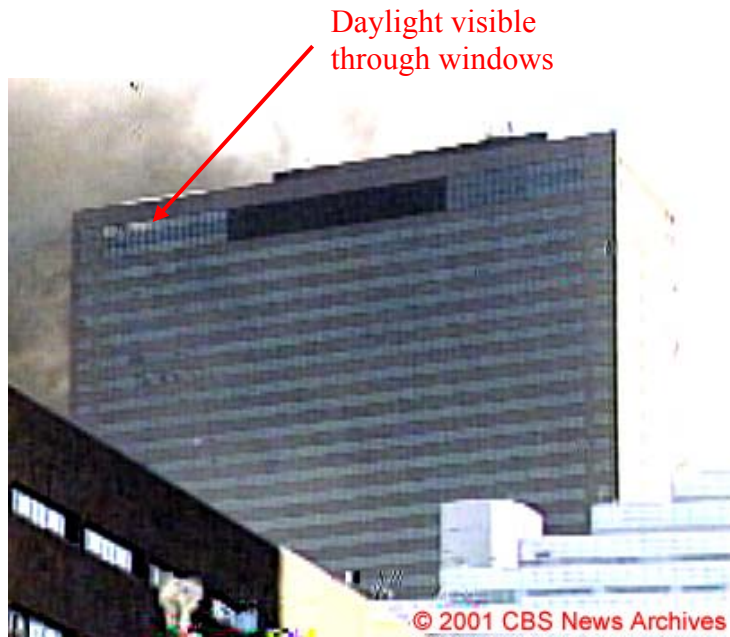
- Daylight was visible through the windows on the 47<sup>th</sup> floor after the entire east side of roof collapsed (Figure 8–4).
- Beginning of global collapse of WTC 7 was detected as the roofline below the location of the east penthouse and the eastern end of the screenwall started dropping simultaneously; and the north wall rotated and developed a kink near column 47 (see Figure 8–5).

Figure 8–4. Daylight visible where roof collapsed on east side of building.

For the widespread failure of the roof on the east side of the building to occur, as evidenced by daylight visible through the upper story windows (Figure 8–4), it appeared likely that Column 79 failed along with the girders that framed into it (including the one that spanned to Column 44) and the surrounding roof beams. The east side of this penthouse was observed to first move downward before rotating inward, which would be consistent with loss of support of the roof beams. The west side of the east penthouse did not move downward initially (Figure 8–2), but rather rotated about its base, which aligned with the east edge of the core along Columns 76, 77 and 78 (Figure 8–7). Thus, at the time of collapse of the east penthouse, it is likely that at least the east edge of the core was still supporting load.

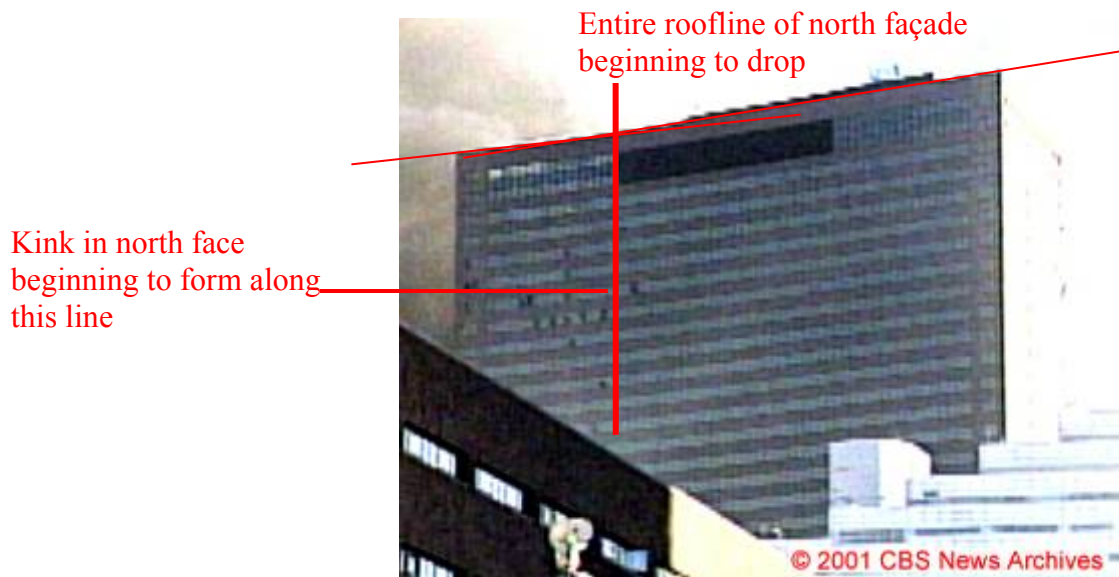
**Figure 8–5. Global collapse of WTC 7 begins about seven seconds after the onset of collapse of the east penthouse.**

The global collapse of WTC 7 began approximately 7 s after the onset of collapse of the east penthouse (Figure 8–5). At this time, the entire upper section of the building -- all floors visible in the videos -- moved downward at the same time suggesting widespread failure of the support structure (columns and/or transfer trusses) in the lower levels of the building (Figure 8–6).

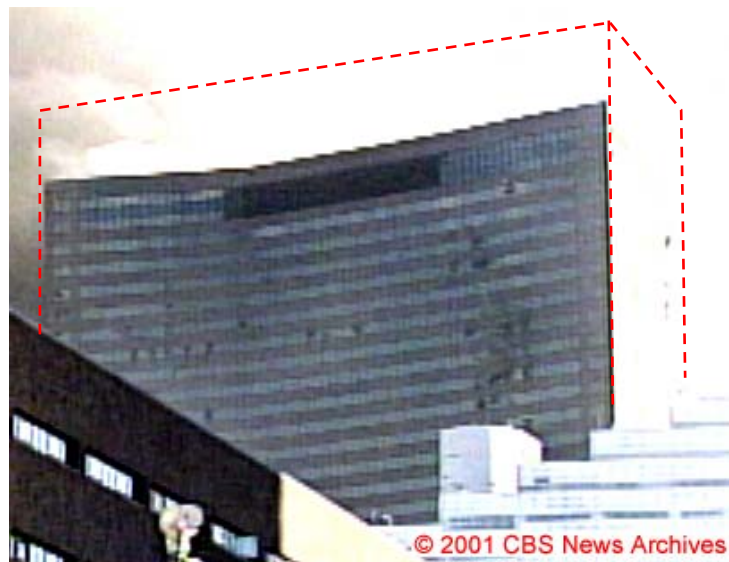
- The entire upper portion of the building, i.e., all floors visible in the videos, began to move downward, and window breakage occurred on the west side of the north face between column lines 53 and 55 as the building collapsed (Figure 8–6). The dashed red lines in Figure 8-6 are the silhouette of the building from Figure 8–1. It is included to provide a qualitative indication of the extent to which the upper portion of WTC 7 had descended.

**Figure 8–6. Entire building continues to collapse.**

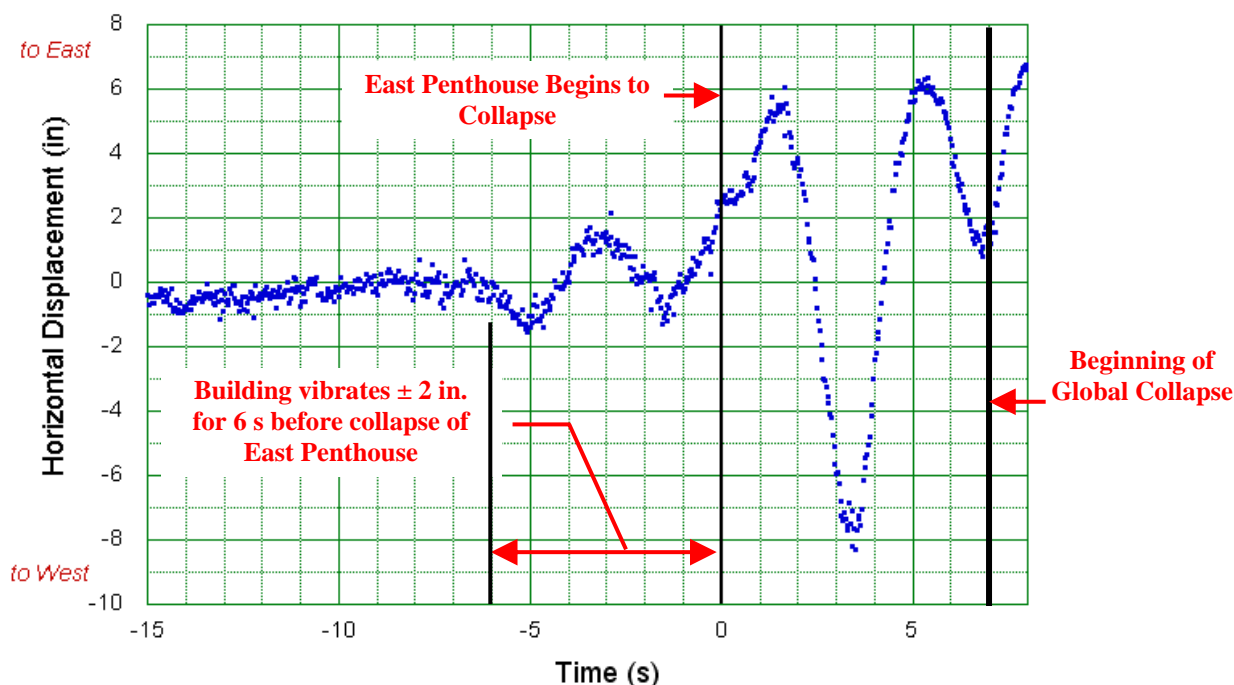
Figure 8–8. Horizontal motion detected on the northwest edge of the building.

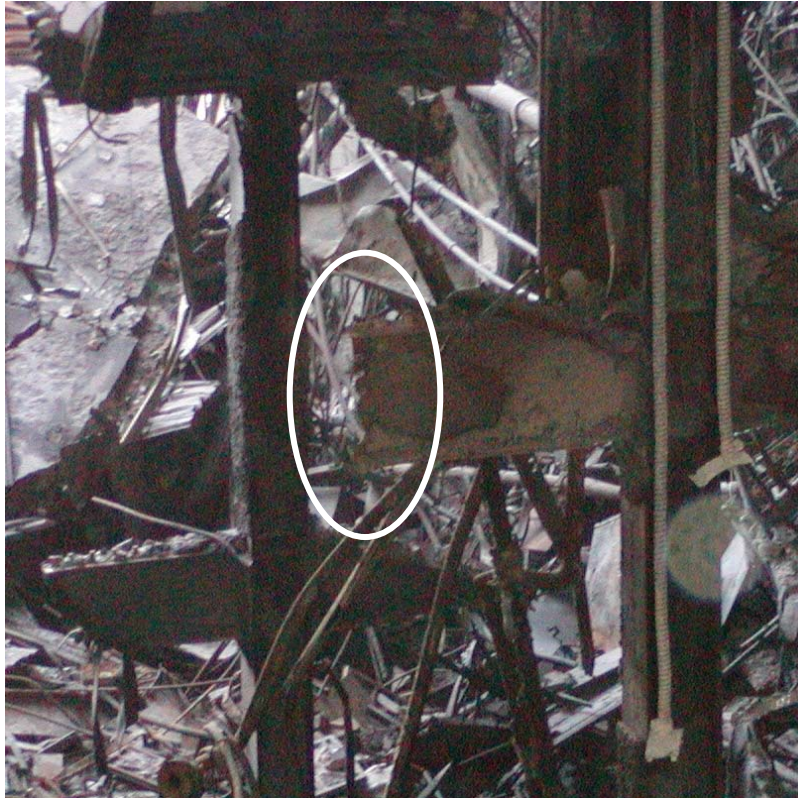
The World Trade Center Building 5 (WTC 5) was a 9 story office building located on the north side of the World Trade Center Plaza. The collapse of WTC 1 caused damage to WTC 5 and started fires in it (McAllister 2002). The uncontrolled fires resulted in complete burnout of most floors and partial collapse of four floors. The building was steel frame construction with field-bolted connections between floor beams and column tree assemblies. Failure of large sections of floor, in areas not damaged by falling debris from WTC 1, resulted from bolt tear-out at these connections as a result of the uncontrolled fires (Figure 8–14). Photographs of two recovered samples of floor beams (Figure 8–15) show how the field bolts tore out from the beam web weakened by the fires (McAllister 2002).

**Figure 8–14. Tear-out of beam web due to uncontrolled fires.**

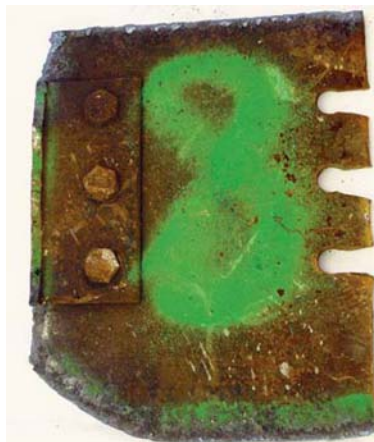
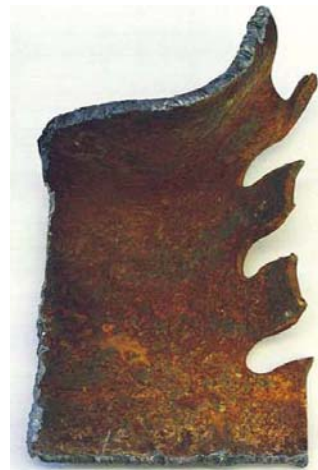
**Figure 8–15. Steel samples recovered from WTC 5, showing tear-out of beam web.**

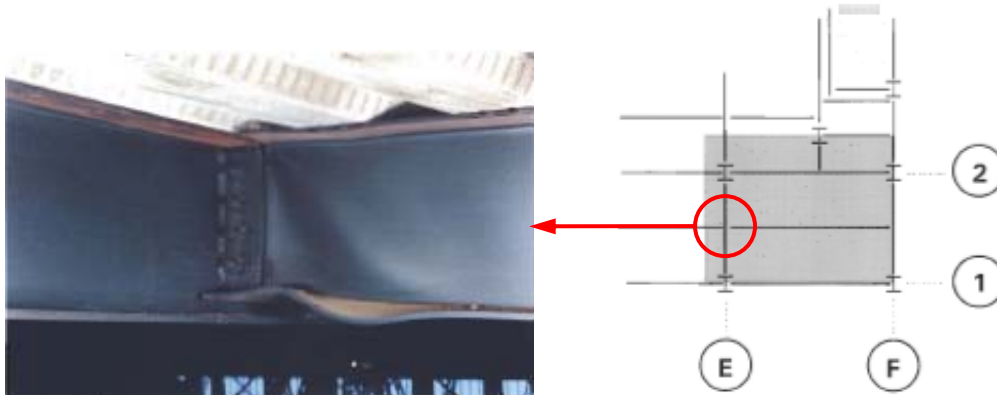
reached almost 1000 °C. The floor beam in this test framed into a girder on column line E, and into a spandrel beam on the building exterior on column line F (Figure 8–17). Thermal expansion of the floor beam framing into the girder on column line E was resisted by a floor beam framing from the opposite side (the floor beam spanning between column lines D and E), resulting in forces sufficient to buckle the bottom flange. The top flange of the beam did not buckle, since both the primary and secondary beams were tied to the slab using shear studs.

**Figure 8–17. Floor beam buckling at symmetrical framing to girder.**

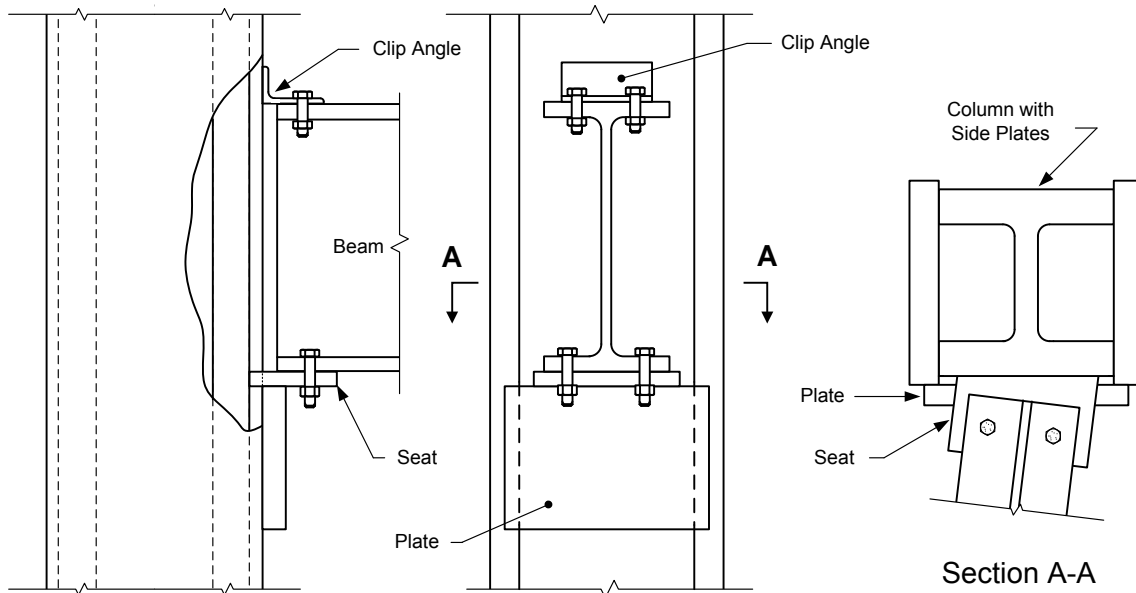
Consider the girder that spans between Column 79 on the interior of the building and Column 44 on the exterior. Thermal expansion of this girder would have loaded the erection bolts in shear, since (1) there were no shear studs anchoring the girder to the slab (and thereby restraining elongation), and (2) the columns to which the beam or girder frames were prevented from movement because they were embedded in the floor slabs which had considerable in-plane stiffness. Additionally, the expansion of floor beams that framed into this girder, because the framing is asymmetrical, tended to load the erection bolts in shear as well. The combination of these two shear loads could have failed the bolts in shear. If

the erection bolts were to fail, then there would be no positive attachment preventing the girder from being pushed off the seat.

**Figure 8–21. Seat connection at Column 79.**
