**Federal Building and Fire Safety Investigation of the  
World Trade Center Disaster**

**Structural Fire Response and  
Probable Collapse Sequence of  
World Trade Center Building 7**

**NIST NCSTAR 1-9**

August, 2008

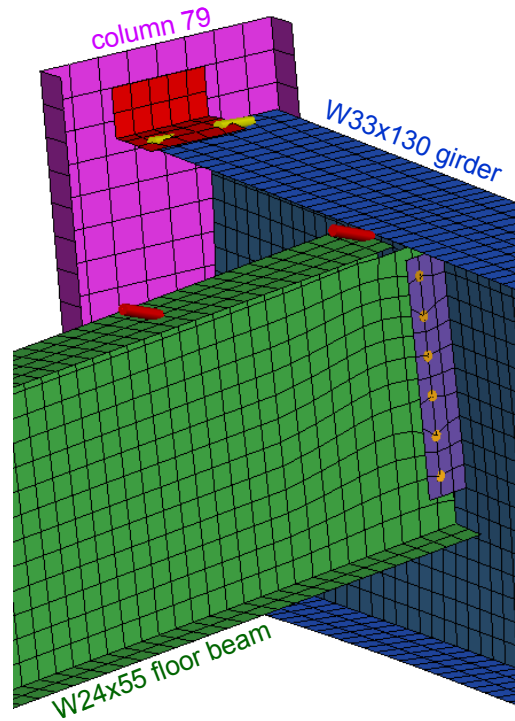
The predicted response of the system is summarized in Table 8–2. The first failures observed were of the shear studs, which were produced by axial expansion of the floor beams, and which began to occur at fairly low beam temperature of 103 °C. Axial expansion of the girder then led to shear failure of the bolts at the connection to Column 79; and, at a girder temperature of 164 °C, all four erection bolts had failed, leaving that end of the girder essentially unrestrained against rotation. Continued axial expansion of the floor beams pushed the girder laterally at Column 79, as shown in Figure 8–26, in which failed shear studs and bolts were evident. When the beam temperatures had reached 300 °C, all but three shear studs in the model had failed due to axial expansion of the beams, leaving the top flanges of the beams essentially unrestrained laterally. Continued axial expansion of the girder caused it to bear against the face of column 79, generating large axial forces that led to failure of the bolts connecting the girder to Column 44. When the girder temperature had reached 398 °C, all four erection bolts at column 44 had failed, leaving the girder essentially unrestrained against rotation at both ends. After failure of the erection bolts in the seat at Column 44, continued axial expansion of the floor beams pushed the girder laterally, where it came to bear against the inside of the column flange. Axial compression then increased in the floor beams, and at a beam temperature of 436 °C, the northmost beam began to buckle laterally. Buckling of other floor beams followed as shown in Figure 8–27 (a), leading to collapse of the floor system, and rocking of the girder off its seat at Column 79 as shown in Figure 8–27 (b). The collapse process took time to occur in the LS-DYNA analysis, during which the temperatures had ramped up to their maximum values in the simulation.

Figure 8–26. Lateral displacement of girder due to thermal expansion of floor beam.  
Note: failed bolts and shear studs

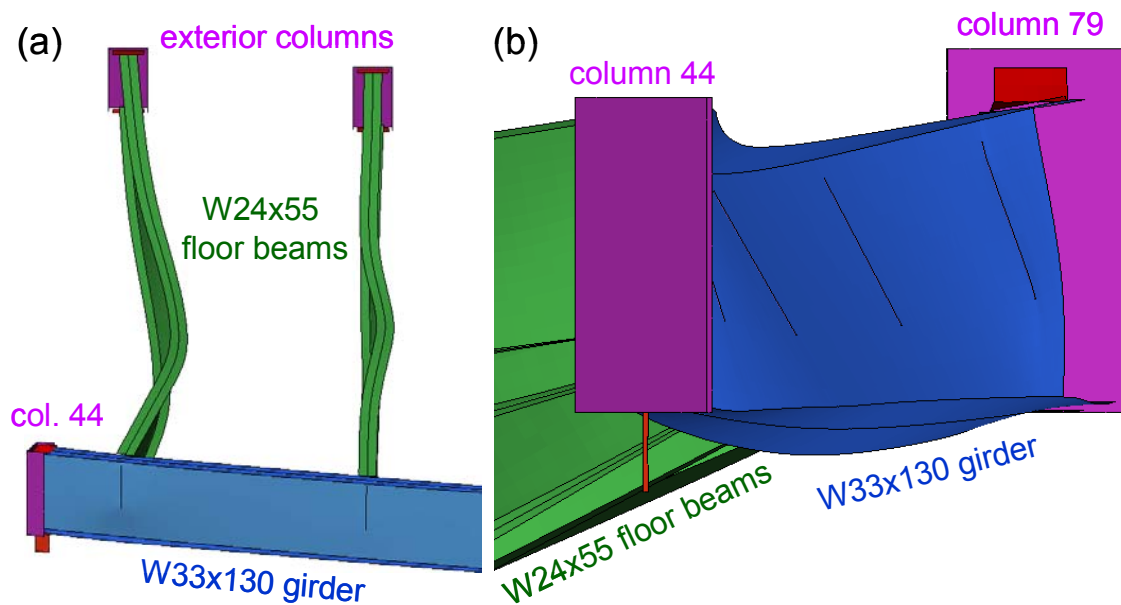
Figure 8–27. Buckled floor beams shown from above (a) and along girder (b).
