NIST Special Publication 1000-5

June 2004
Progress Report on the
Federal Building and Fire Safety
Investigation of the
World Trade Center Disaster

Volume 1

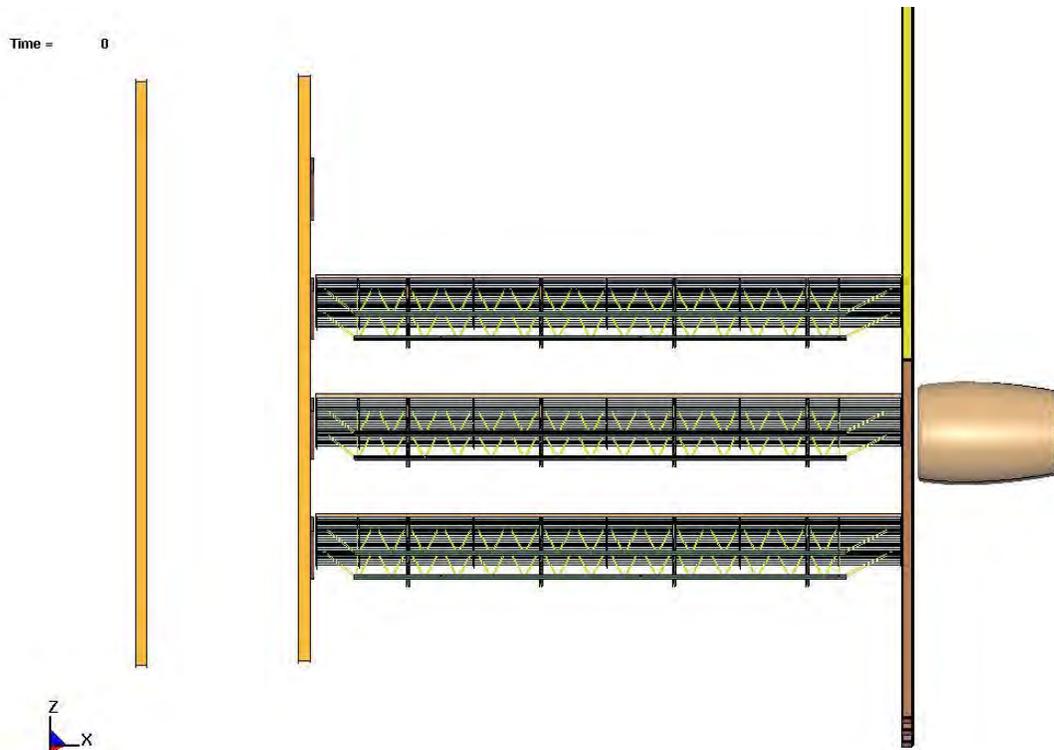
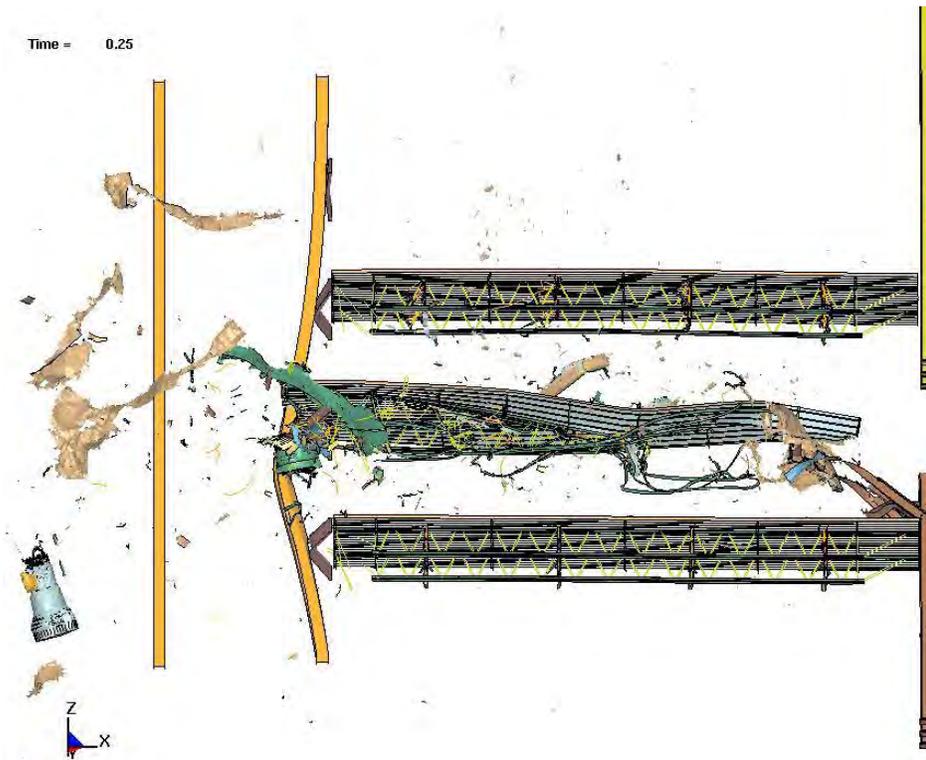
Figure 2–2. Example engine impact subassembly analysis.

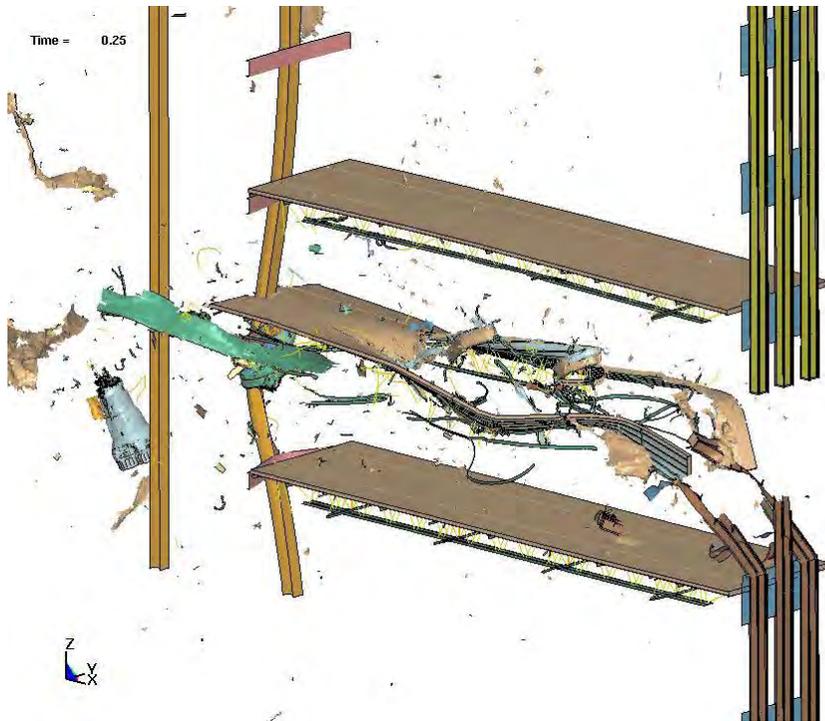
Figure 2–3. Oblique view of the subassembly engine impact damage.

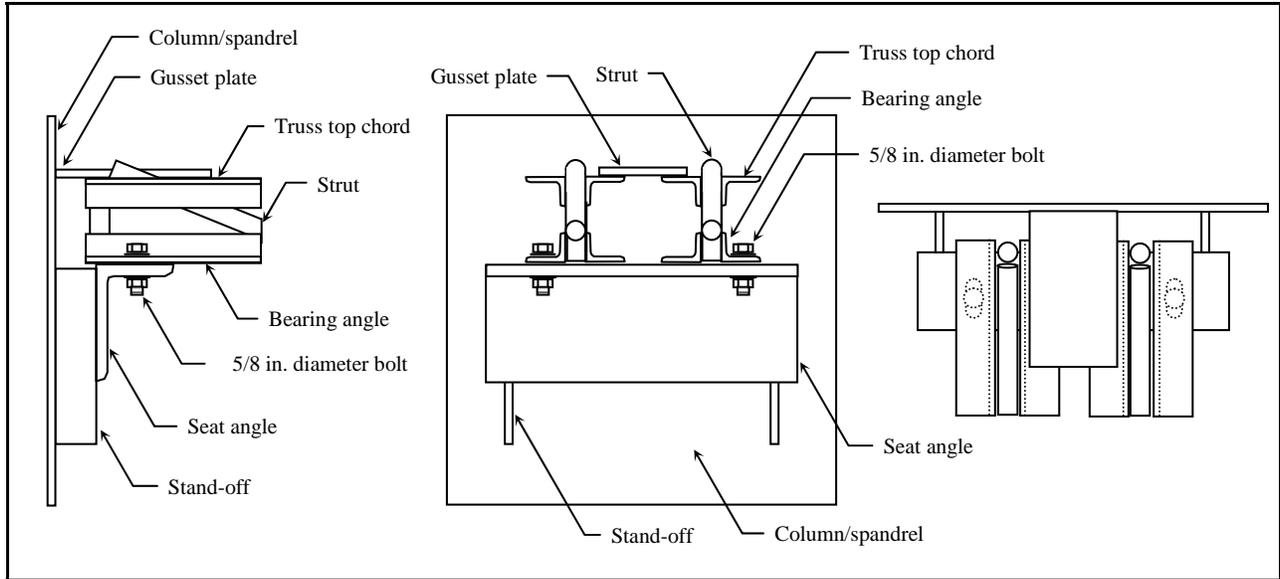
The horizontal and vertical load capacities of the twelve truss-to-column connection configurations on floor 96 have been calculated. These calculated capacities were used to develop simplified models of the connection behavior for use in the floor and exterior wall subsystem analyses. As an illustration, Fig. 2–12 shows a seated connection of the floor truss to the exterior wall of the tower (spandrel plate). The connection is designed to carry vertical floor loads and horizontal loads that are at least 2 percent of the column design load. These connections may be subjected to large horizontal forces, and the capacity of the exterior truss connection under such circumstances must be ascertained.

Figure 2-12. Exterior connection of the floor truss to the spandrel plate.

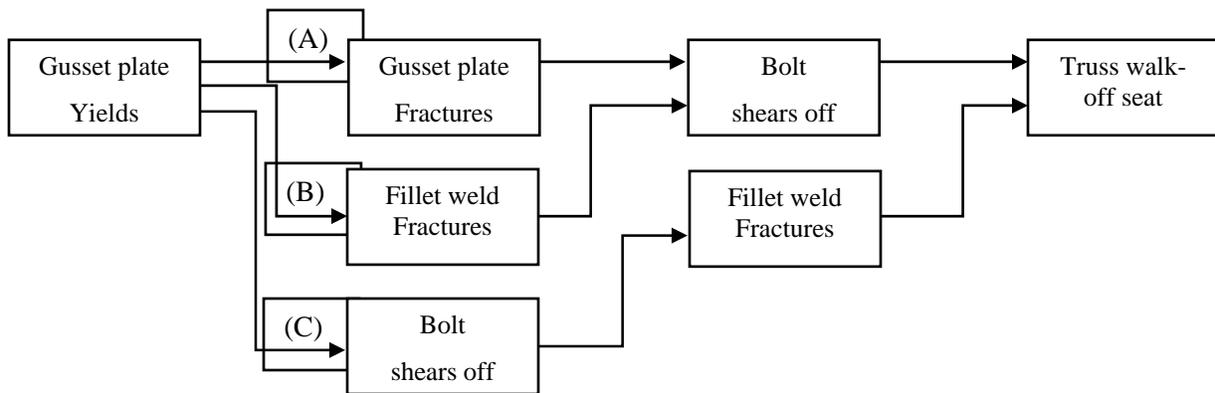
The failure modes considered for the truss-to-column connections are: (1) failure of the groove weld between gusset plate and spandrel, (2) failure of the fillet weld between the gusset plate and the truss top chord, (3) tensile failure of the gusset plate, (4) bolt shearing off, (5) bolt bearing, (6) bolt tear-out, and (7) block shear failure. Possible failure sequences are illustrated in Fig. 2-13. Of the seven exterior connections types that were analyzed, path A is the failure sequence most frequently followed, which is described as follows: first the gusset plate yields across its section and then fractures, followed by truss sagging and deformation and the bolts slipping until they bear against the edge of the slotted hole, then the bolt shears off, and finally the truss walks off the seat. The travel distance for the truss to walk-off of the seat is 4 5/8 in. Sequence (A) and typical tensile force resistance for an exterior seat is shown in Fig. 2-14.

Figure 2-13. Failure sequence of exterior seats for tensile forces.

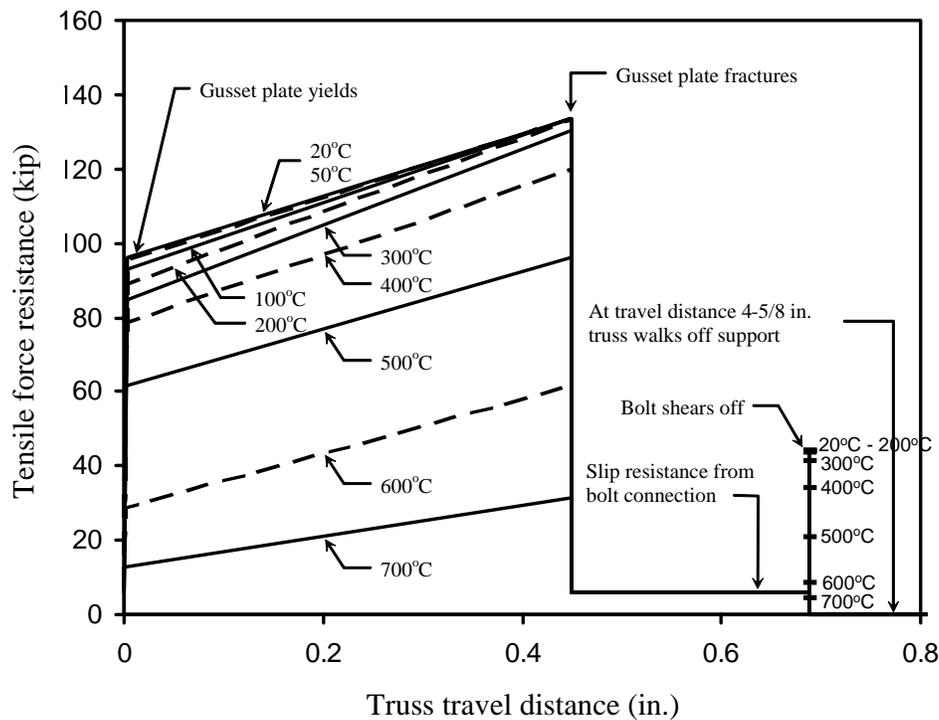
Figure 2-14. Typical tensile force resistance of exterior seat connection.

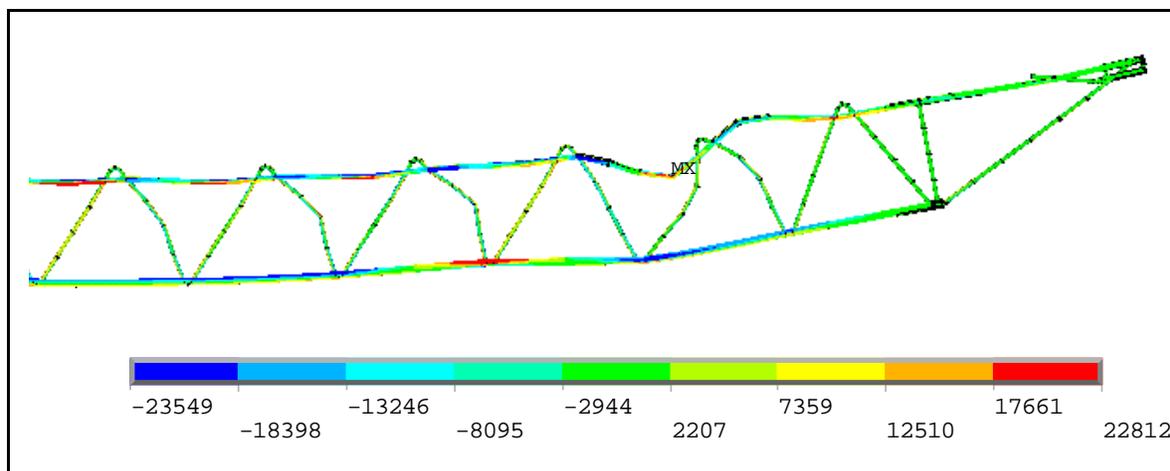
Figure 2–16 shows that the top chords of the truss yield in compression beyond 300 °C (for clarity, the concrete floor slab is not shown). This is due to a significant difference of coefficients of thermal expansion (CTE) between concrete and steel. At 500 °C, the CTE of steel is twice that of light-weight concrete. Bottom chords remain in the elastic range throughout the thermal loading. Web diagonal buckling starts around 350 °C and, as seen in the figure, some diagonals are bent significantly in the plane of the truss by high axial force and end moments.

Figure 2–16. Finite element solution for floor truss under gravity and temperature loads.

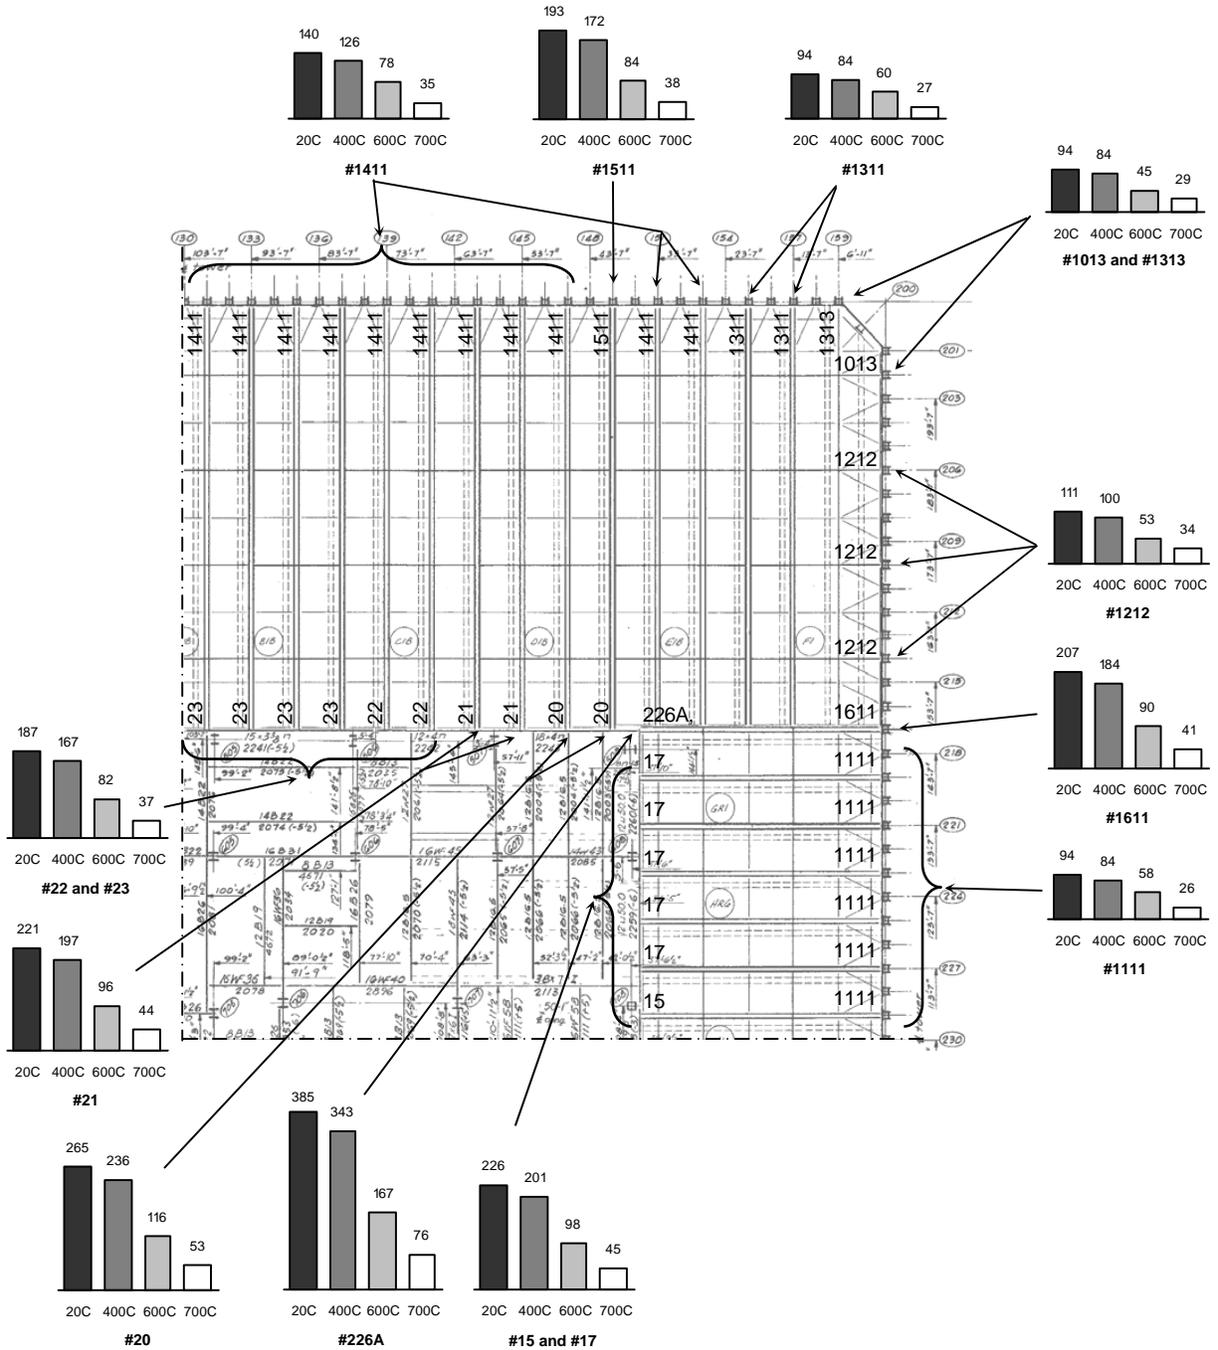
Failure mode of the interior truss seat for vertical force is the fracture of the fillet welds at the seat-to-channel beam connection. Failure mode of the exterior truss seat for vertical force is fracture of the fillet welds at the stand-off-to-spandrel connection. Preliminary findings of connection capacities for vertical bearing forces at room temperature (20 °C), 400 °C, 600 °C, and 700 °C are summarized in Fig. 2–17.

Figure 2-17. Truss seat capacity for vertical forces.

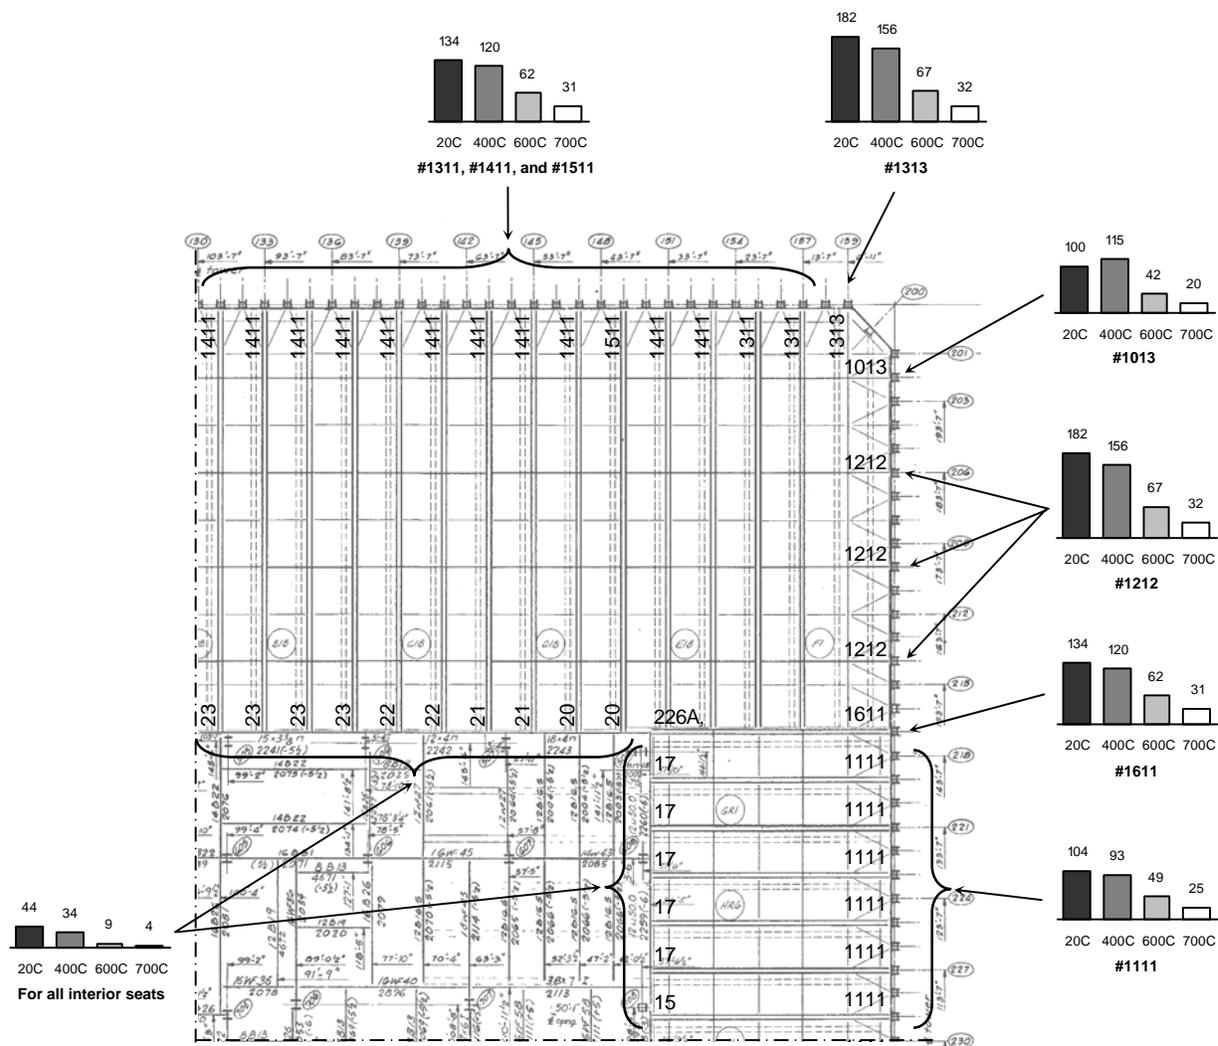
Similarly, connection capacities for horizontal tensile forces at the same temperatures are shown in Fig. 2–18. For interior truss seat connections, the shear strength of the two bolts controls the horizontal tensile capacity. The connection capacity of exterior truss seats that follow failure sequence (A), as shown in Fig. 2–13, equals the failure load for the tensile capacity of the gusset plate. Note that the strength of the truss seat #1013 increases by approximately 38 percent at a temperature of 100 °C. For temperatures less than 100 °C, the horizontal capacity is controlled by the gusset fillet weld strength, and for temperatures above 100 °C, the bolt bears against the edge of the slotted hole and increases the capacity of the connection.

Figure 2–18. Truss seat capacity for horizontal forces.

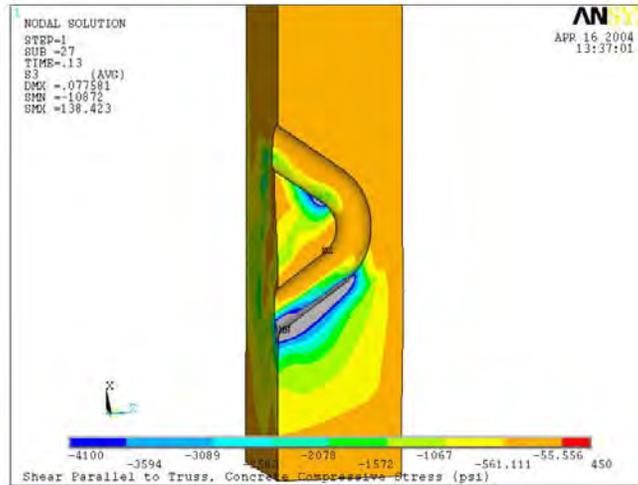
FEA results of the knuckle under longitudinal loading are shown in Fig. 2–19. Displacement results shown in Fig. 2–20 indicate a significant dependence on the characteristic of the interface between the steel and concrete. Results show that each knuckle has a capacity in the range of 15 klb to 35 klb, depending on the steel-to-concrete interface assumption. Results of longitudinal shear tests conducted by Laclede Steel in 1967, using normal weight concrete with an average compressive strength of 3,707 psi, indicate an average shear capacity of approximately 28.3 klb per knuckle. After adjusting for the strength of in-place light-weight concrete of 4,100 psi (i.e., multiplying 28.3 klb by the ratio of 4,100 to 3,707 psi), the longitudinal shear capacity of the knuckle is approximately 31 klb per knuckle. This is consistent with the finite element solution for the fully bonded case shown in Figure 2–21 (note results are for two knuckles). A shear capacity of approximately 30 klb per knuckle is used for subsequent analyses of the floor truss.

Figure 2-19. Compressive stress in longitudinal shear.

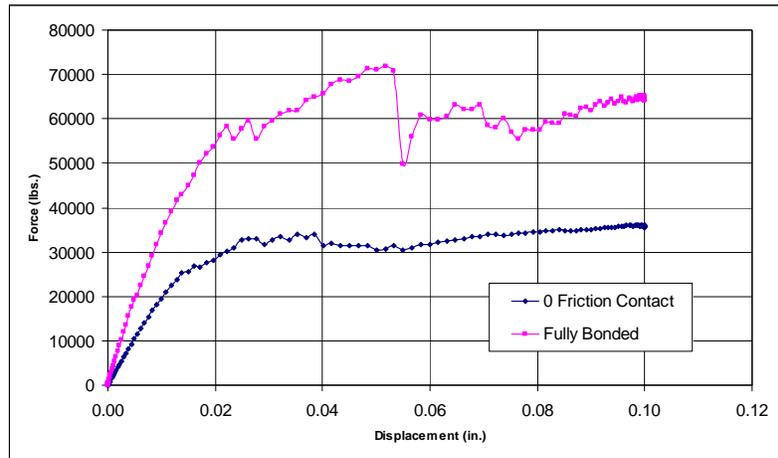
Figure 2-20. Shear force versus displacement for two knuckles under longitudinal shear.

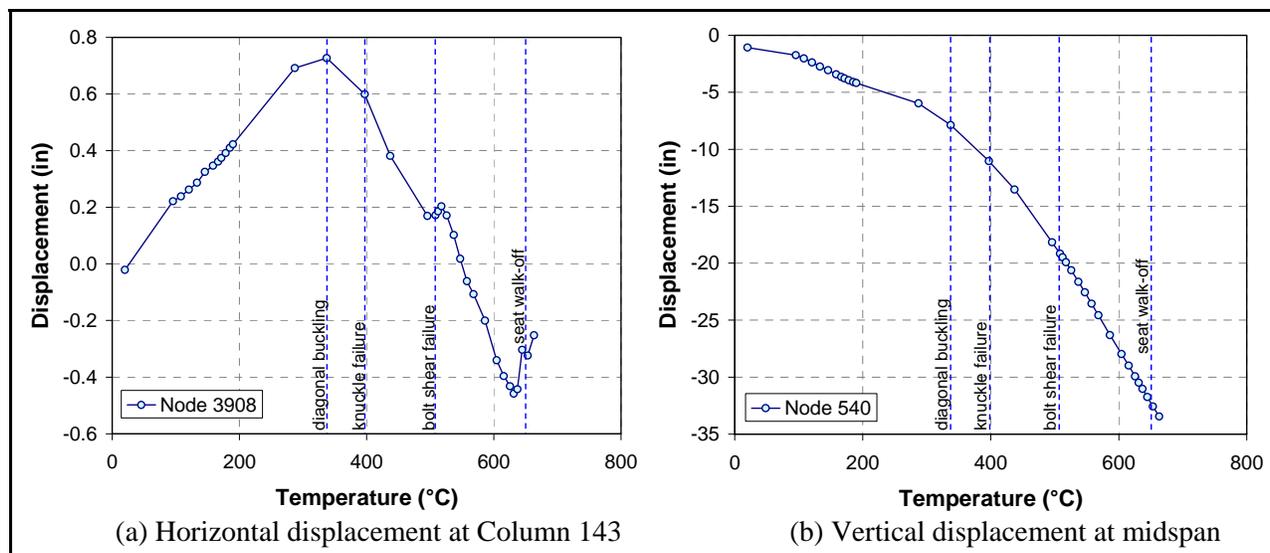
The floor truss analysis was carried out dynamically with 5 percent Rayleigh damping and a temperature ramp set to 1.0 s. The floor slab had only gravity loads applied; no other loads related to floor diaphragm action were included. The analysis of truss behavior under the gravity plus thermal loading proceeded to a temperature of $T=663^{\circ}\text{C}$. Figure 2-20 shows the horizontal displacement of the column and the vertical midspan displacement of the truss. A positive horizontal displacement indicates that the exterior columns are pushed out, and a negative vertical displacement indicates that the truss is deflected downward.

Figure 2–21. Floor truss response due to gravity load and uniform heating.

As the truss and floor slab heat up, the column is pushed outward by thermal expansion. The truss top chord begins to yield in compression around 300 °C due to the difference in coefficient of thermal expansion between steel and lightweight concrete. At approximately 340 °C, web diagonals begin to buckle and the horizontal displacement at the exterior column reverses and begins to decrease. At 400 °C, knuckles start to fail sequentially from both interior and exterior supports toward the center. With the loss of composite action, the floor begins to sag at an increasing rate. Eventually, at about 500 °C, with the truss sagging almost 20 in., the bolts at the interior connection are found to shear. At 560 °C, the exterior columns begin to displace inward, and the truss begins to act as a catenary. At 650 °C, the truss walks off the interior seat while the interior end of slab remains intact and continues to carry vertical load. For the truss to walk off the interior seat, the truss must shorten by 4 in. This shortening is caused mainly by the significant plastic deformation of the top chord of the truss (Fig. 2–14), resulting from differences in the thermal expansion of the top chord relative to the slab and the failure of the first two knuckles near the interior seat. At roughly 660 °C, the gusset plate fracture at the exterior end which precipitates vertical failure of the exterior seated connection.

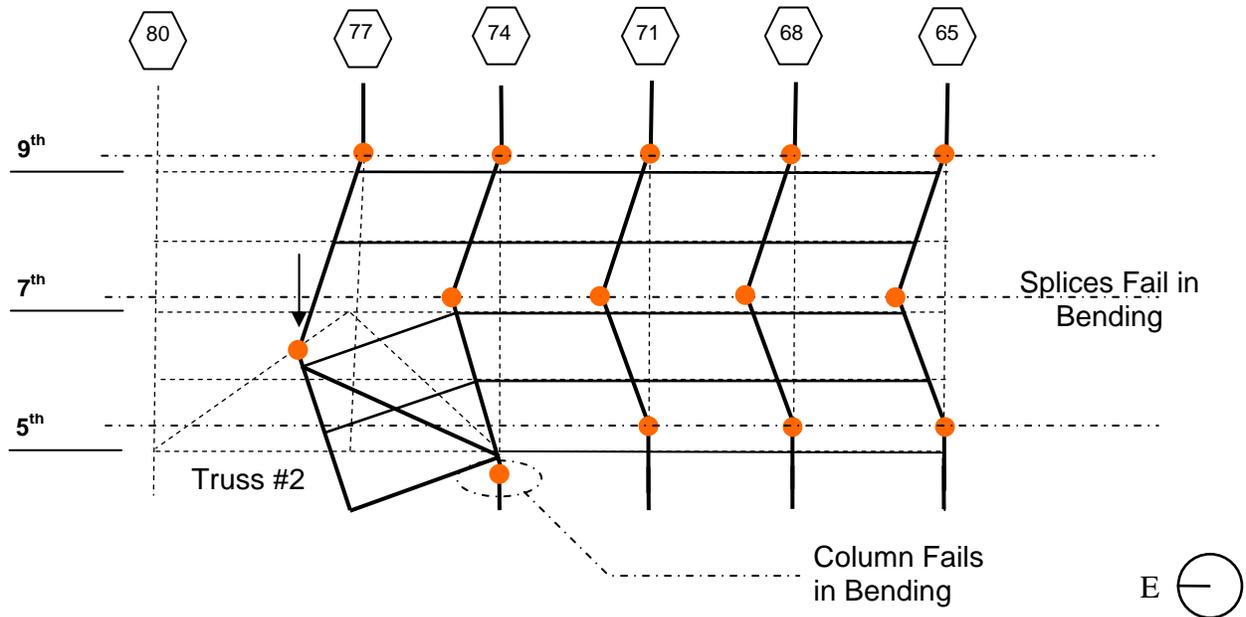
Figure 2–25. Example of horizontal progression of failure in core columns following damage to transfer components on the east side of the building.

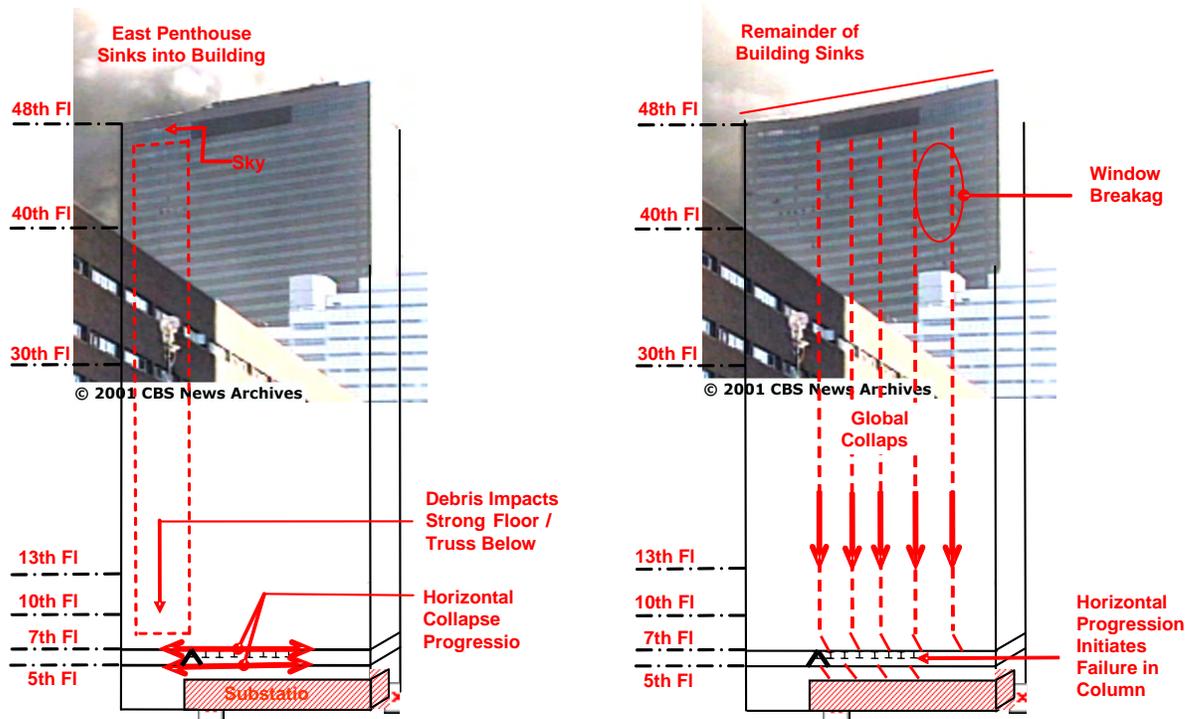
- The core columns failed sequentially and redistributed loads until the building loads could no longer be supported, and the global collapse occurred with few external signs prior to the system failure, as illustrated in Fig. 2–26.

Figure 2-26. Horizontal progression to the west side of WTC 7.

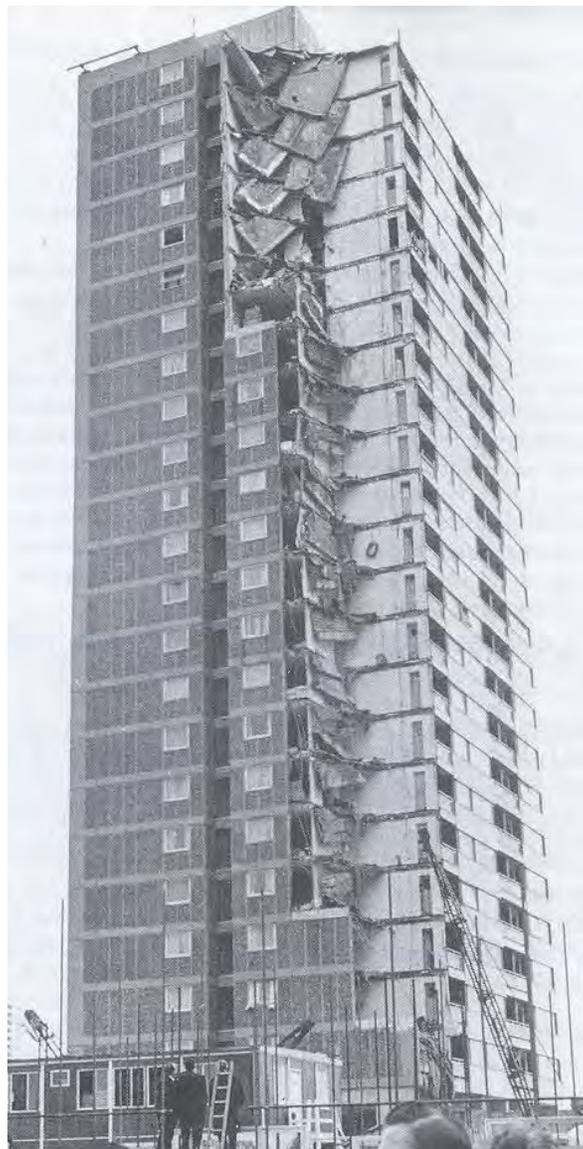
Figure 3–1. Ronan Point Collapse in 1968.

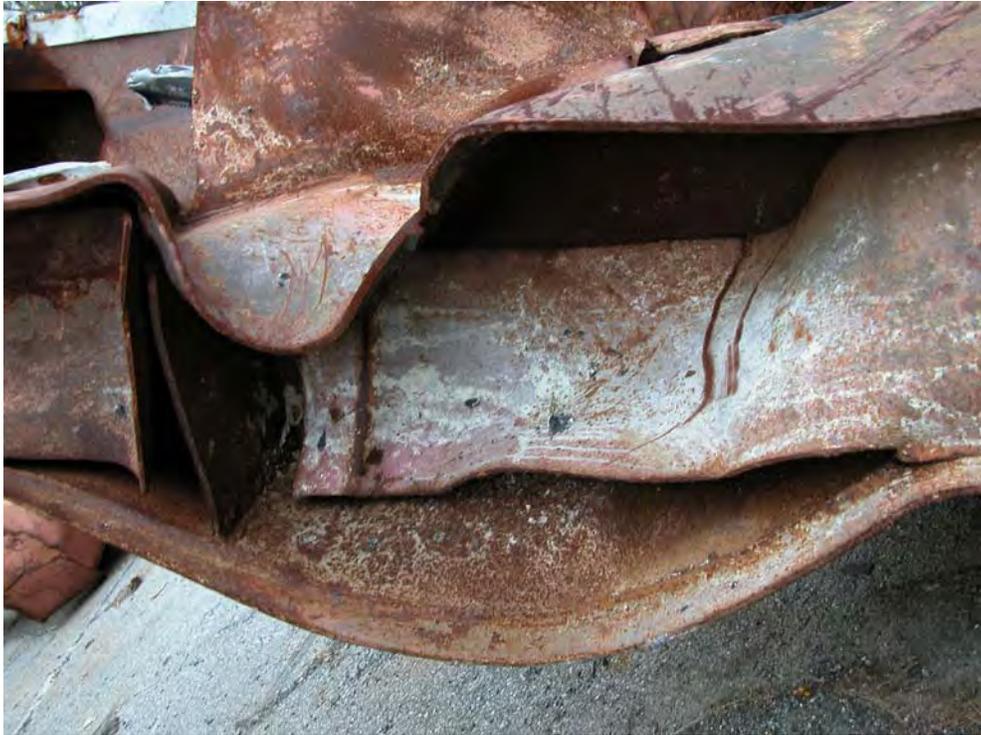
Photographs of the WTC towers immediately after impact, and inspection of the recovered exterior wall panels in the impact zone, have shown that failure along the weld zone was a characteristic feature of the impact damage. An example exterior column from the impact zone that has significant fractures along the weld zone for the outer web is shown in Fig. C-21. The amount of energy dissipated by these weld fractures is very small compared to the overall impact energy. As a result, the failure of the welds will have little effect on the subsequent damage to the interior structures and contents of the towers. However, to capture the damage mechanisms of the impacted exterior columns and to develop models and failure criteria for the global impact analysis, a failure model for the weld zone is required.

Figure C-21. Photograph of an exterior column with weld zone fractures.

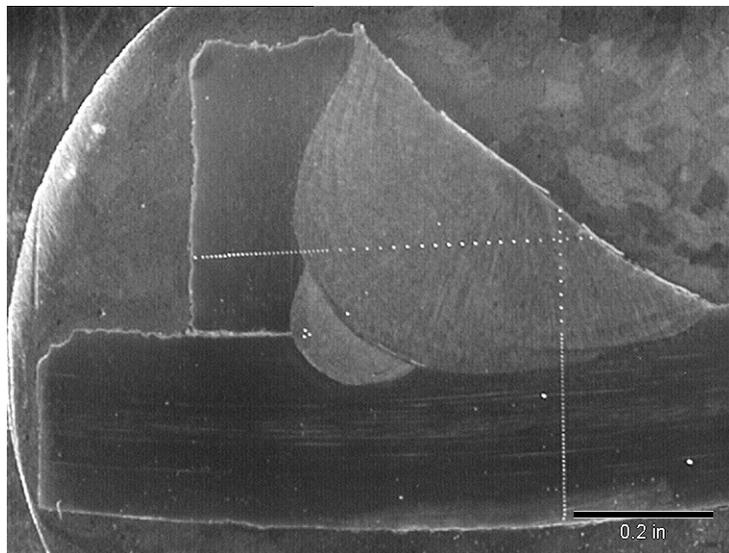
Figure C-22. Micrograph of an exterior column weld geometry.

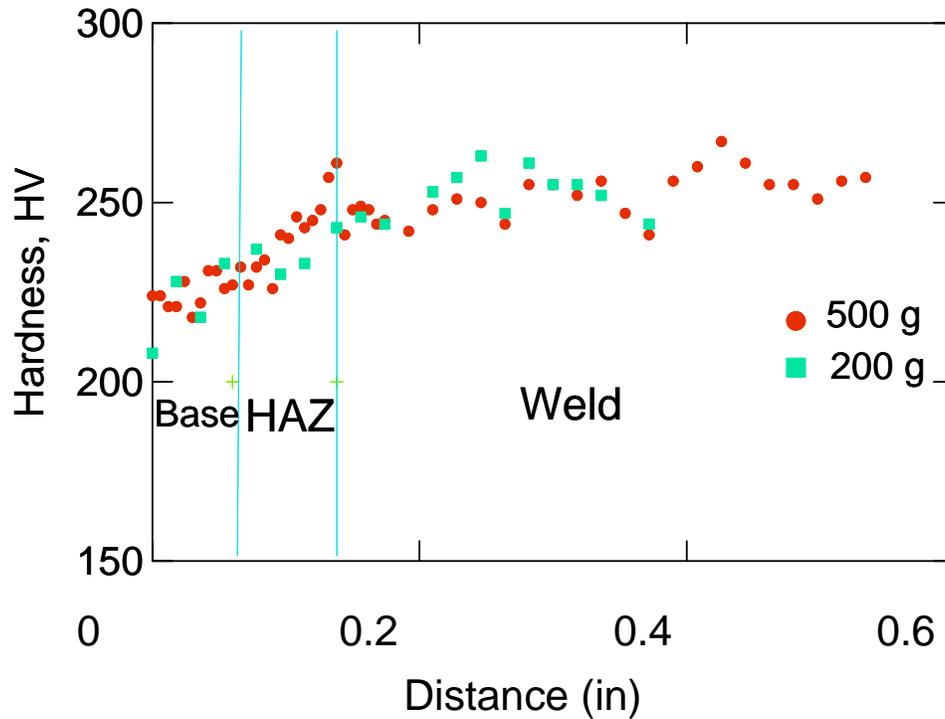
Figure C–23. Microhardness characterization of the weld and HAZ materials.

The microhardness measurements shown in Fig. C–23 were used to develop approximate plasticity behaviors for the weld and HAZ material regions. The approach used was to use the base material constitutive behavior and shift the flow stress of the HAZ and weld materials by 12 percent and 18 percent, respectively. These shifts correspond to the relative magnitude of the average measured hardness in each material region.

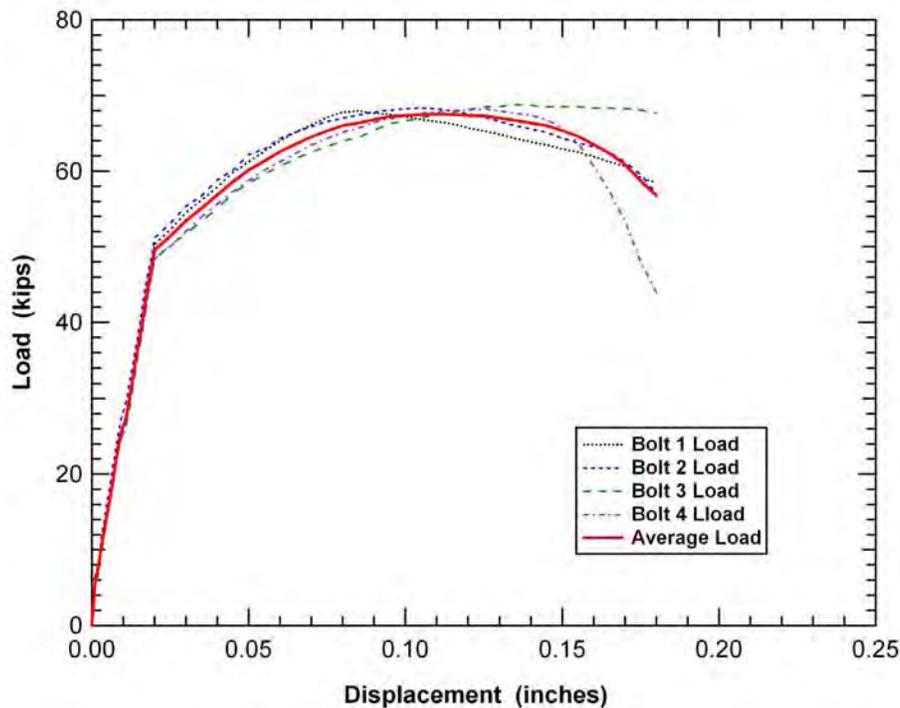
Subsequently, a series of tests was performed by Project 3 on bolts recovered from the WTC towers. A summary of the bolt testing is given in Fig. C–35. The bolts were found to yield at a load of approximately 50 kip and have an ultimate failure load of approximately 68 kip. The measured elongation at failure is approximately 0.18 in.

Figure C–35. Measured bolt load-displacement behavior.

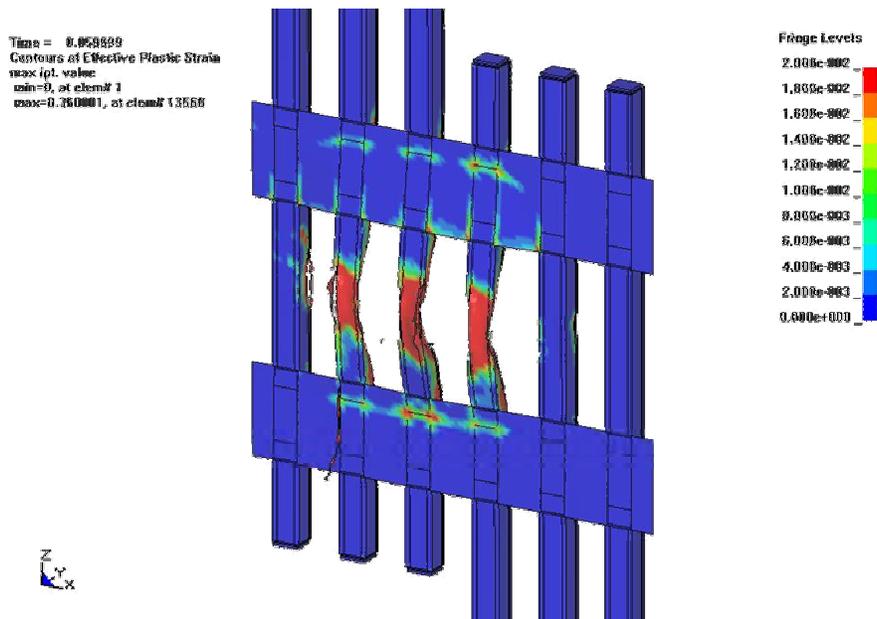
The calculated impact response produces large scale damage and fragmentation of the empty wing section and significant damage to the exterior columns. The calculated impact damage to the exterior column panel is shown in Fig. C-61. The damage includes significant distortion of the columns, large plastic strains, and fracture of the plate connections within the columns. However, the columns are not completely severed and still maintain some load carrying capacity.

Figure C-61. Damage produced by the empty wing section impact.

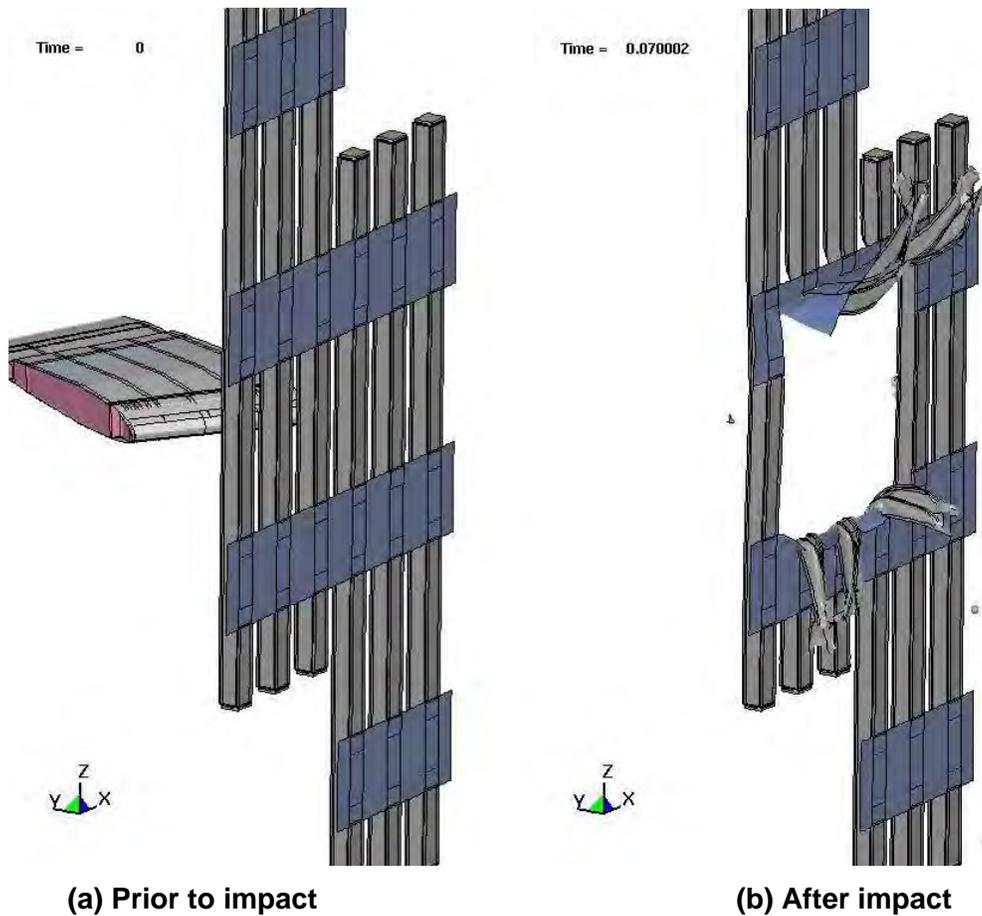
For the wing section with fuel component analyses, the impacted structures are the same two exterior panels as used in the empty wing section analysis above. As shown in Fig. C–63, the columns of the exterior panels are completely destroyed due to impact. Both the SPH and ALE methods simulate this extensive damage. This was not the case for the empty wing section model, as discussed in the previous section.

Figure C–63. Exterior panels impact behavior for a wing segment with fuel (SPH fuel model).

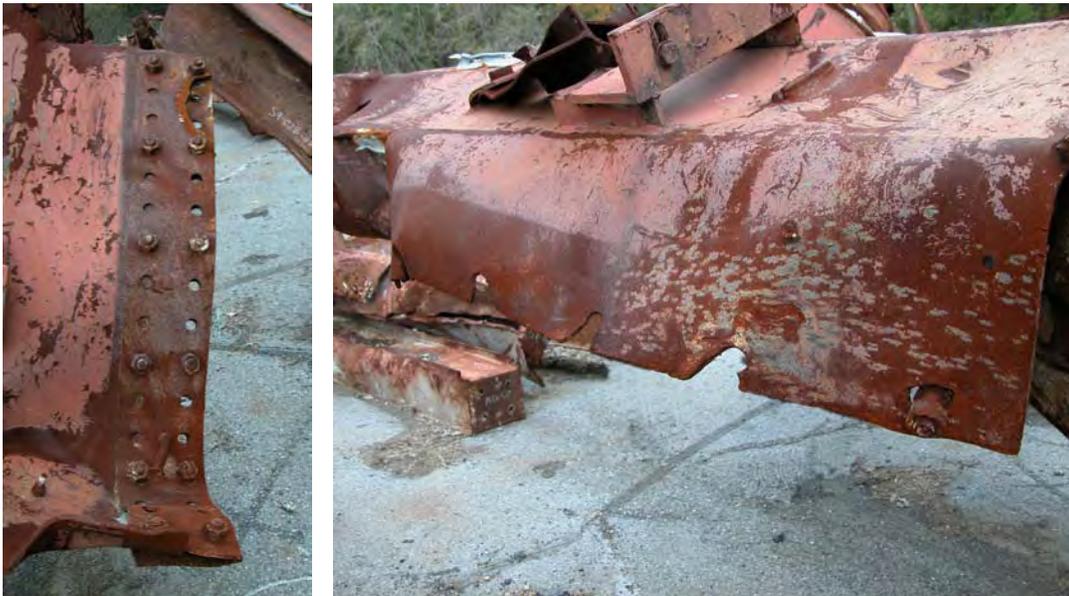
The spandrel connections consist of an overlapping splice plate across a spandrel joint with a row of bolts on either side of the joint. Typical failure of these spandrel joints in the impact zone resulted from bolt bearing shear failures, typically in the spandrel plate, as shown in the photographs in Fig. C-69. A common configuration in the impact zone would have six bolts on either side of the joint. The bolt bearing shear failure mechanism would be difficult to model using a beam element bolt as applied

Figure C-69. Typical bolt bearing shear failures of spandrel connections.

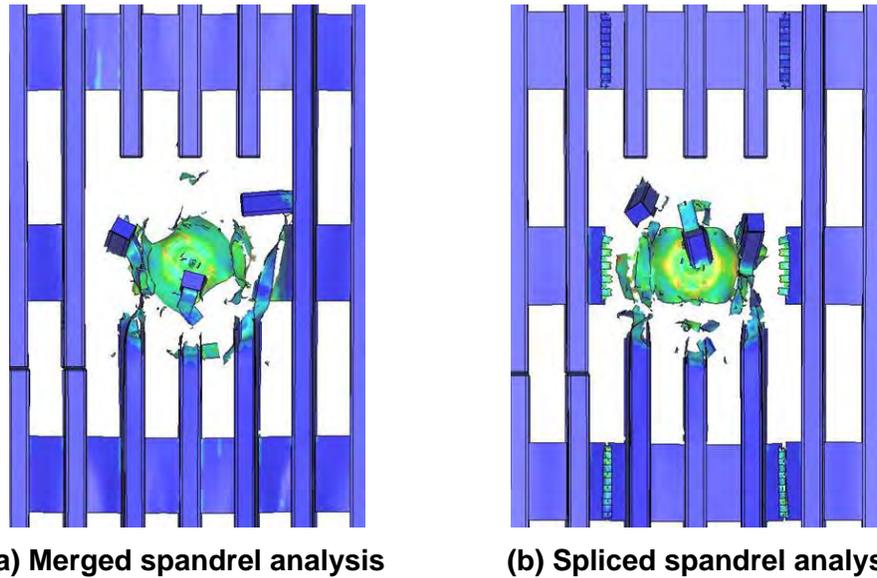
A final revision of the above analysis included adding splice plates at the spandrel connections as explained in the previous subsection. Figure C-74 presents a comparison of both models. The figure shows exterior wall damage as seen from the outside without engine components. Contours of plastic strain are shown in the plot with blue being zero strain and red being at the failure strain threshold (20 percent in this case). Material exceeding the maximum failure strain is eroded and no longer shown

in Fig. C-74. The analyses differ most in spandrel failure modes. Spandrels fail at the column connection in the merged spandrel case, while the connection fails in the splice plate case. In the latter case, a realistic bearing stress type tear-out mode is seen in the splice plate. Engine core velocities for the three engine impact analyses are compared in Fig. C-75 for a single representative engine component. The splice plate model resulted in a 74 mph (33 m/s) velocity reduction of the engine core. The splice plate model results in the largest reduction in velocity in the engine.

Figure C-74. Example engine impact analysis with different spandrel connection treatments.

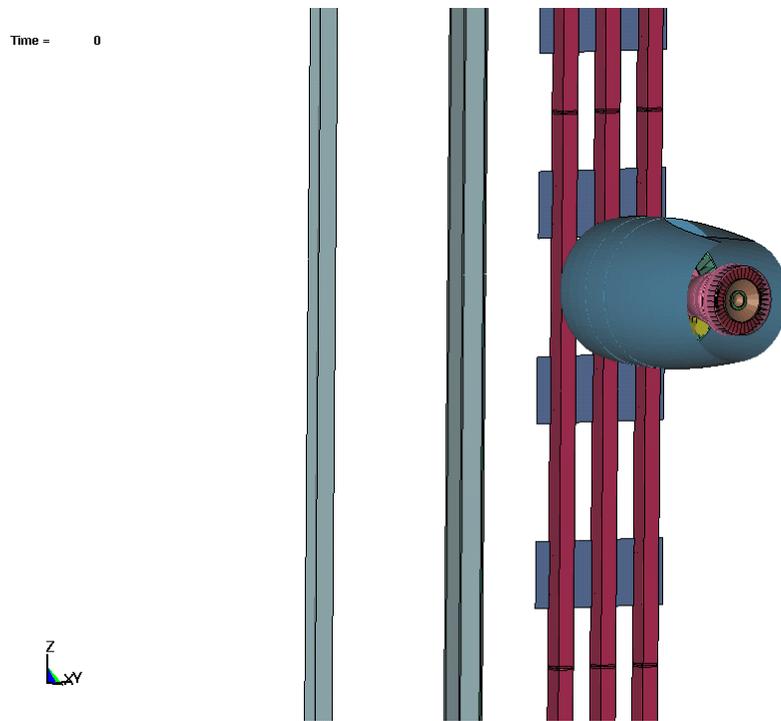
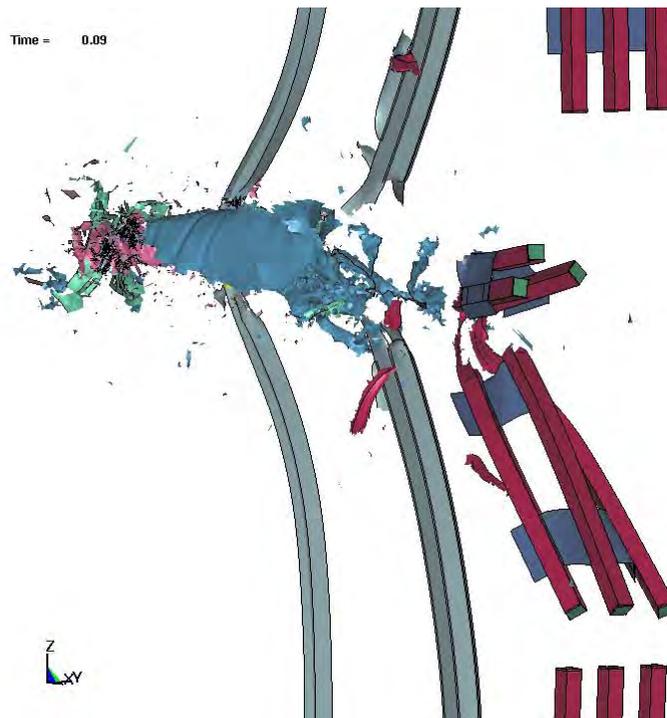
The impact scenario is illustrated in Fig. C-80 (a). The calculated impact damage is shown at a time of 90 ms in Fig. C-80 (b). The calculated engine impact response completely fails all of the columns with a residual velocity of the engine of approximately 224 mph (100 m/s). The deformations of the column include large lateral displacements which would be significantly reduced if the constraint effects of the concrete floor slab were added. The deceleration profile of the major engine debris fragment is given in

Figure C-80. Example engine impact analysis with interior and exterior columns.

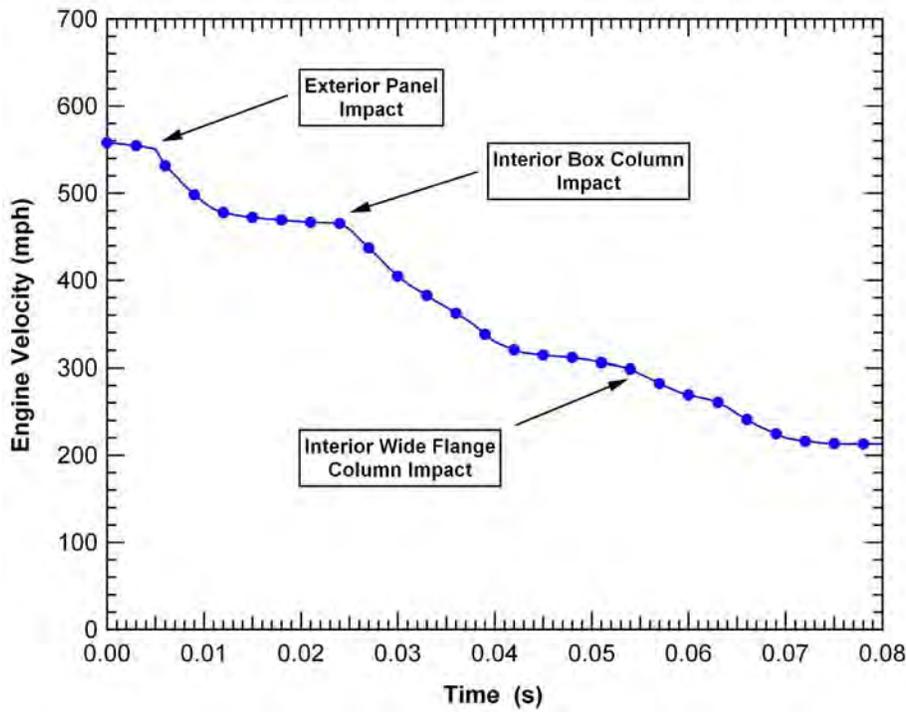
Fig. C-81. The majority of the engine structure has been broken into fragments by the combination of the three impacts. The resulting size, strength, and velocity of the engine debris are not likely to produce severe impact damage or failure to a subsequent core column.

Figure C-81. Example engine impact analysis with interior and exterior columns.

This example illustrates the large level of damage produced by a massive aircraft component, such as an engine, at high impact velocity. The impact energy is sufficient to overwhelm a single core column and, therefore, makes it difficult to determine the effects of column component modeling parameters on the impact response using this impact scenario.

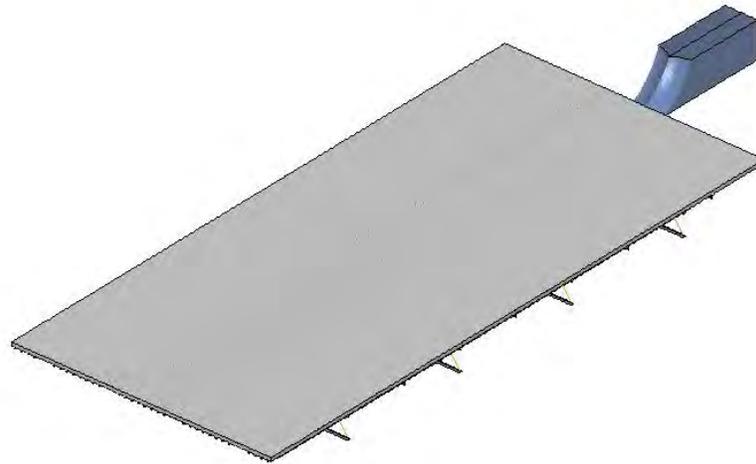
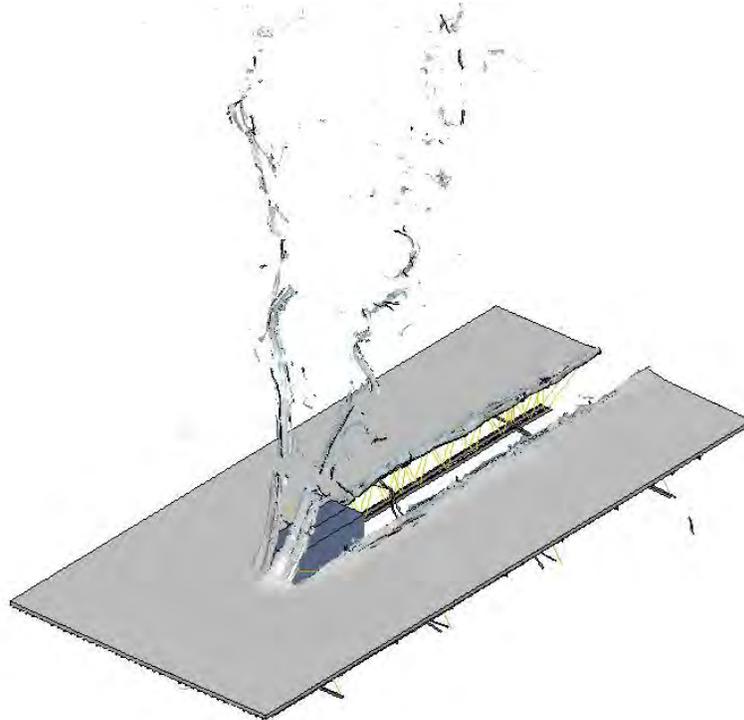
Figure C-82. Floor assembly impact analysis with brick element concrete slab.
