NIST Special Publication 1000-5

June 2004
Progress Report on the
Federal Building and Fire Safety
Investigation of the
World Trade Center Disaster

Volume 1

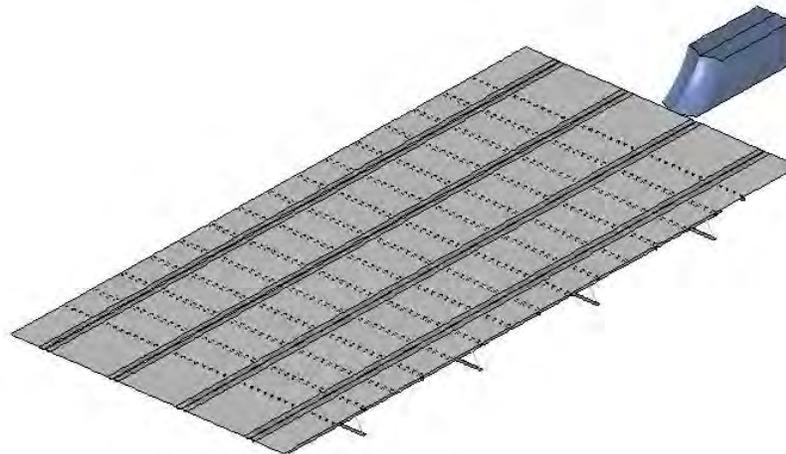
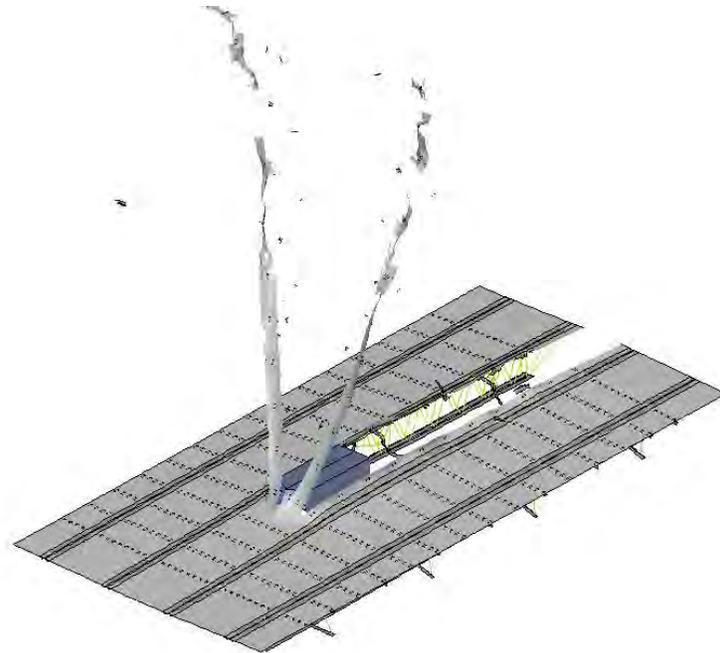
Figure C–83. Floor assembly impact analysis with shell element concrete slab.

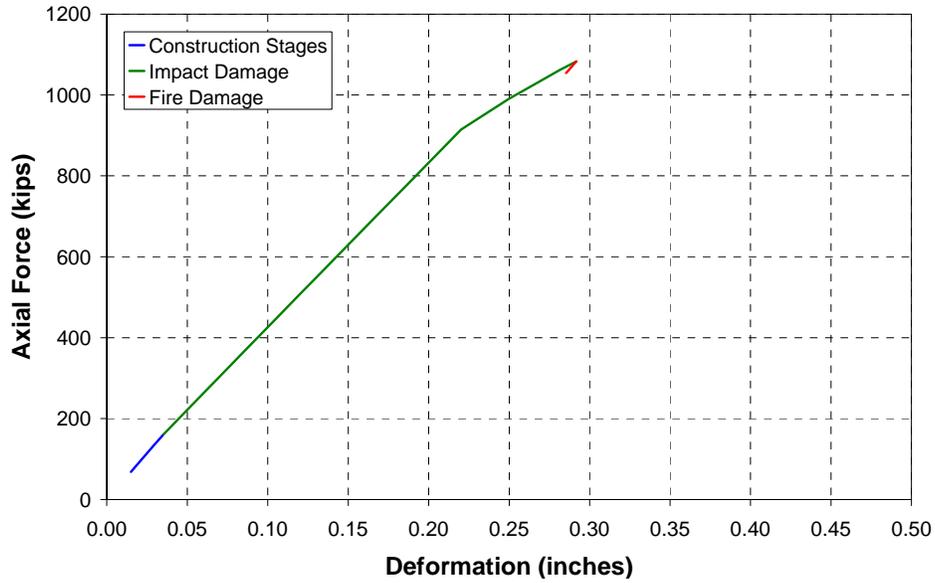
Figures D-4 and D-5 show the load deformation curves for columns 111 and 145 (see Fig. D-3) on either side of the damage on the north face of the tower. Both of these columns yielded during the impact damage analysis, but had sufficient strength and ductility to resist the peak loads. Note that the loads on these two columns were slightly reduced during the fire damage analysis. This occurred because the south face of the tower lost stiffness when members were lost to the fire, which caused the upper portion of the tower to rotate slightly toward the south. This redistributed a small portion of the load on the north face through the hat trusses to the core. The columns at the edge of the damage on the south face experienced the opposite effect. As can be seen in Fig. D-6, column 332 on the west side of the damage on the south face (see Fig. D-3) did not have a significant change in its load during the impact damage stage, but received a large additional load during the fire damage analysis. This column remained within the linear response range throughout the analysis.

Figure D-5. Load vs. deformation in column 145 at floor 95 (north face, east side of damage).

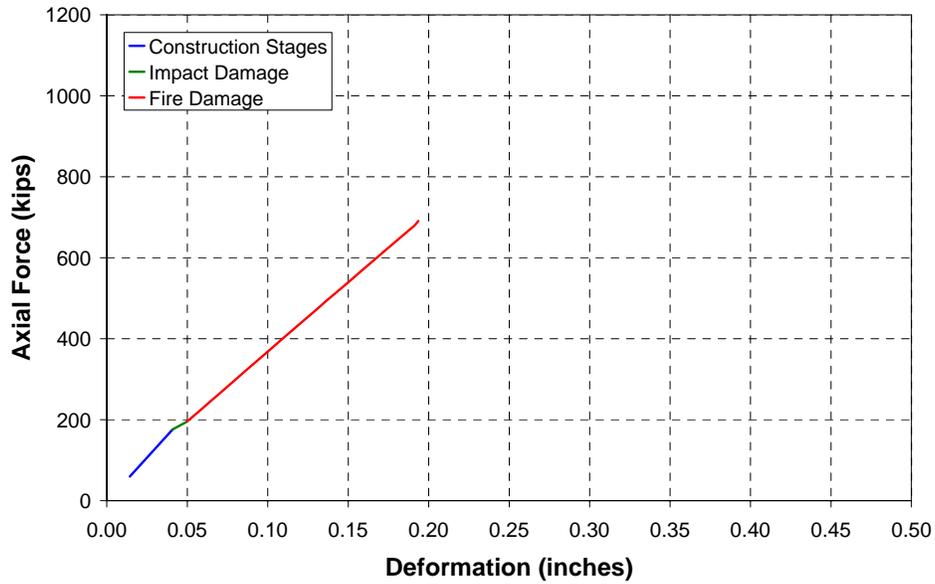
Figure D-6. Load vs. deformation in column 332 at floor 97 (south face, west side of damage).

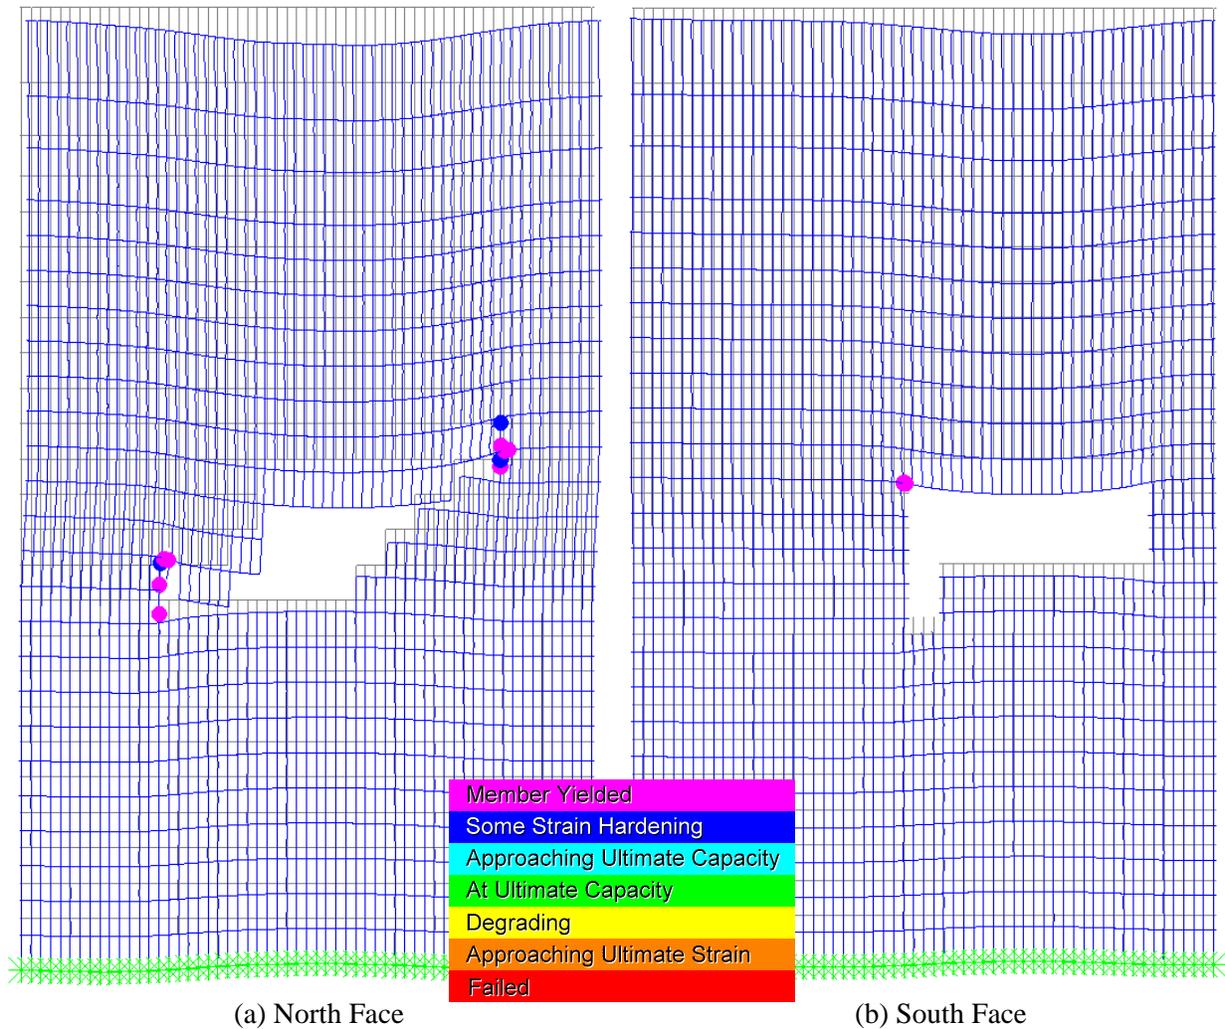
The analyses show that the most stressed members were the columns next to the damaged area on the north wall of the tower. The analyses show that the tower also remained standing after losing columns in the south wall due to fire effects with some reserve capacity left. This indicates that additional loss or weakening of columns in the core, weakening of additional columns in the exterior, or additional loss of floors is needed to collapse the tower.

Figure D–8. Displacements and locations of plastic hinges in the north and south exterior walls of WTC 1 after impact and fire.

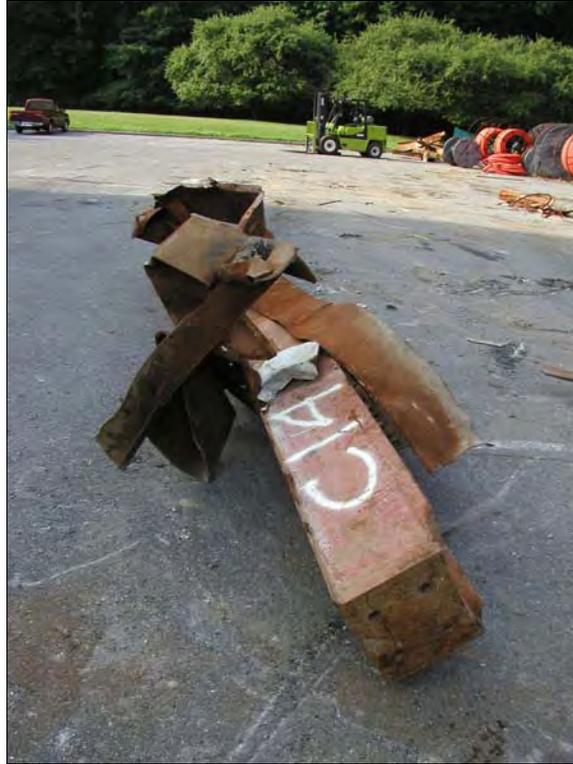
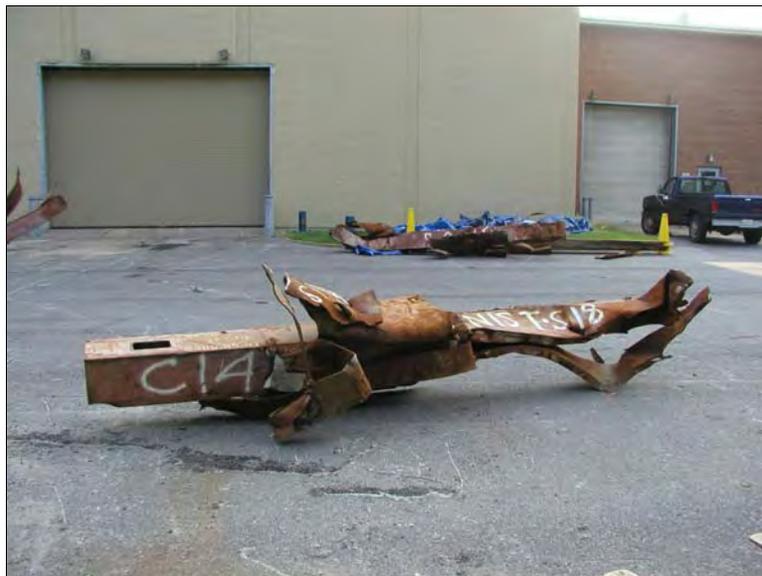
Figure F-1. Characteristic “overall” view of the samples taken for each piece received. Sample shown here is C-14.

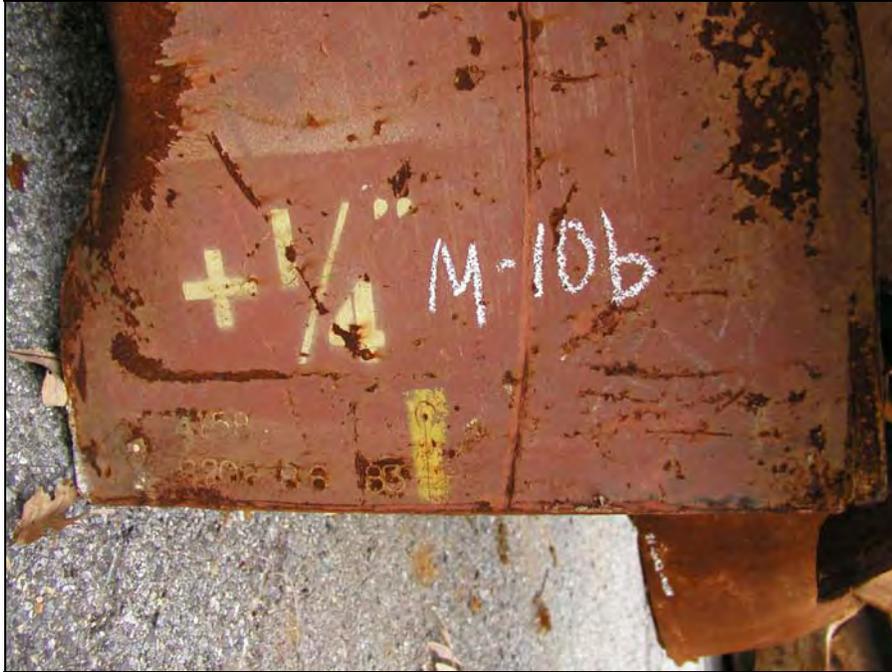
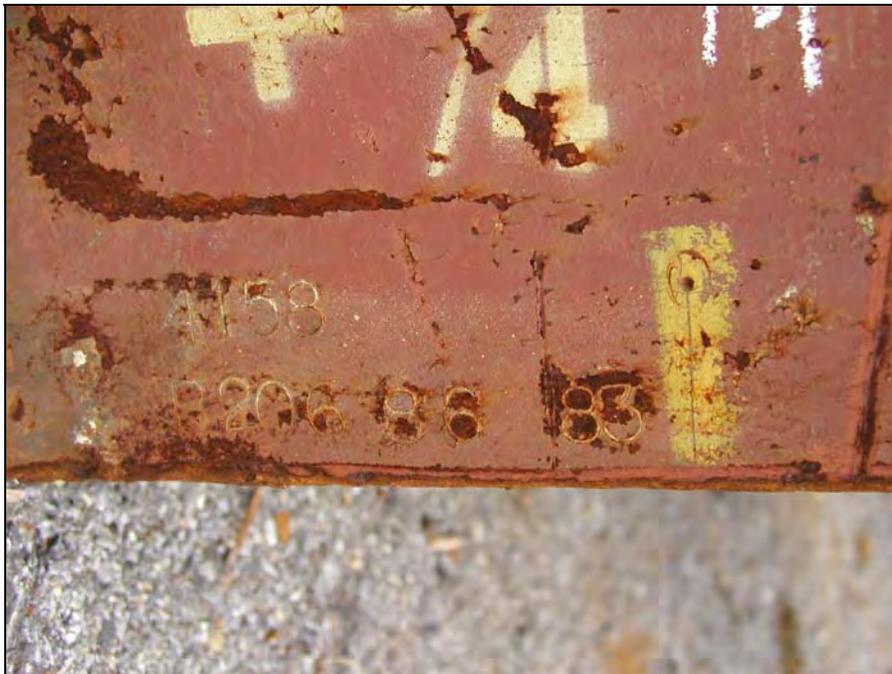
Figure F-3. Example of stampings on the interior base of the middle column for each panel.

lower end of the component near the connector. The building was typically represented as “A” for WTC 1 and “B” for WTC 2. An example of a stamping found on an exterior column is shown in Fig. F-3, where the stamping indicates that the piece was from WTC 2, with center column line number 206, spanning floors 83 through 86. Core column material was found to have similar markings (Fig. F-4). Other stampings have also been found on the flanges of the perimeter columns that indicated the column type (Fig. F-5 and Table F-5) as well as the specified minimum yield strength of the column. Additional stampings are located on the flanges, but are not yet understood.

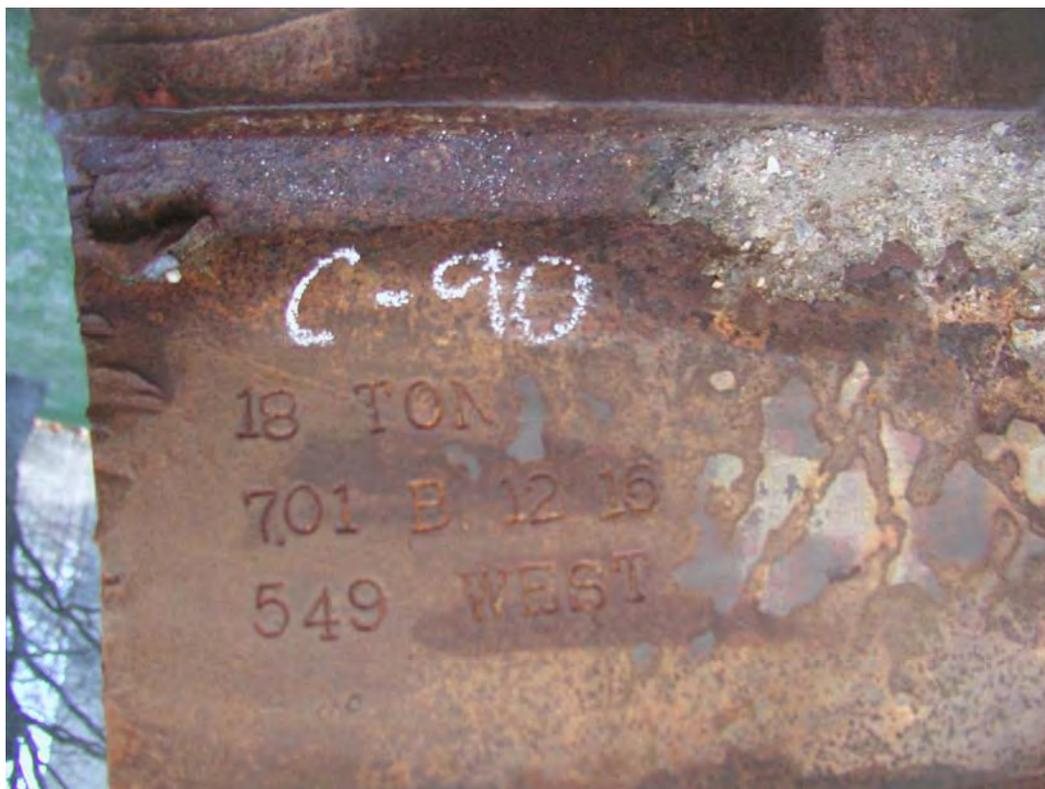
Figure F-4. Example of stampings placed on one end of a core column.

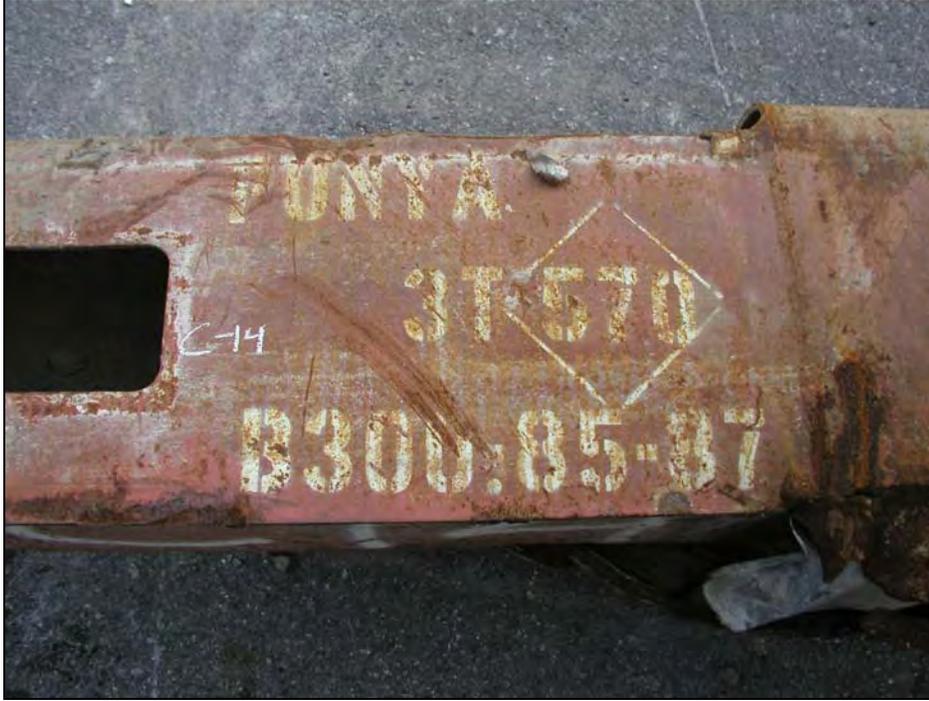
a)

Figure F-6. (a) Characteristic stenciling found on the lower portions of the exterior column panels for sample C-14. (b) Characteristic stenciling found on an interior core column for sample B-6152.

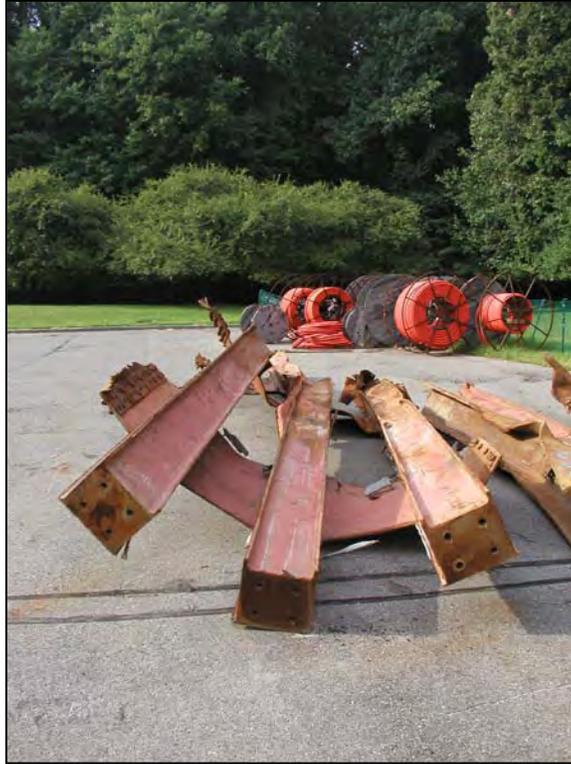
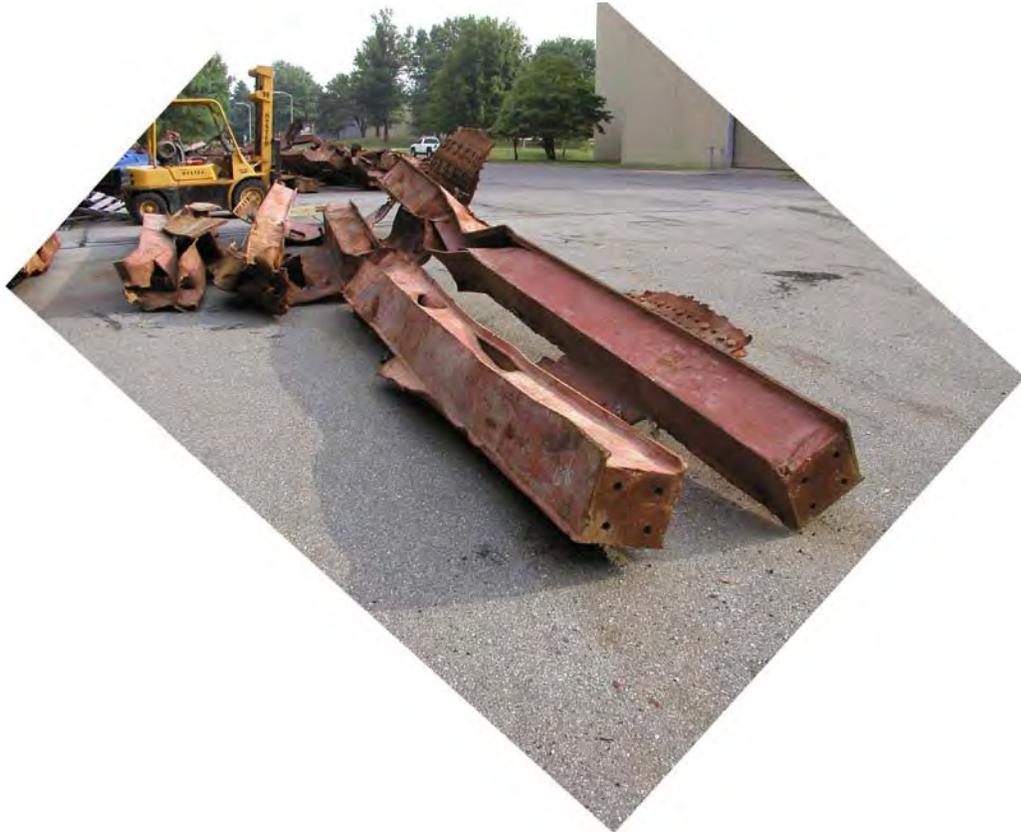
Figure 1-1. Exterior column panel, sample C-46 shown.

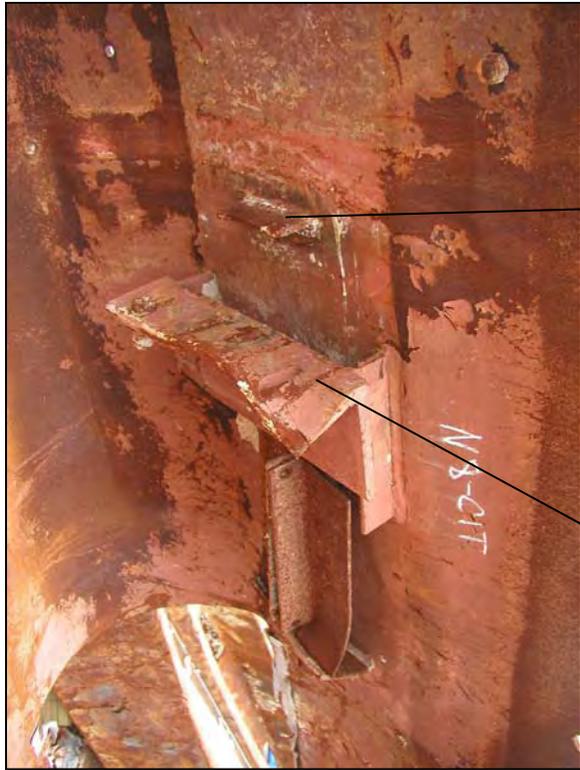
Welded gusset plate

Seat with 2 intact bolt holes for floor truss attachment. Intact bolt remains in far hole.

Figure 1-2. Floor truss seats shown from sample N-8.

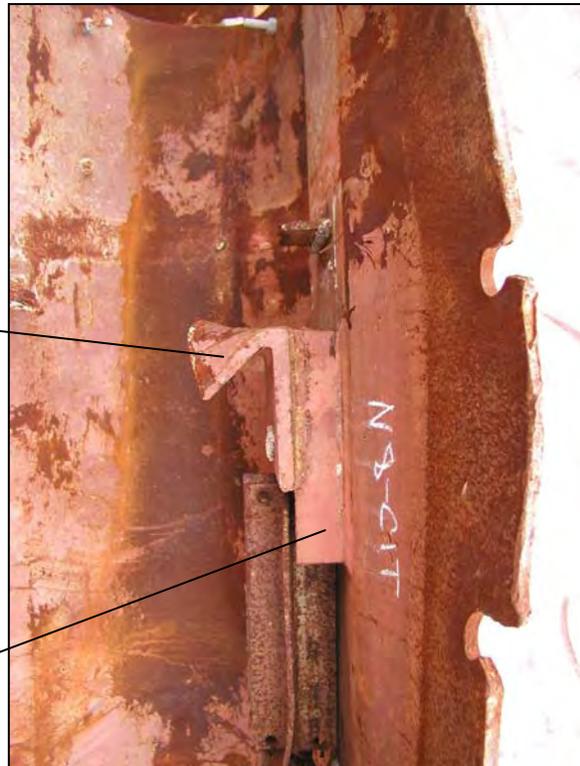
Seat

Stand off plates used to attach seat to column interior

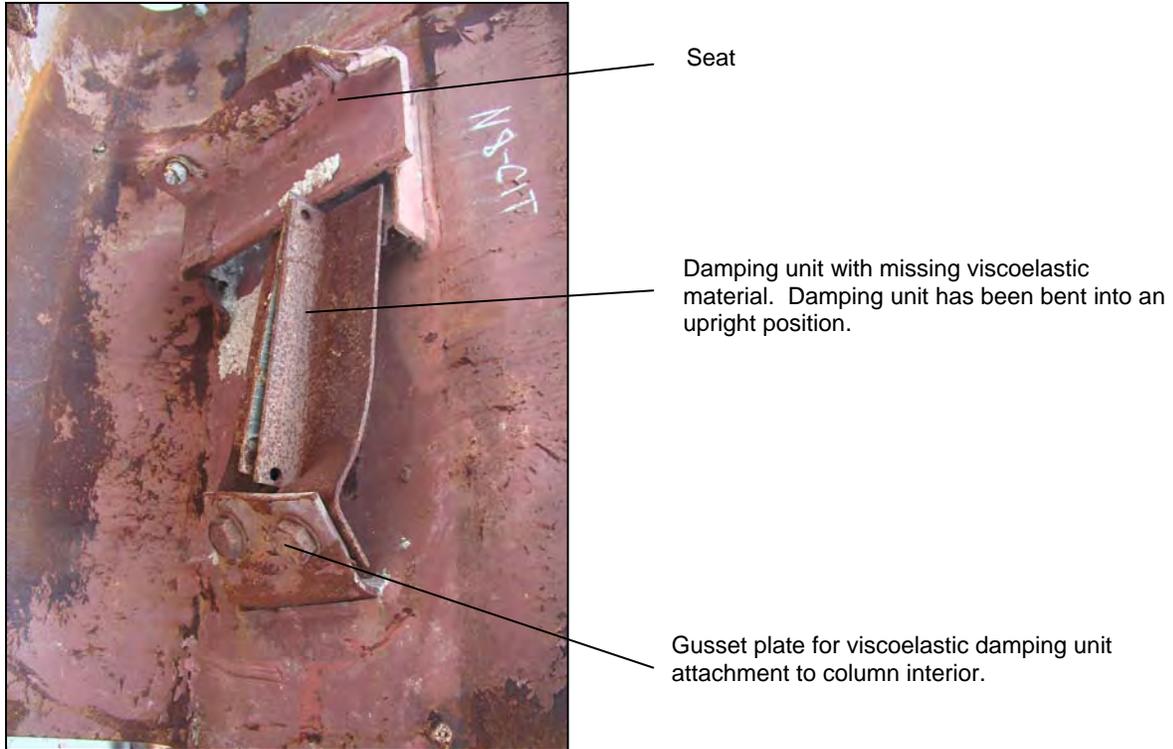
Figure 1-3. Damping Unit shown from sample N-8.

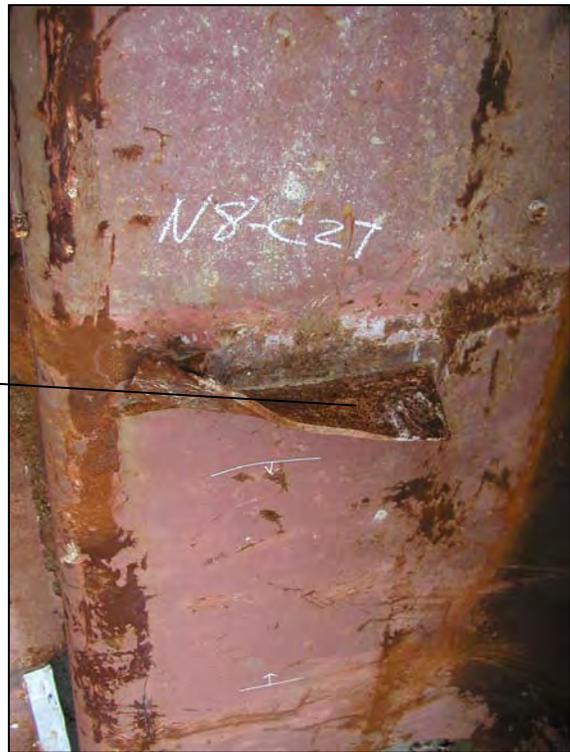
Welded gusset plate used in place of seat on alternate column/spandrel intersections. One method used to attach diagonal bracing strap to exterior wall

Figure 1-4. Gusset plate shown from sample N-8.

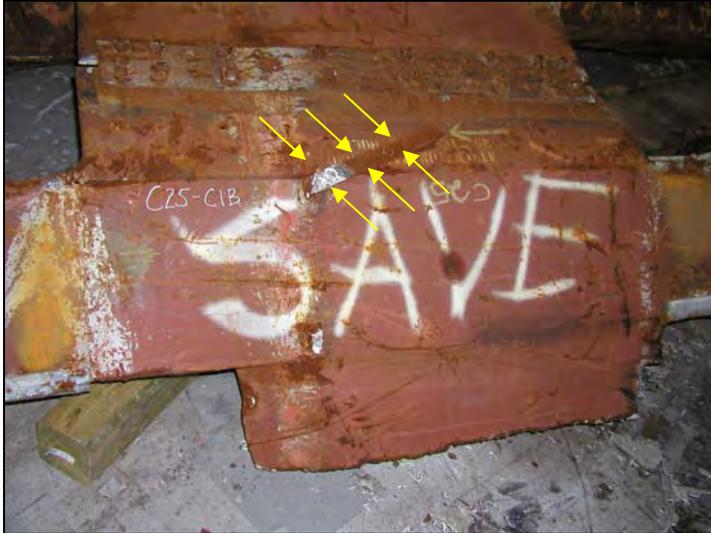
On Sample C-25

Diagonal bracing strap attached directly to exterior column

Figure 1–5. (left) Diagonal bracing strap shown on sample C-25, (top), and single strap labeled M-29 (bottom).

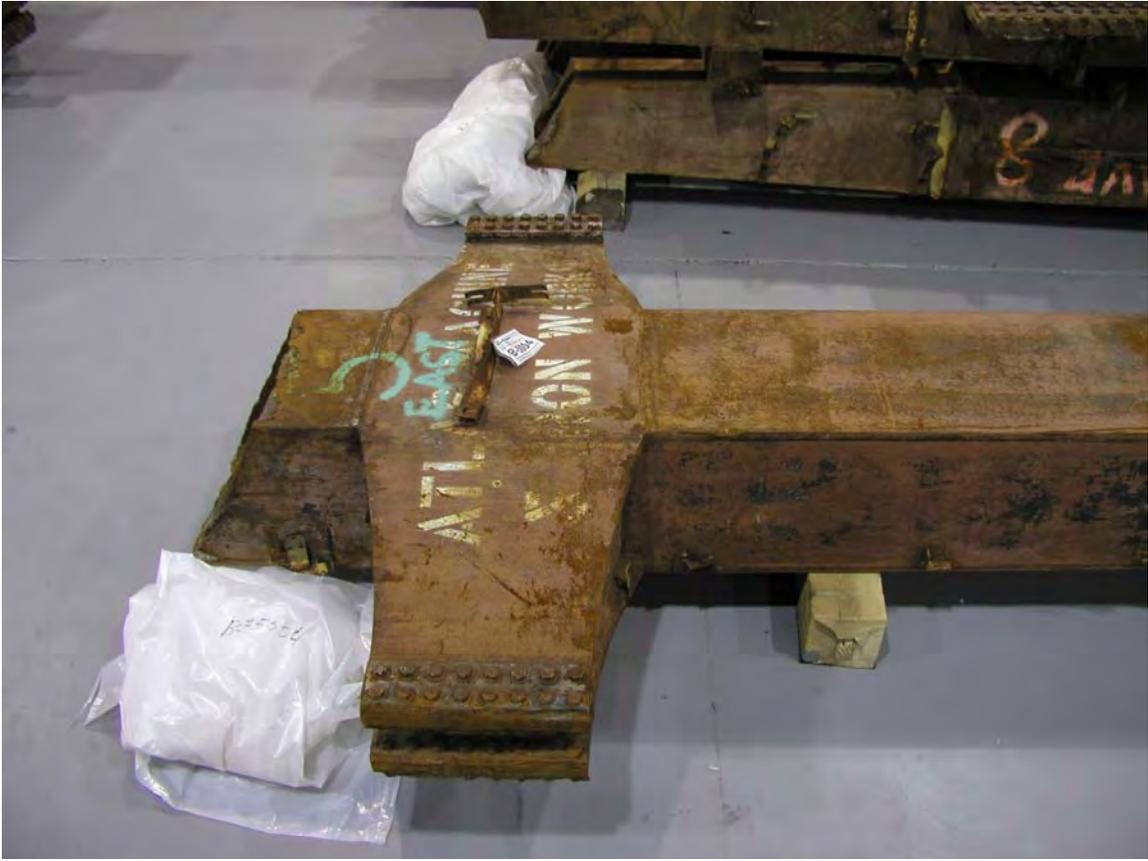
B-5004 at JFK

Figure 1–6. Bowtie section of exterior wall.

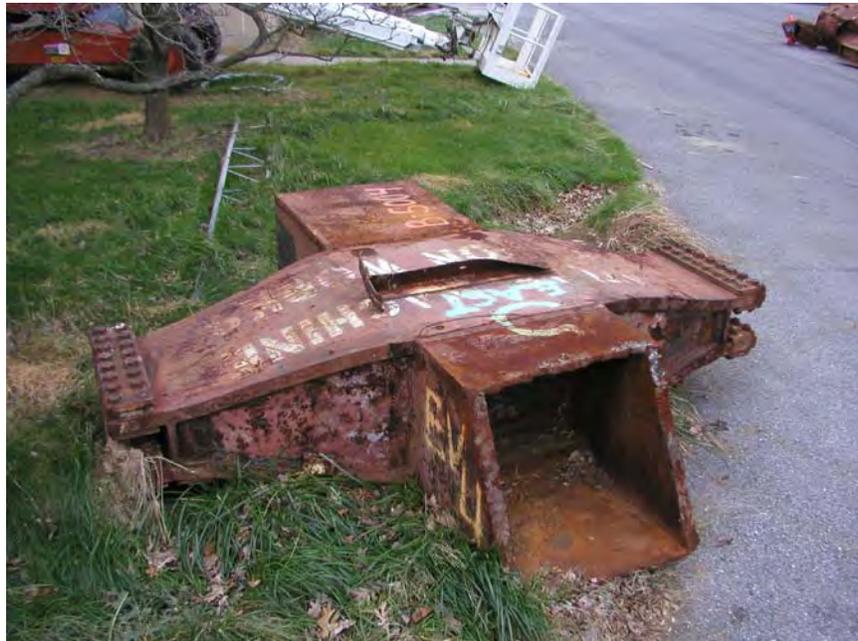
B-5004 portion cut and moved to NIST campus

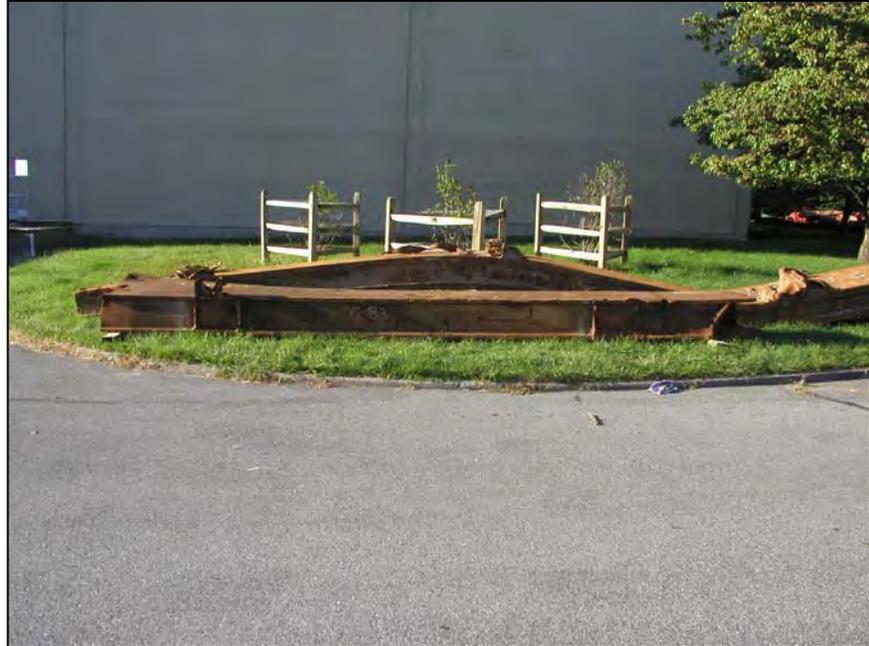
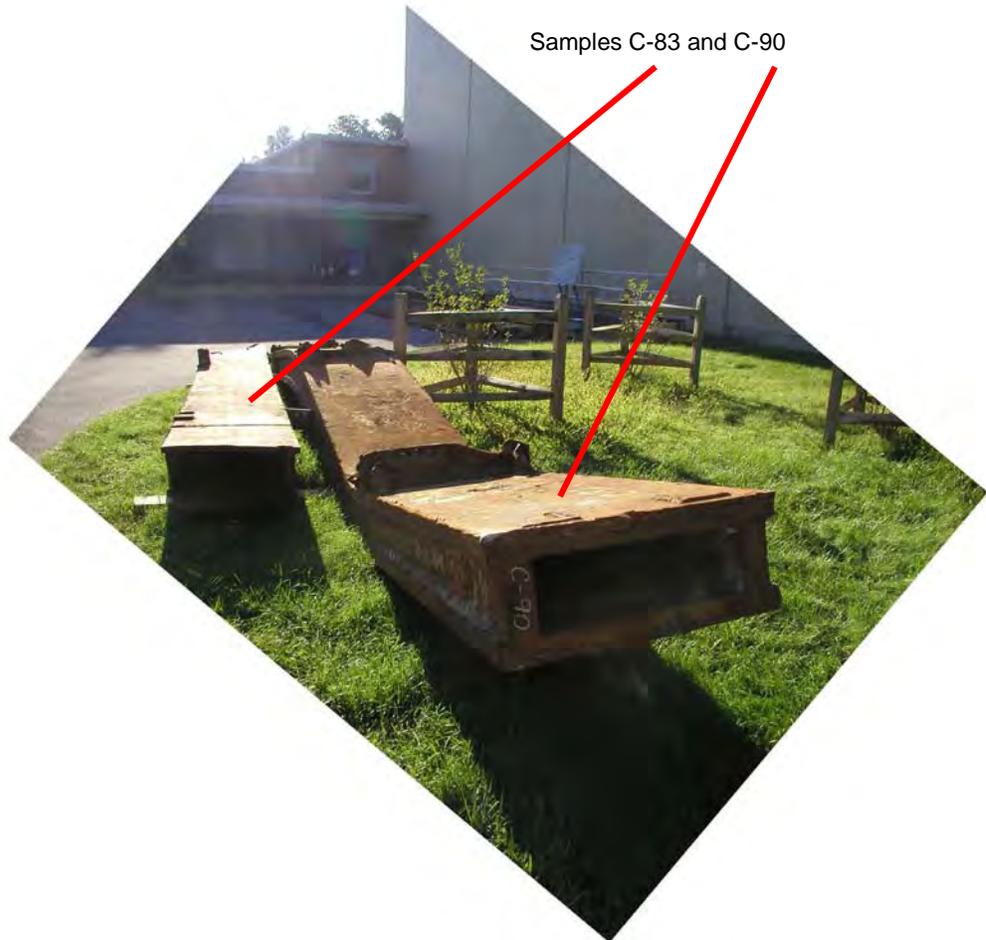
Figure 1-7. Recovered rectangular built up box sections used as core columns.

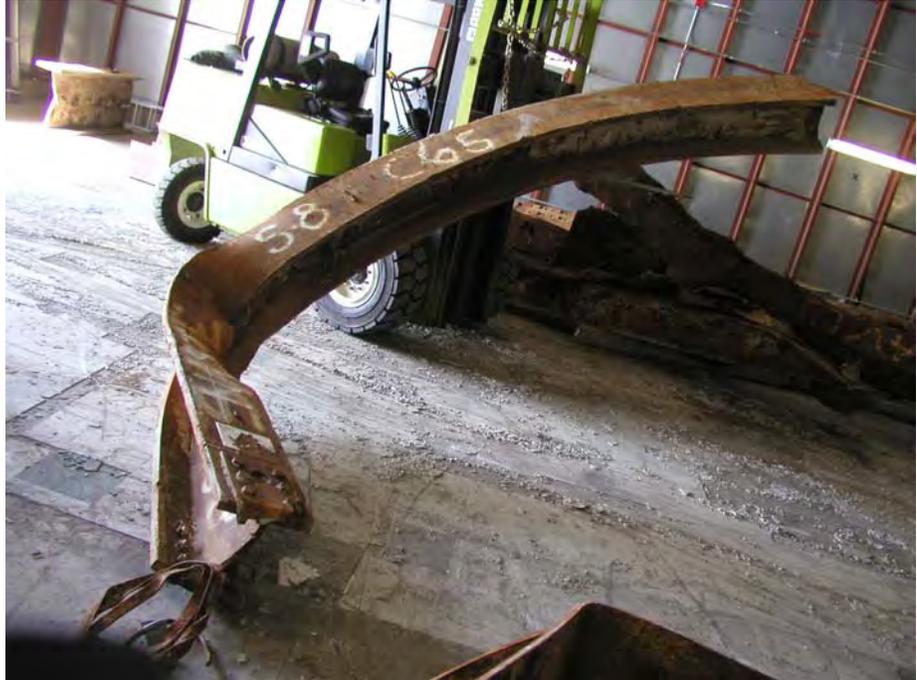
Sample C-65

Figure 1–8. Recovered wide flange sections used as core columns.

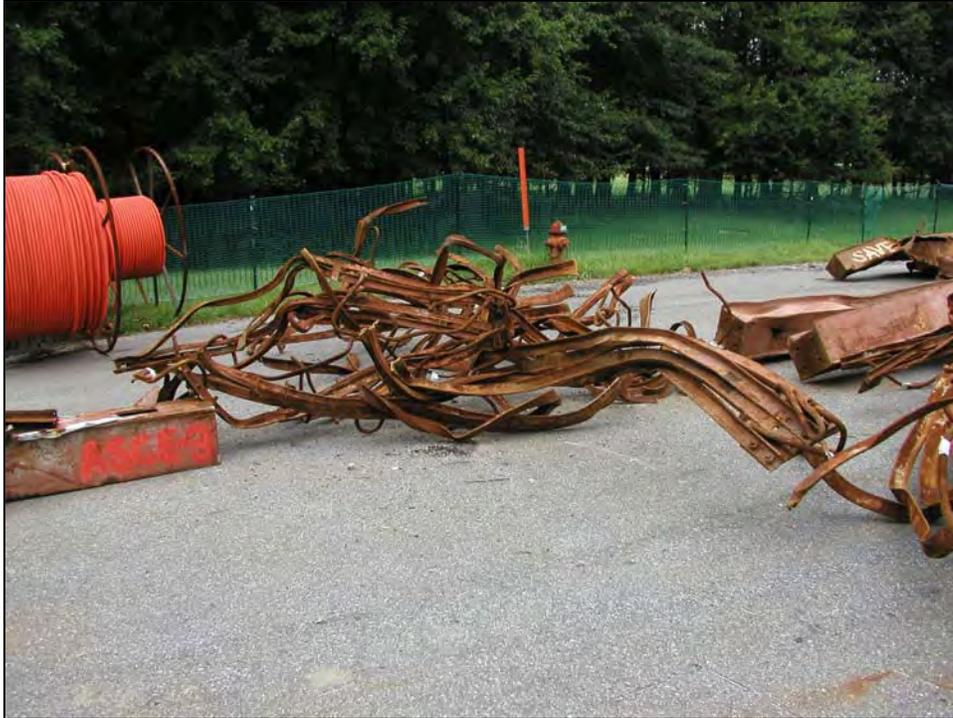
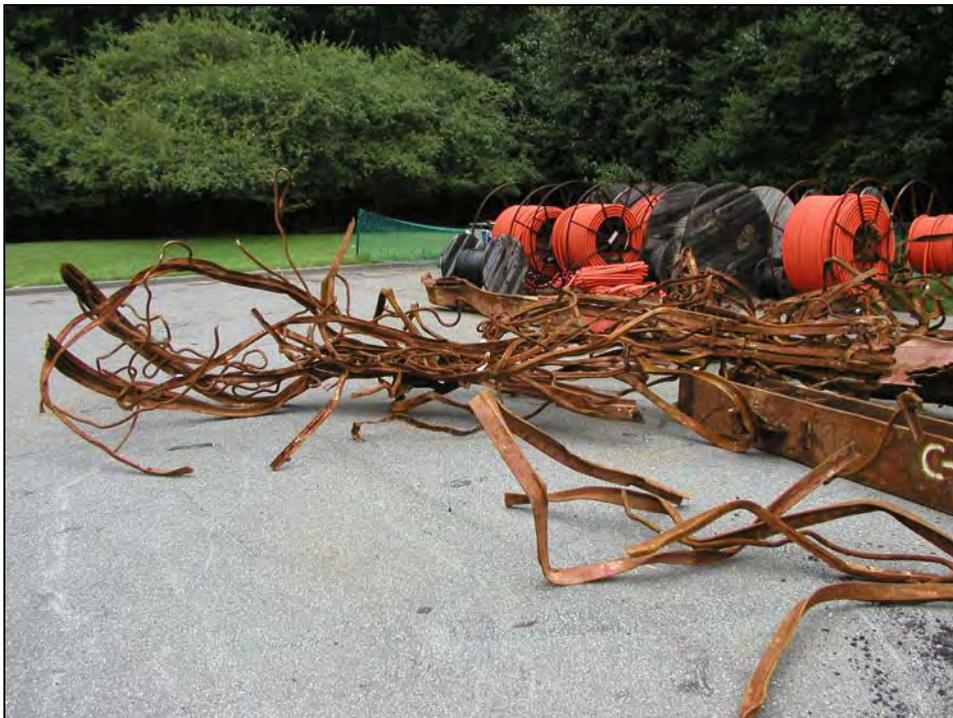
Figure 1–9. Other recovered wide flange sections, shown is sample C-42.

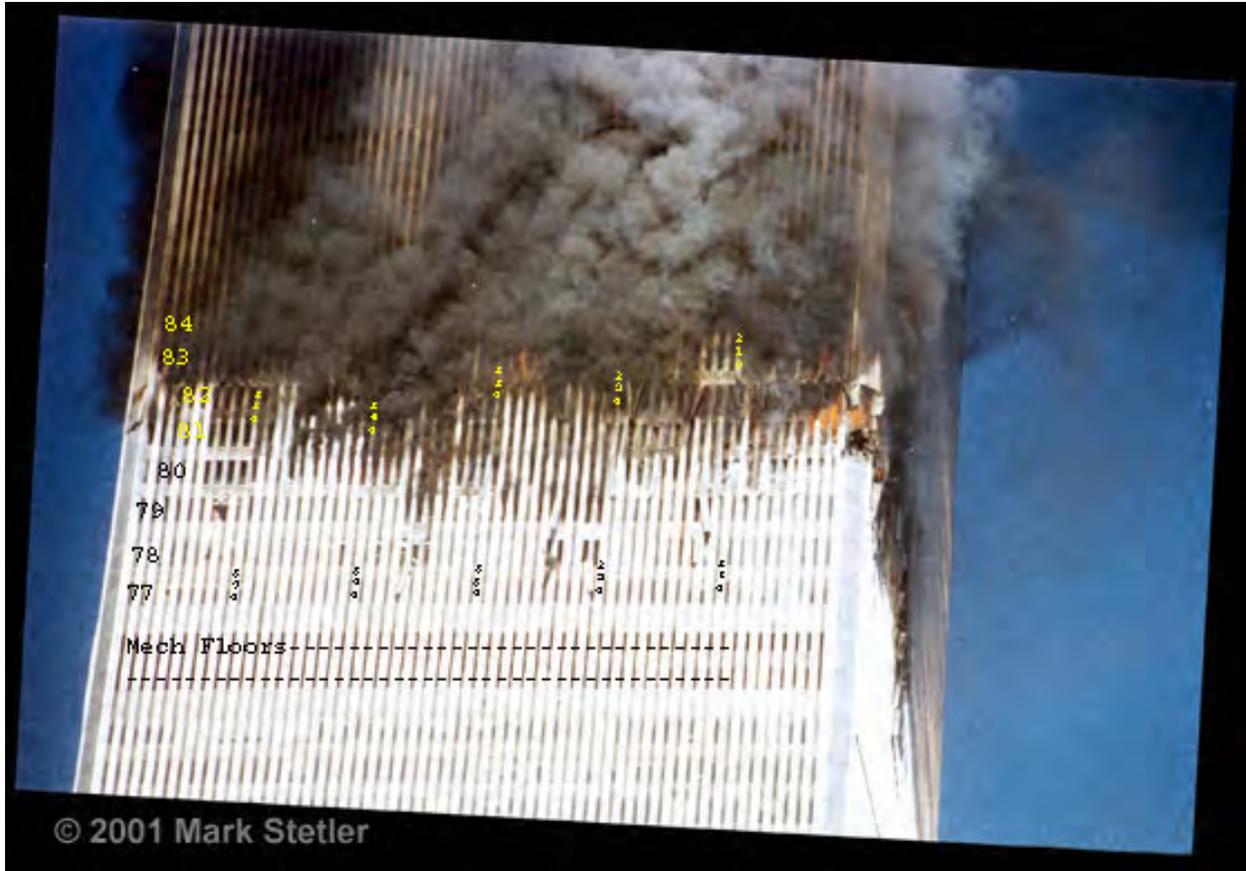
Figure H-6. Photograph taken at 9:26:20 a.m. on September 11, 2001, showing the east face of WTC 2. It has been enhanced, and lettering indicating floors and columns has been added.

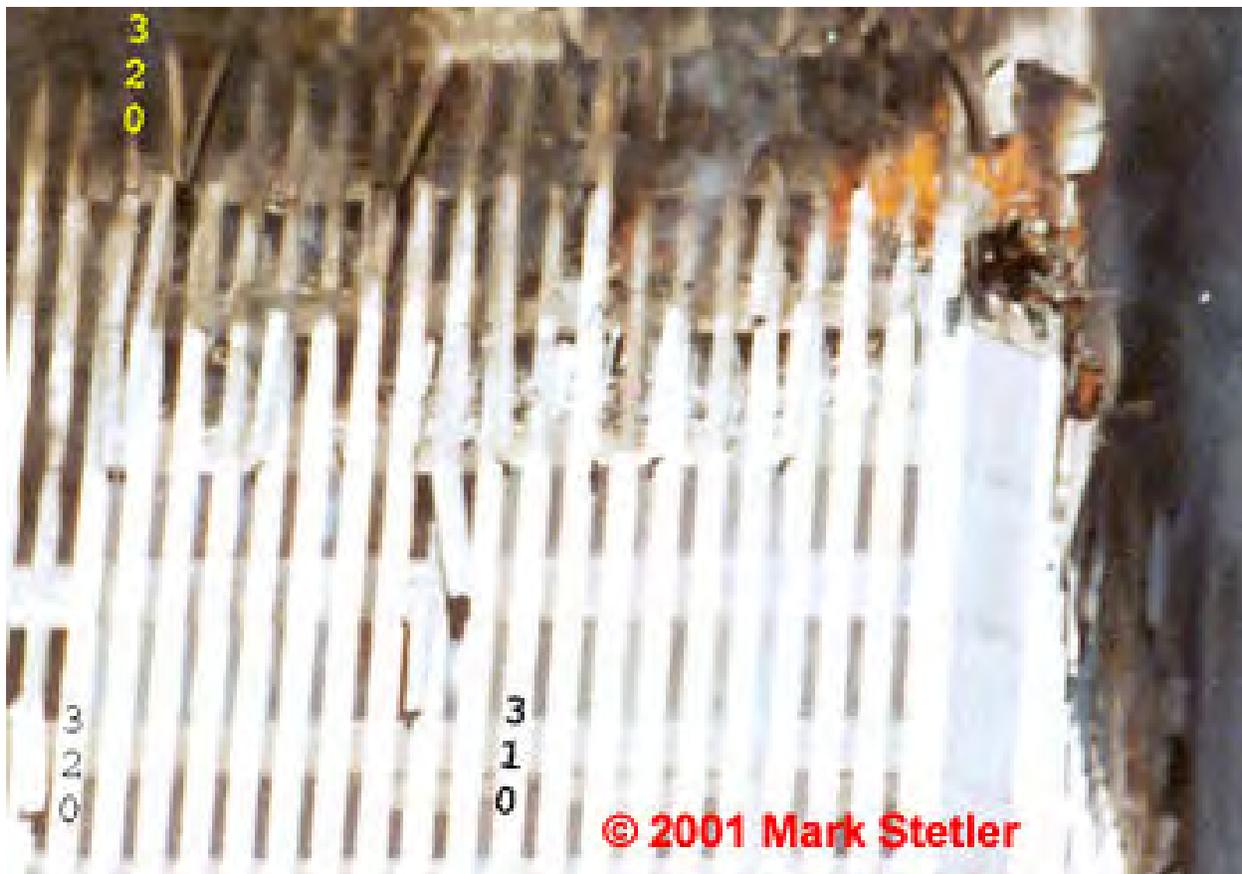
Figure H-7. This photograph is cropped from the image shown in Figure H-6. It was taken on September 11 and shows the east face of WTC 2 at the northeast corner from floor 77 to floor 82. Note the large piles of debris evident on floor 80 and floor 81.

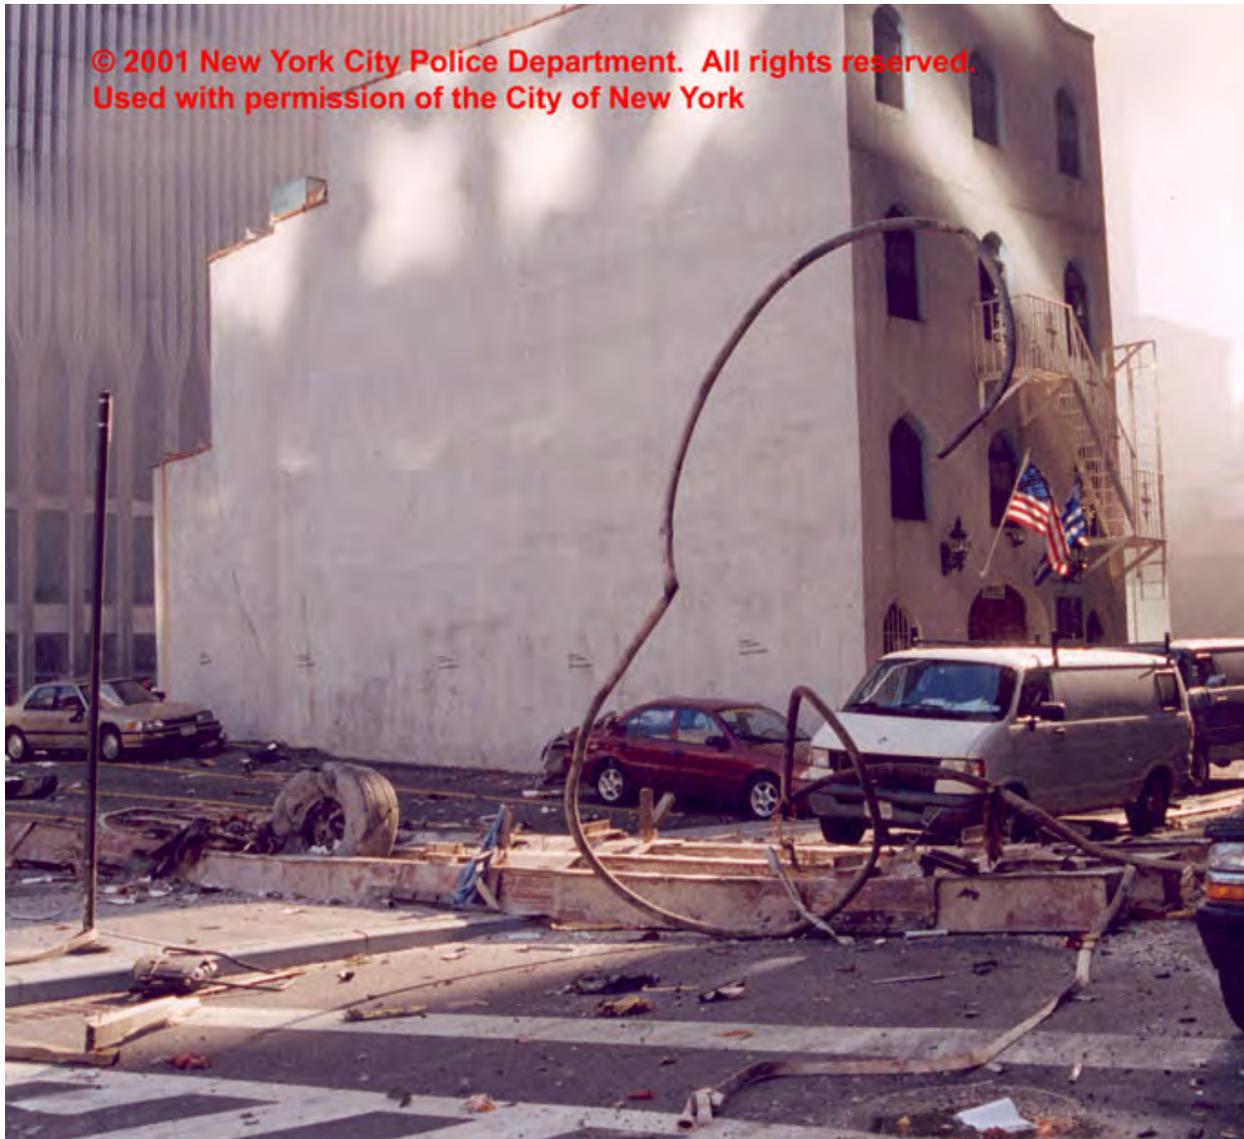
Figure H-14. Photograph showing a full panel section lying in Cedar Street near its intersection with West Street. An aircraft wheel can be seen imbedded in one of the windows. The building behind the panel is Saint Nicholas Greek Orthodox Church and the lower section of WTC 2 can be seen across Liberty Street.

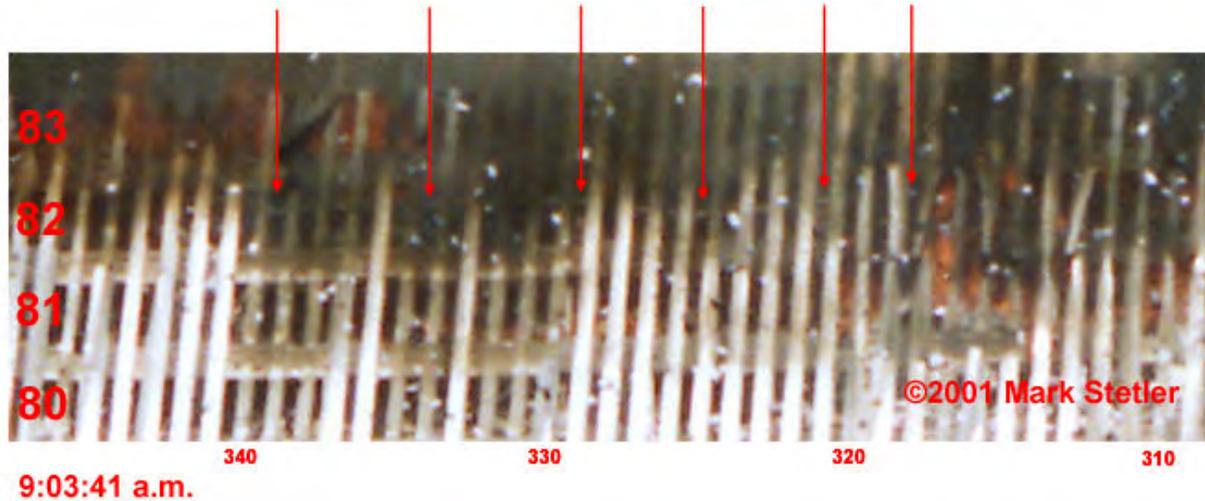
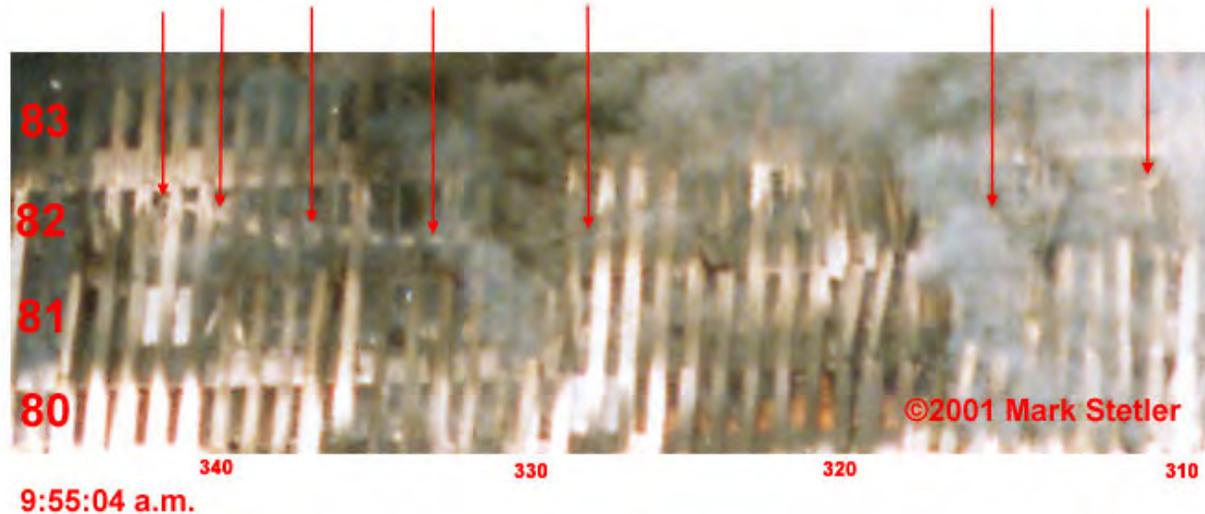
In the *May 2003 Investigation Progress Report* (NIST 2003), a photograph was shown in which there appeared to be a floor draped across a number of windows extending roughly from 310 to 342 across the east face of floor 82 of WTC 2. Figure H-22 compares an image taken shortly after the plane strike at 9:03 a.m. and one taken at 9:55 a.m. shortly before the tower collapsed. At the earlier time, the hanging object is already present, but is seen through the windows draped much higher on the floor 82. An interpretation consistent with these observations is that floor 83 along the east side of WTC 2 was partially collapsed over a significant fraction of its length by the passage of the plane through the building. At the later time the floor has sagged further. By reviewing a number of photographs and videos, it has been determined that the change in floor position occurred between 9:34 a.m. and 9:38 a.m.

Figure H-22. Images of the east face of WTC 2 taken shortly after the plane struck and shortly before the tower collapse are shown. An object that is most likely a floor can be seen through windows on floor 82 as indicated by the arrows. The object has dropped lower between the times the two photographs were taken.
