NIST Special Publication 1000-5

June 2004
Progress Report on the
Federal Building and Fire Safety
Investigation of the
World Trade Center Disaster

Volume 1

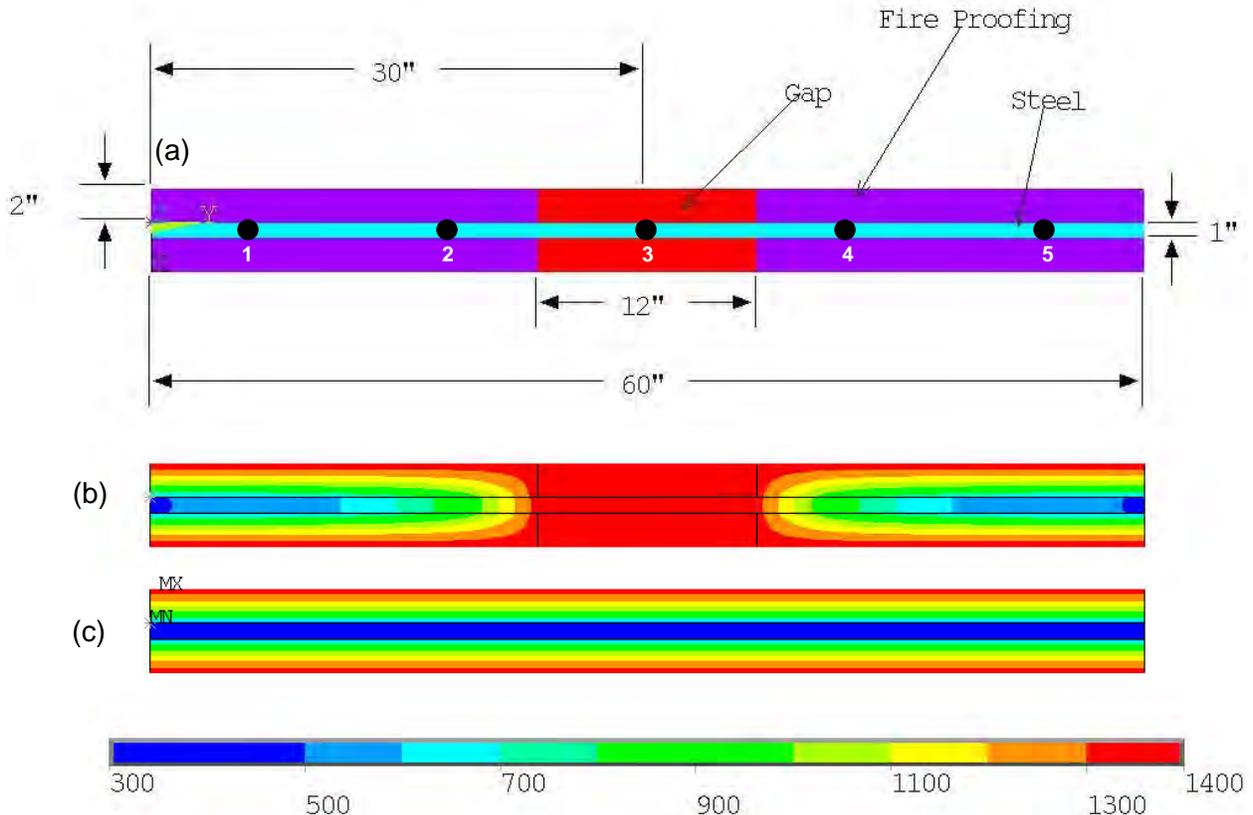
In addition to the effect of variation in thickness, it is important to understand the effect of missing fireproofing over a portion of a member. As an example, Fig. I-4 shows missing fireproofing from a diagonal of a bridging truss of the WTC towers floor system. Figure I-5 (a) shows an example of a numerical model with missing fireproofing. In this case, there is 12 in. of missing fireproofing on the steel plate, which is otherwise protected by 2 in. of uniform thickness fireproofing. Figure I-5 (b) shows the temperature contours (isotherms) at time 50 min. For comparison, Fig. I-5 (c) shows isotherms at the same time in a plate with no gap in the fireproofing. As expected, the bare steel at the missing fireproofing is at the gas temperature, but more importantly the “gap” in fireproofing leads to a “leakage” of heat into the interior steel.

Figure I-5. Effects of gap in fireproofing: (a) model of plate with fireproofing having 2 in. uniform thickness and 12 in. gap, (b) isotherms (K) at time = 50 min with 12 in. gap, and (c) isotherms without gap.

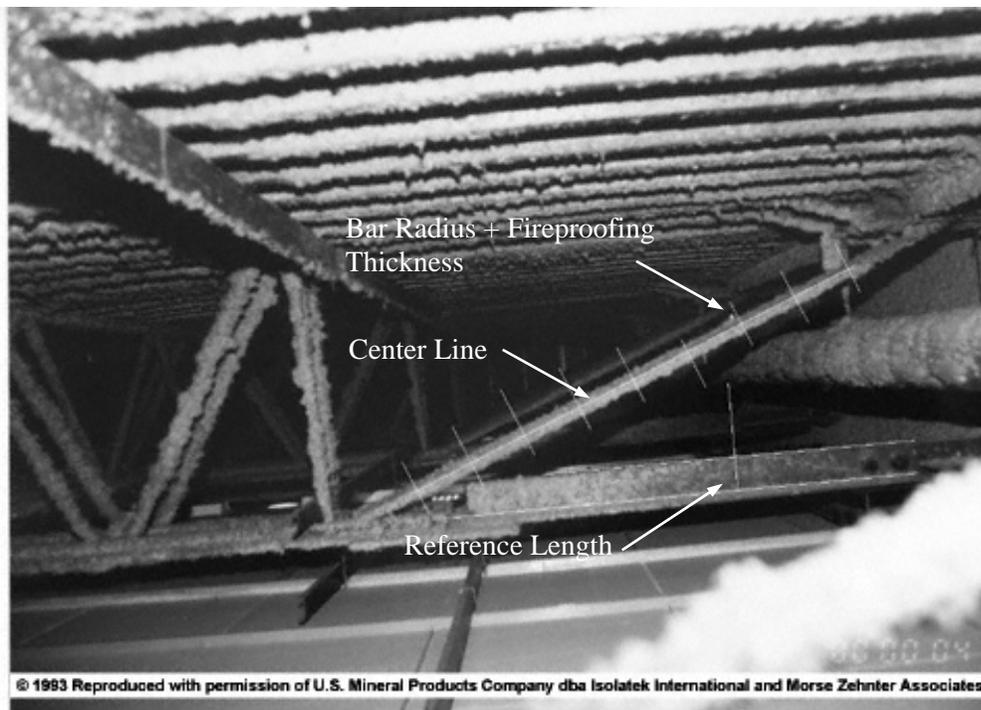
- Lines were drawn perpendicular to the “virtual” centerline. The number of pixels along the lines from the “virtual” centerline to the edge of the fireproofing was determined from the cursor positions indicated by the software. Measurements were made at regularly spaced intervals to avoid bias. Figure I-8 is an example of a series of measurements made on a strut.

Figure I-8. Example of measurement procedure used to estimate fireproofing thickness from photographs.

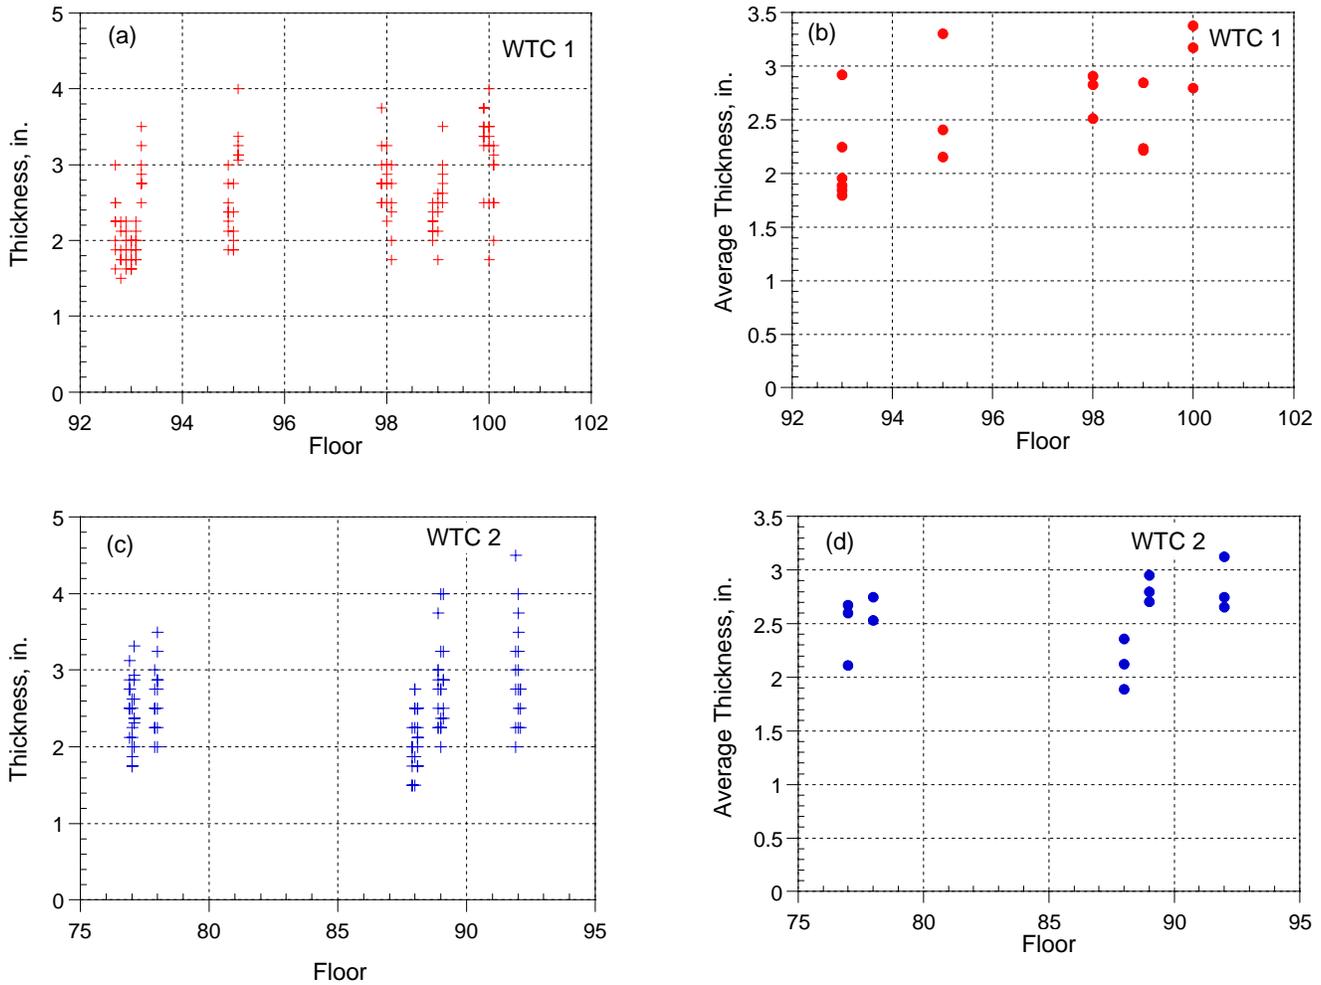
Figure I-11. Fireproofing thickness on floor trusses in upgraded portions of WTC towers: (a) individual measurements in WTC 1, (b) average thickness in WTC 1, (c) individual measurements in WTC 2, and (d) average thickness in WTC 2.

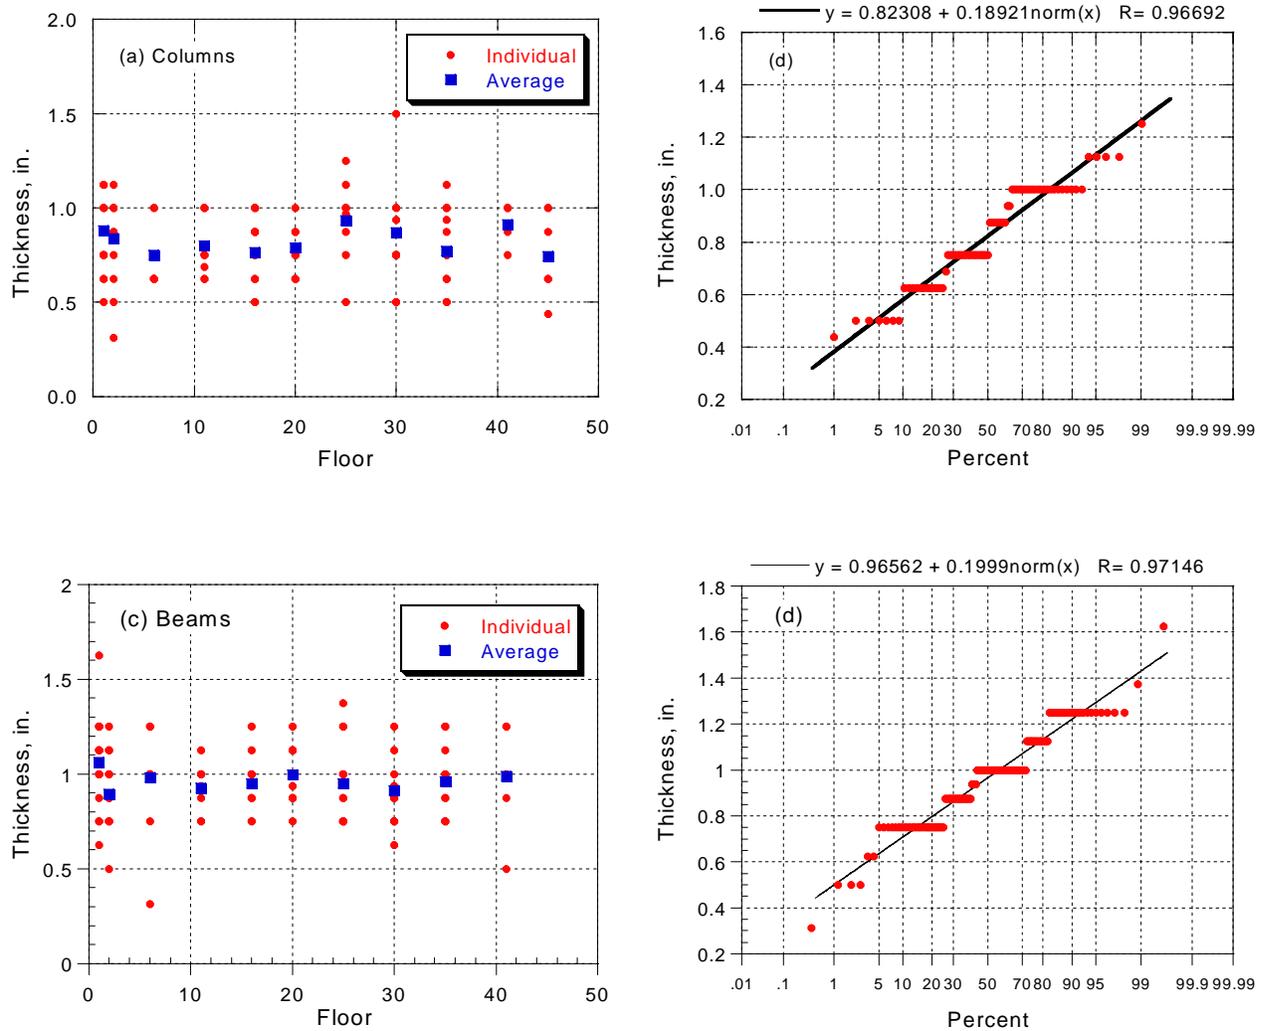
Figure I-12 (a) shows the individual and average fireproofing thickness on the core columns. Analysis of variance indicated no statistically significant differences among the average values and all data were pooled together. The average thickness for the columns is 0.82 in., the standard deviation is 0.20, and the coefficient of variation is 0.24. The information from the Port Authority indicated that the “minimum thickness required” for the columns was 0.5 in. Figure I-12 (b) is the normal probability plot of the individual thickness measurements. Because most of the thicknesses were reported to the nearest 1/8 in., the points are staggered instead of uniformly distributed. The plot, however, shows that the points follow a linear trend, and it appears that the thickness of the fireproofing on the core columns could be described by a normal distribution. Figures I-12 (c) and (d) shows the corresponding plots for the thickness of fireproofing on the beams. The average thickness for the beams is 0.97 in., the standard deviation is 0.21 in. and the coefficient of variation is 0.21. The information from the Port Authority indicated that the “minimum thickness required” for the beams was 0.75 in.

Figure I-12. (a) Individual and average thickness for core columns, (b) normal probability plot of individual measurements on columns, (c) individual and average thickness for core beams, and (d) normal probability plot of individual measurements on beams.

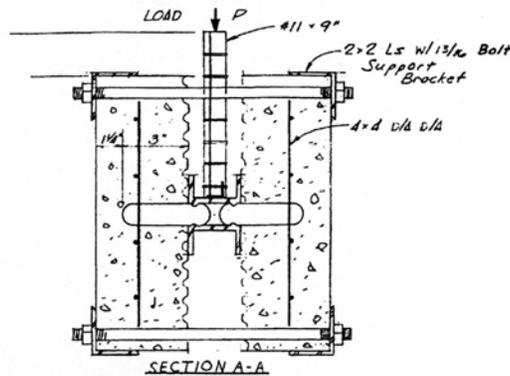
Figure K-16. Transverse shear test of a knuckle.

The transverse shear test consists of double knuckles placed into two reinforced concrete blocks that were confined on the corners by angles as shown in Fig. K-16. The concrete density of 110 pcf corresponds to the lightweight concrete in the office areas. The concrete compressive strengths reported for 7 day and 27 day cylinder tests were 1,330 psi, and 2,600 psi, respectively. The inner ends of the two knuckles were connected through channels to a #11 rebar and the rebar was loaded until the concrete failed. The tests were conducted at concrete age of 6 and 27 days. The primary failure mode observed was concrete shear failure. The pictures from the tests show formation of the shear crack in one of the concrete blocks and edging of the channel into the concrete. The transverse shear capacity of the knuckle as the average of the

two reported tests is 16.9 kip per knuckle. After adjusting it for the strength of in-place, mature, lightweight concrete in the slab of 4,100 psi relative to the average strength of the lightweight concrete used in the test of 1,965 psi, by multiplying by the ratio of 4,100 to 1,965 psi, the transverse shear capacity of the knuckle is approximately 35 kip per knuckle.

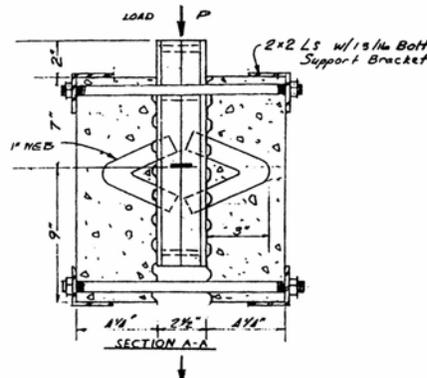
Figure K-17. Longitudinal shear test of a knuckle.

The longitudinal shear test consists of double knuckles placed into two concrete blocks as shown in Fig. K-17. The test specification shows corner angles confining concrete blocks and no reinforcement for the concrete. However, the test pictures show reinforcement in both directions for each concrete block, with the corner angles dismantled. The test specification calls for concrete density of 152 pcf, which corresponds to a normal-weight concrete. The slab in office areas is of lightweight concrete. The average strength of two 28 day cylinders tested is 4,290 psi. A third sample, tested after 96 days, showed a strength of 2,850 psi. The test specification does not identify the weld size connecting the inner ends of the two knuckles to two channels. However, the primary failure mode observed for three tests is weld failure. Weld failure is not identified as the failure mode of the knuckle for the other two tests. The results of the shear tests of the knuckle in the longitudinal direction based only on these two tests are approximately 28.3 kip per knuckle. After adjusting for the strength of in-place, mature, lightweight concrete in the slab of 4,100 psi relative to the 28 day corrected average strength of the normal-weight concrete used in the test of 3,707 psi, by multiplying by the ratio of 4,100 psi to 3,707 psi, the longitudinal shear capacity of the knuckle is approximately 31 kip per knuckle.

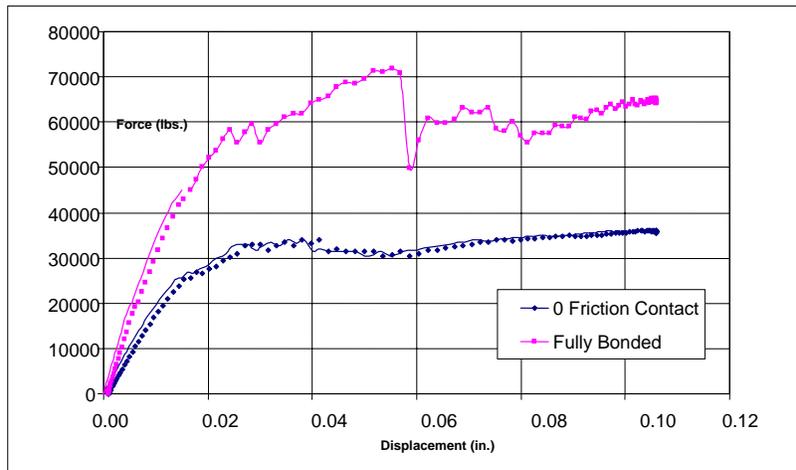
Figure K-21. Shear force versus displacement from finite element model for longitudinal shear of two knuckles.

The results of the analysis are shown in Figs. K-19 through K-22. They show significant dependence on the characteristic of the interface between the steel and concrete. The longitudinal shear test FEA results, shown in Fig. K-21, show that each knuckle has strength in the range of 15 kip to 35 kip, depending on interface. The test results show that the interface is closer to fully bonded case. For the transverse shear, the FEM results, Fig. K-22, show that transverse knuckle strength is about 24 kip for 2,500 psi concrete, corresponding to 39 kip for 4,100 psi concrete. Figure K-20 shows that for transverse shear concrete crushes in a small region next to the knuckle and extending in front of the shear load. Figure K-20 also shows large regions of crushing at the lower boundary of the model. These regions are the result of imposing the boundary condition $UY=0$. This boundary condition, and the crushing at the boundary, although realistic for the test, would not obtain in a pair of transversely loaded knuckles of the double

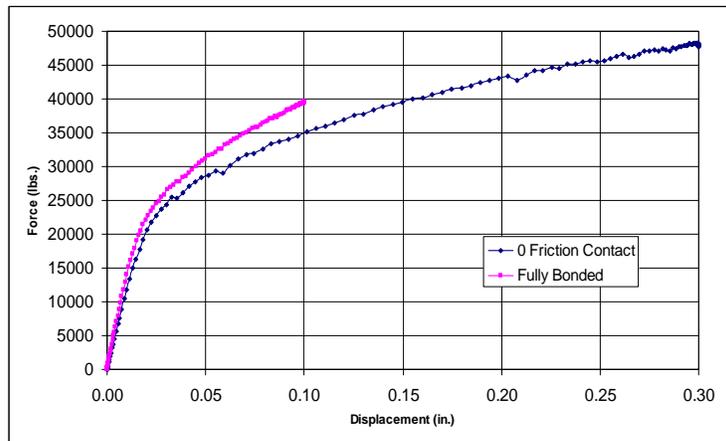
Figure K-22. Shear force versus displacement from finite element model for transverse shear of two knuckles.

truss. The small crushing regions at the knuckle indicate that a pair of knuckles in a double truss can be expected to behave nearly independently of each other, and, therefore, have nearly double the capacity of a single knuckle. Unfortunately, test results are not available that would confirm this conclusion.

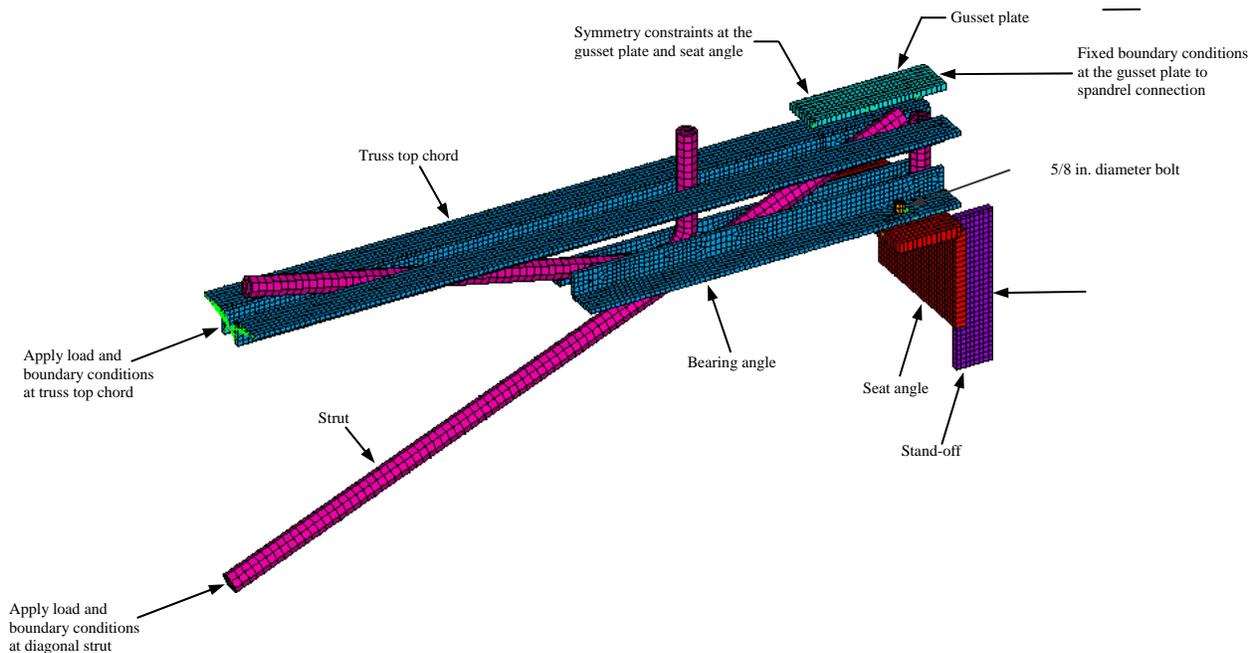
Figure K-26. Finite element model of exterior seat.

Figure K-26 shows the finite element model of the seat connection, where half of the seat was modeled and symmetry boundary conditions were applied. The results of the finite element analysis show that shear force is carried primarily by the stand-off plates shown in Fig. K-24, while the bending moment is resisted by tensile force in the gusset plate and compressive force in the stand-off plate. The seat restrains the moment until horizontal force in the connection causes slippage between the seat angle and bearing angle. Fillet welds at the stand-off to spandrel connection, which must resist shear, bending, and compression, control the seat capacity. The failure mode is fracture of the fillet welds at this connection, which results in loss of truss vertical support.

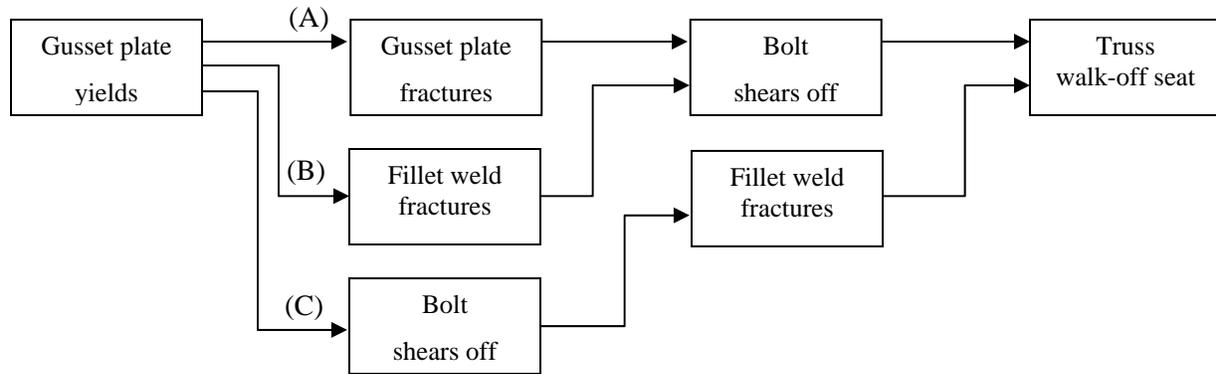
Failure Modes of Exterior Seat against Horizontal Tensile Force: The failure modes considered are: (1) failure of the groove weld between gusset plate and spandrel, (2) failure of the fillet weld between the gusset plate and the truss top chord, (3) tensile failure of the gusset plate, (4) bolt shearing off, (5) bolt bearing, (6) bolt tear-out, and (7) block shear failure. For calculation purposes, the bolts are assumed to be centered in the slotted holes. The typical failure sequence of the truss seat is as follows: first the gusset plate yields, then it fractures, followed by truss deformation and bolt bearing against the slotted hole, the bolt shears off, and then finally the truss walks off the seat. The travel distance for the truss to walk off of the seat is 4 5/8 in. This failure sequence is illustrated in Fig. K-27 as path (A) and shown in Fig. K-28, where the relationship between the tensile force resistance from the seat connection and the truss travel distance is plotted. In this plot, frictional resistance between the seat angle and bearing angle was not included.

(A) Seat details 1111, 1311, 1411, 1511, and 1611 at all temperatures.

(B) Seat detail 1013 at temperatures below 100 °C.

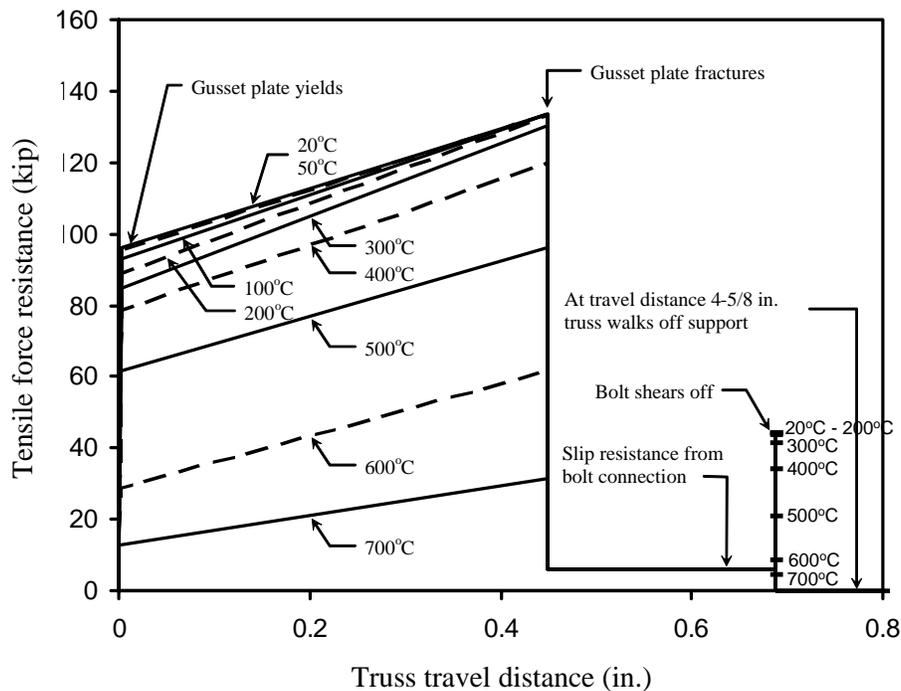
Figure K–28. Typical tensile force resistance from exterior seat (Detail 1411).

Seat details 1212 and 1313 have a wider gusset plate and follow path (C) which differs from the typical sequence where the bolts will bear against the slotted hole then shear off before the gusset plate connection fails. The failure sequence of seat detail 1013 is temperature-dependent. At temperatures below 100 °C, the fillet weld connection between the gusset plate and the truss top chord fractures before bolts shear off. At temperatures greater than or equal to 100 °C the failure sequence is the same as for Details 1212 and 1313.

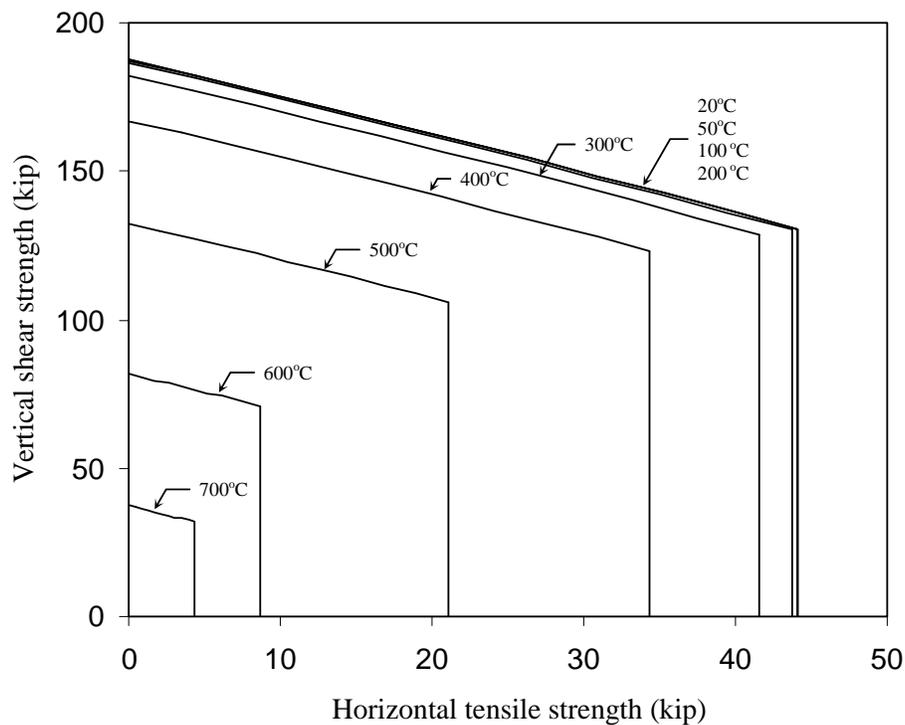
**Figure K-29. Strength of combined vertical and horizontal force (Detail 22).**

Capacity of Interior Seat against Combined Vertical and Horizontal Force: A typical interaction relationship for combined vertical and horizontal tensile force is shown in Fig. K-29. As can be seen from this figure, the vertical shear strength of the seat reduces because of the additional horizontal tensile force that the fillet weld connection between the truss seat and the channel beam must resist.

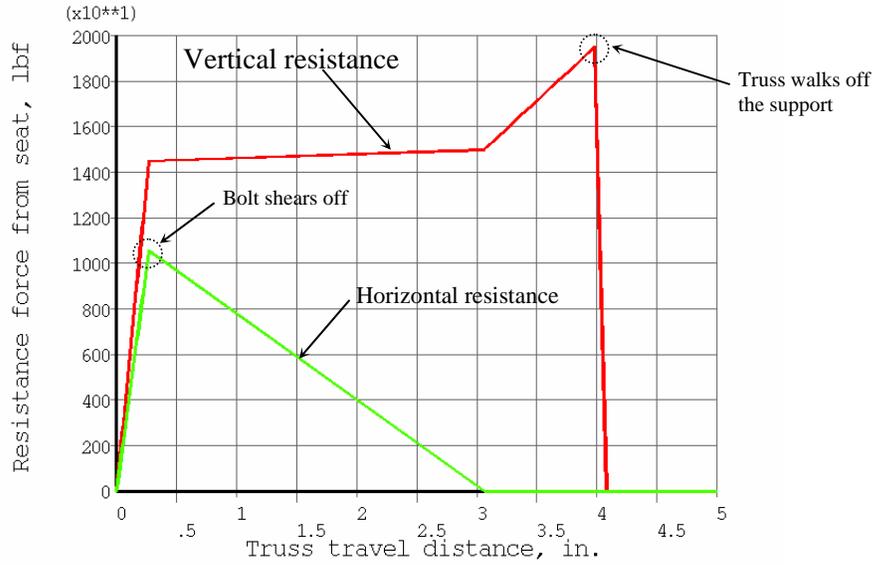
Figure K–32. Results of simplified seat model capturing failure from truss walking off interior seat.

When truss reaction force on the seat is large in horizontal tension and small in vertical shear, the failure mode is bolt shearing off followed by truss walking off the support as shown in Fig. K–32. Bolt shear is controlling the seat horizontal resistance capacity. Bolt shear by itself however does not cause the truss to lose its vertical support, but it is the prerequisite of truss walking off the seat. The travel distance for a truss to walk off an interior seat is 4 in. When truss reaction force on the seat is large in vertical shear and small in horizontal tension, the failure mode is exceeding the seat vertical shear capacity as shown in Fig. K–33. This failure mode will cause the truss to lose both its vertical and horizontal support from the seat.

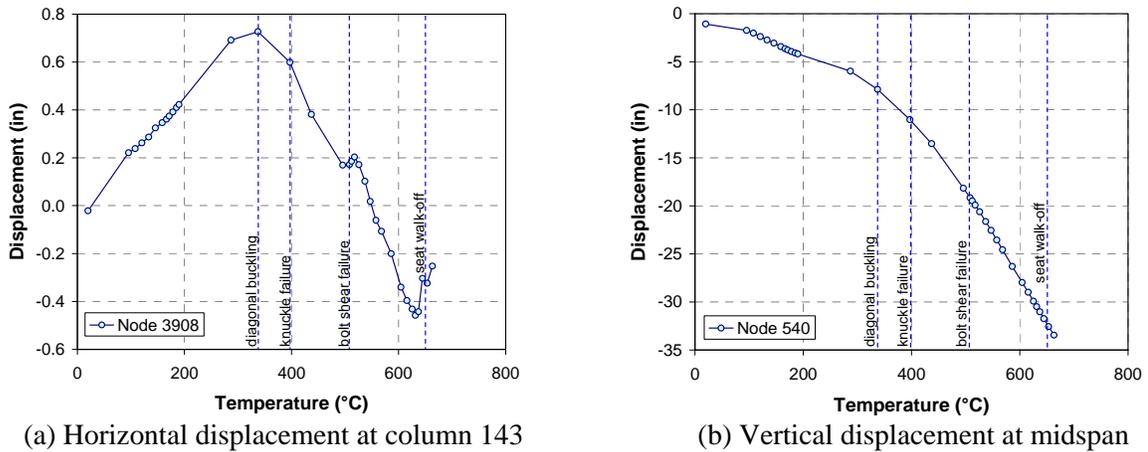
Figure K–40. Displacement versus temperature.

Gravity Plus Thermal Loading—The analysis is carried out dynamically with 5 percent Rayleigh damping. To shorten the run time, the total time period is set to 1.0 s for the temperature ramp. The analysis proceeded to a temperature of $T=663\text{ }^{\circ}\text{C}$. Figure K–40 shows horizontal and vertical displacement results. A positive horizontal displacement indicates that the exterior columns are pushed out, and a negative vertical displacement indicates that the truss is deflected downward. At $340\text{ }^{\circ}\text{C}$, the horizontal displacement at the exterior column starts to decrease. At $560\text{ }^{\circ}\text{C}$, the exterior columns are pulled in, and the truss becomes catenary from that point on.

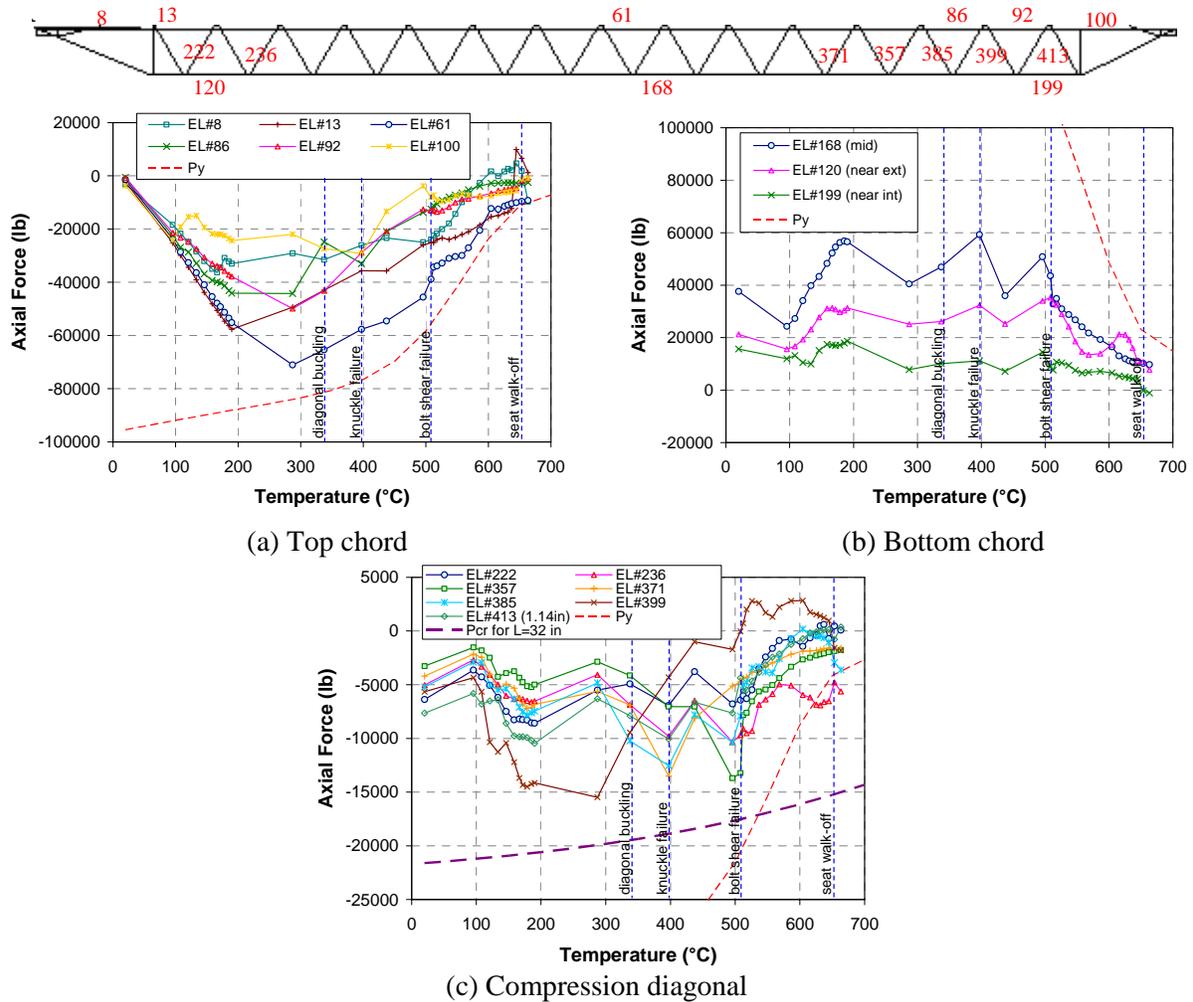
Figure K–41. Axial force in truss members versus temperature.

Figure K–41 shows axial forces in the truss members. In the figure, P_y is the axial force at yield and equals the product of the net area of the member and the yield strength which varies with temperature. P_c is the compressive strength per AISC formula (AISC 2003) for the top chord with fixed ends in Fig. K–41 (a) and for 1.09 in. diameter diagonal bar with pinned ends in Fig. K–41 (c).

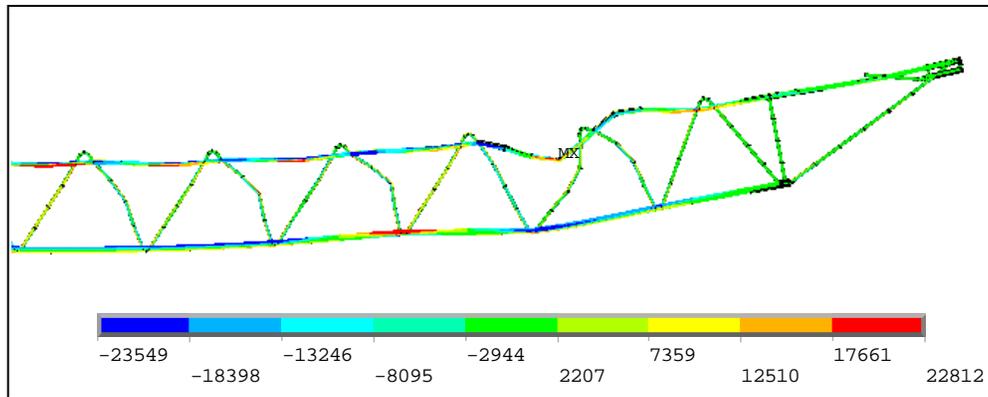
Figure K-42. Axial stress contour in the truss members at 663 °C (displacement magnification factor = 1.0).

Figure K–42 (a) shows the top chords yielding beyond 300 °C. This is due to a significant difference of coefficients of thermal expansion (CTE) between concrete and steel. At 500 °C, the CTE of steel is twice that of lightweight concrete. Bottom chords are still in the elastic range at the end of analysis. Some diagonals are bent significantly in the plane of the truss by high axial force and end moments (see Fig. K–42 for the deformed shape at the interior end). This diagonal buckling starts at approximately 340 °C.

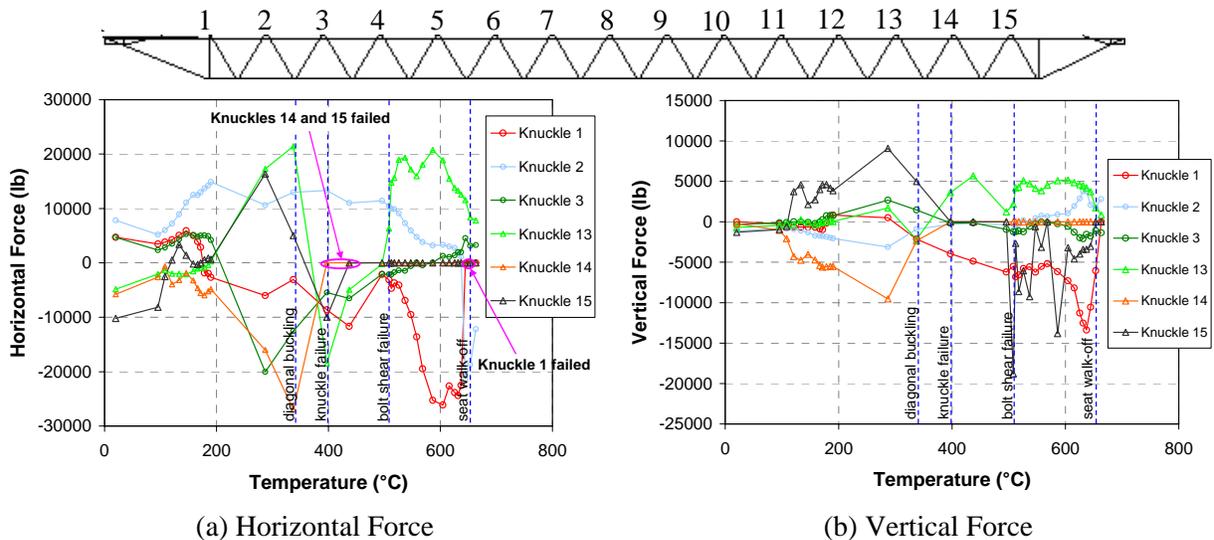
Figure K-43. Force in the knuckles versus temperature.

Figure K-43 shows knuckle forces in the y direction (longitudinal truss direction) and the z direction (vertical direction). The capacity of a knuckle in the y direction is assumed to be 30,000 lb, and in the z direction 15,000 lb in tension. Knuckles 14 and 15 fail due to horizontal shear around 400 °C. Knuckle 1 also fails due to the horizontal shear around 650 °C.

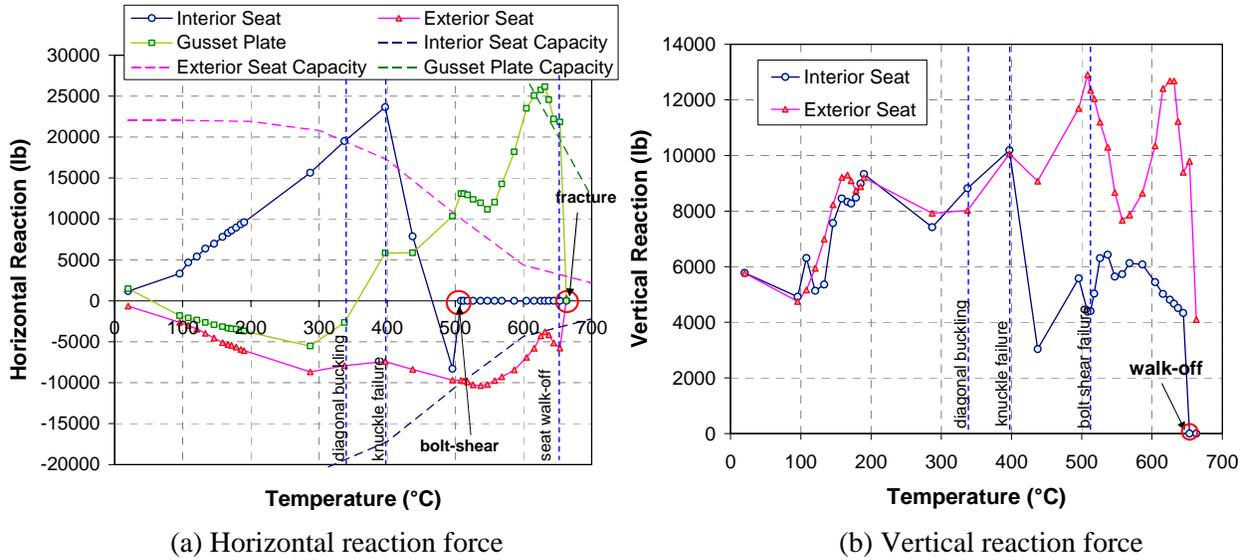
Figure K-44. Reaction forces at seats.

Figure K-44 (a) and (b) show horizontal and vertical reaction forces at seats, respectively. At 510 °C, the interior seat bolt shears off. At 650 °C, the truss walks off the interior seat. At 660 °C, the gusset plate at the exterior end fails in tension.

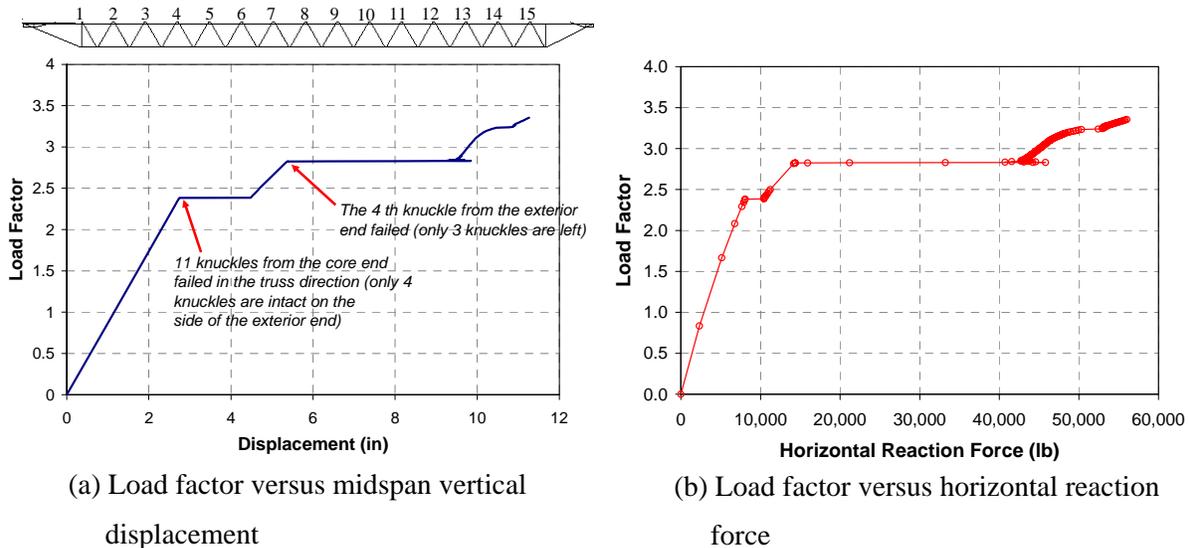
Figure K-45. Finite element analysis results from increasing gravity.

The capacity of the truss model against additional debris load is determined by increasing the gravity loading at room temperature. The analysis is performed with the previous model, where boundary conditions of the slab are as described in the section “Bounding Conditions.” Let us define load factor as the ratio of the gravity load plus debris weight to the gravity load, where gravity load includes self weight, superimposed dead load, and 25 percent of the reduced live load. The analysis was terminated at a load factor of 3.4. Figure K-45 (a) shows midspan vertical displacement versus load factor. At 2.4 times the gravity loading, 11 knuckles from the core end fail in the truss direction. At 2.8 times the gravity loading, the fourth knuckle from the exterior end fails. Figure K-45 (b) shows the sum of horizontal reaction forces measured at the exterior columns. Note that seat capacities are not modeled in this analysis.

The results for the additional debris weight show that the knuckles start failing when the load factor is 2.4. Most knuckles fail before load factor reaches 3.0. After the knuckle failure, the truss loses composite action between the truss and the concrete slab, and the vertical displacement increases significantly. As a result, horizontal reaction force increases.

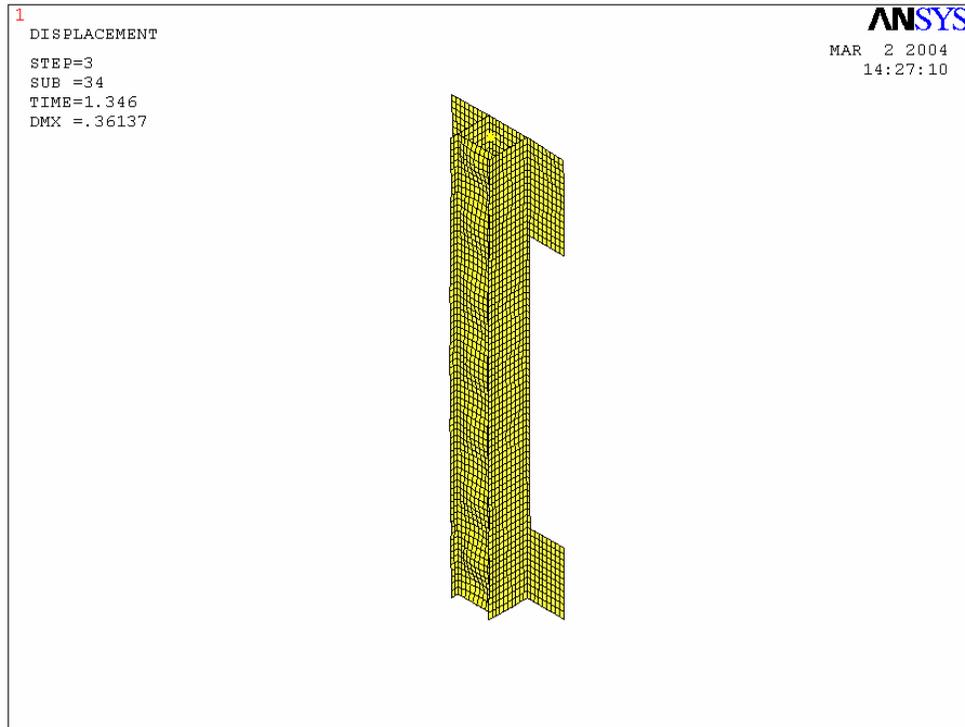
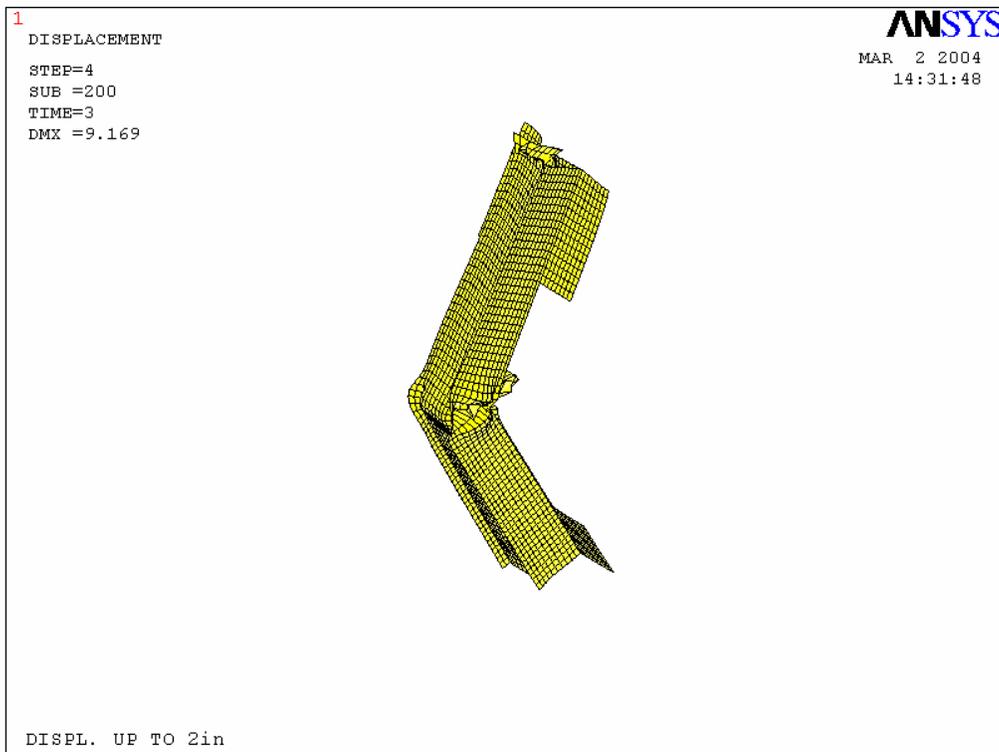
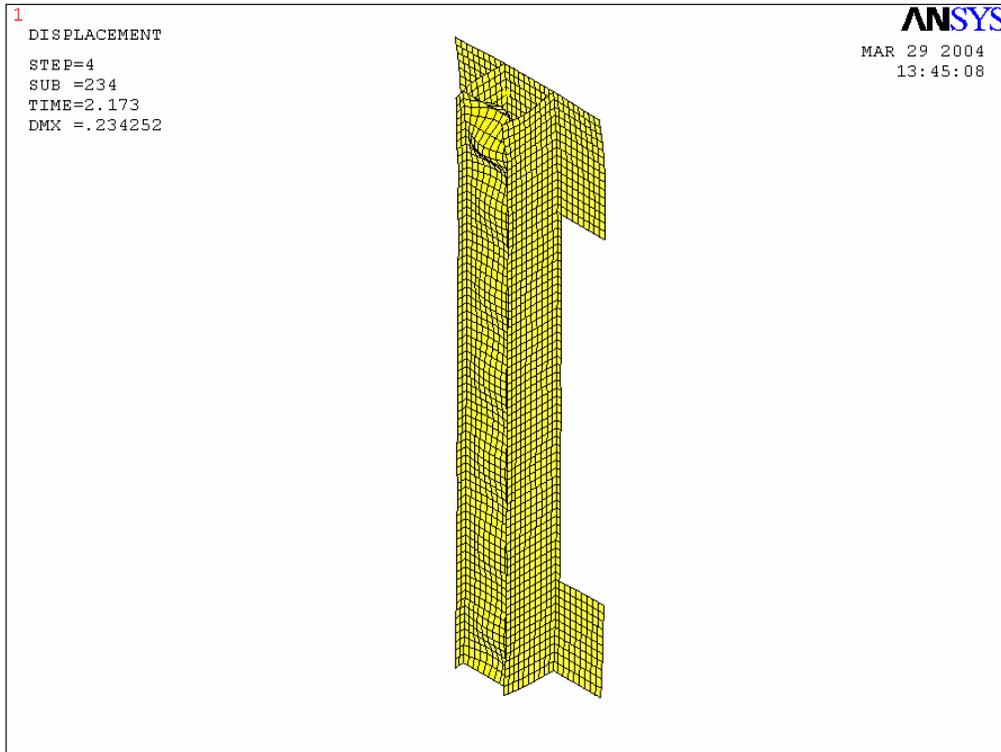
Figure K-54 shows the local buckling deformation of Plate 2 and Plate 3 at the maximum load level. Figure K-55 shows a plastic hinge at mid-height of the column for an axial displacement of 2 in. Figure K-56 shows the presence of local buckles in Plate 2 and Plate 3 at the maximum load.

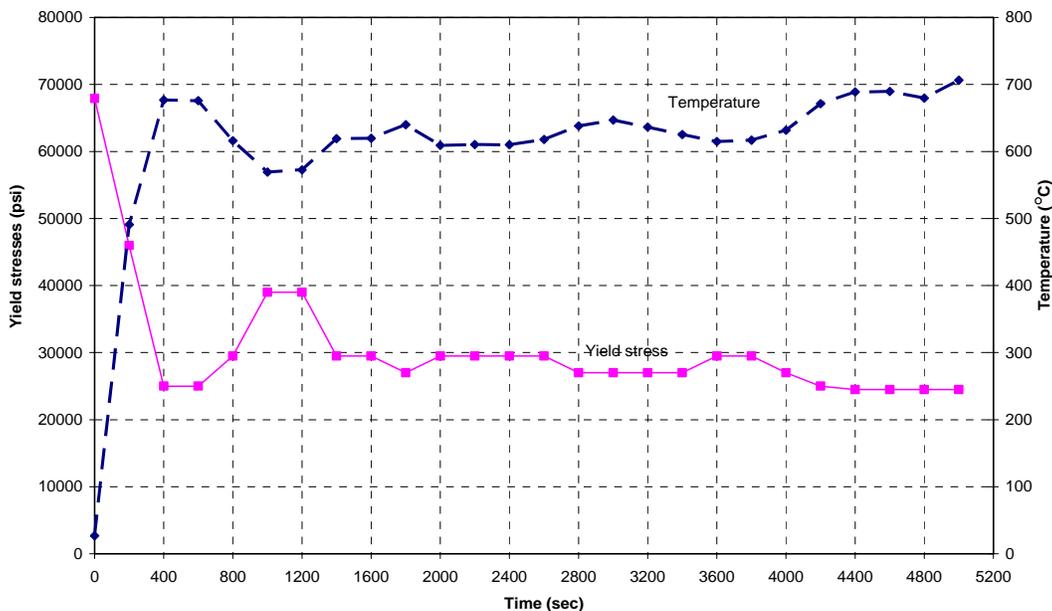
In Fire Scenario G, the fire starts on floors 95, 96, and 97 and spreads to floors 93 through 98. Gas temperature reaches 1,100 °C. Convection cools the outside face of the column. Radiation heats the other three faces. The inside face of the column is not fireproofed. Temperatures are provided at 200 s intervals up to 5,000 s. Figure K–58 shows the variation of the maximum temperature anywhere in the column with time and the yield stress at the point of maximum temperature. The temperature reaches a maximum of 706 °C at 5,000 s.

Figure K–58. Variation of maximum temperature and corresponding yield stress with time, fire scenario G.

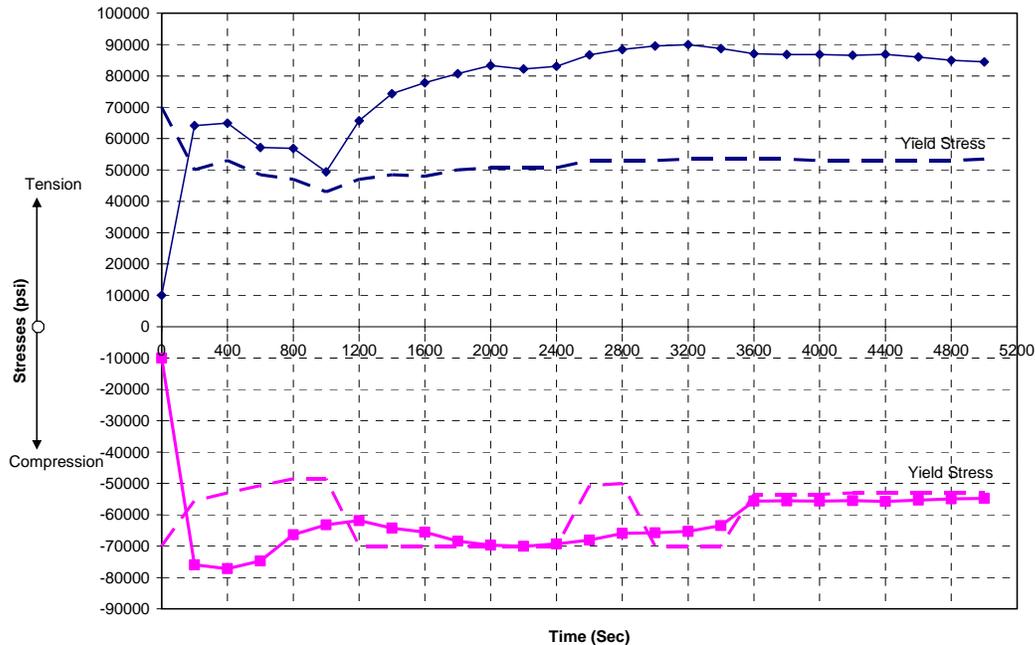
Figure K-59. Maximum compressive and tensile axial stress and corresponding yield stress with time, fire scenario G.

Figure K-59 shows that the tensile and compressive stresses exceed the yield stress for most times during the duration of the fire.

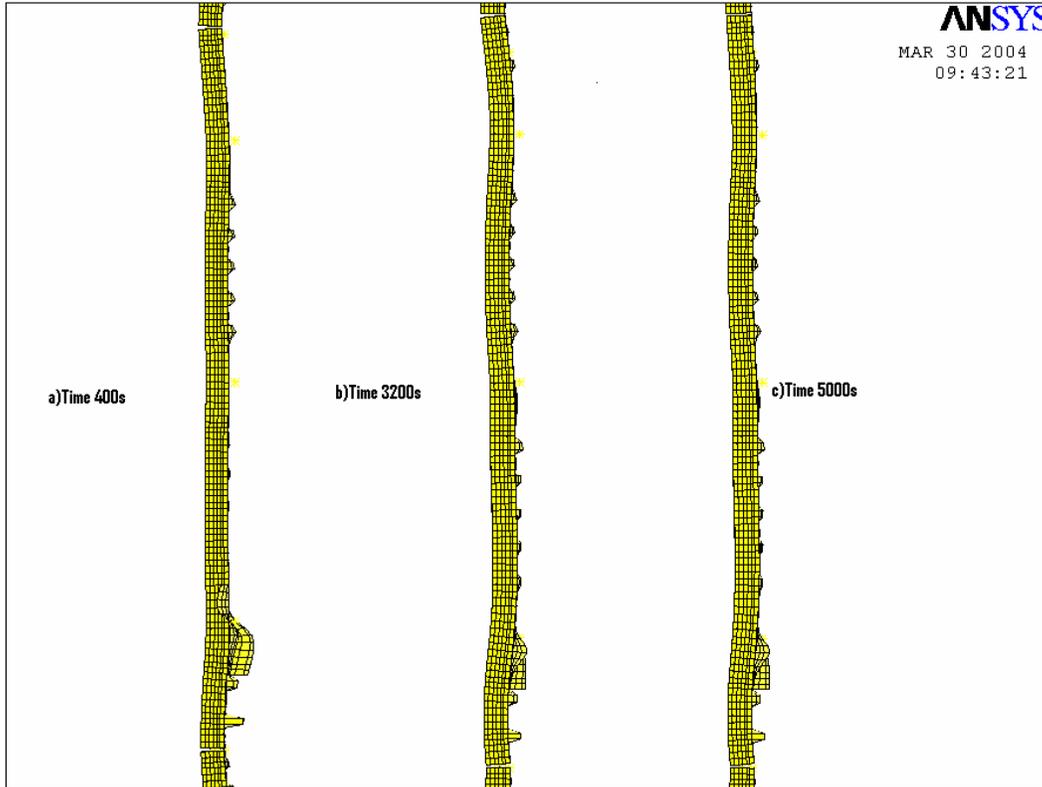
Figure K-59 shows the variation of maximum tensile and maximum compressive stresses with time and the corresponding yield stress. Figure K-60 shows the deformed shape of the column at 400 s when the compression stress in the column is a maximum. Figure K-60 also shows the deformed shape of the column at 3,200 s when the tensile stress in the column is a maximum. Figure K-60 also shows the deformed shape of the column at 5,000 s when the temperature in the column is a maximum.

Figure K-60. Deformed shape of column at 400 s, 3,200 s, and 5,000 s (floors 95-97).

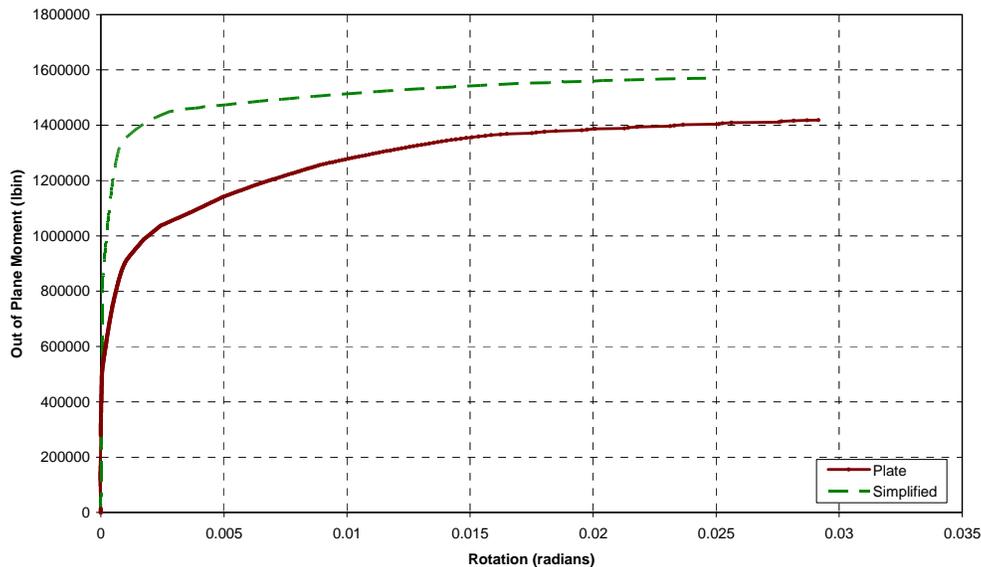
Figure K-66 shows the rotation variation with out-of-plane of the wall moment. Figure K-67 shows the rotation variation with in-plane-of-the-wall moment. Figure K-68 shows the twist variation with torque. Figures K-66, K-67, and Fig. K-68 show large differences between the results of the simplified and plate models of the column splice. These differences are due to the fixed locations of pivot points in the simplified model, provided by pairs of CONTA178 point-to-point contact elements, about which the faying surfaces rotate. The CONTA174 and TARGE170 surface contact elements for the faying surfaces in the plate model permit the location of the pivot point to adjust to the demand of the applied moment. Adjusting the location of the point-to-point contact elements can minimize these differences, but they cannot be eliminated. In the exterior wall subsystem model, the locations of the single point contact elements in the column splices will be adjusted and the sensitivity of the response of the model results to these locations computed.

Figure K-66. Variation of rotation with moment, out of wall plane.
