NIST Special Publication 1000-5

June 2004
Progress Report on the
Federal Building and Fire Safety
Investigation of the
World Trade Center Disaster

Volume 1

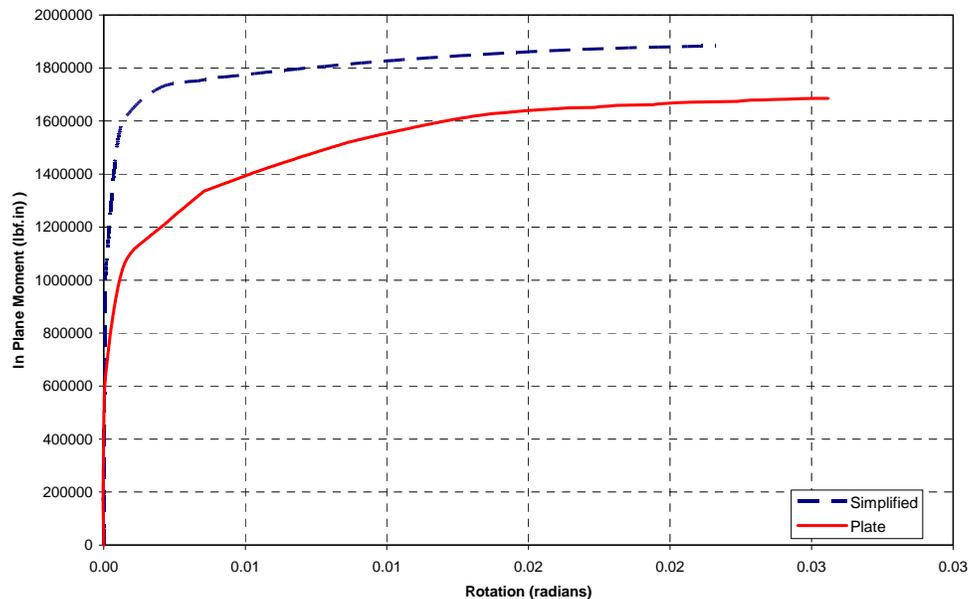
Figure K-66 shows the rotation variation with out-of-plane of the wall moment. Figure K-67 shows the rotation variation with in-plane-of-the-wall moment. Figure K-68 shows the twist variation with torque. Figures K-66, K-67, and Fig. K-68 show large differences between the results of the simplified and plate models of the column splice. These differences are due to the fixed locations of pivot points in the simplified model, provided by pairs of CONTA178 point-to-point contact elements, about which the faying surfaces rotate. The CONTA174 and TARGE170 surface contact elements for the faying surfaces in the plate model permit the location of the pivot point to adjust to the demand of the applied moment. Adjusting the location of the point-to-point contact elements can minimize these differences, but they cannot be eliminated. In the exterior wall subsystem model, the locations of the single point contact elements in the column splices will be adjusted and the sensitivity of the response of the model results to these locations computed.

Figure K-67. Variation of rotation with moment, in plane of wall.

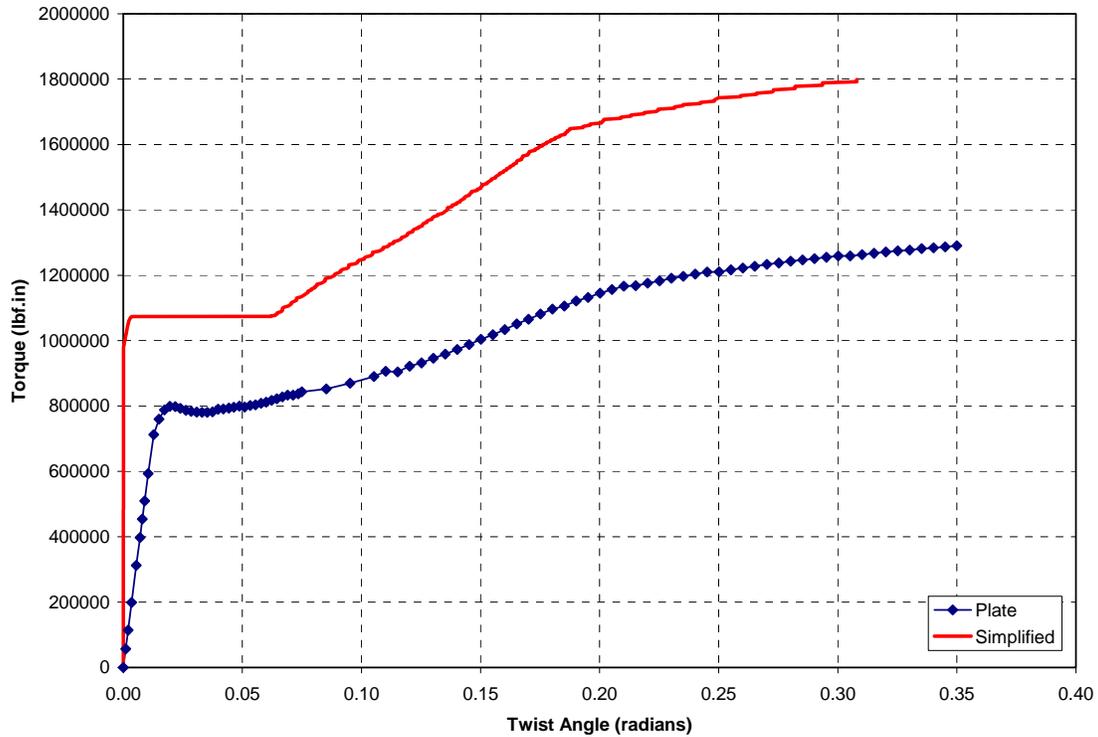
Figure K-68. Variation of twist angle with torque.

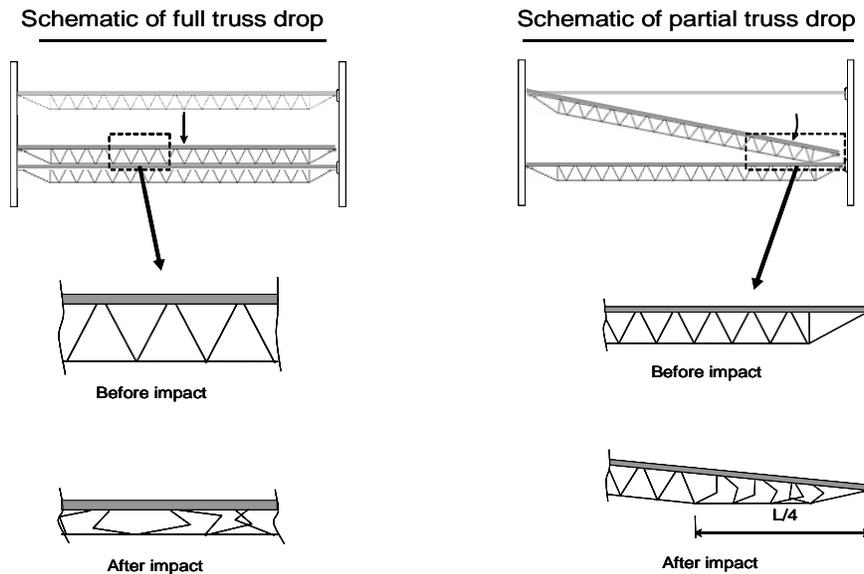
The failure of dropping floor may occur due to thermal response and/or additional debris weight on the truss, and/or as a result of the aircraft impact. A floor truss or a group of floor trusses could lose support at both the exterior and interior supporting ends and drop onto the floor below. This failure mode, which is shown in Fig. K-75, will be referred to as “full truss drop.” Alternatively, a floor truss or a group of floor trusses could lose support on one side and drop down to impact the floor below. This failure mode, which is also shown in Fig. K-75, will be referred to as “partial truss drop.”

Figure K-75. Schematic of full truss or partial truss drop and diagonal crushing at impact.

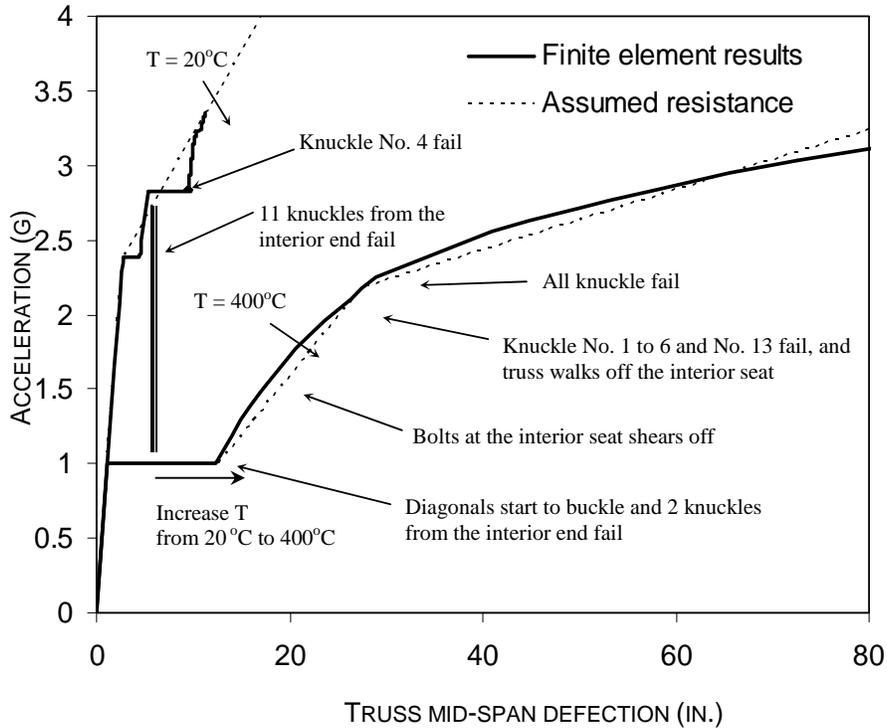
The demand-to-capacity ratio of the long-span truss for gravity loads is shown in Table K-18 and for gravity plus impact load is shown in Table K-19. The result for gravity load alone shows that both the exterior and interior truss seats have sufficient capacity to support the weight of two floors for all temperatures considered. The result for gravity plus impact load shows that at temperatures below 400 °C neither the exterior nor interior truss seat is expected to fail. Peak deflection response due to gravity and the dynamic impact of the dropping truss is given in Table K-20. The results show that at room temperature, and more so at 400 °C, the impacted truss will deflect to an extent that it loses composite action, and become a catenary. At 400 °C the truss walks off the interior seat. Obviously, a catenary truss is not able to restrain the exterior column against transverse movement and cannot restrain it from instability. Although a truss response to increasing acceleration at 700 °C has not yet been developed, the strength reduction of the truss seats clearly indicates that the failure of truss seats will occur. The results for long-span truss, for partial truss drop, and for the short-span truss are in progress.

Figure K-76. Target truss resistance against increasing acceleration.

At room temperature, the impact of a dropping truss will not cause failure of truss seats, but will cause the impacted truss to deform into a catenary. At 400 °C, the impacted truss will walk off the interior seat. In either case, the impacted floor will not restrain the exterior column against transverse movement and instability. The impact of a dropping truss at 700 °C will cause failure of truss seats.

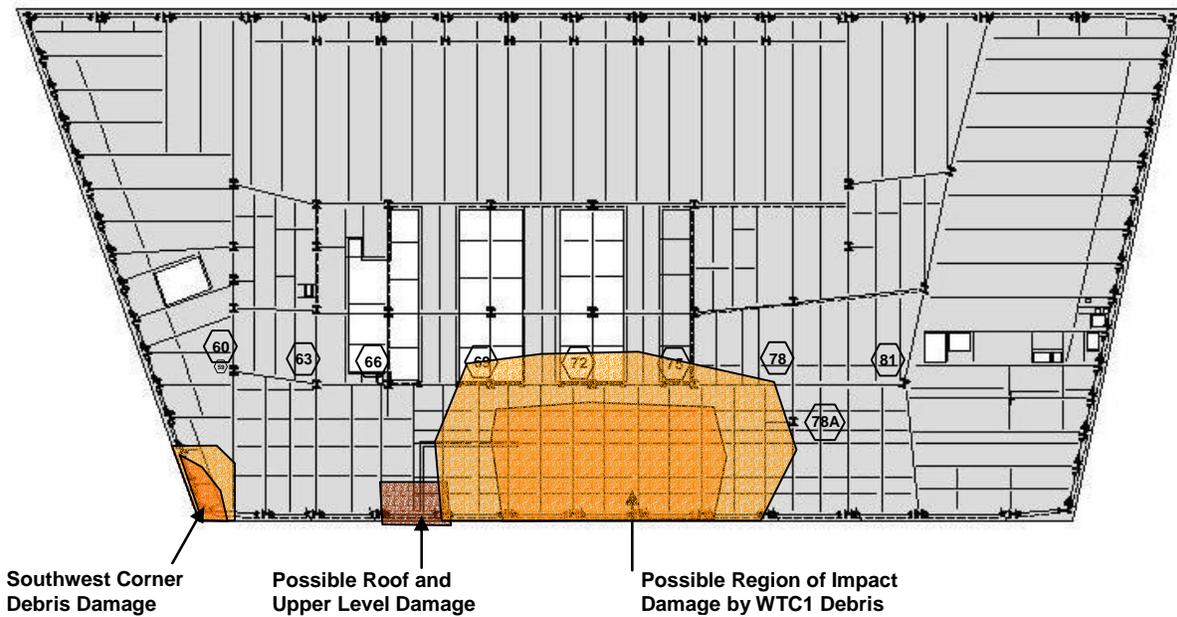
promenade (L-23b) appear to be standing, although damaged. Exterior panels from WTC 1 can be seen on Vesey Street and on the promenade. The approximate extent of possible damage due to debris from WTC 1 is shown in Fig. L-23c.

Figure L-23c. Possible extent of debris damage in plan.

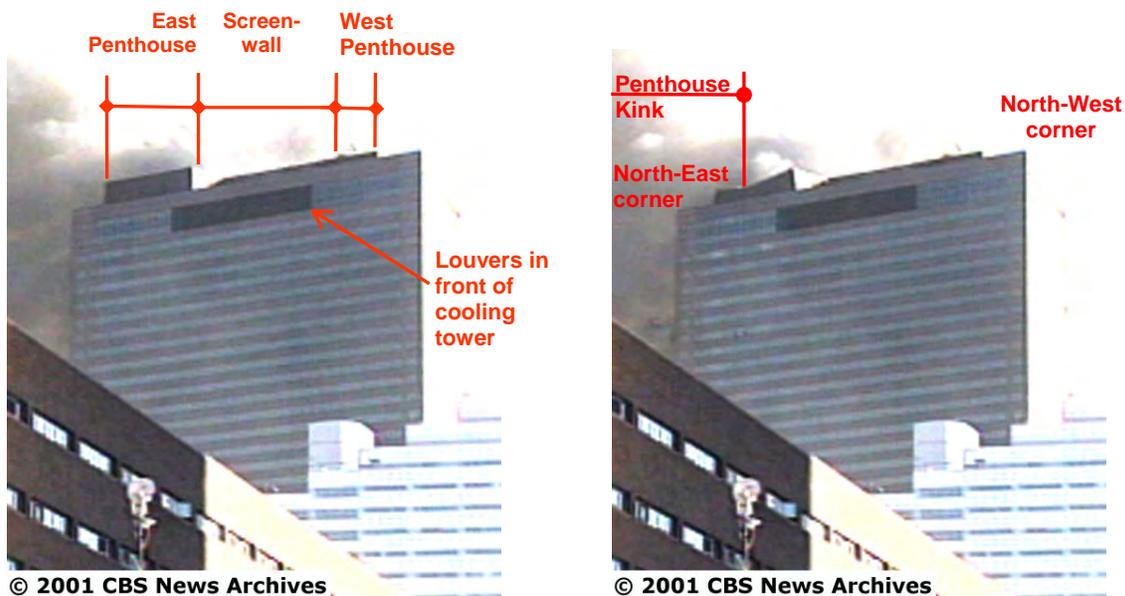
Time Interval (s)	Total Time (s)	Observation from CBS Video
0.0	0.0	- First movement of east penthouse roofline downwards
0.9	0.9	- East penthouse kink between columns 44 and 45 (Fig. L-25) - First 2 windows at Floor 40 fail between columns 44-45 (windows 9 and 11 from east end)

Figure L-25. East penthouse kink.

Second, Fig. L–25 shows a snapshot as the east penthouse starts to collapse. When the roof of the penthouse starts to fall, a line of windows (roughly in line with columns 79 to 81) has broken over the entire height of the visible region. In free fall, it would take 3 to 4 seconds for an object to fall from the roof elevation to the height of the bottom visible broken window, around Floor 33. Since the bottom window is broken nearly simultaneously when the kink is seen at the east penthouse, the initial failure may be assumed to have propagated upward from the lowest window breakage rather than propagated downward from the top of the building. Therefore, initial failure within the penthouse may be considered unlikely.

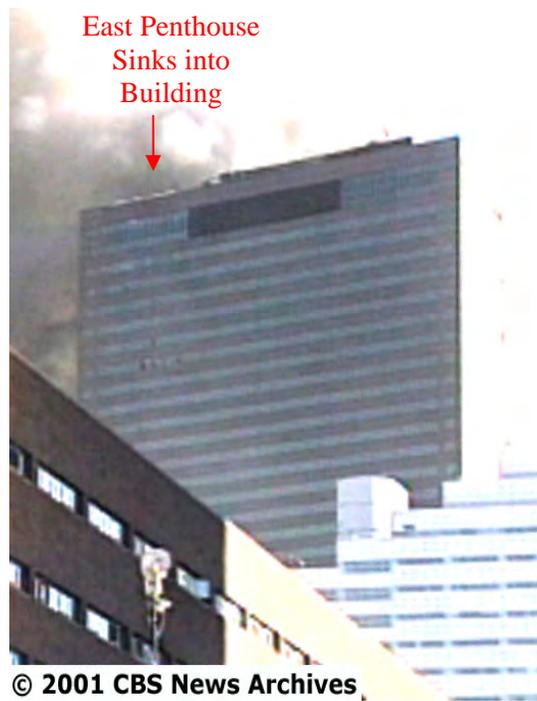
Figure L-26. East penthouse sinks (2.2 s).

Interior columns 79, 80, and 81, were located directly below the east penthouse on the roof and supported large tributary areas. It appears that some sequence of component failures in the region identified in Figs. L–29 and L–30 led to the failure of one or more of these columns, as discussed above. The failure progressed vertically upward within the failed bay to the roof level, based upon observations of window breakage relative to failure of rooftop structures, and was first visible from the exterior when the east penthouse lost support (see Fig. L–26).

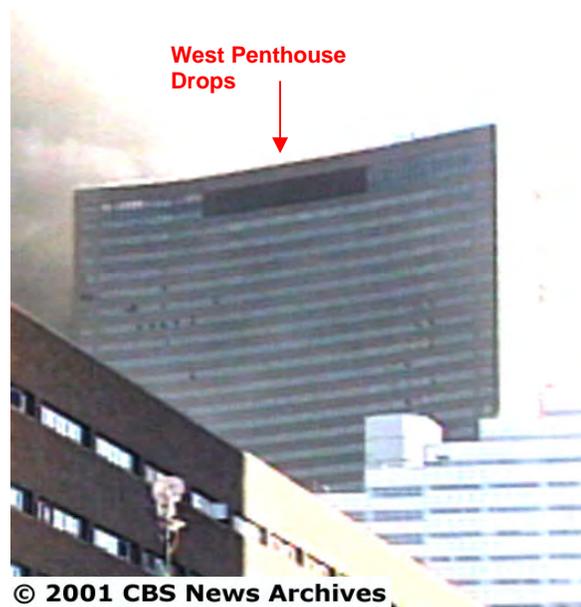
Figure L-27. Center screenwall and west penthouse sink (7.9 s).

The 5 s to 6 s delay between the failure of the east penthouse and the failure of the screenwall and west penthouse (shown in Fig. L-27) approximates the time it would take for the debris pile from the vertical failure progression on the east side of the building to reach Floors 5 to 7 and damage the transfer trusses and girders in this area.

When the screenwall and the west penthouse sank into the building, a line of windows broke from Floor 44 down to the bottom of the visible range, which is approximately at Floor 33 on the west side of the structure (see Fig. L-27). This area aligns with column 61, which is supported by the cantilevered end of transfer truss #3 between Floors 5 and 7, as shown in Fig. L-31. This suggests that the observed window breakage may be related to the failure of column 61 or truss #3.

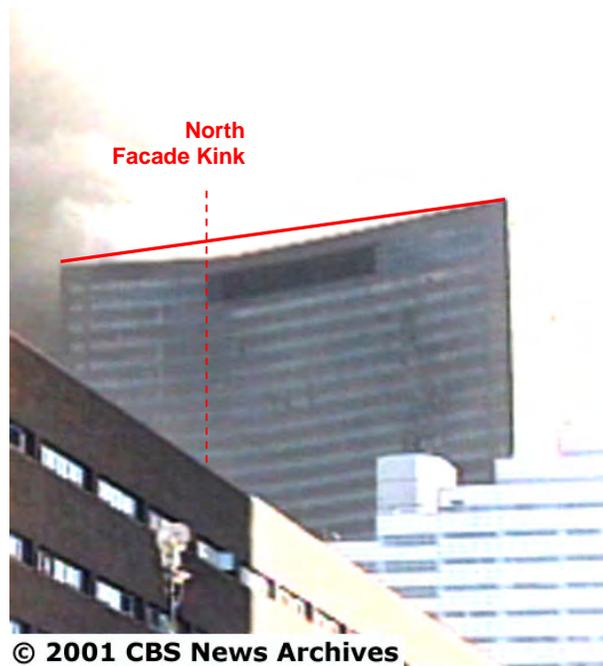
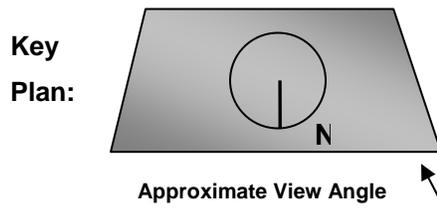
Figure L-28. Global collapse.

The simultaneous failure of screenwall and west penthouse structures, window breakage on the west side of the north facade, and initiation of global collapse (see Fig. L-28) indicates that the building loads could no longer be supported. Horizontal progression of the collapse appears to have occurred after the vertical collapse on the east side of the building. The greater strength of Floors 5 and 7 relative to the other floors and the transfer trusses between these floors suggests that this region of the building played a key role in destabilizing the remaining core columns, and the global collapse occurred with few external signs prior to the system failure.

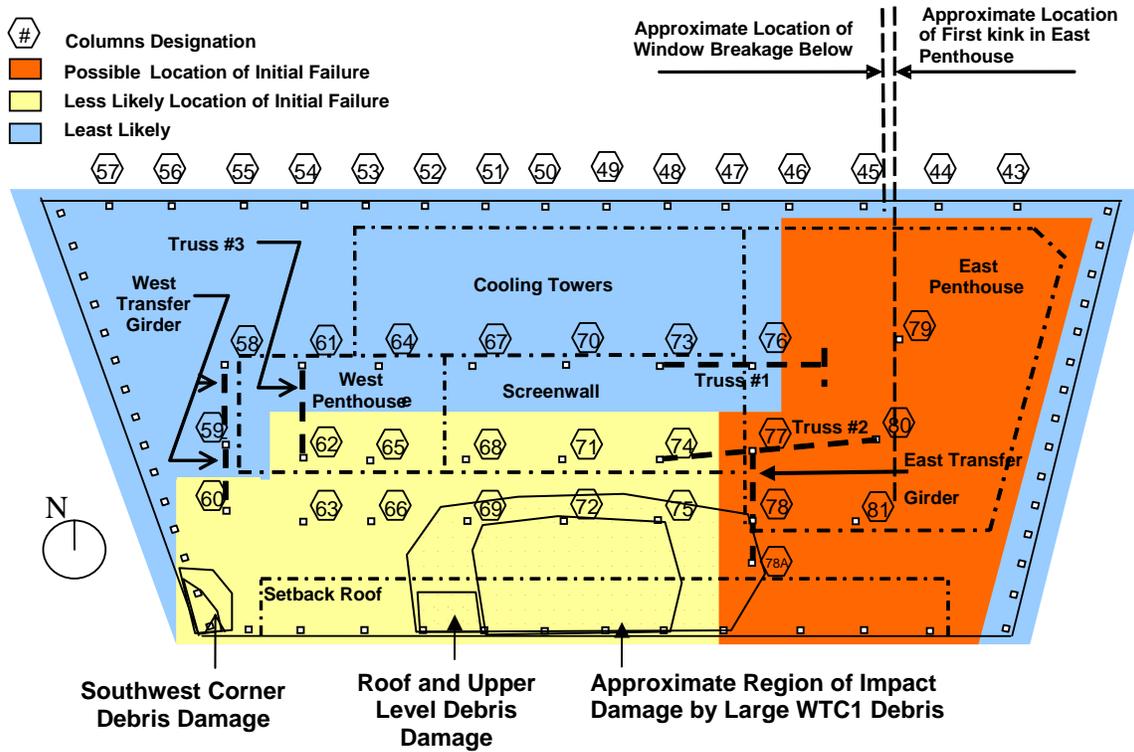
Based on review of the photographic and videographic records, a failure of any column within the plan area shown in Fig. L–29, and below Floor 13, likely contributed to the collapse initiation. This includes columns 76, 77, 78, 79, 80, and 81, truss #1, truss #2, column 78A, the east transfer girder and adjacent framing and floor systems within this region (see Fig. L–30).

Figure L-29. Plan view of regions for collapse initiation.

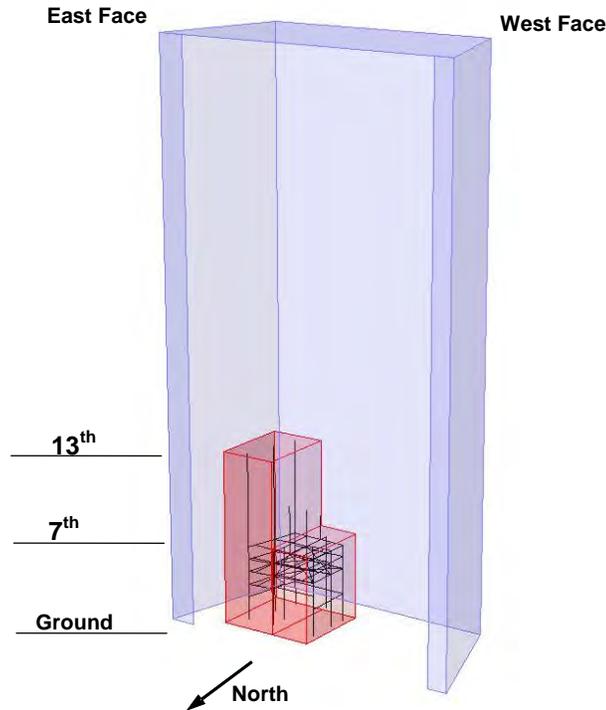
Figure L-30. Likely region of initiating component failures based on videographic and photographic records of fire and collapse.

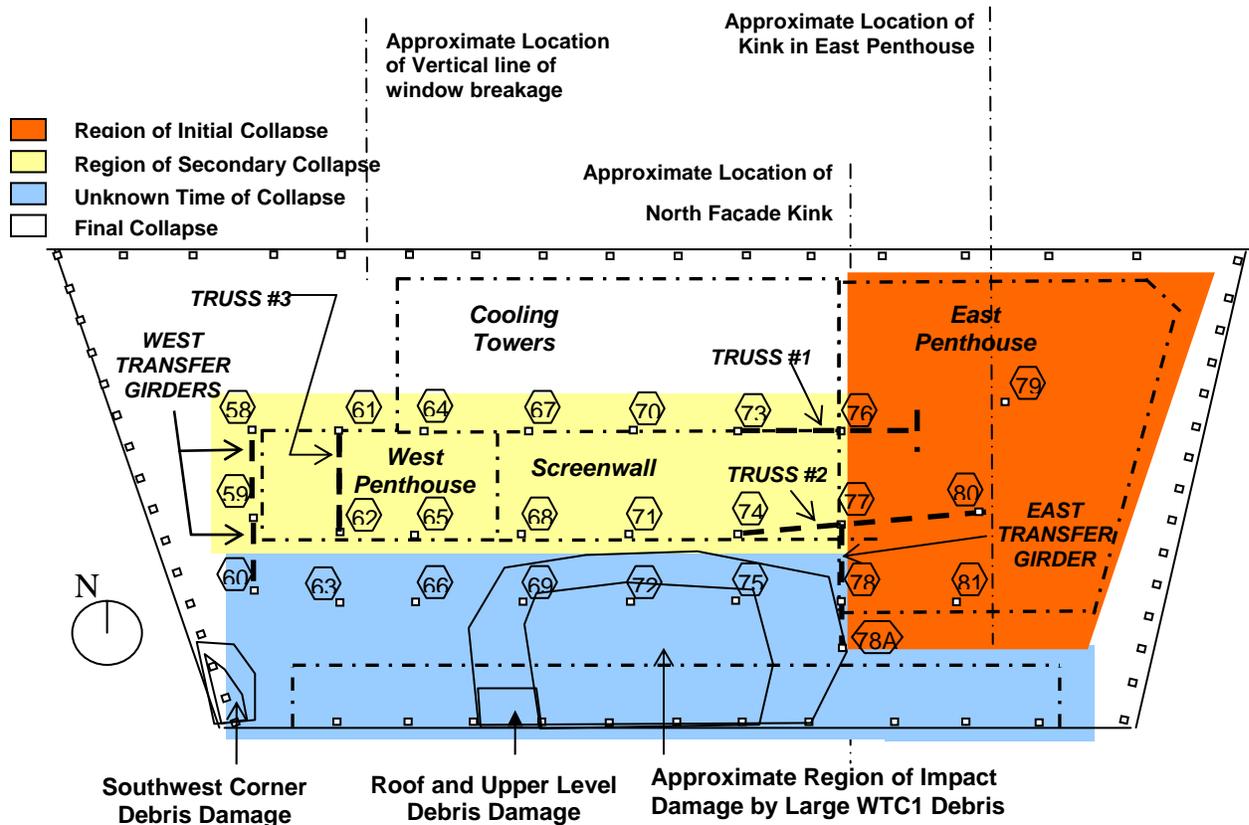
Figure L-31. Plan View of Collapse Progression.

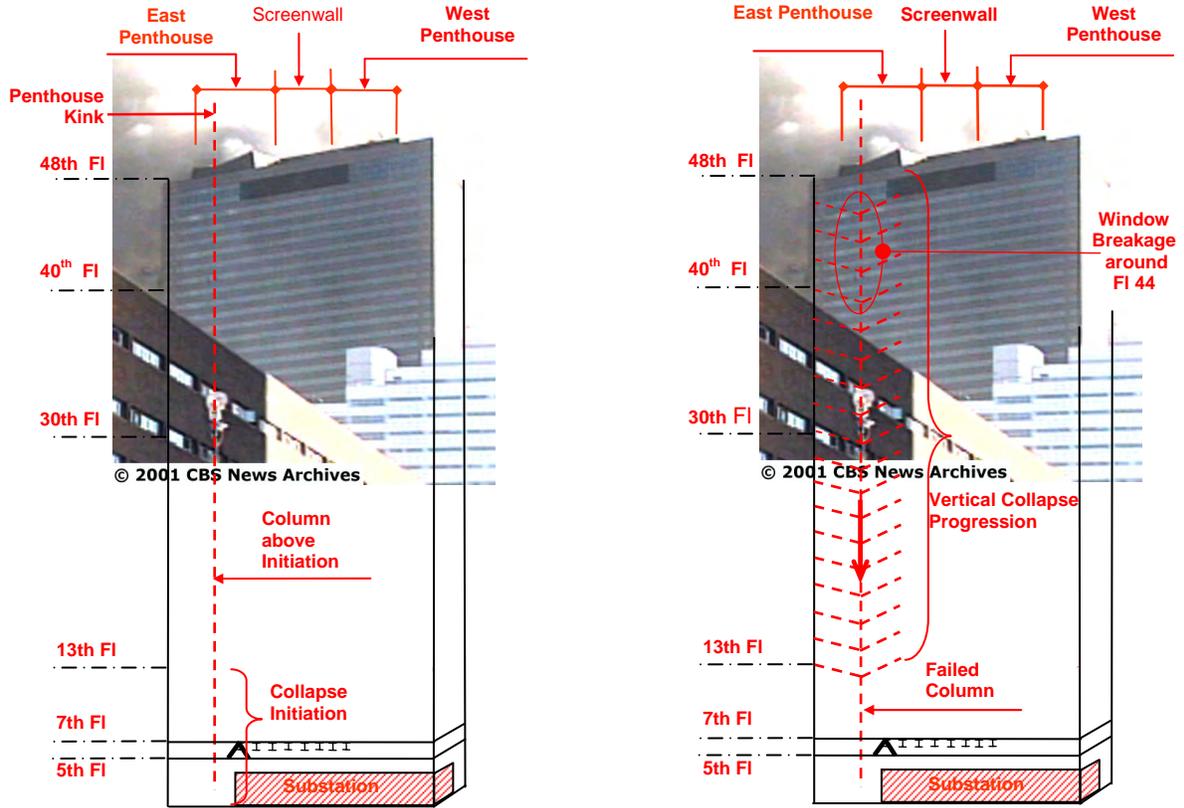
Figure L-33. Collapse initiation and vertical progression on the east side of WTC 7.

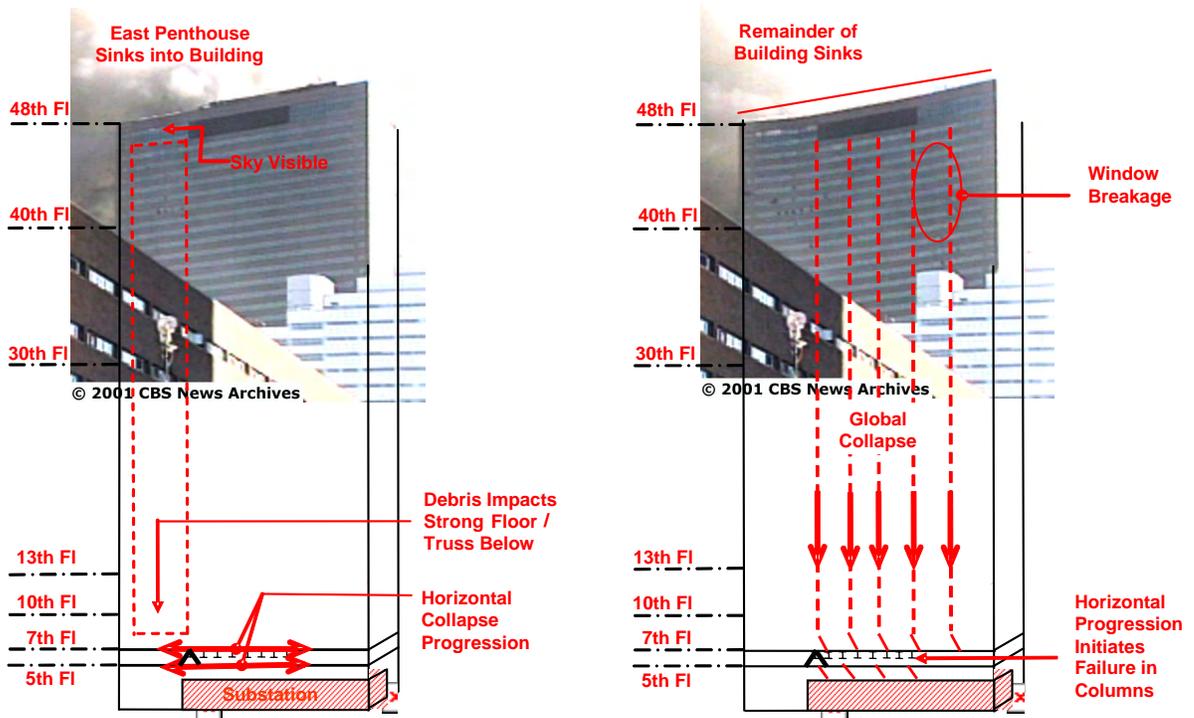
Figure L-34. Horizontal progression to the west side of WTC 7.

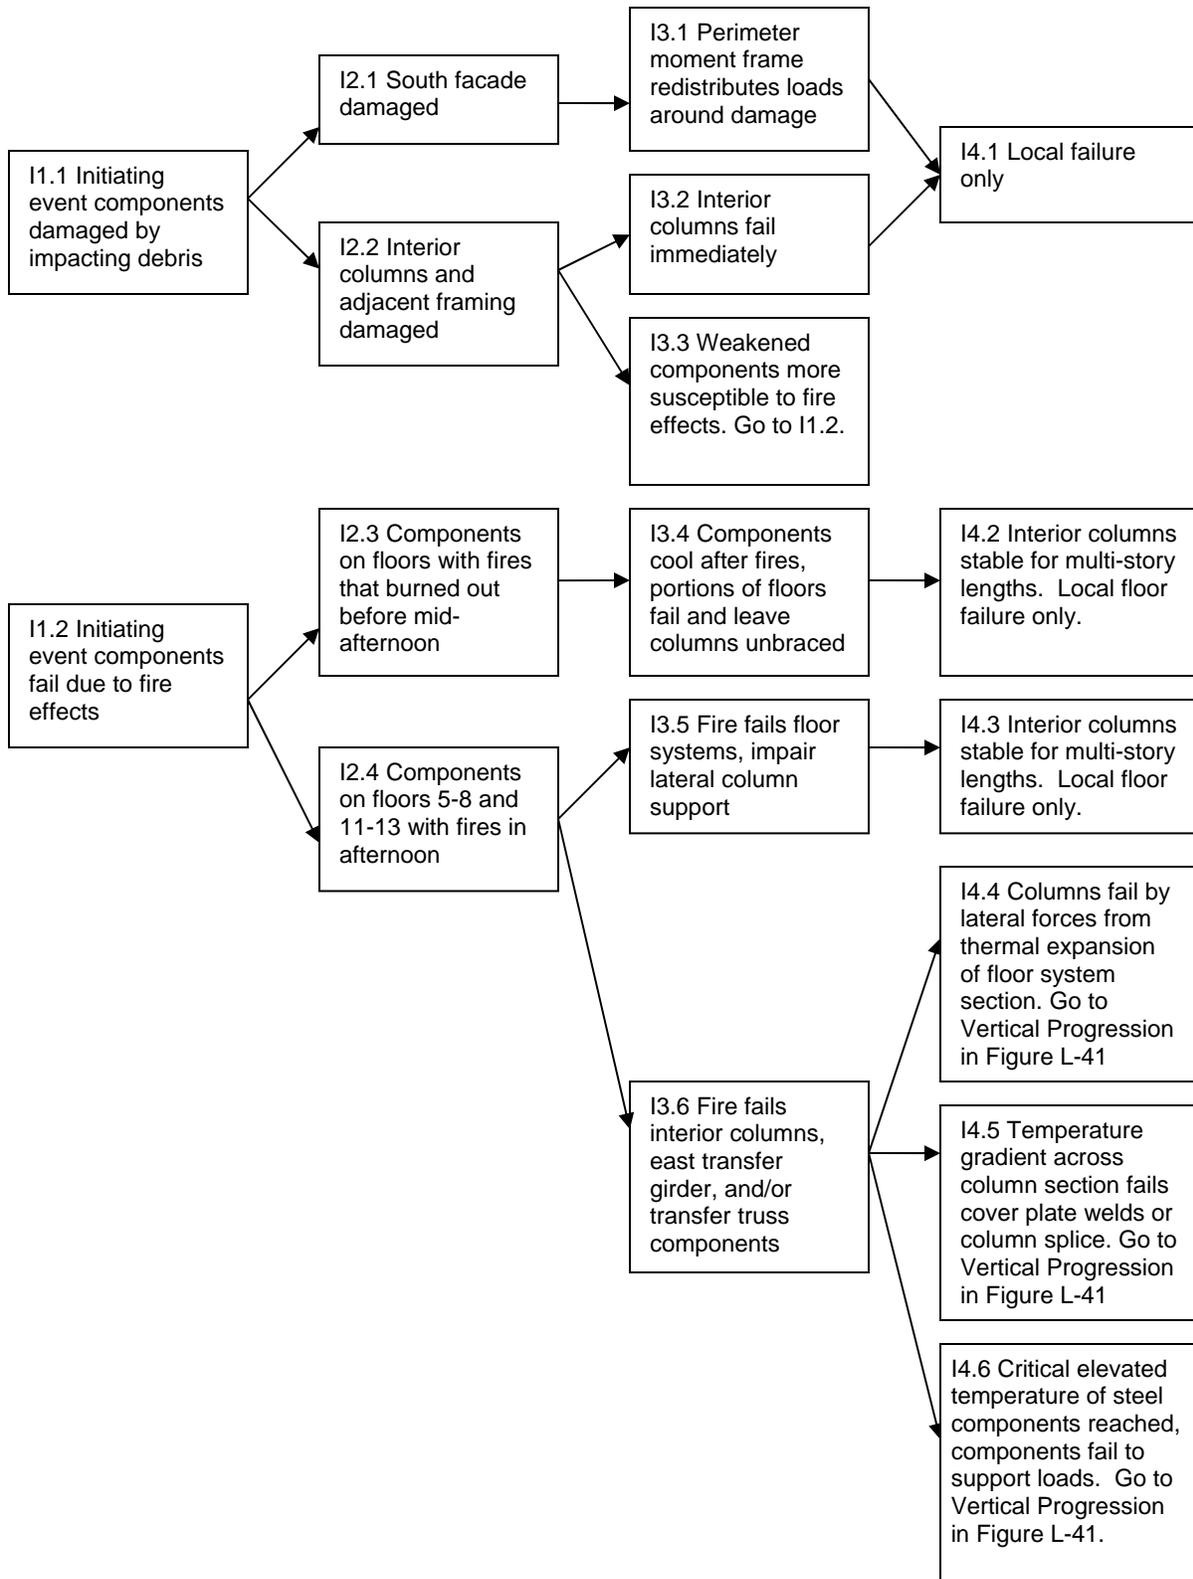
Figure L-36. Collapse initiation scenarios.

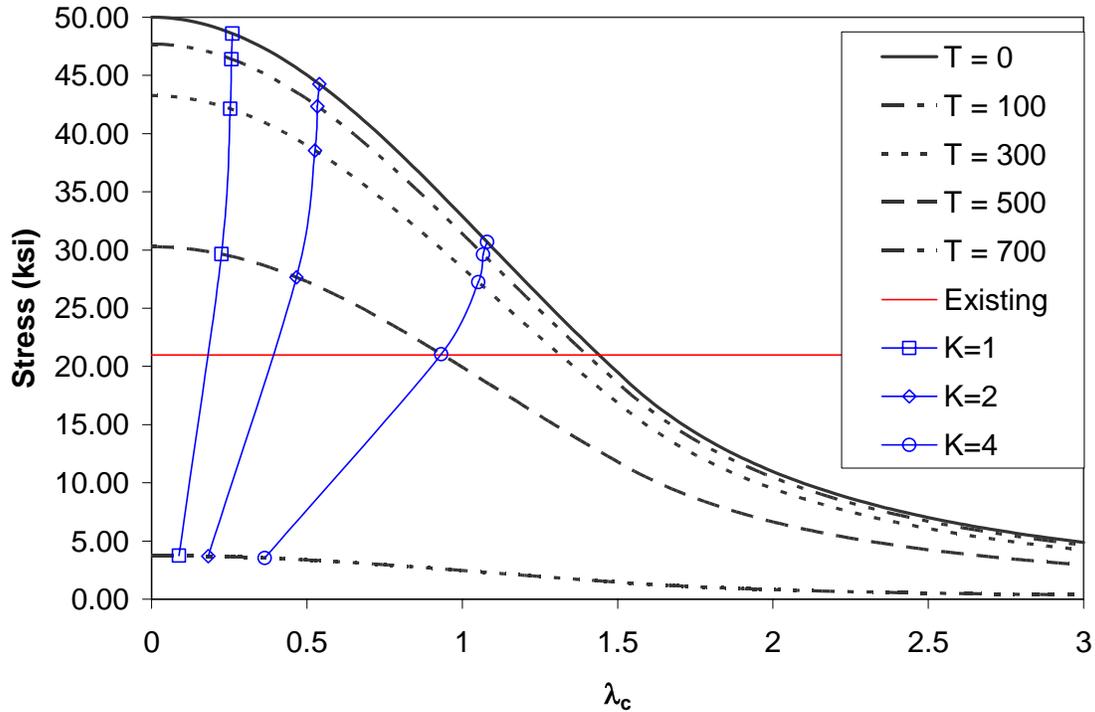
Figure L-37. Column 79 capacity versus temperature and unbraced length K.

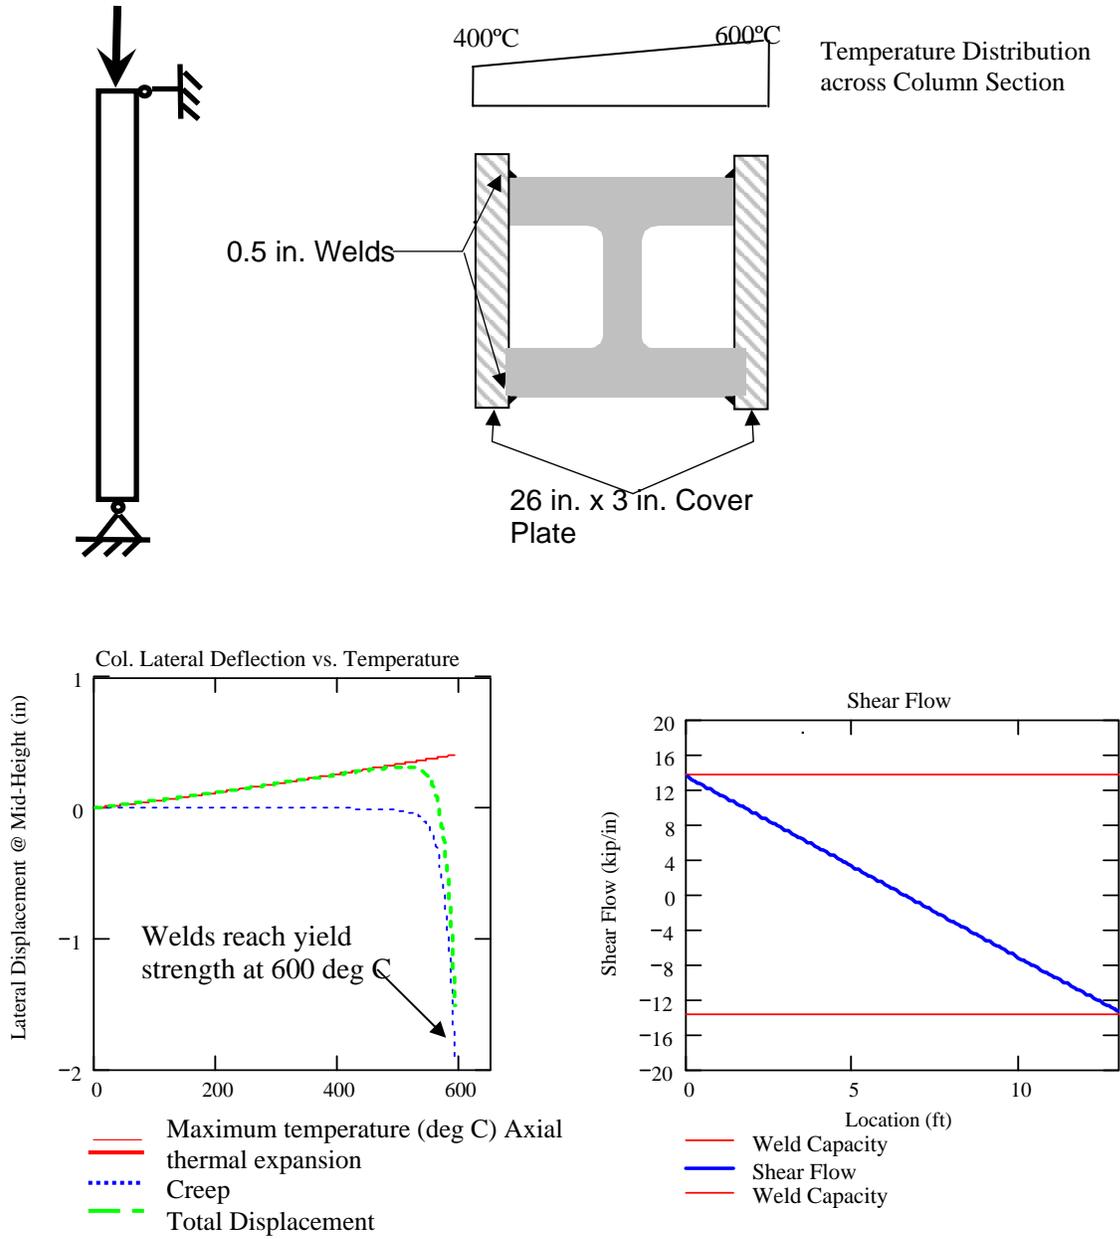
- **I4.5 Temperature Gradients:** Fire effects may have caused the failure of columns and other components through the forces induced by temperature gradients through their cross section. Bending and shear forces may be induced that are sufficient to yield either the column splice or reinforcing plate welds. Analysis of a one-story segment of interior column 79 indicates that the cover plate weld would begin to yield at a mean temperature of 490 °C with a 200 °C gradient across the section, as shown in Fig. L-38. Other mean temperature and gradient combinations may also cause this type of failure.

Figure L-38. Effects of temperature gradient on interior column 79.

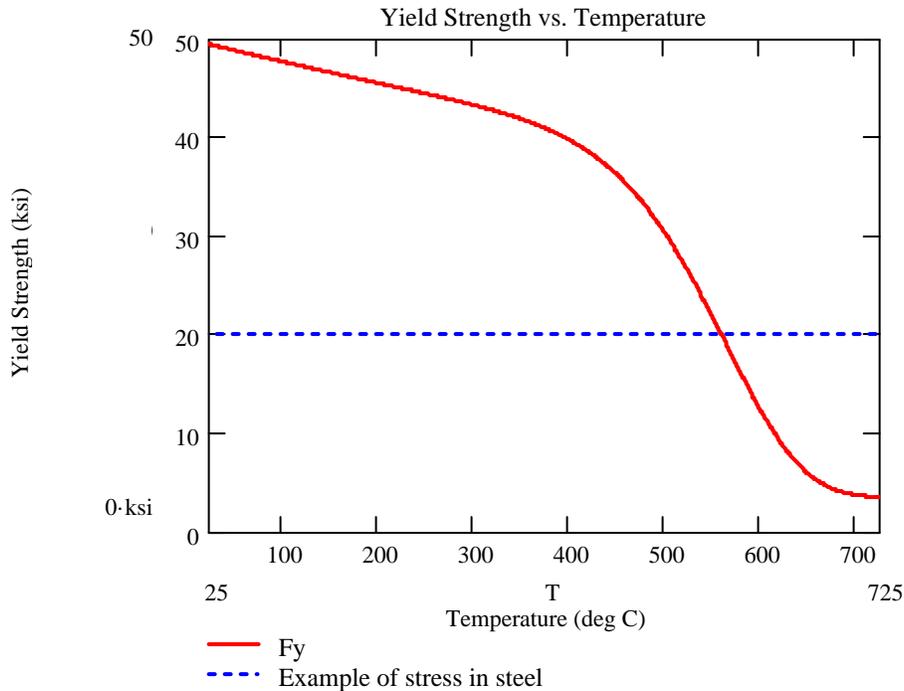
- **I4.6 Uniform High Temperatures:** If initiating event components were sufficiently exposed to fire effects to be uniformly heated to elevated temperatures, the steel strength would be reduced below that required to support the load. Figure L-39 shows that for interior columns subject to service loads (shown as approximately 20 ksi of compressive stress), uniform steel temperatures of approximately 570 °C would result in column failure.

Figure L-39. Steel strength versus temperature.

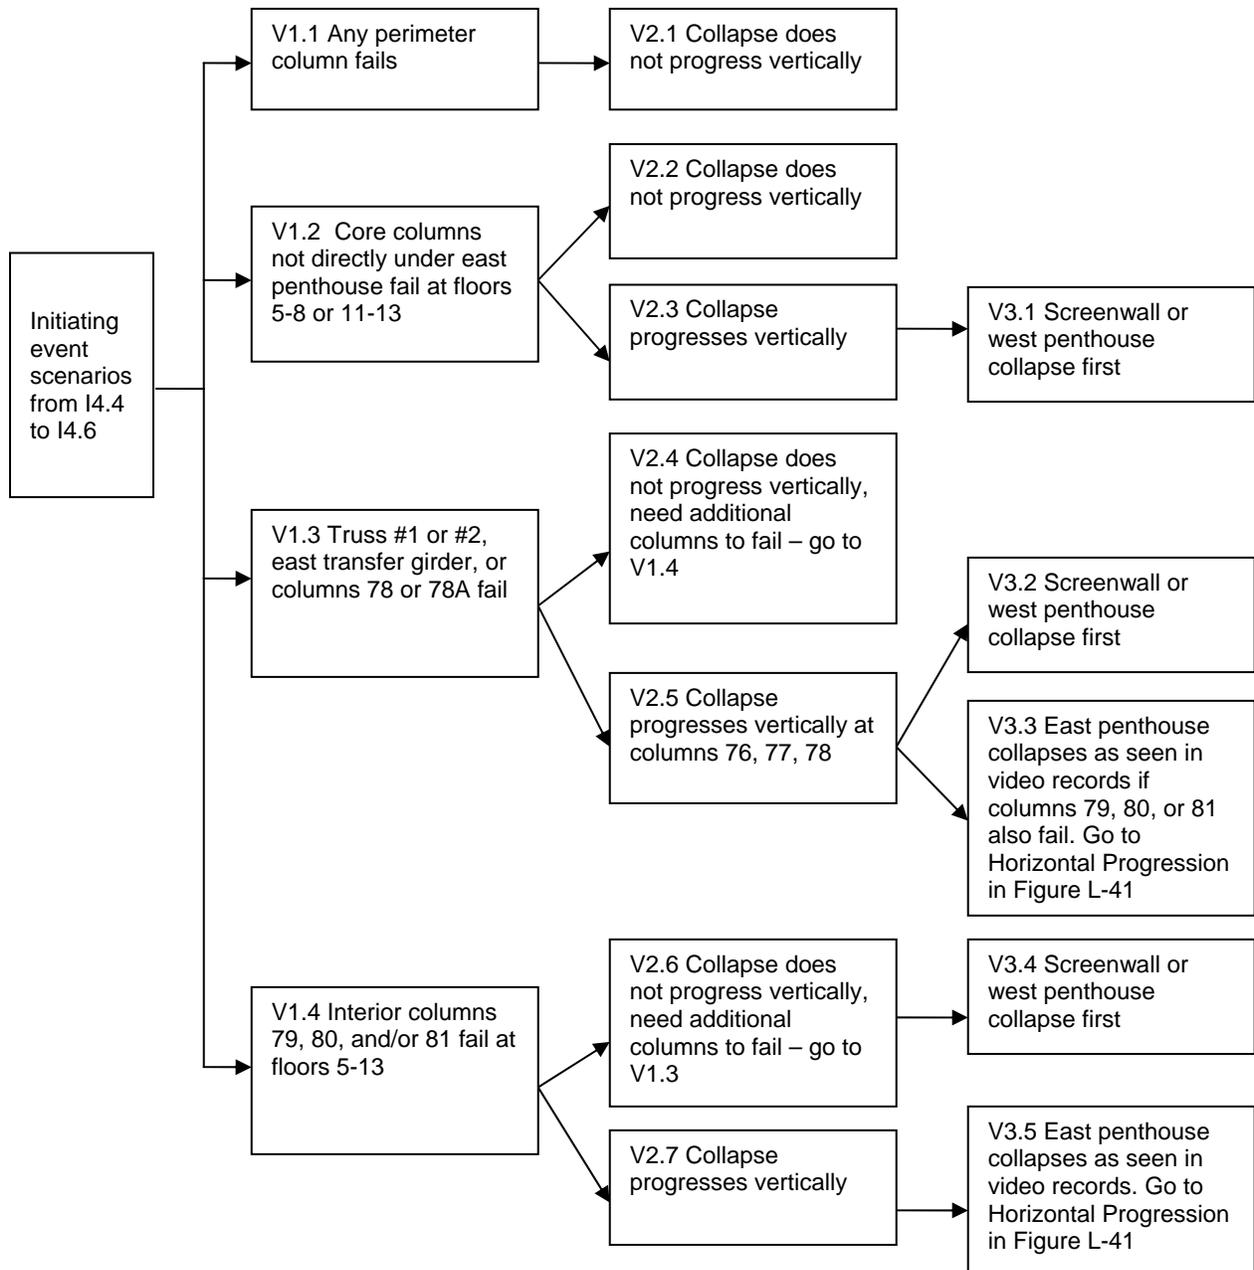
Figure L–40. Vertical collapse progression scenarios.

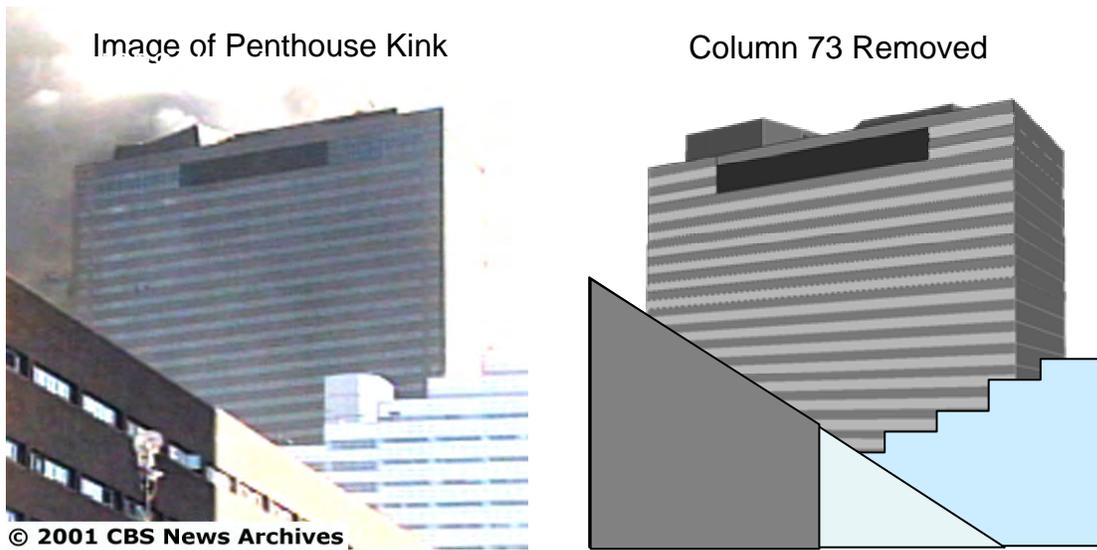
- V3.1 Something Else Besides East Penthouse Observed to Collapse First:** Had the failure of core columns progressed upwards, then the first exterior sign of the internal failure likely would have been seen in the screenwall or west penthouse, which are located above the core columns. A collapse mechanism analysis performed for the removal of columns 61, 64, 67, 70, and 73 produced geometry changes that differed from the observed collapse. For the scenario where each of these columns fails and the failure progresses upwards to the roof line as the adjacent floors cannot redistribute the loads, the screenwall or the west penthouse collapses, and no kink develops in the east penthouse (see Figs. L-41, L-42, and L-43).

Figure L-41. Geometry changes for removal of column 73.

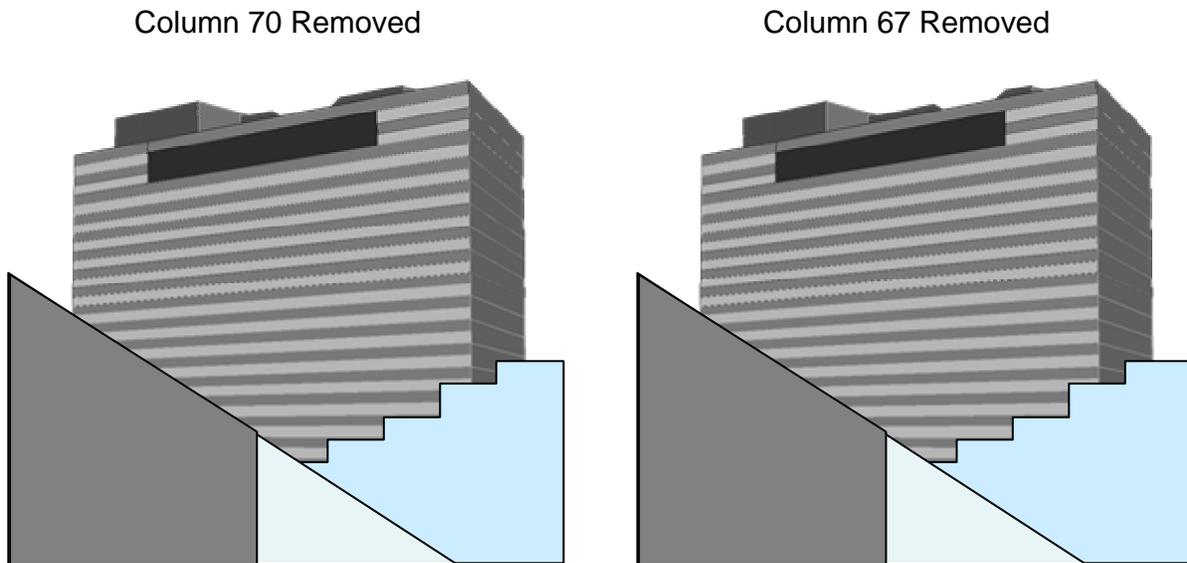
Figure L-42. Geometry changes for removal of columns 70 and 67.

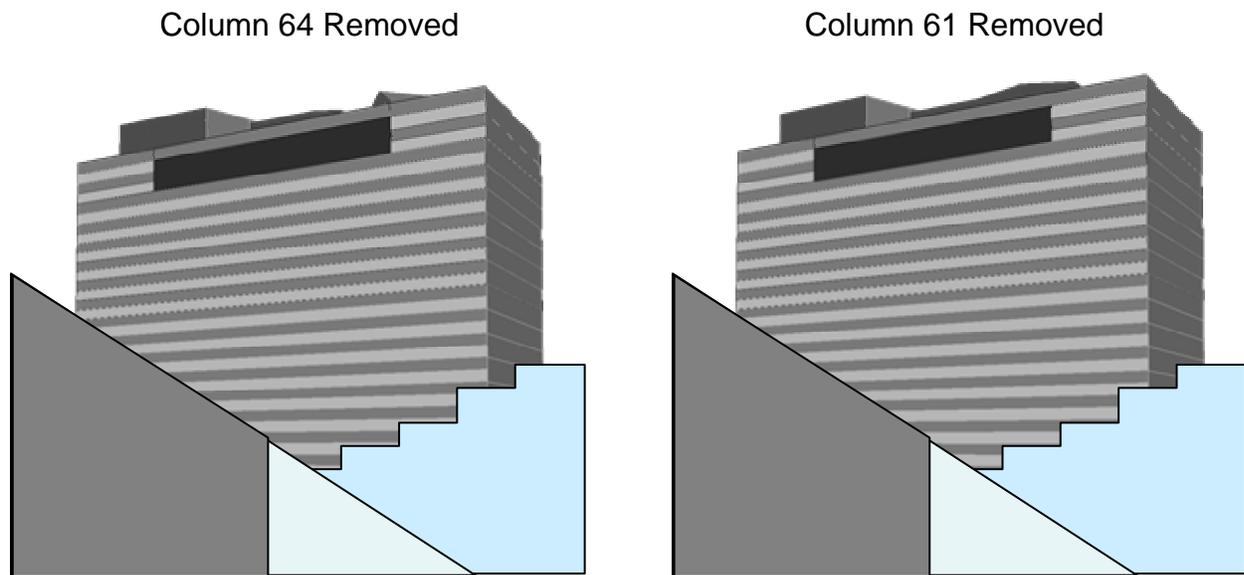
Figure L-43. Geometry changes for removal of columns 64 and 61.

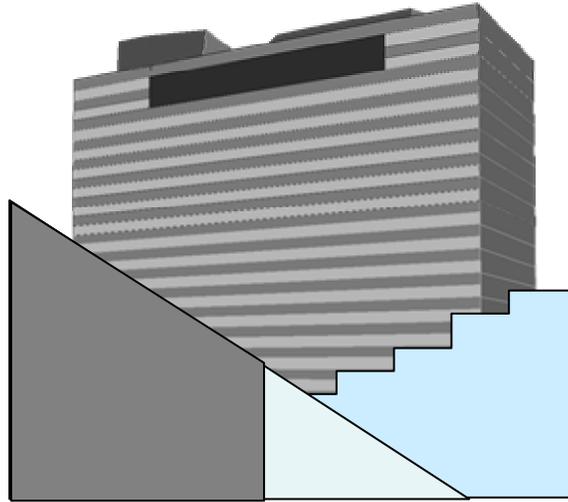
Column 76 Removed

- **V3.2 East Penthouse Collapses Differently Than Observed:** If truss #1 or truss #2 failed and the failure progressed vertically upward to the roof level, the exterior deformations observed in the roof structures would be different from what was actually observed. Column 76 supported the west side of the east penthouse and the east end of the screenwall. A collapse mechanism analysis performed for the removal of column 76 produced a geometry change that shows the west side of the east penthouse and the east end of the screenwall deflecting downward (see Fig. L-44).

Figure L-44. Geometry changes for removal of column 76.

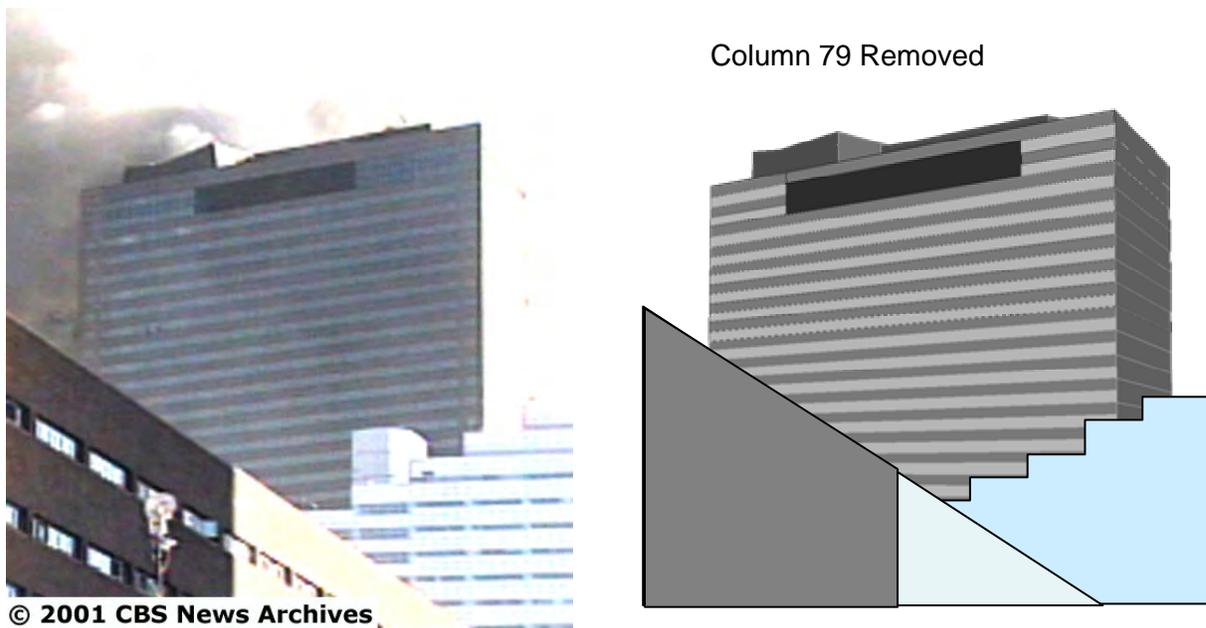
- **V3.4 East Penthouse Collapses Differently than Observed:** The collapse could have progressed upwards, but the failure caused in the east penthouse could be different than what was actually observed.
- **V3.5 East Penthouse Collapses as Observed:** Had the failure of the column progressed upwards, then it could have been reflected in the observed collapse of the east penthouse, which sits directly above columns 79, 80, and 81. Also, the kink observed in the roof of the east penthouse was in line with these columns. A collapse mechanism analysis performed for the removal of column 79 produced a deformed shape with a kink in the roof of the east penthouse (see Fig. L-45). This is a possible collapse scenario.

Figure L-45. Geometry change for removal of column 79.
