NIST Special Publication 1000-5

June 2004
Progress Report on the
Federal Building and Fire Safety
Investigation of the
World Trade Center Disaster

Volume 1

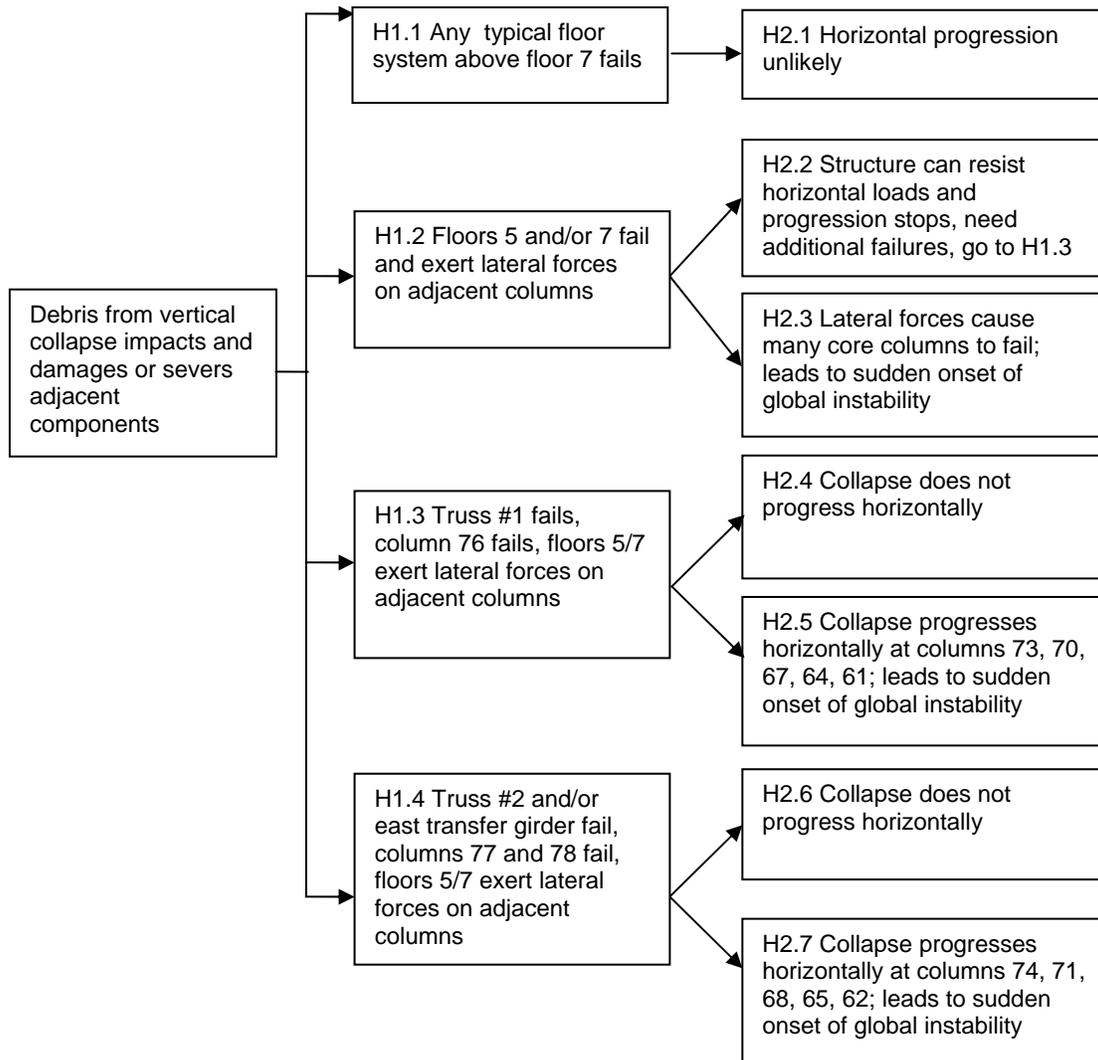
After the east penthouse was observed to sink into the building core, approximately five seconds lapsed before the screenwall and west penthouse were observed to also sink into the building core. The screenwall and west penthouse movements occurred almost simultaneously with the global collapse of the structure. From these external observations, it appears that after the vertical progression failure on the east side of the building, the failure progressed horizontally across the core. The horizontal progression of the collapse could have started due to any of the likely vertical progression scenarios, which are shown in Fig. L-46.

Figure L-46. Horizontal collapse progression scenarios.

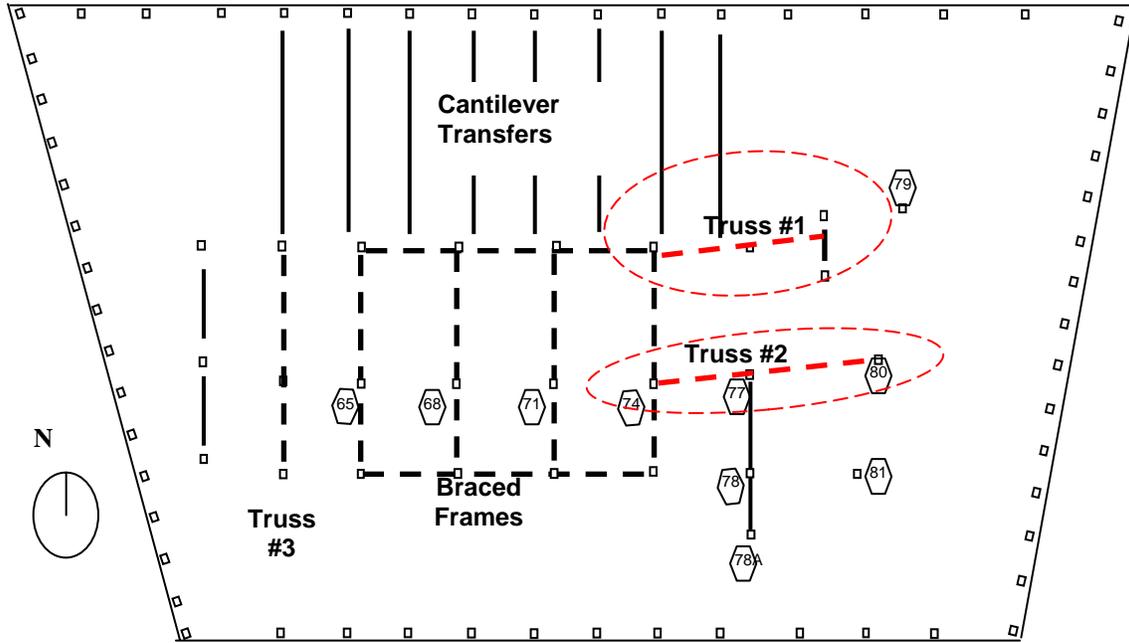
H1.3 Truss #1: If one of the diagonals of truss # 1 (see Fig. L-47) was damaged or severed by collapse debris from the vertical progression, there would be a horizontal force developed in the Floor 7 slab as column 76 became unstable. The floor beam between column 76 and column 73 would try to restrain column 76 movement through tensile forces to column 73.

Figure L-47. Transfer components between Floors 5 and 7.

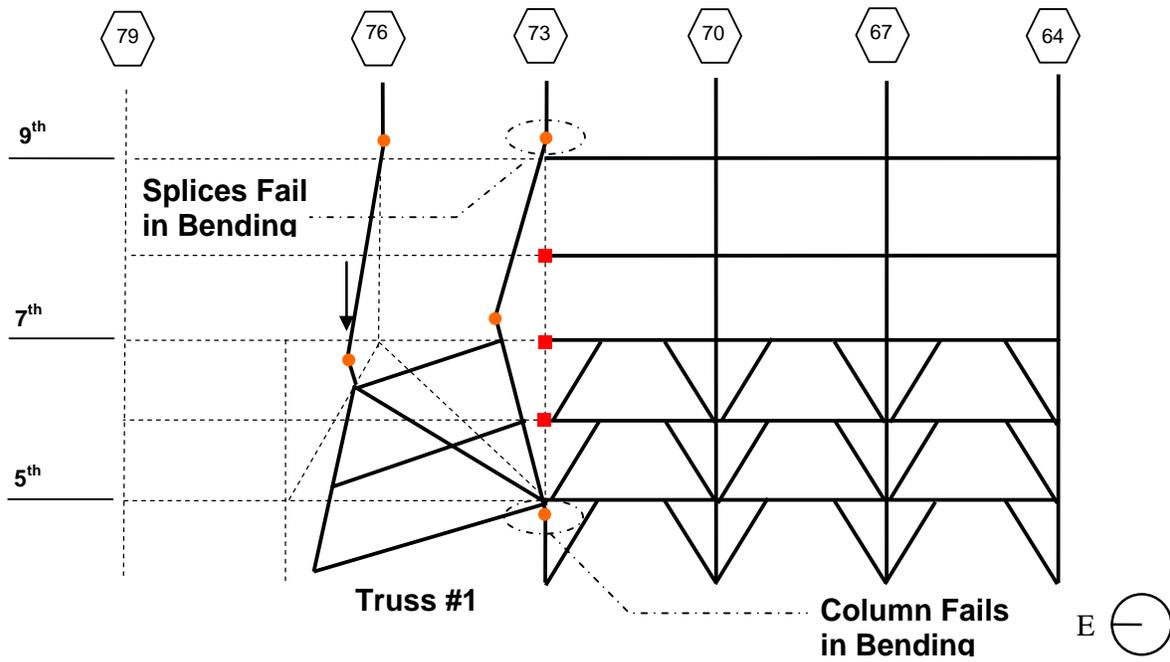
- **H2.4 Collapse Does Not Progress:** The horizontal tensile force would tend to pull the line of columns 73, 70, 67, 64, and 61 towards the east. The continuity of the Floor 7 slab and the presence of braced frames around the north core column line makes the simultaneous lateral displacement of the core columns less likely, as such displacements within a rigid slab may similarly displace other columns, including perimeter columns.
- **H2.5 Collapse Progresses:** The failure of column 76 may create its own vertical collapse, due to the inability of the floor systems above to redistribute the loads and fail at the column splices near Floors 5 and 7 as shown in Fig. L-48. If column 76 cannot be restrained and there is a vertical collapse of the surrounding bay, it would cause a debris pile at the lower floors which may then destabilize adjacent columns.

Figure L-48. Horizontal progression mechanism for truss #1 failure.

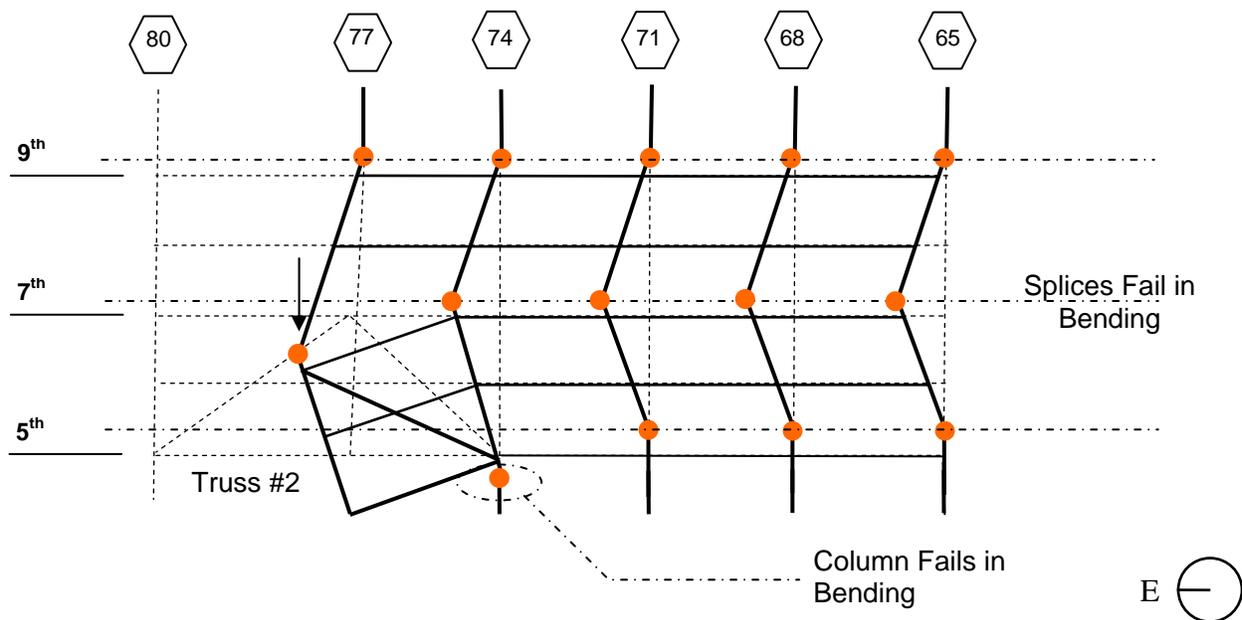
- **H2.6 Collapse Does Not Progress:** The Floor 7 slab may fail at adjacent columns prior to imposing lateral displacements sufficient to fail the columns or their splices.
- **H2.7 Collapse Progresses:** The horizontal tensile force would tend to pull the line of columns 74, 71, 68, 65, and 62 towards the east. The general absence of the Floor 7 slab and braced frames around the center core column line, due to the presence of elevators shafts, creates a more likely scenario for the simultaneous lateral displacement of the center core columns without similarly displacing other core columns. The possible result is a failure of all the columns at their splices, as shown in Fig. L-49.

Figure L-49. Horizontal progression mechanism for truss #2 failure.

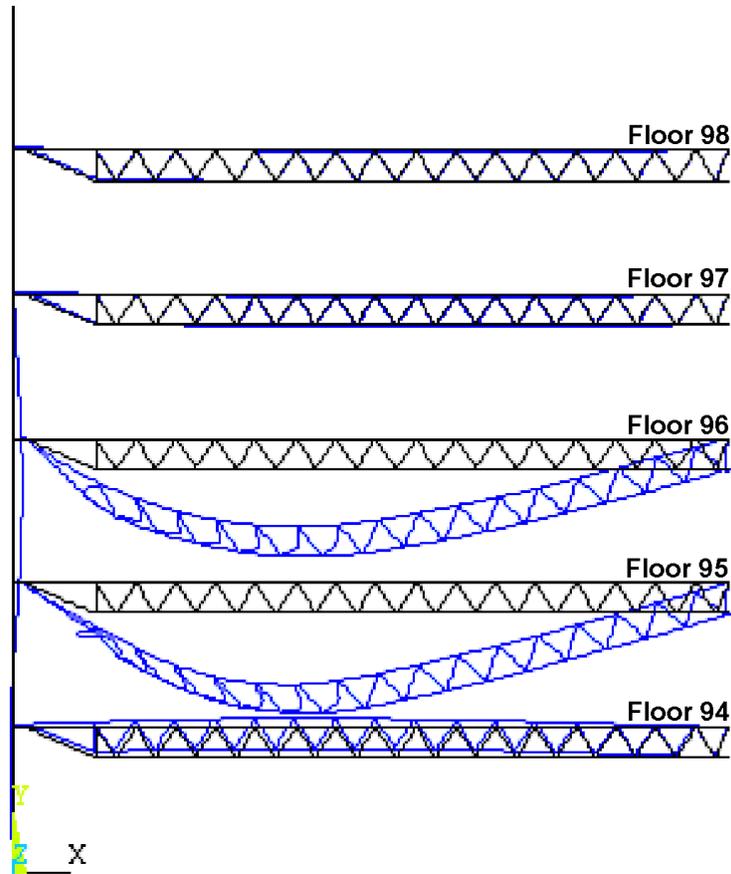
At room temperature, even under the severe load redistribution due to the damage caused by the airplane impact, the structure still behaves linearly. The maximum floor sag is 35 mm (1.4 in.), causing the horizontal span to decrease and the column to pull in slightly. Approaching 200 s and a temperature of 915 K (the temperatures referred to in these results are the hottest temperatures in the structure at any given time), the heated truss begins to show distress, especially in the compressed diagonal and vertical web members, which buckle inelastically. This means these heated steel members do not buckle elastically, but rather reach yielding in compression. Buckling is then governed by the tangent modulus of steel, which is about 0.5 percent of the elastic modulus, and the members immediately buckle after yielding, in the inelastic range. At 200 s, the maximum floor sag increases to 335 mm (13.2 in.), and the column is pushed out (peak of 38 mm or 1.5 in.) by the thermal expansion of floor 95. At that time, the connection of floor 95 to the perimeter column experiences its maximum compression of 125 kN (28 kip). Because slab 96 has a thermal gradient with its top surface at room temperature, its lateral expansion is much smaller than for slab 95, and its sag is larger. The connection between slab 96 and the column is always in tension (Fig. M-6). As expected, slab 94, heated at the top and cool at the bottom, bows upward. As the temperature continues to rise, more of truss 95 web members buckle inelastically, and the increasing sag begins to pull the column in. The horizontal deflection of the column becomes positive (inward), and the connection force between column and floor 95 turns to tension. This inward movement of the column relieves the tension in the connection between the column and floor 96. Further temperature rise causes further weakening in truss 96, which eventually becomes active in pulling the column in. At the peak temperature of 1,273 K, the maximum lateral deflection in the column (183 mm or 3.3 in.) occurs at floor 96, inward, and the connection between the column and floor 96 experiences a tension of 185 kN (42 kip).

Figure M-5. Deformed shape at 1,273 K (not to scale).

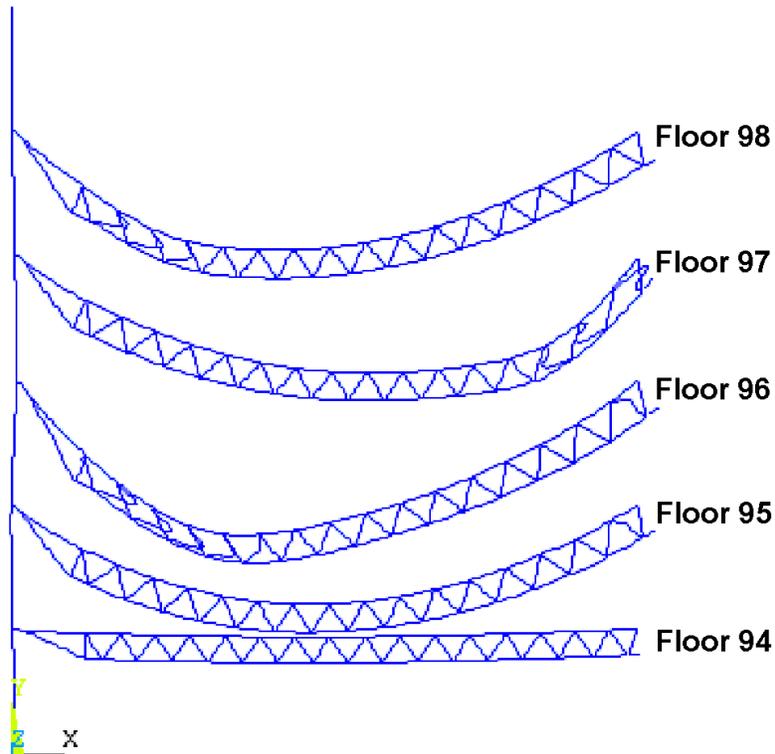
Under the second fire scenario, the structure exhibits similar behavior. Figures M-8, M-9, and M-10 show the resulting deflections. Inelastic buckling of the diagonals causes considerable vertical deflection of the heated floors beyond a maximum temperature of 900 K. At 1,220 K, the sag of floors 96 and 97 overcomes the outward push on the perimeter column due to thermal expansion of floors, and pulls the column inward. This transition causes the column to temporarily straighten up, causing the overall floor deflection to be less. Figures M-11 and M-12 show severe horizontal tension greater than 120 kN (27 kip) at the connection of floors with the internal column (floor 95) and external column (floor 96).

Figure M-8. Overall deflected shape for fire scenario 2-04 (not to scale).

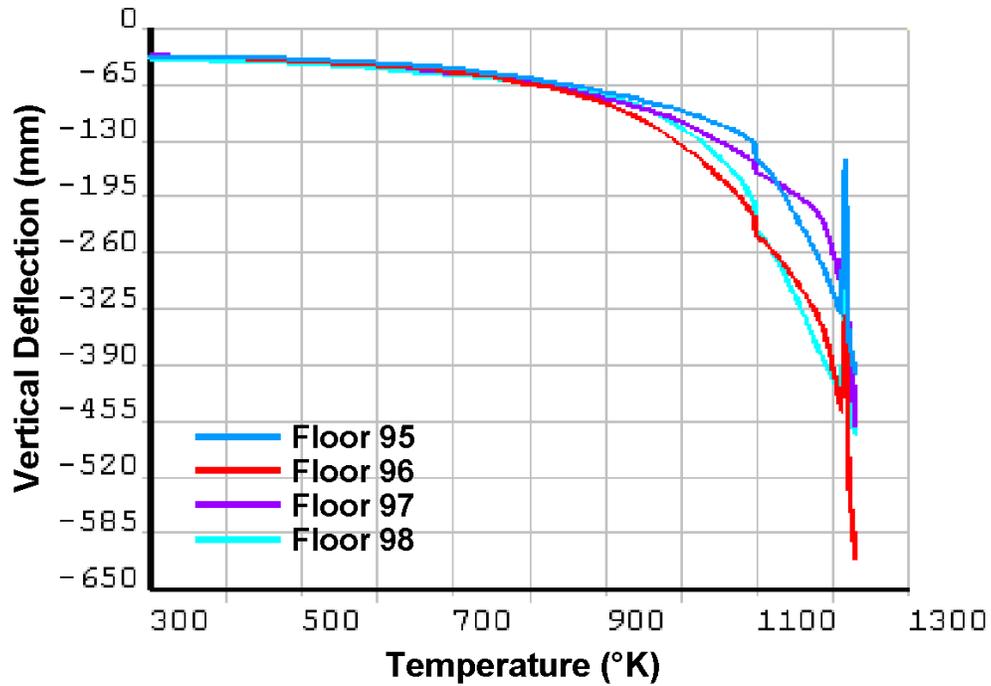
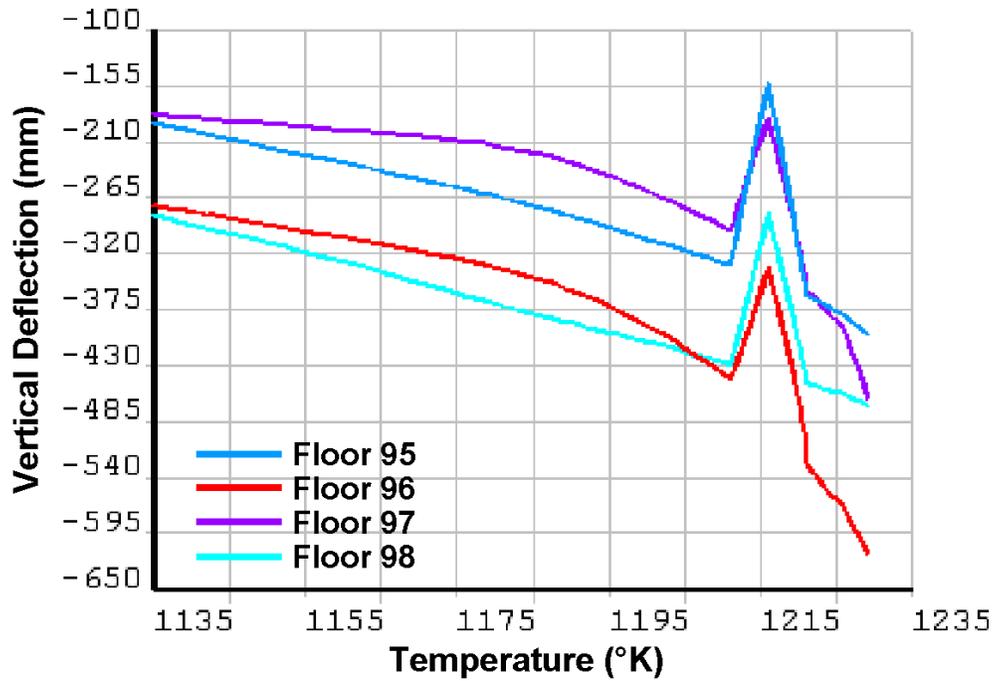
Figure M-9a. Maximum deflection of floors 95-98 for fire scenario 2-04.

Figure M-9b. Maximum deflection of floors 95-98 for fire scenario 2-04: details of Fig. M-9a at high temperatures.

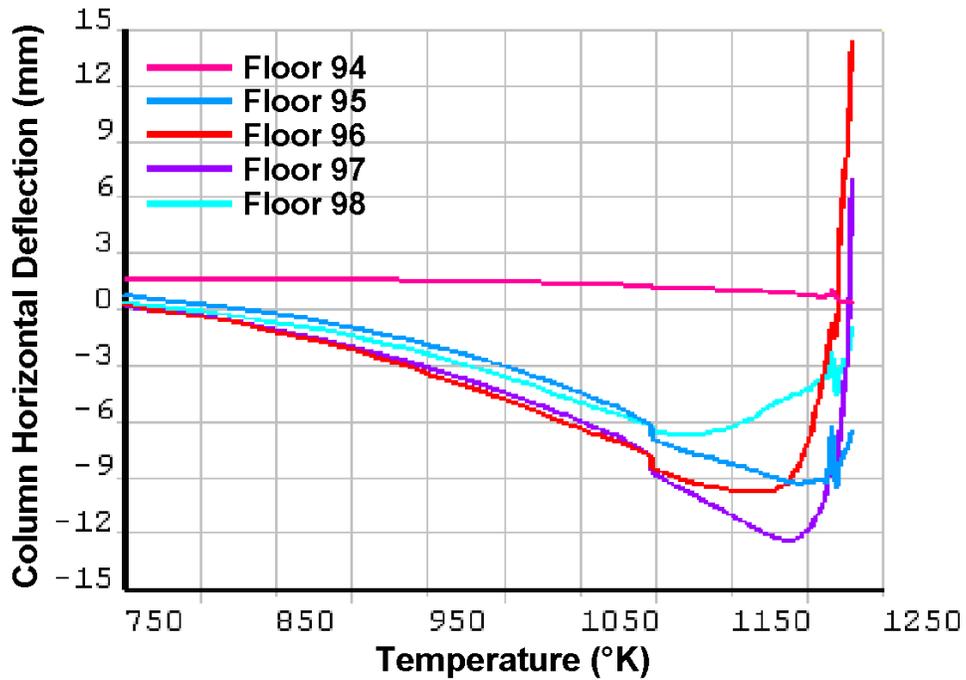
Figure M-10. Perimeter column lateral deflection for fire scenario 2-04.

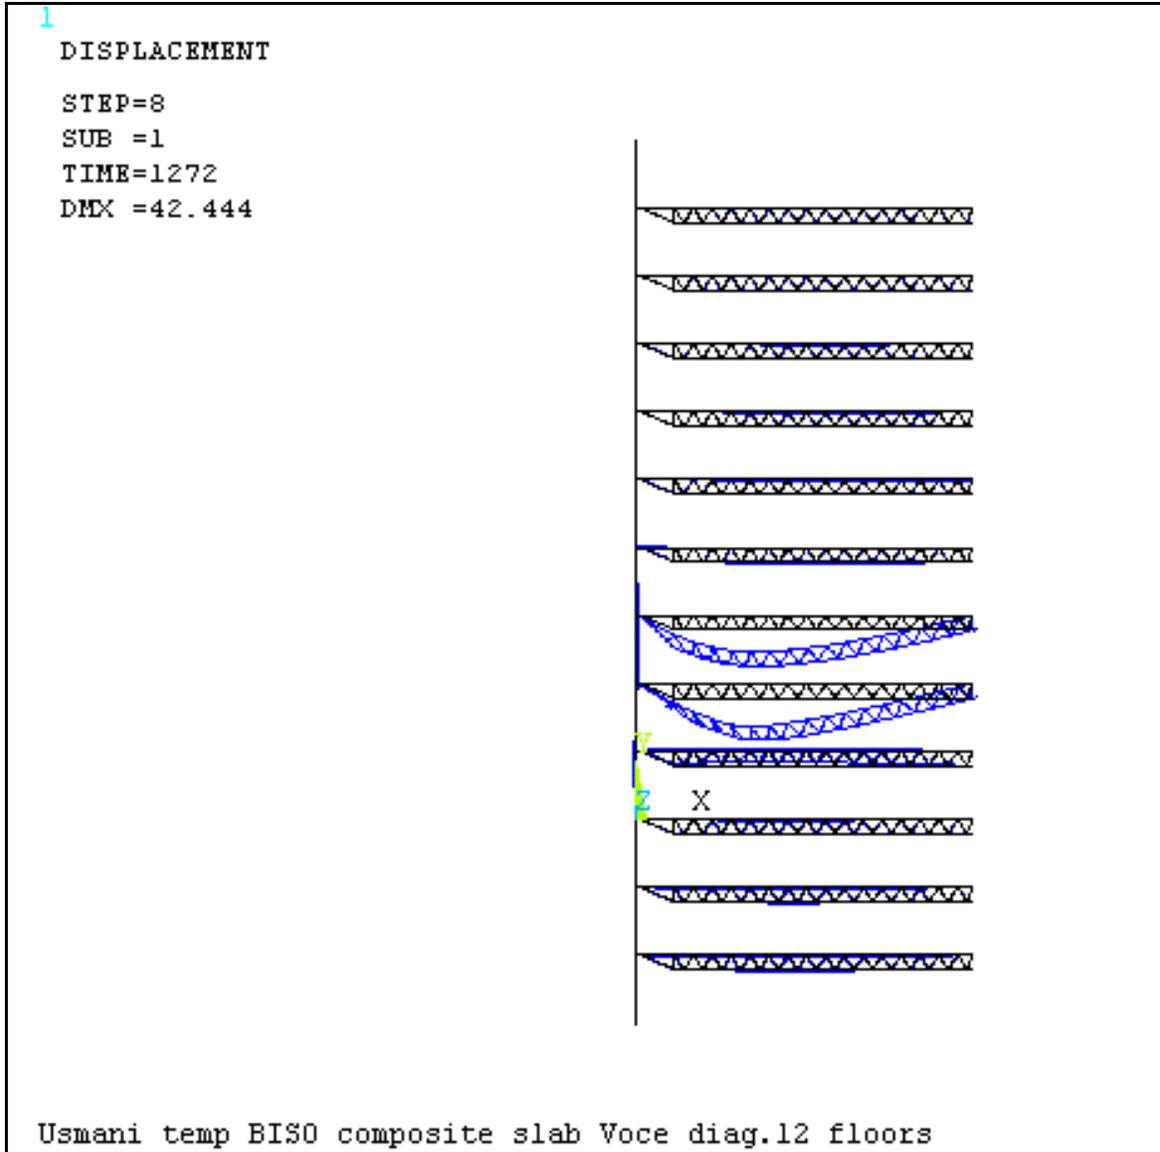
For confirmation, a 12-floor model (from floors 91 to 102) was developed and loaded with the same floor load and conventional temperature distribution described by Eq. 1 (Usmani et al. 2003) and mentioned above. Compared to case 1 reported earlier, the hinged column end conditions, the heated floors (95 and 96) and the bending moment applied on top of the perimeter column are the same, but the axial compression is reduced (950 kN or 210 kip) because of the fewer floors above the model. Results of the 12-floor model, shown in Figs. M-13, M-14, and M-15, are very similar to those of the 5-floor model, thus confirming the discussion in Section M.3.

Figure M-13. Overall deflection (not to scale) of 12-floor model (floors 91-102) subjected to gravity loads and with floors 95 and 96 under conventional fire: at the maximum temperature of 1,272 K, the maximum deflection is 1.08 m.

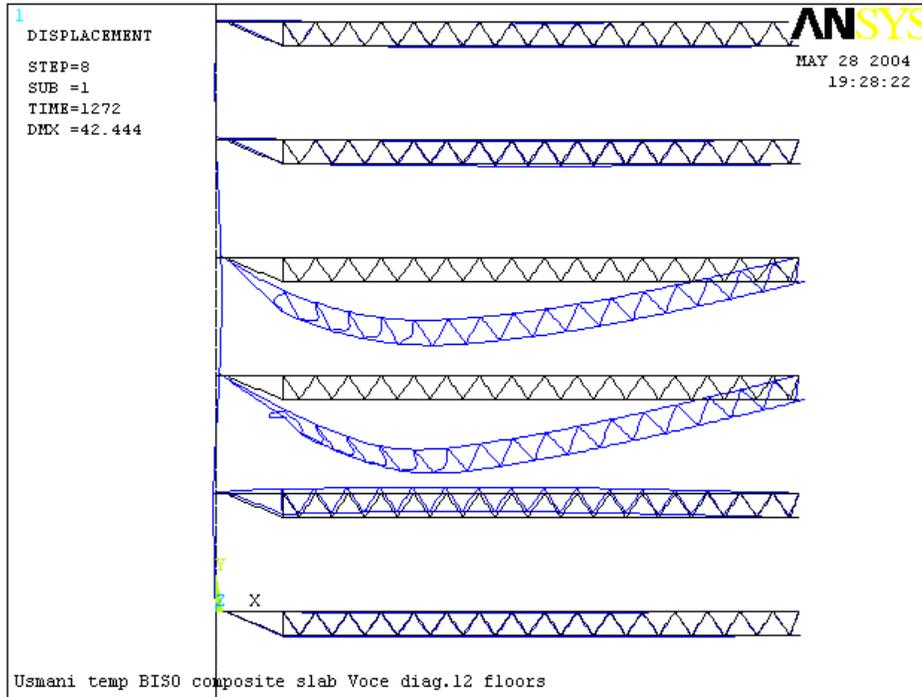
Figure M-14. Details of floors 93–98 for the 12-floor model shown in Fig. M-13 (compare with Fig. M-5).

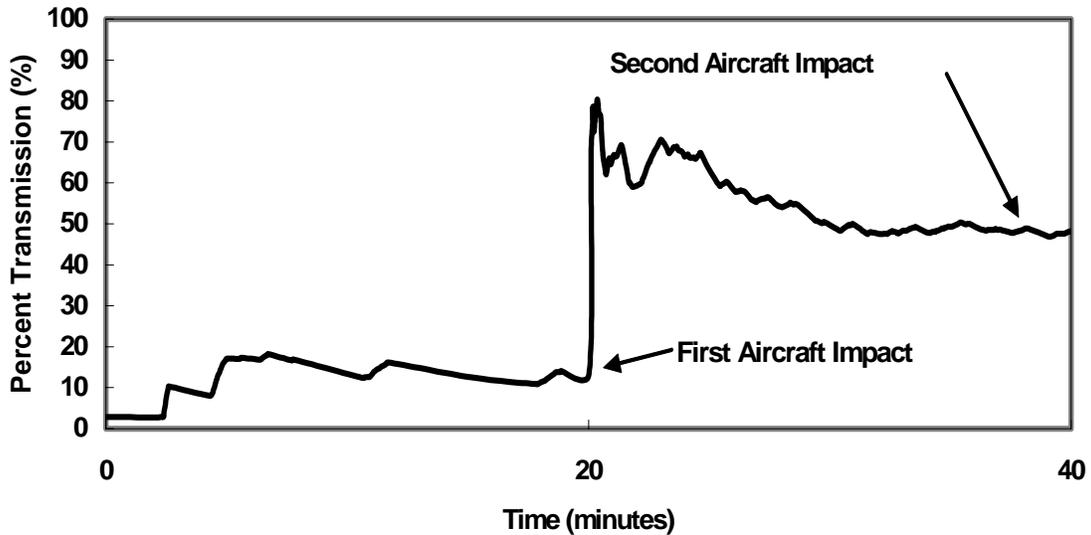
Traffic load for this FDNY channel is summarized in Tables P-1 and P-2 and in Fig. P-2. Figures P-1 and P-2 shows that there was a significant peak in radio traffic that approached an 80 percent level which then dropped to a near steady high level of operations several minutes following the aircraft impact. The communications traffic level following the aircraft impact was four times greater than the level prior to impact.

Figure P-1. PAPD police desk Channel 26/W plot of percent transmission versus time.

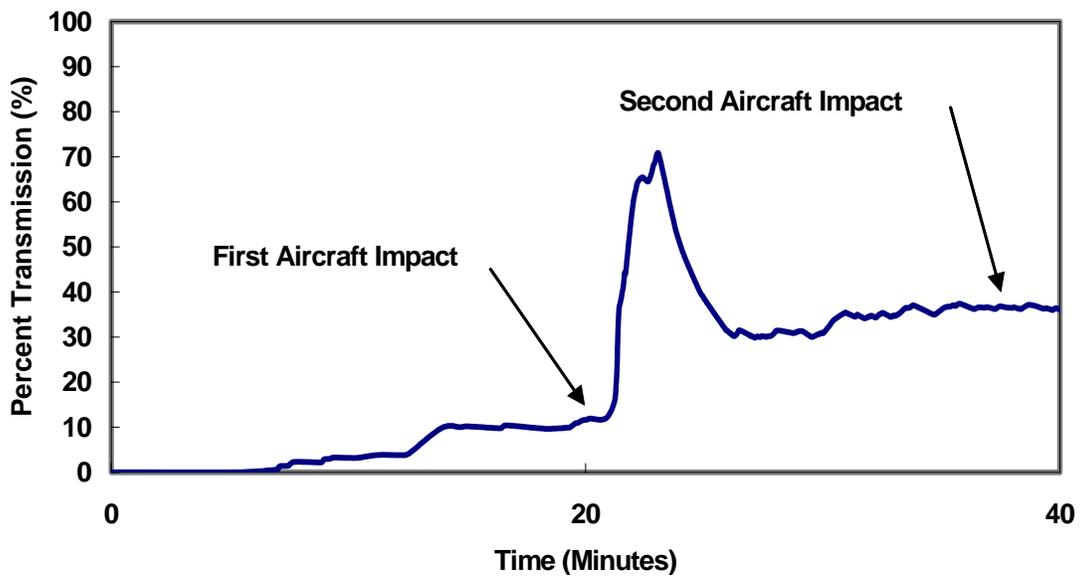
Figure P-2. FDNY City-wide high-rise Channel 7 (PAPD Channel 30) plot of percent transmission versus time.

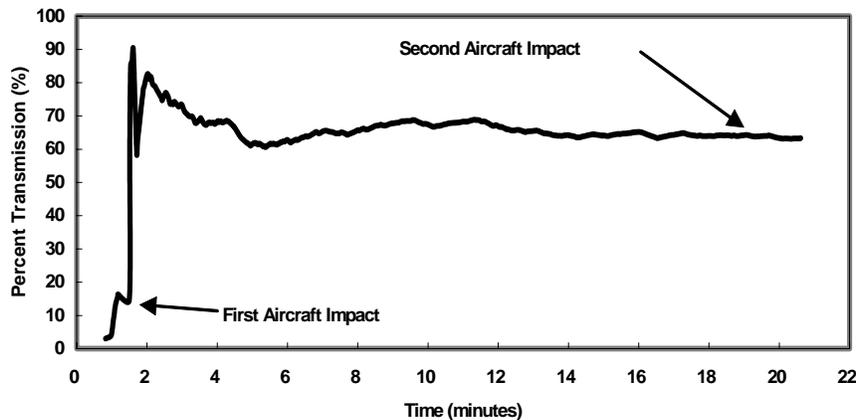
The communications recordings provided by NYPD did not typically contain communications that preceded the attack. However, the Division 1 radio channel recording did start approximately 2 minutes before the first aircraft impacted WTC 1. This 2 minute period provides a limited sample of the level of radio communications prior to the attack. The volume of NYPD communications is shown in Tables P-1 and P-2. These data demonstrate that NYPD had a similar surge in radio traffic immediately following the attack. Figure P-3 shows that the level of transmissions before the attack was at approximately 15 percent. Following the attack the level of transmissions jumped to over 90 percent and then settled down to a level of 63 percent. Radio traffic on the Special Operations Division channel was even higher, as shown in Fig. P-4, peaking near the 95 percent level and staying in the 80 percent range over the remainder of the sample period.

Figure P-3. NYPD Division 1 channel plot of percent transmission versus time.

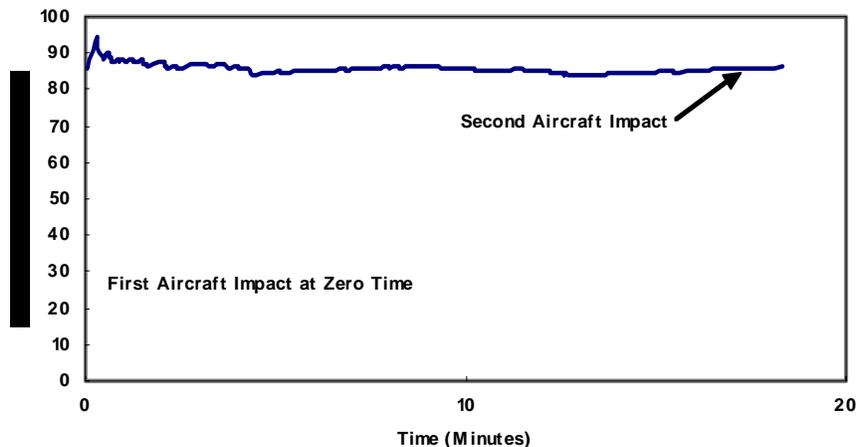
Figure P-4. NYPD Special Operations Division channel plot of percent transmission versus time.

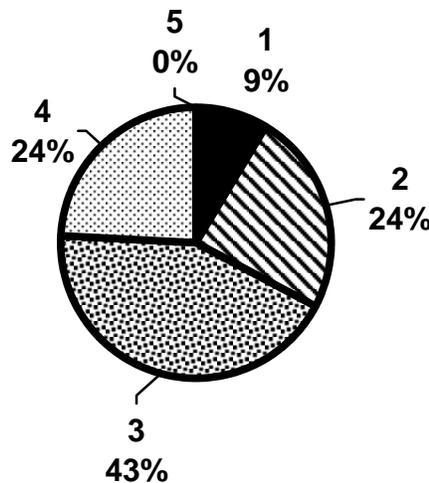
As each of the communications files was transcribed a readability value was assigned for each attempt to communicate. Results of this analysis are shown in Figs. P-5 through P-8. Analysis of these data showed that the ability to transmit a complete message was difficult during the communications surge. Data showed that approximately one-third to one-half of the radio communications for each of the three departments did not exceed a readability level of 2. These emergency communications were not complete and may have not been fully understood. The largest fraction of readability for all radio communications analyzed was recorded at a readability level of 3. This means that this fraction of communications was readable, but audio and radio transmission problems were being experienced. Some conditions that will cause poor communications quality are:

Figure P-5. PAPD police desk Channel 26/W radio communications readability.

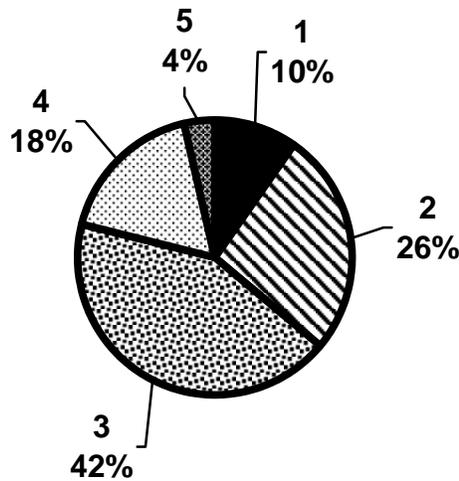
Figure P-6. FDNY City-wide high-rise repeater Channel 7 at the WTC site (PAPD Channel 30), radio communications readability.

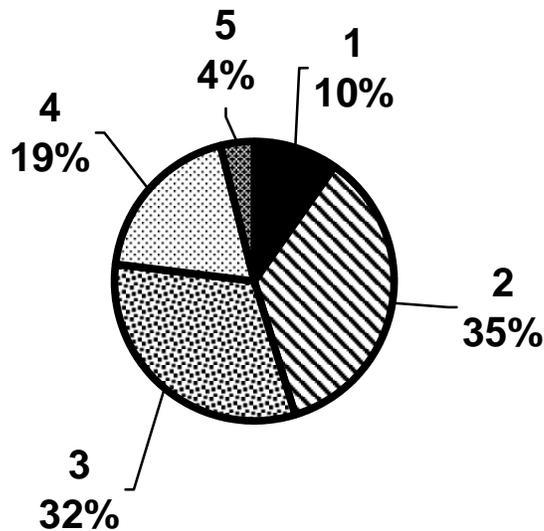
Figure P-7. NYPD Special Operations Division channel radio communications readability.
